CERTIFIED TREE INVENTORY

February 4, 2021

Revision 1

Fountain Alley
San Jose, CA

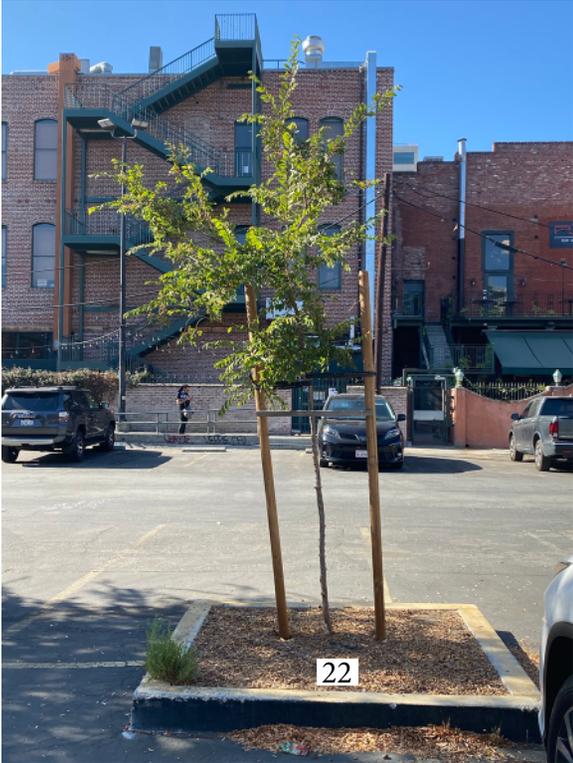
TREE #	BOTANICAL NAME	COMMON NAME	DBH (INCHES)	CIRCUMFERENCE (INCHES)	ORDINANCE TREE	HEALTH	PRESERVATION SUITABILITY	NOTES
22	<i>Ulmus parvifolia</i>	Chinese Elm	1.1	3	NO	4	Good	Newly planted tree
23	<i>Ulmus parvifolia</i>	Chinese Elm	7.0	22	NO	4	Good	
24	<i>Ulmus parvifolia</i>	Chinese Elm	10.5	33	NO	4	Good	
25	<i>Syzygium paniculatum</i>	Brush Cherry	13.1	41	YES	2	Poor	Overgrown shrub / tree, PS, CD
26	<i>Platanus acerifolia</i>	London Plane	14.5	46	YES	3	Moderate	CDB, CR,SD,ST, Anthracnose symptoms
27	<i>Platanus acerifolia</i>	London Plane	11.7	37	NO	3	Moderate	CDB, CR,SD,ST, Anthracnose symptoms
28	<i>Platanus acerifolia</i>	London Plane	13.7	43	YES	3	Moderate	CDB, CR,SD,ST, Anthracnose symptoms
29	<i>Platanus acerifolia</i>	London Plane	14.0	44	NO	3	Moderate	CDB, SD, ST. Limited planting area in small tree well
30	<i>Platanus acerifolia</i>	London Plane	11.0	35	NO	3	Moderate	CDB, SD, ST. Limited planting area in small tree well
