Phase I Environmental Site Assessment

TYPE OF SERVICES	Phase I Environmental Site Assessment Update
LOCATION	San Jose Flea Market 1590 Berryessa Road and 1411 Mabury Road San Jose, California
CLIENT	David J. Powers & Associates
PROJECT NUMBER	118-98-1
DATE	March 28, 2018

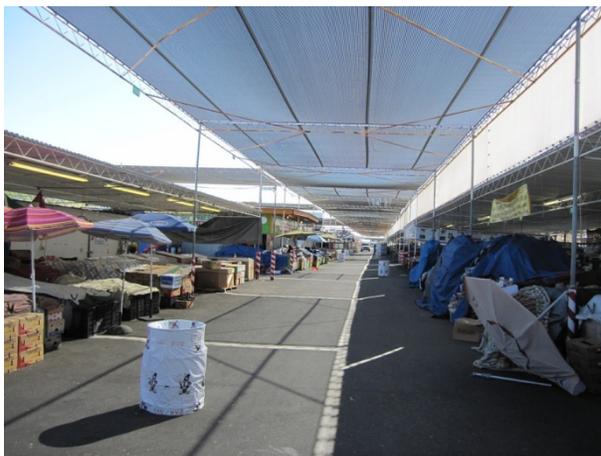
Photograph 1. View of merchandise sales area.

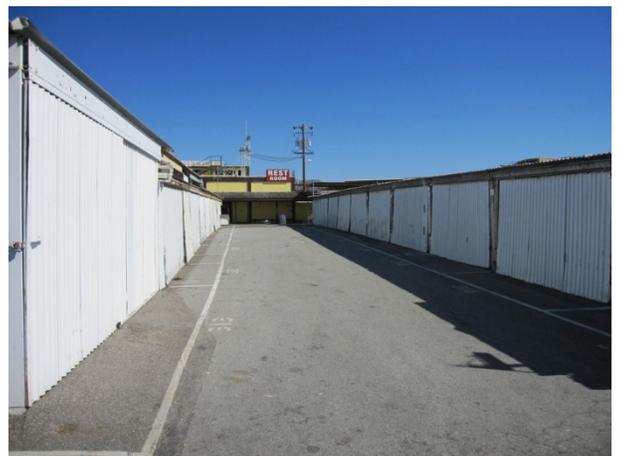
Photograph 2. View of merchandise sales area.

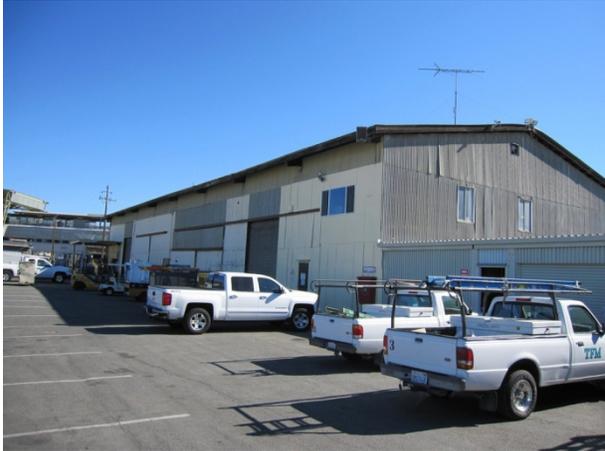
Photograph 3. View of main maintenance building.

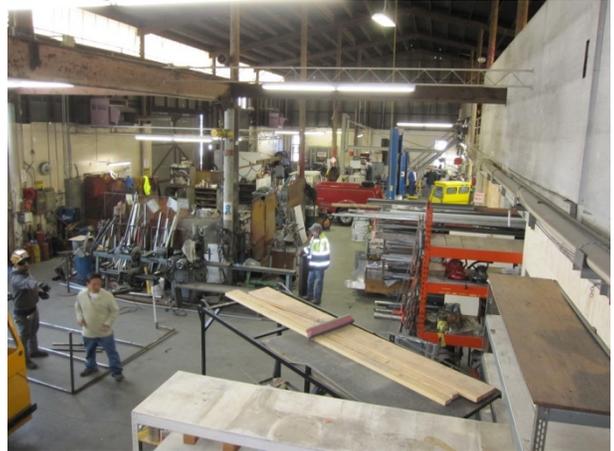
Photograph 4. Interior of maintenance building.

As part of the facility closure process, the two below grade hydraulic vehicle lifts within the maintenance building should be removed (including associated piping and hydraulic fluid reservoirs) and verification soil samples should be collected to document soil quality. We additionally recommend that soil sampling be conducted at the locations of the drains associated with the two steam cleaning areas. The removal and sampling activities should be observed and documented by an Environmental Professional.

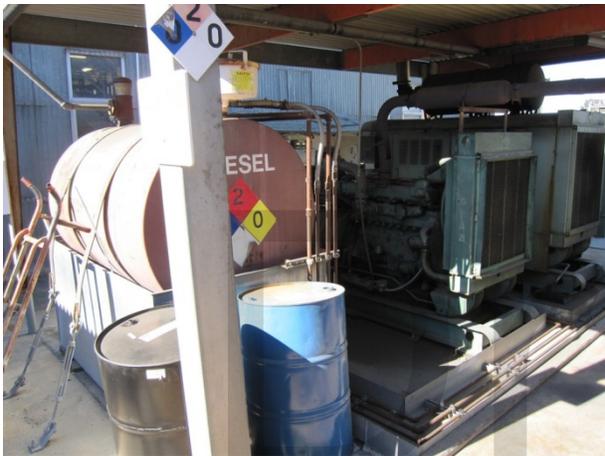
Photograph 5. Two emergency generators and associated diesel AST.

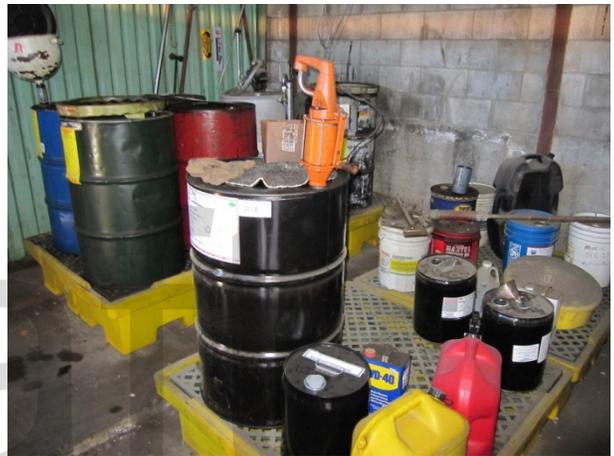
Photograph 6. Stored items in hazardous materials storage shed.

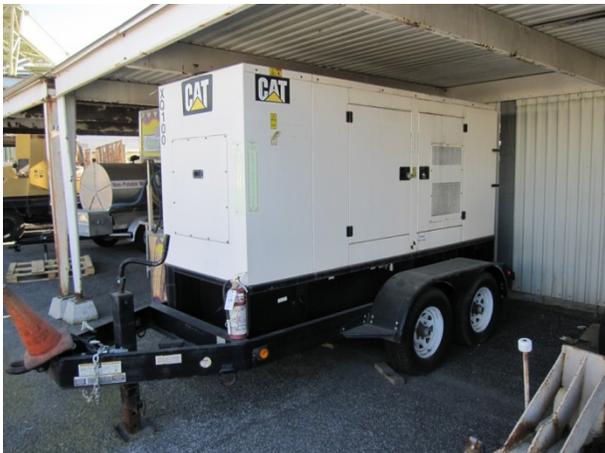
Photograph 7. One of several trailer mounted emergency generators.

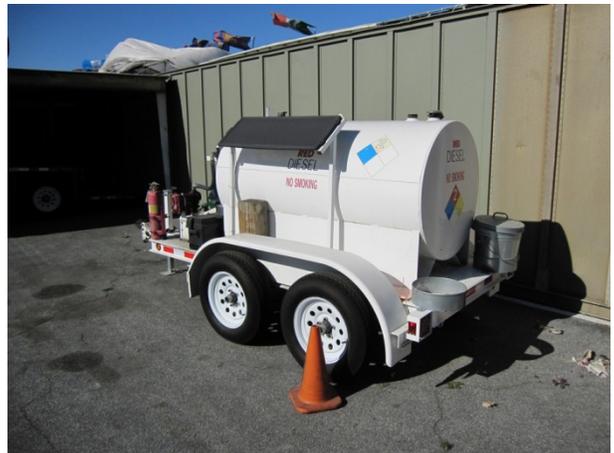
Photograph 8. Trailer mounted diesel AST.

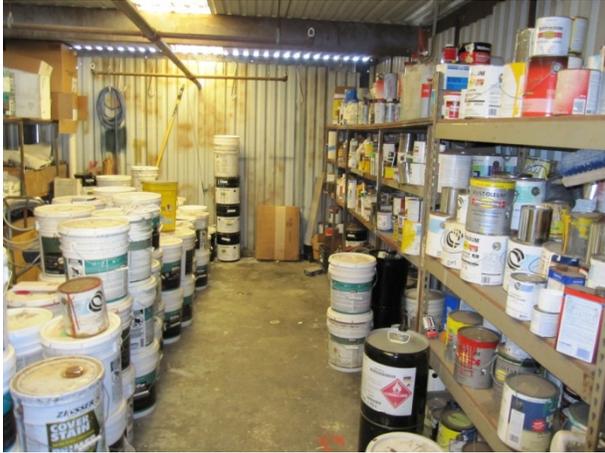
Photograph 9. Paint storage shed.

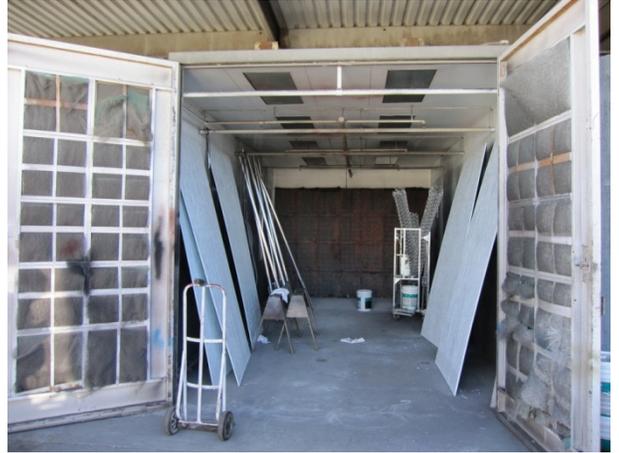
Photograph 10. Paint spray booth.

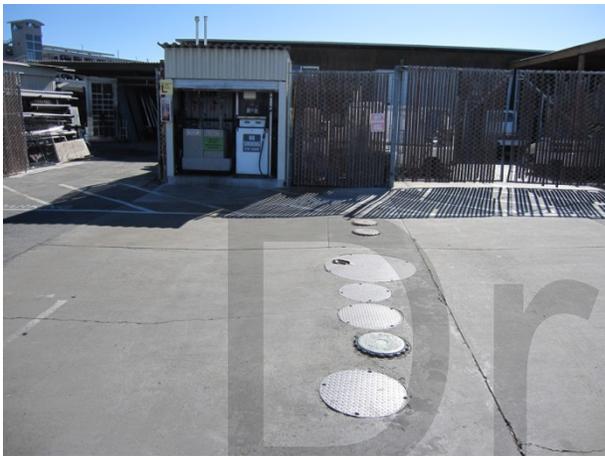
Photograph 11. Dual compartment UST, dispenser and adjacent oil and hydraulic fluid ASTs.

Gasoline and diesel currently are stored within a dual compartment 8,000 gallon UST. Prior to redevelopment of the Site, this UST should be removed in coordination with the San Jose Fire Department and DEH, and underlying soil and ground water quality should be evaluated. For a higher level of comfort, sampling can be performed prior to UST removal to help establish baseline conditions.

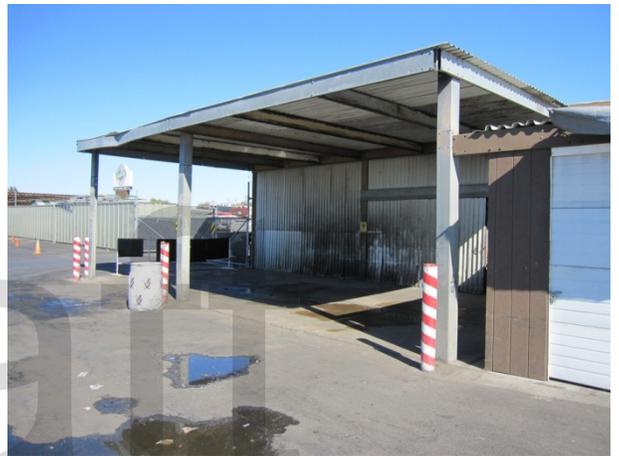
Photograph 12. Steam cleaning area near food services warehouse.

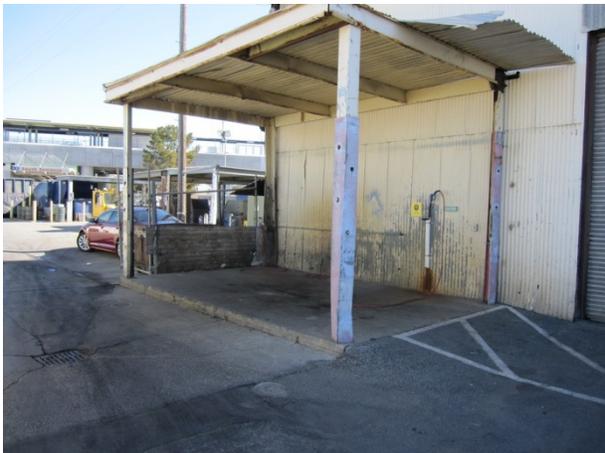
Photograph 13. Steam cleaning area at maintenance building.

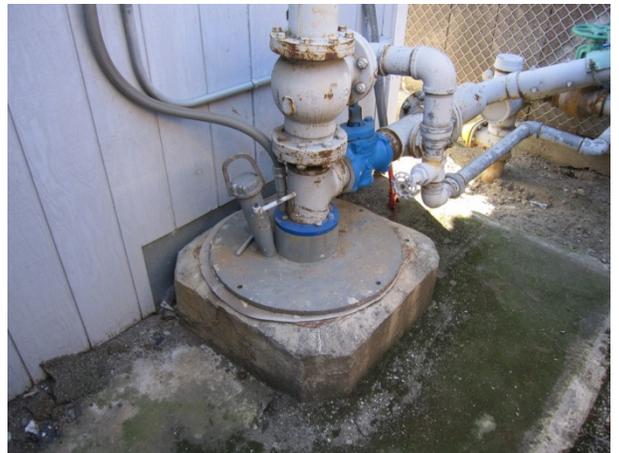
Photograph 14. Water supply well.

Several ground water monitoring wells historically were installed near the USTs. An active water supply wells also is present at the Site. Additional water supply wells reportedly were historically present at the Site prior to acquisition by The Flea Market. Abandoned wells⁴ can act as a conduit for the vertical migration of ground water contamination. Also, if ground water levels rise, an abandoned well can become an artisan well with uncontrolled water flow that can adversely impact future developments. Prior to redevelopment of the Site, we recommend that well records from the SCVWD be researched and that attempts be made to locate abandoned wells at the Site. If identified, or subsequently encountered during earthwork activities, they should be properly destroyed in accordance with SCVWD Ordinance 90-1.

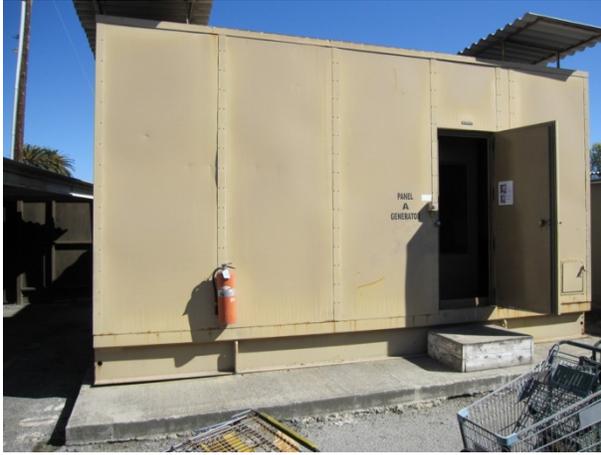
Photograph 15. Emergency generator near water supply well.

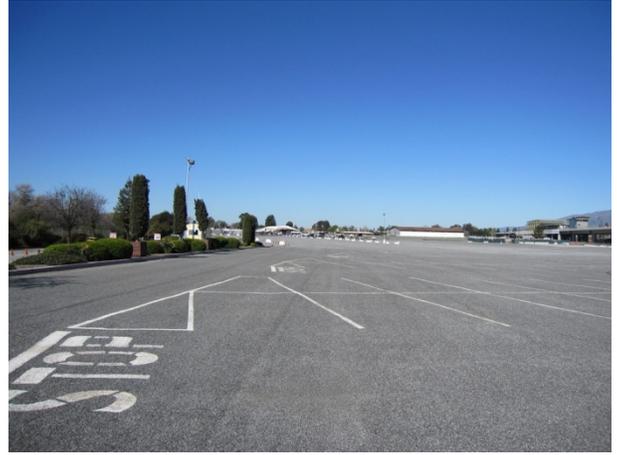
Photograph 16. Southern parking lot, looking north.
