January 28, 2013

DRAFT REVIEW FOR REVIEW ONLY- Updated

Subject: 12-201, Town Of Samoa, Contributing Outbuilding Study

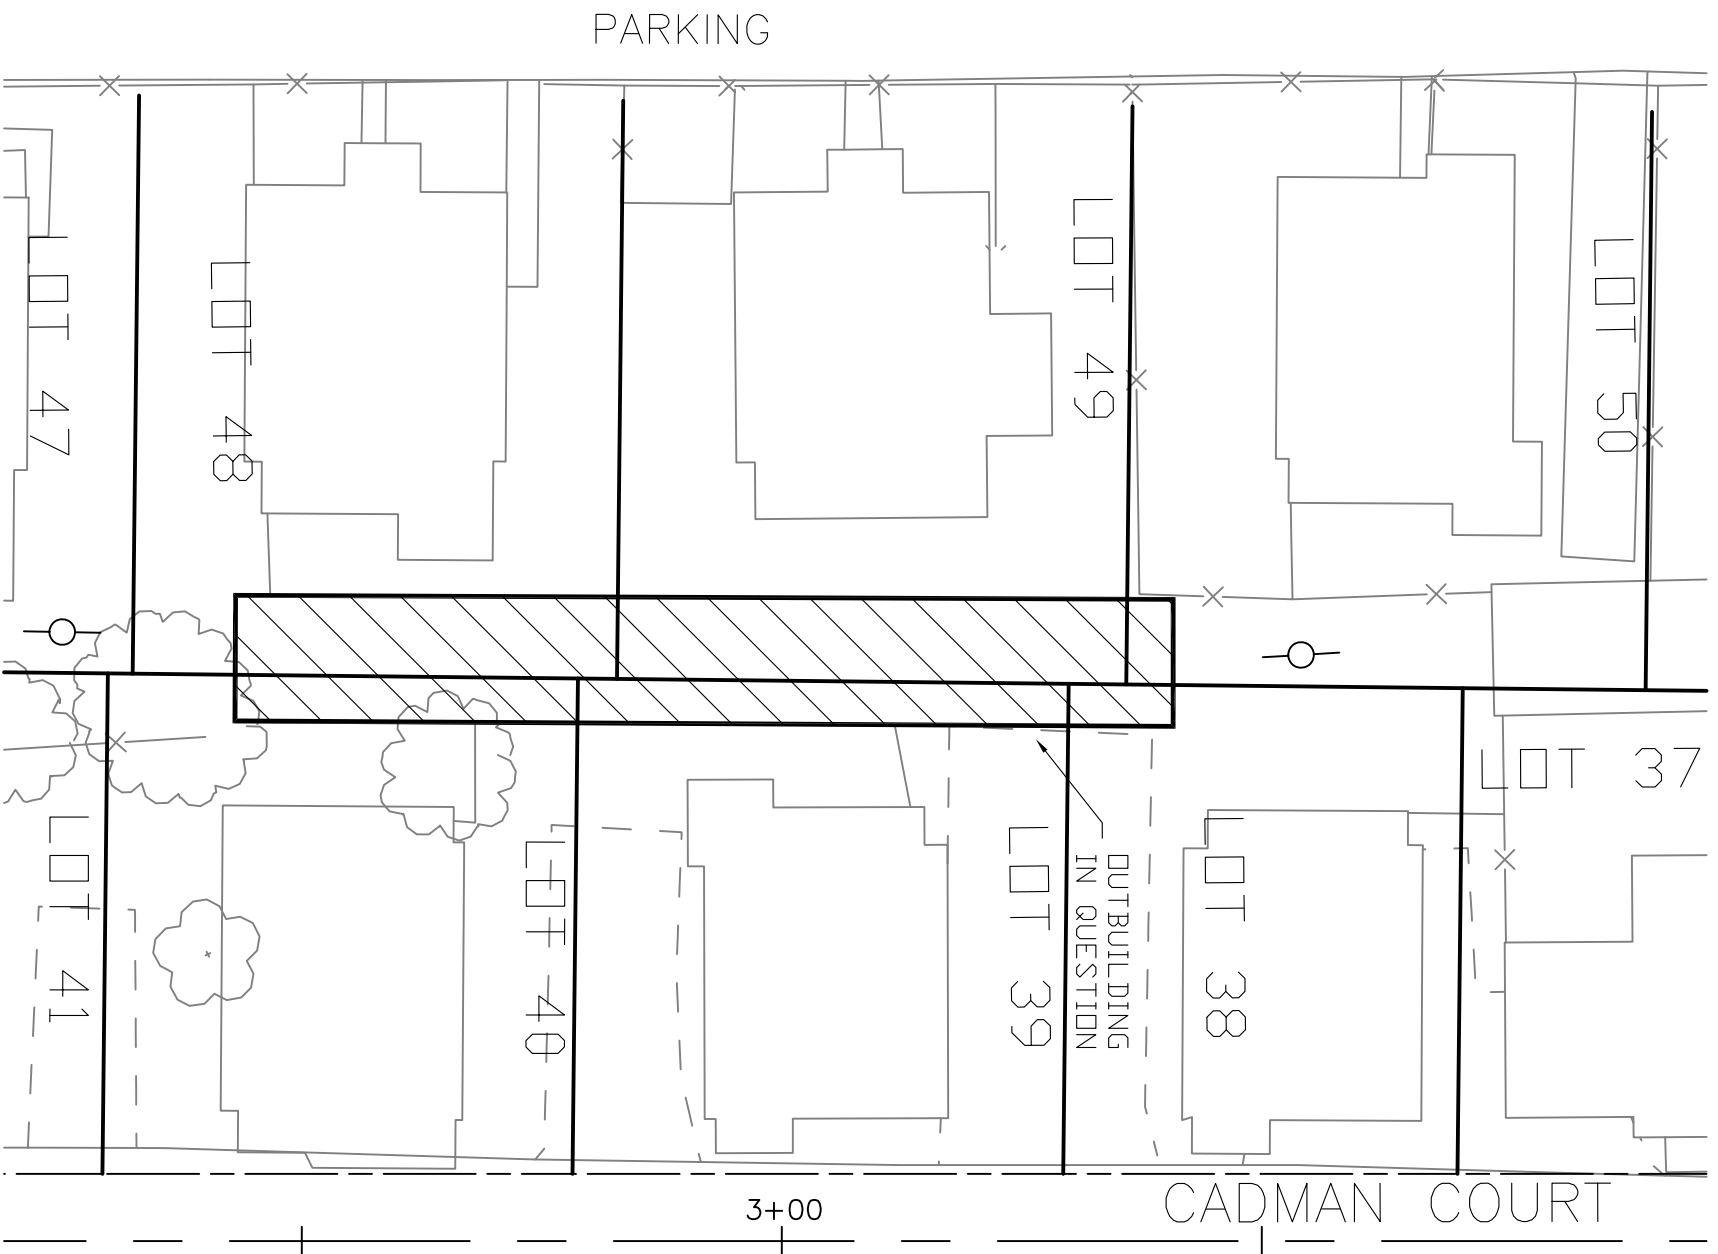
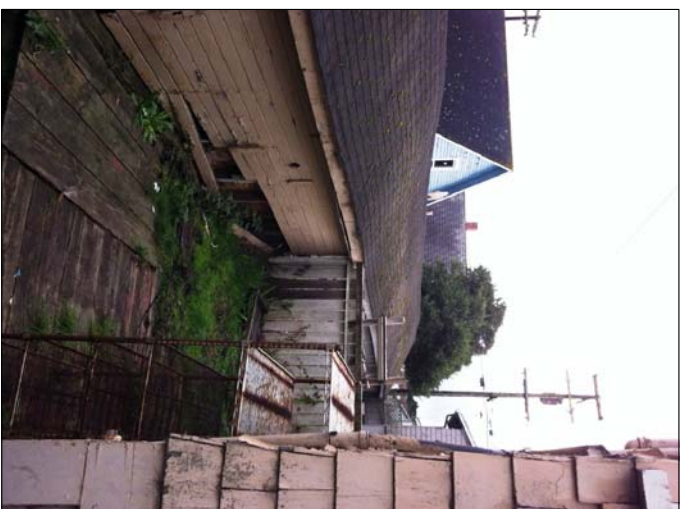
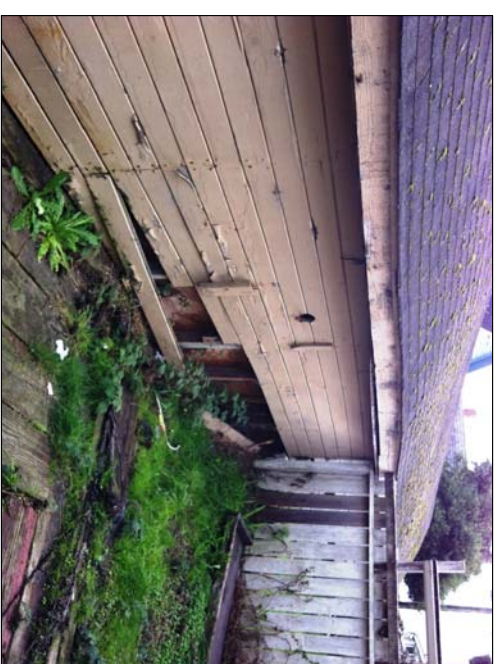
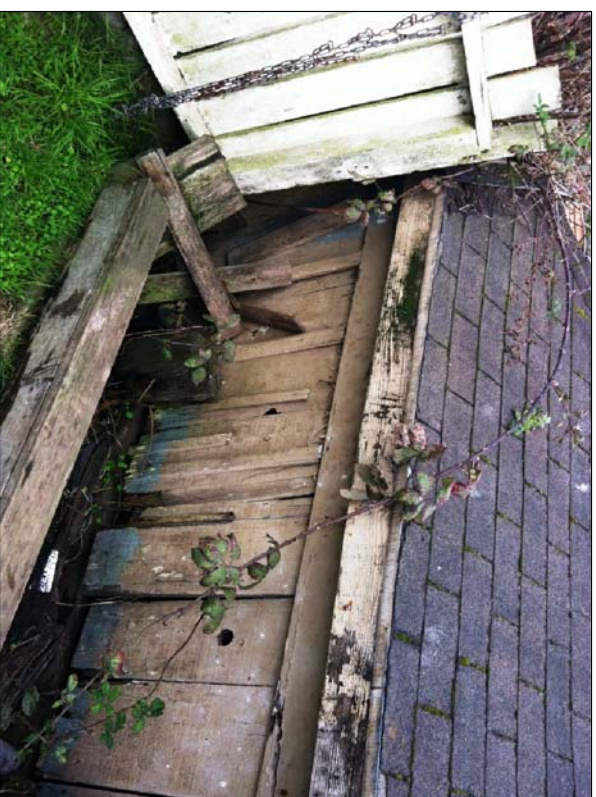
SHEET 1 OF 9

Lot No's 48, 49, 50 Cadman Ct, 40, 39, 38 Vance Avenue (plot plan sheet 1)

This building is of wood frame construction, it has a wooden post and pier block foundation, horizontal tongue & groove wood siding, and shingle roof. The building is located on six different lots and is approximately 98 feet long by 13 feet wide. Its condition shows advanced deterioration; the roof has moss growing on it, and appears to be failing due to the broken trusses located inside, evidenced by the sags which can be seen on the outside. The roofing system has significant areas of structural failure, and leaks. The building sides have significant structural failure and some of the siding has fallen off. The paint is peeling. The building is not structurally sound in it's current state and by my estimation is beyond it's useful life. I would consider it a hazard. The remaining wood pieces are dilapidated, so that they could not be re-used in the event the building were to be torn down with the intention of reconstruction. My recommendation would be to demolish and remove it due to the impossibility of moving it because of its size. As well, it appears to be near the end of its usable life span due to deterioration.

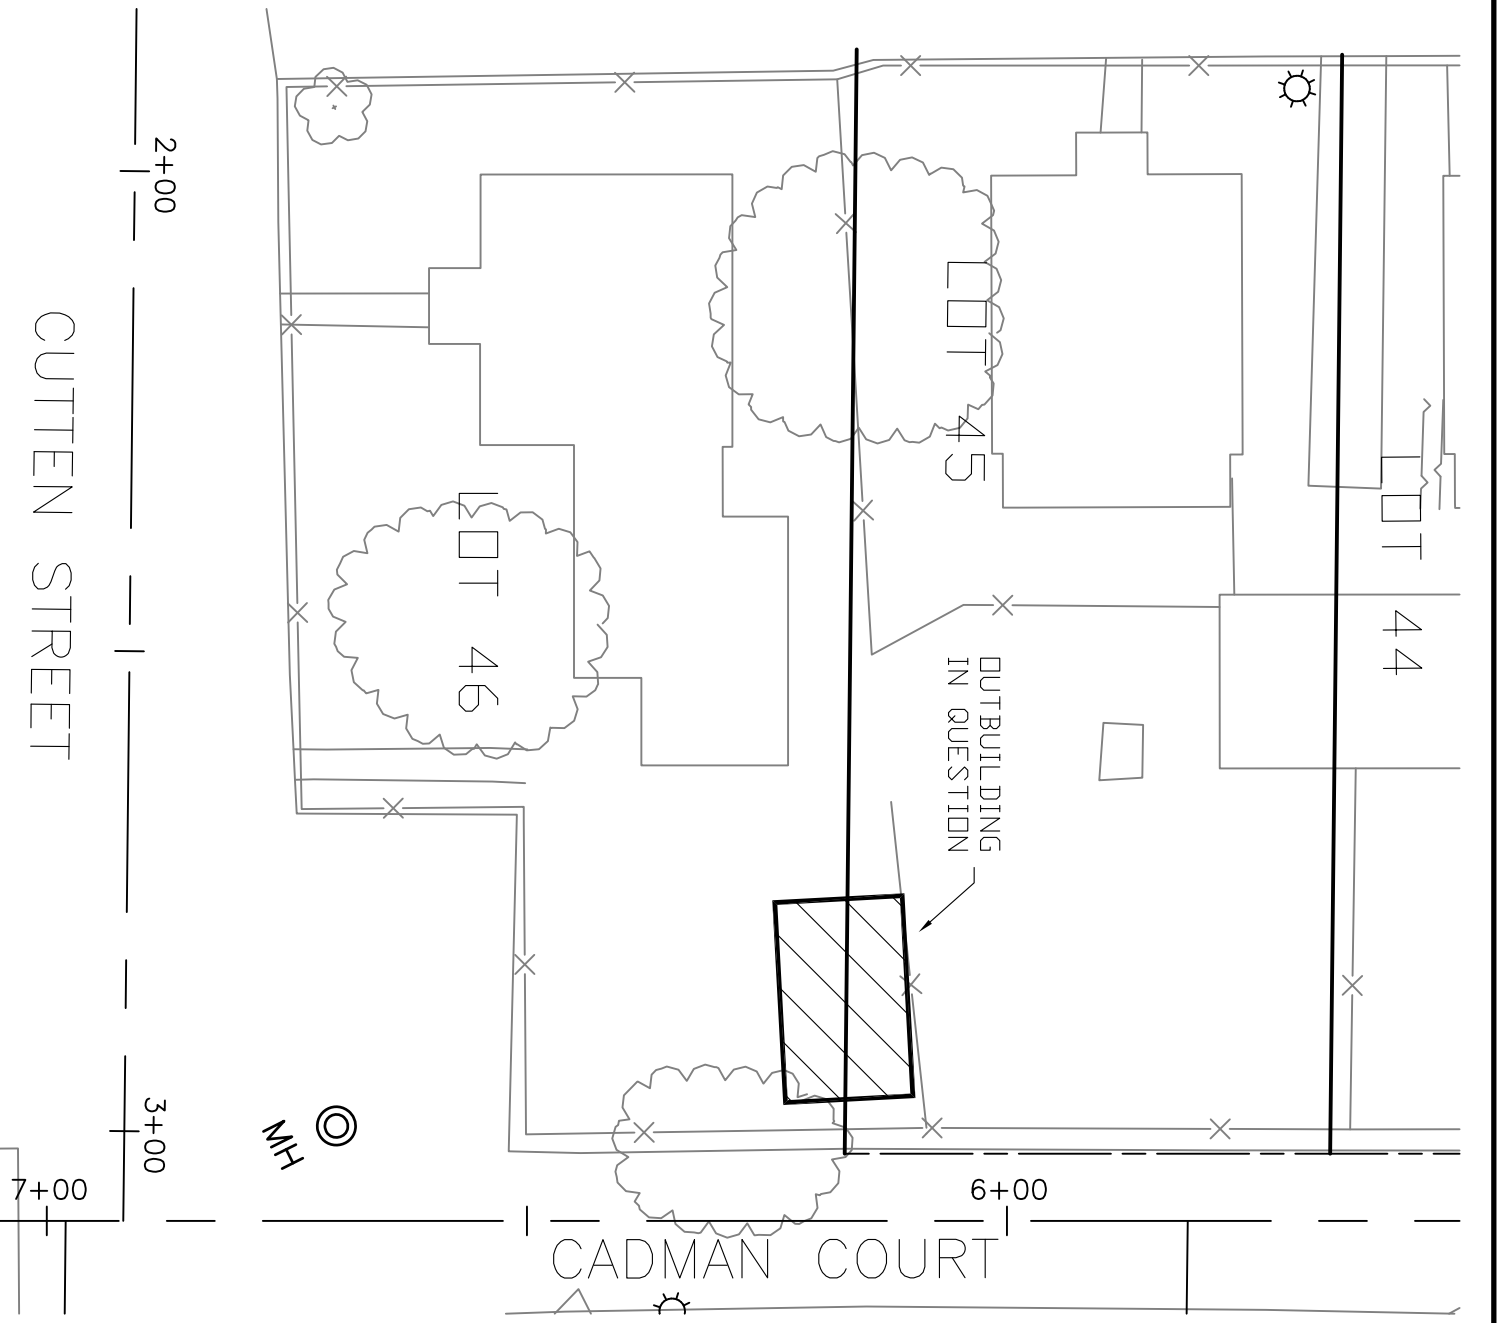
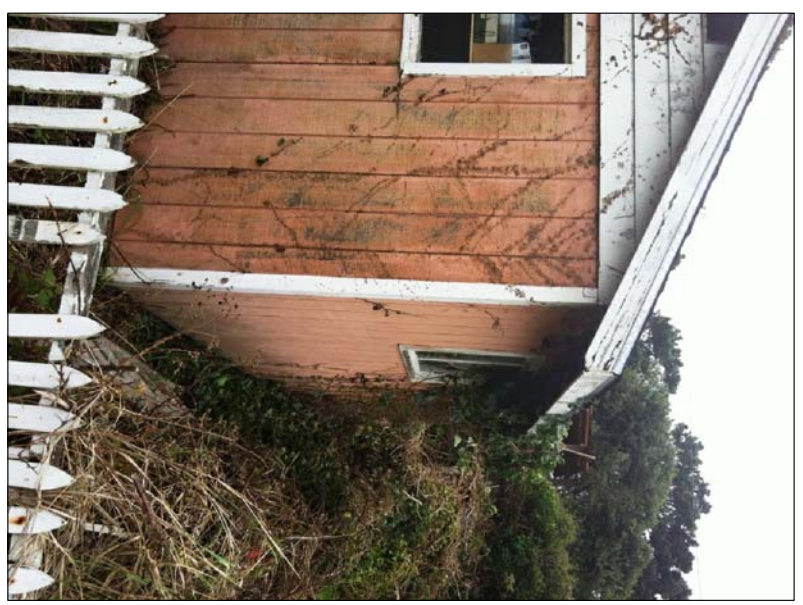
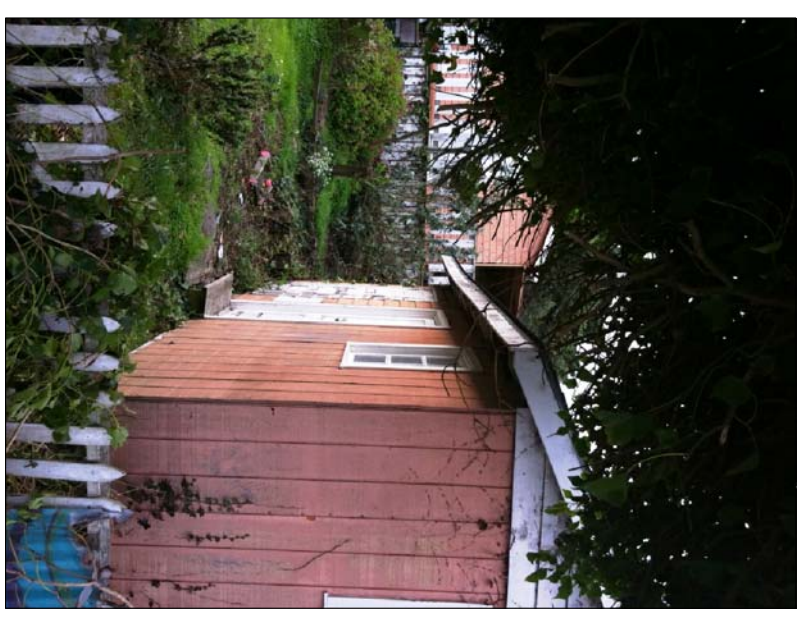
SHEET 2 OF 9

Lot No's 45, 46 Cutten Street (plot plan sheet 2)

This building is of wood frame construction, it has a wooden post and pier block foundation, plywood siding, and shingle roof. This building is located on two different lots, and measures approximately 21x13. The structure is in poor condition; the shingles are newer and siding intact, however there is significant dry rot throughout the structure. This building does not appear to be of the same chronological era as many of the other structures located within the town, and it's my assertion that this structure may be of limited or no historical significance. Its my assessment that this building could not be moved, however, even though it's in fair shape, as the floor diaphragm would not be able to hold the building together and upon picking it up, I feel that the building floor will not structurally support the acting downward and lateral forces as would be caused by moving the structure. Due to the wood type and age, it's my assessment that tearing the

building down and placing it in another location is not a viable option. Even though the building appears to be in fair condition, moving or relocating it otherwise would destroy it, so it's my recommendation is that this outbuilding be removed entirely from the site.

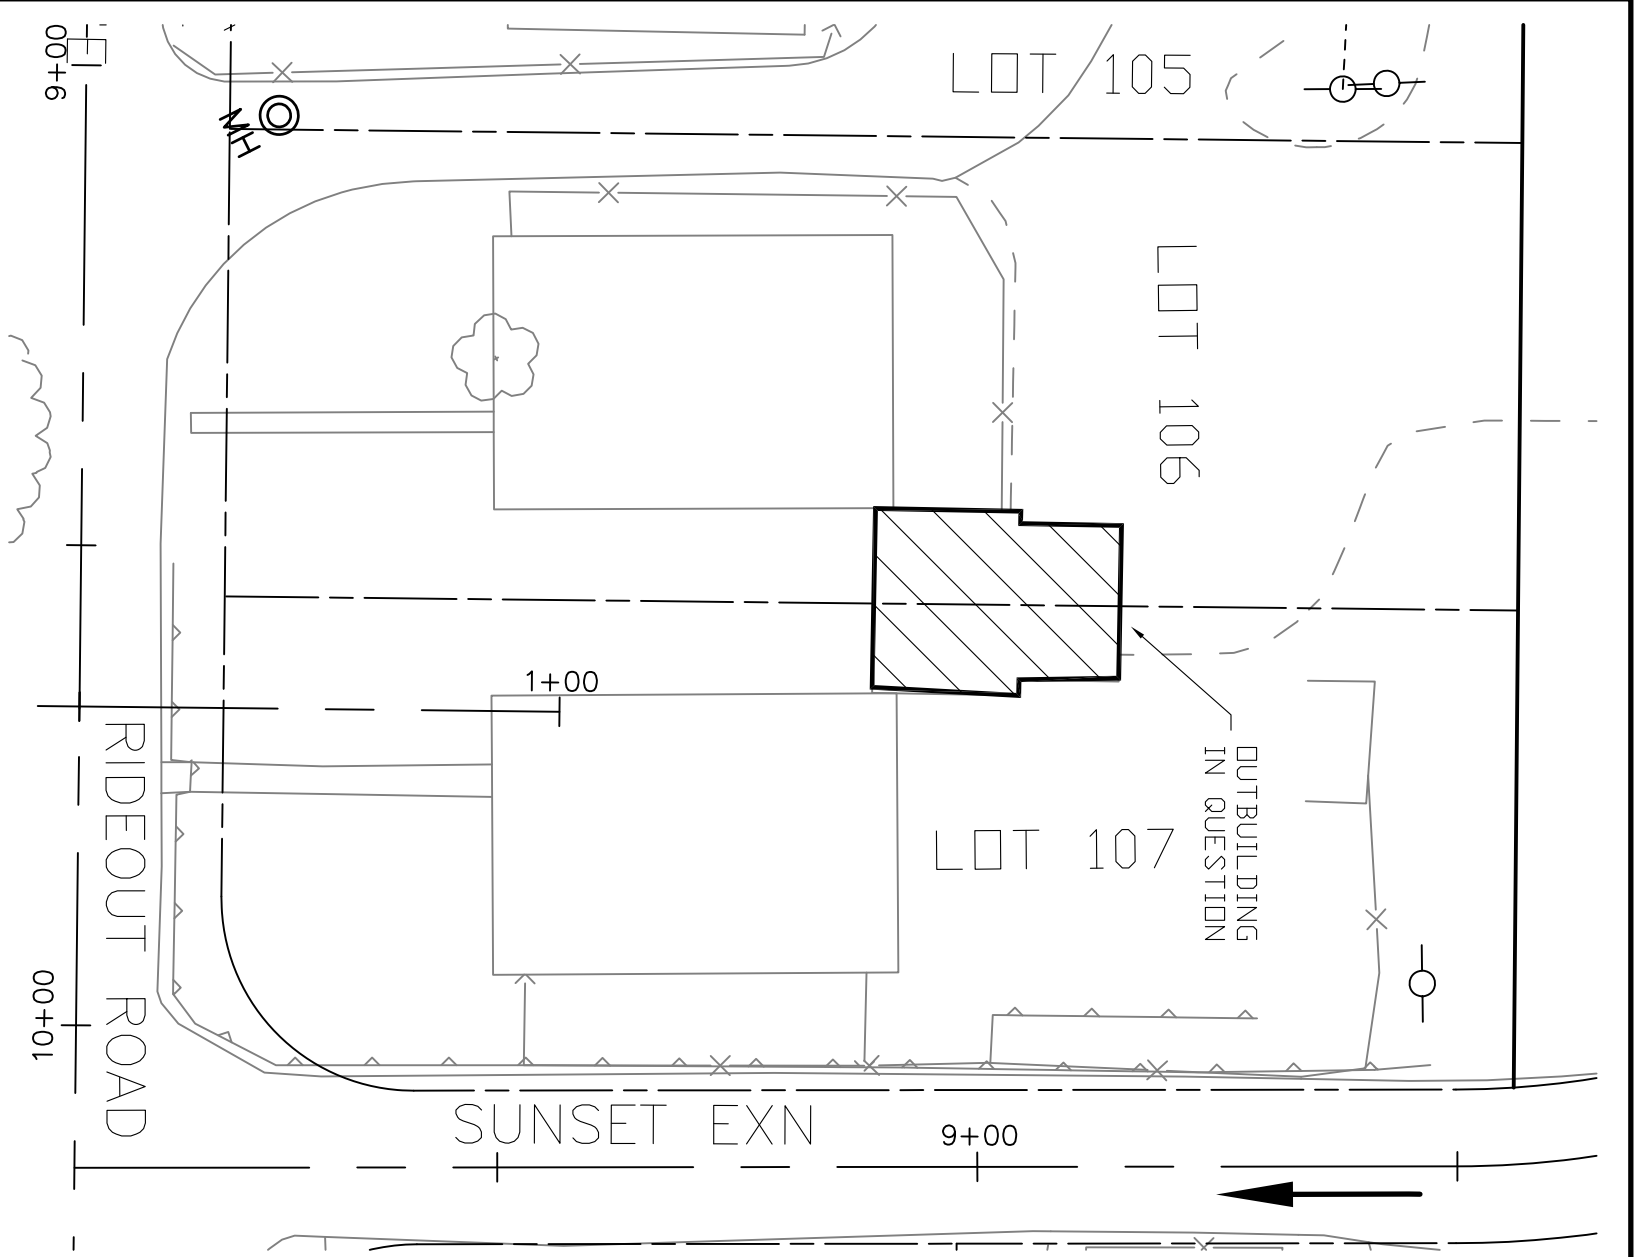
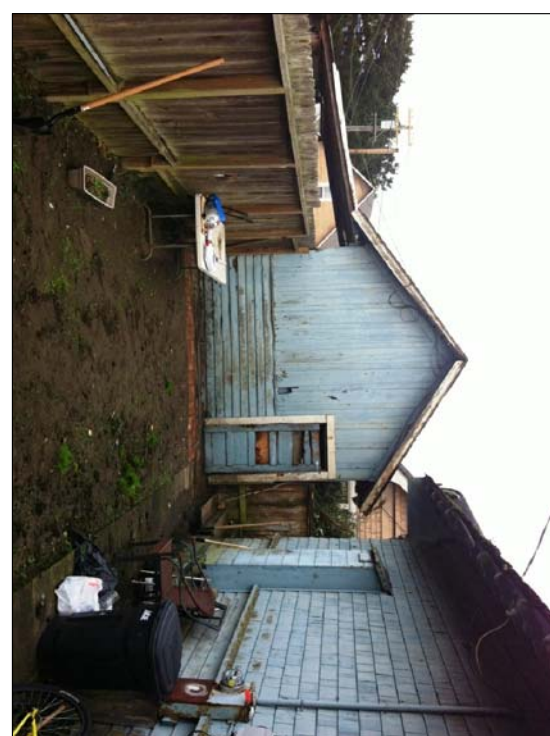
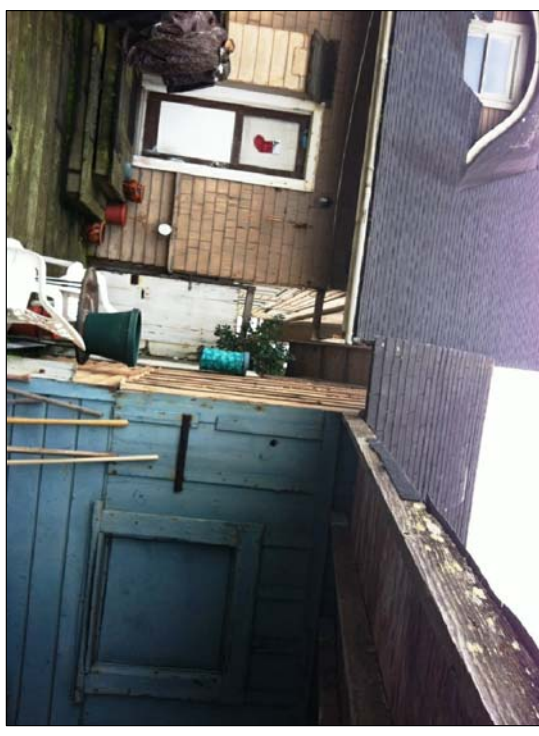
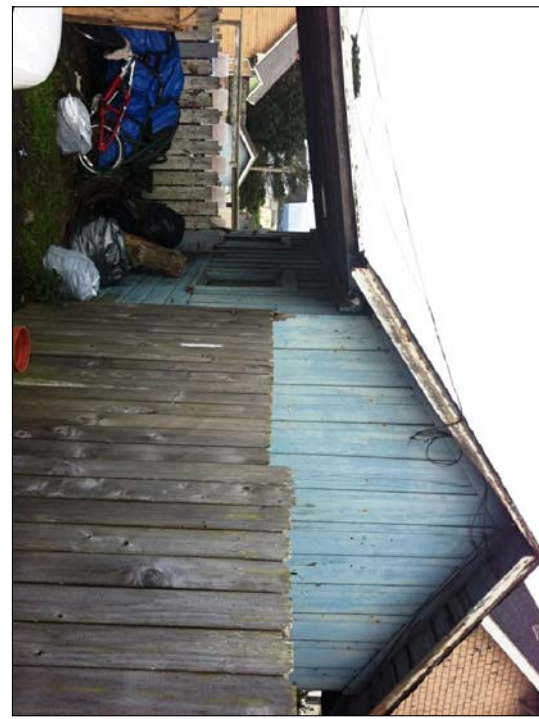
SHEET 3 OF 9

Lot No's 106 & 107 Rideout Road (plot plan sheet 3)

This building is of wood frame construction, it has a wooden post and pier block foundation, a combination of vertical board and batten; and horizontal tongue & groove wood siding, and shingle roof. It is located on two lots and is 19x15 with an attached 16x11 attached overhang. The overall condition of the structure is poor. The interior roof trusses show signs of failing and the exterior of the walls are in disrepair. The building is beyond its useful life and would completely fall apart upon attempting to move it. The building materials are extremely poor shape and it would not be a candidate to tear down and reconstruct at another location, because the existing materials would not be useable. I recommend removing this building and the attached awing/overhang.

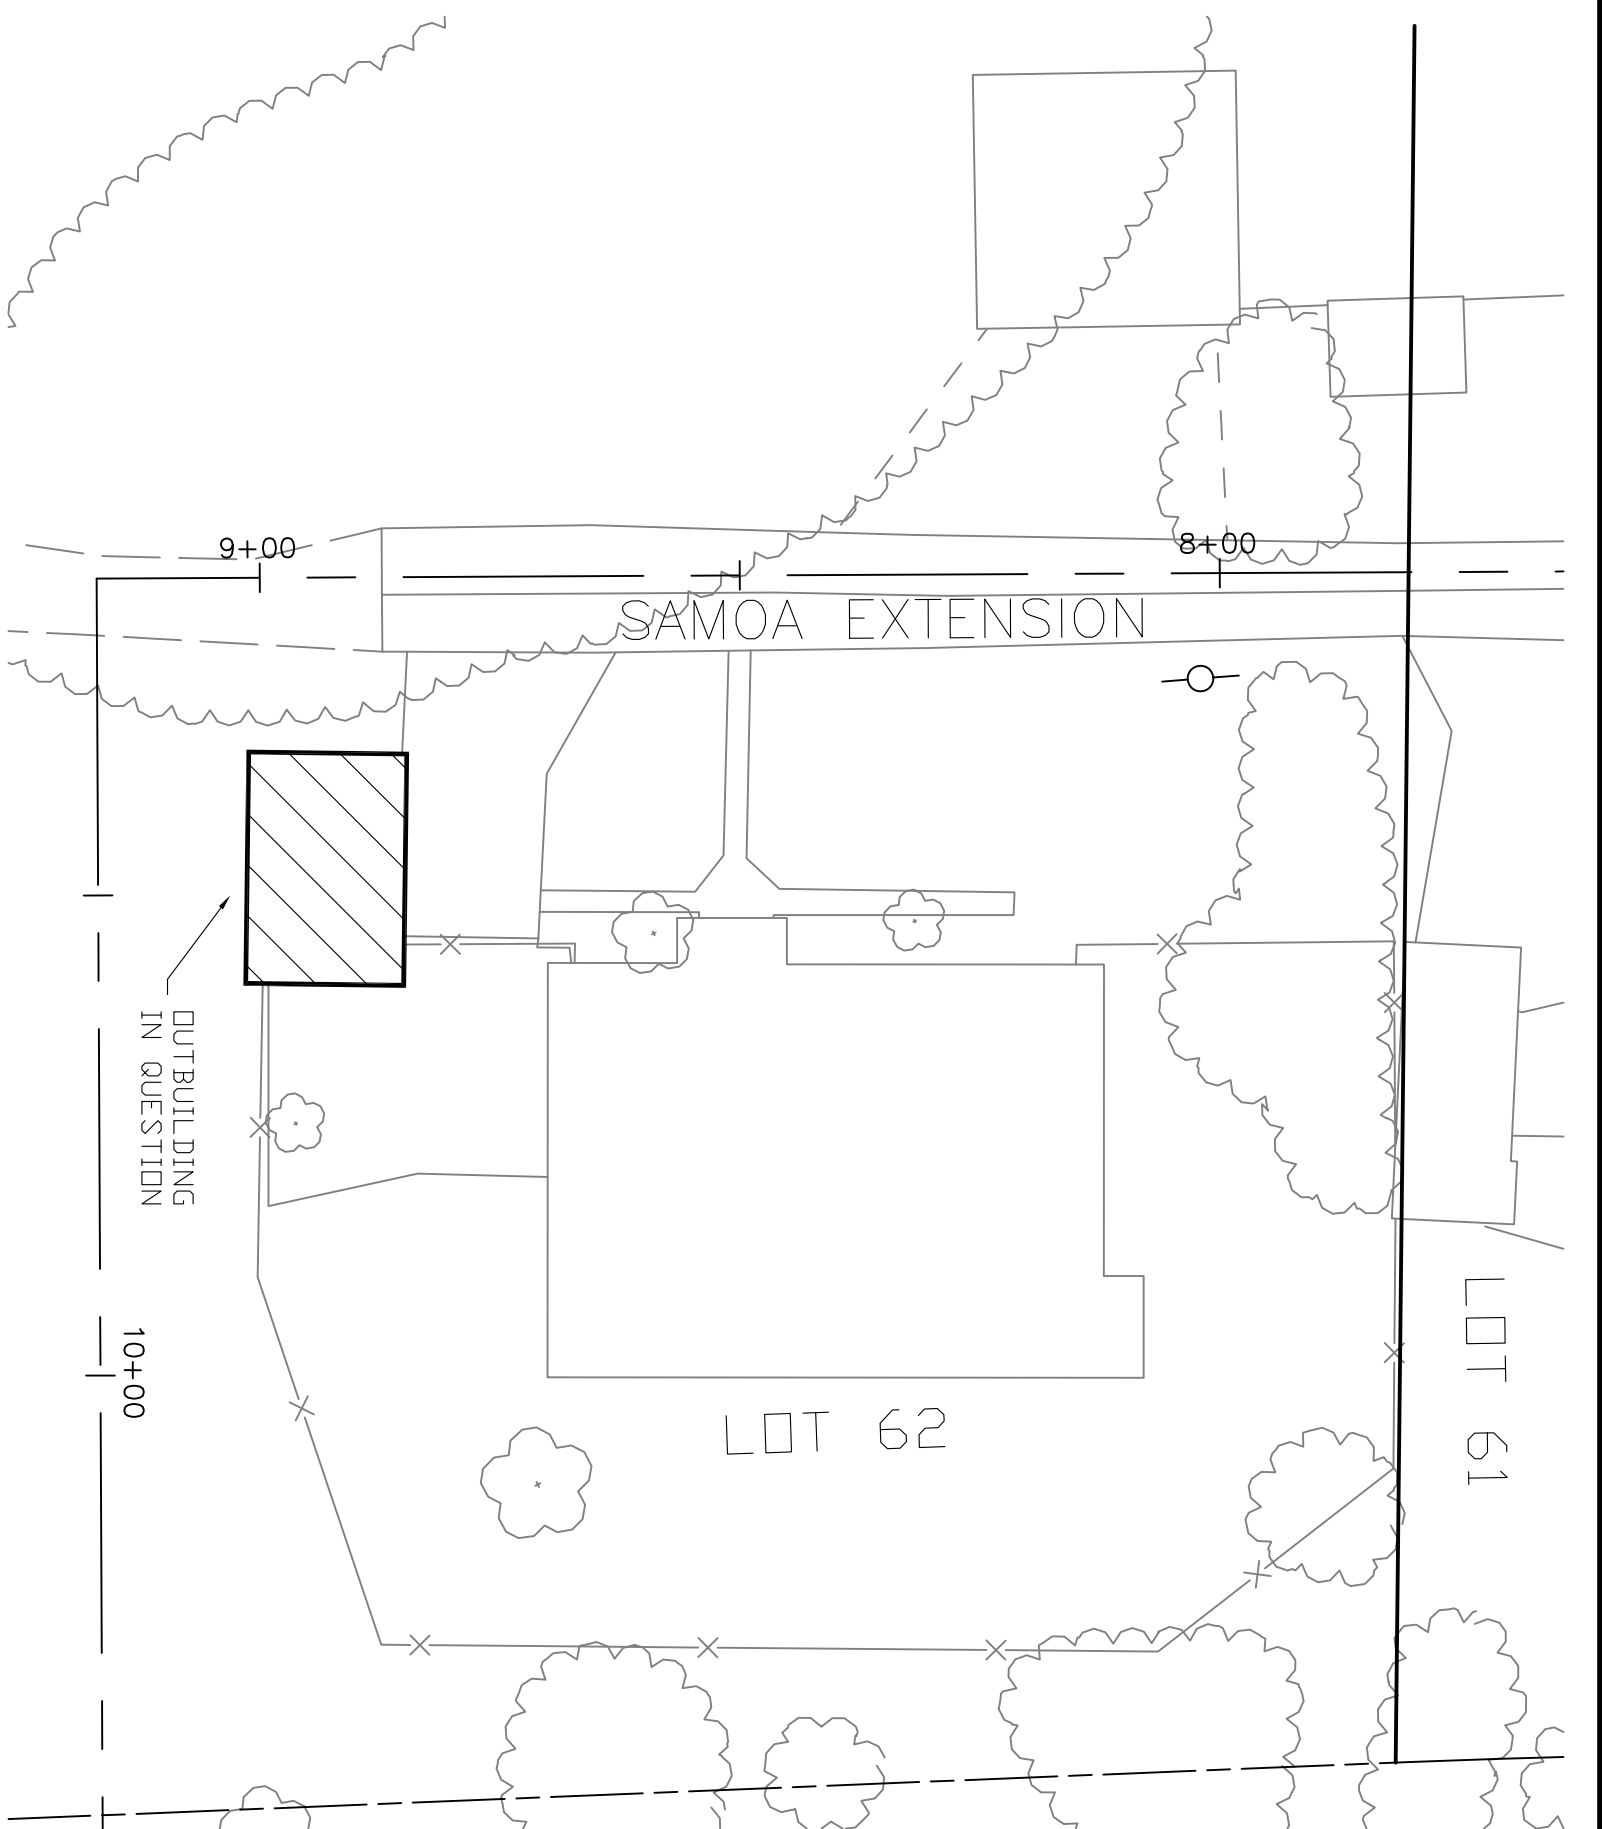
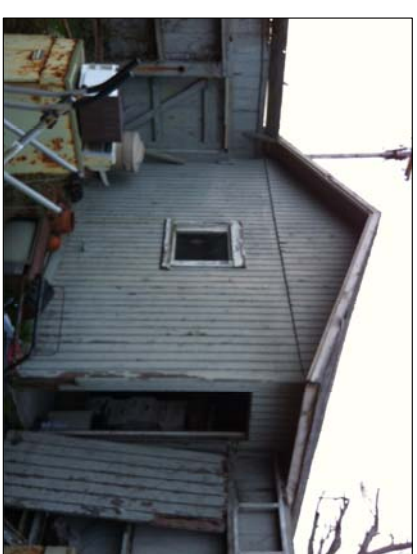
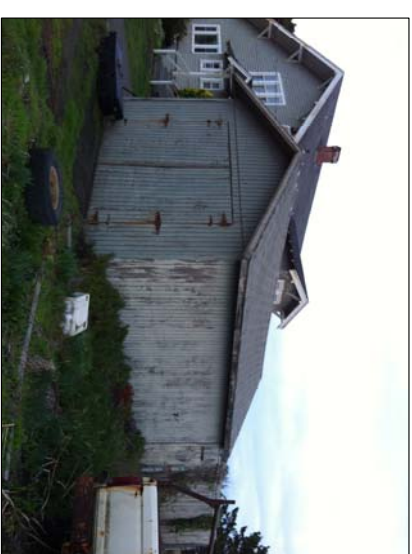
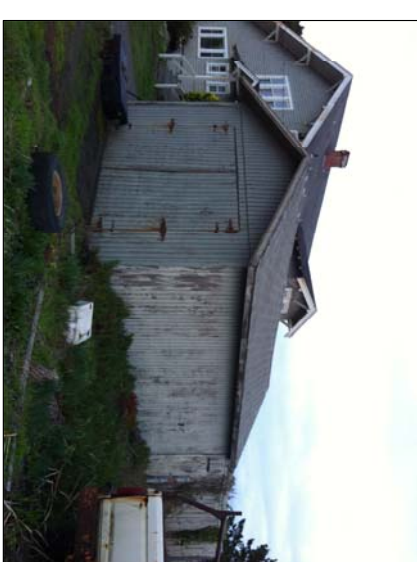
SHEET 4 OF 9

Lot No's 62 Samoa Extension (plot plan sheet 4)

This building is of wood frame construction, it has a wooden post and pier block foundation, wood plank tongue and groove siding, and shingle roof. Located on one lot, the building is approximately 16.5x24 in dimension. It has two large gate-hinge doors so as to allow a vehicle inside. The condition of the roofing is fair/poor. Paint has peeled badly in places. One door has come off. The building otherwise seems structurally sound. This building could not be relocated as it lacks any structural integrity to withstand a move. The existing materials could not be removed and reconstructed elsewhere as they are no longer of structural. This building could be repaired/preserved if addressed in a timely fashion (right away) and new door hinges and roof shingles added. My recommendation would be to preserve the outbuilding due to its moderate amount of remaining lifespan, which could be extended and location on a solitary lot.

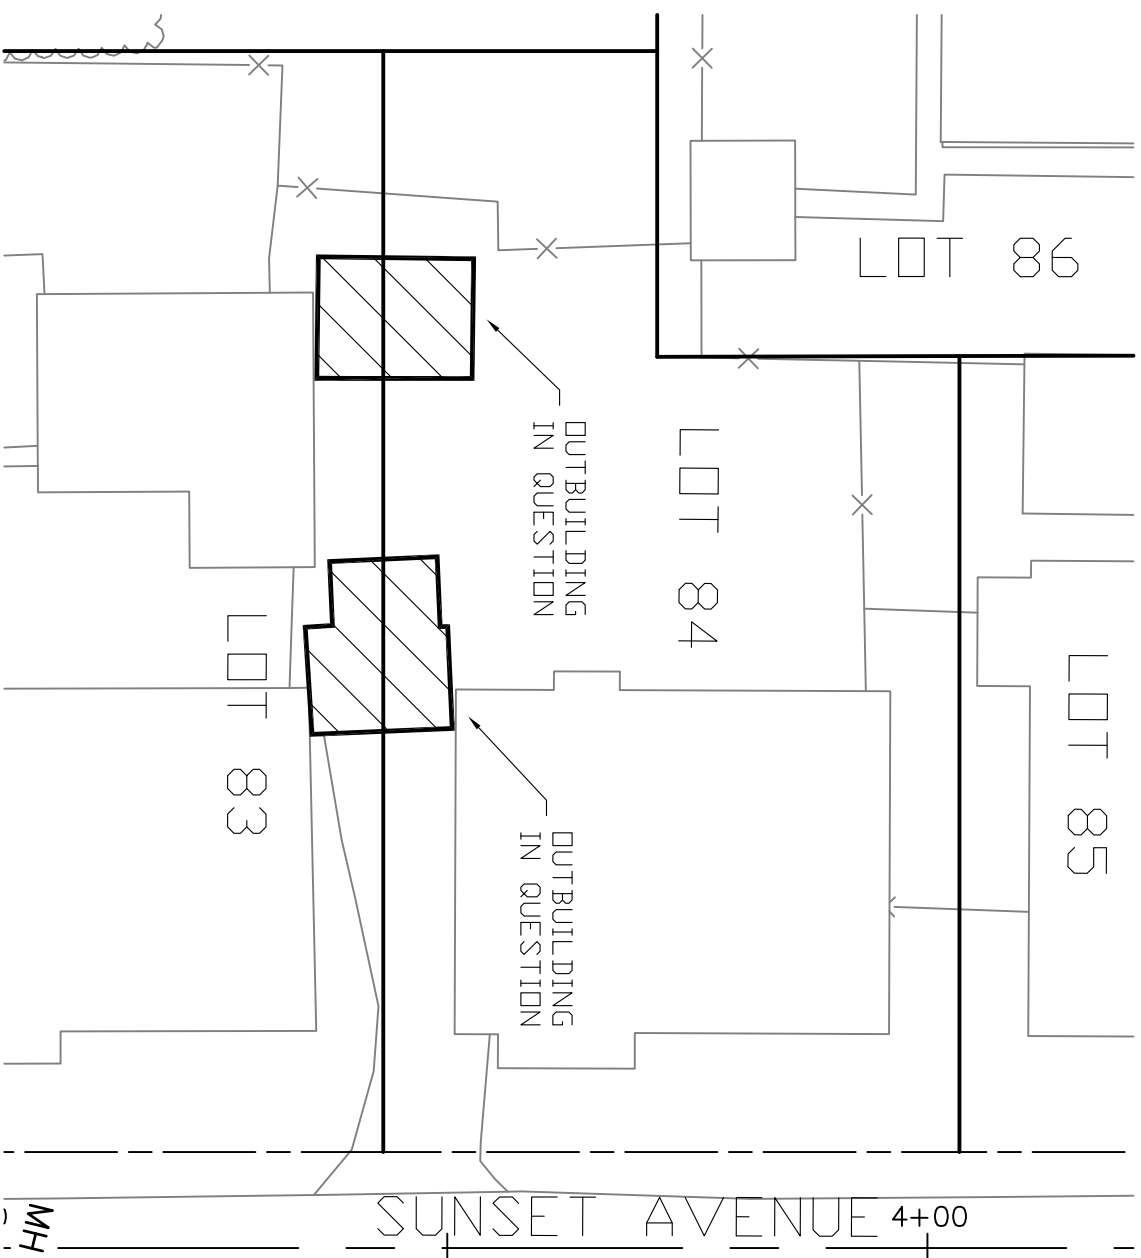
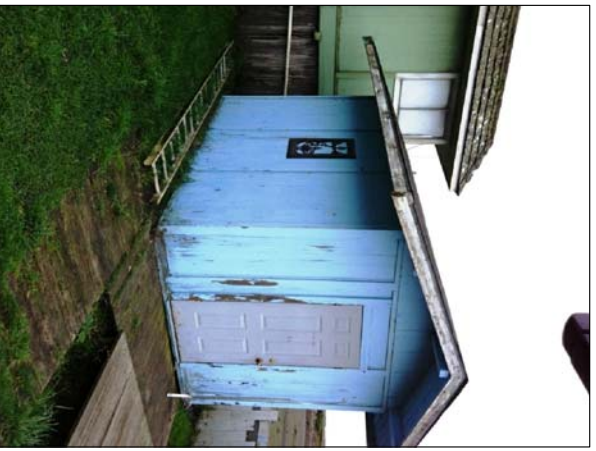
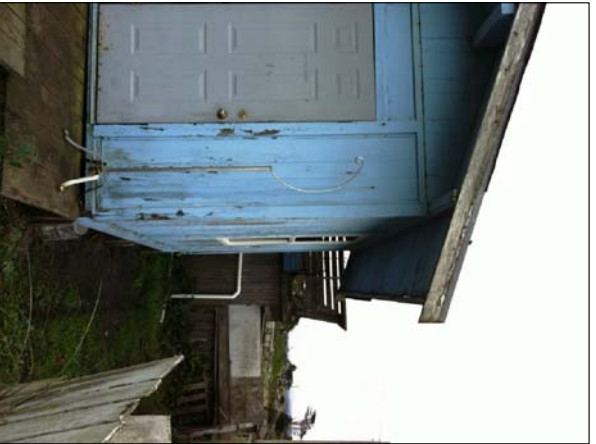
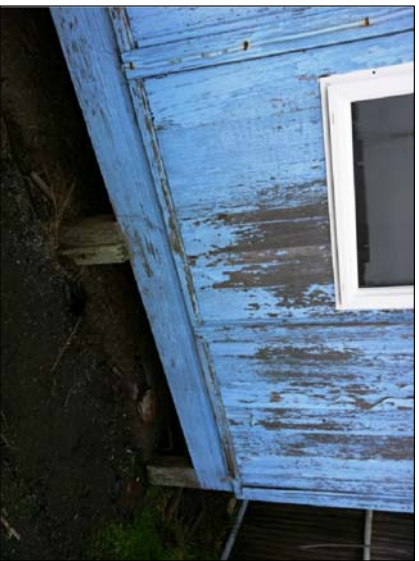
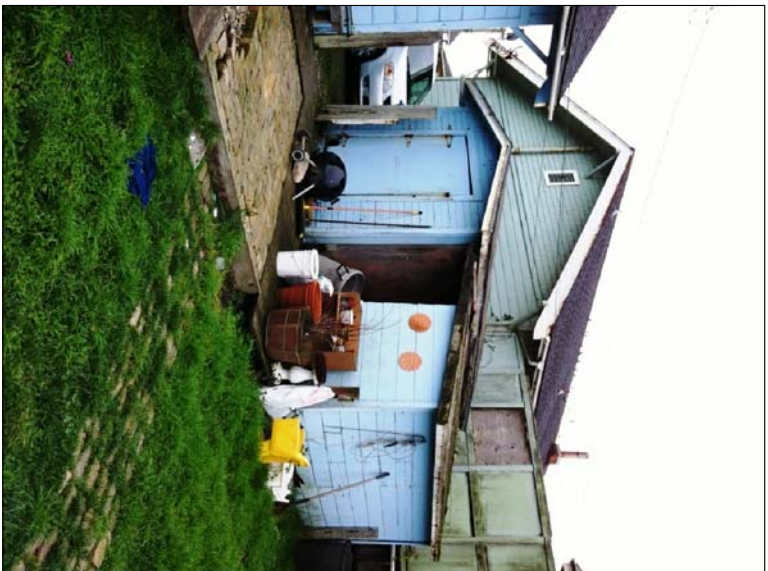
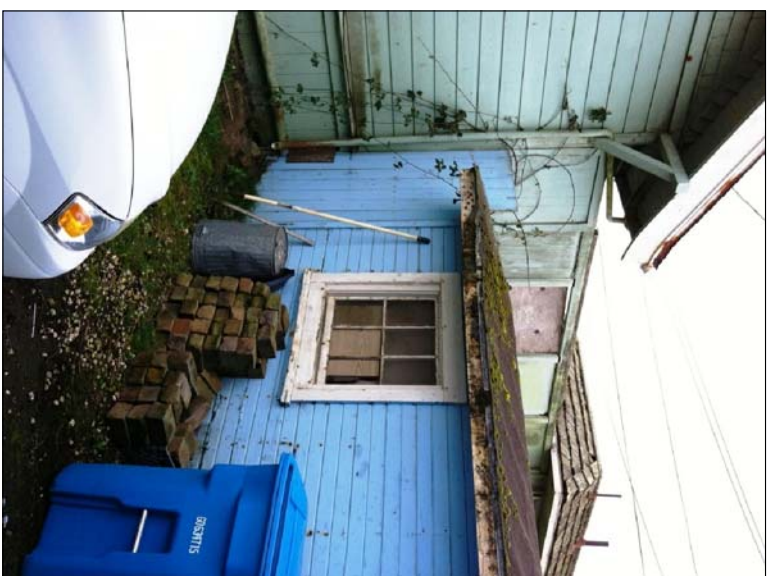
SHEET 5 OF 9

Lot No's 83 & 84 Sunset Avenue (plot plan sheet 5)

The first building (nearest Sunset Ave) is of wood frame construction, it has a wooden post and pier block foundation, horizontal tongue & groove wood siding, and tarpaper roof. It measures 18x15 with an open breezeway. The roof is in poor condition with considerable moss. Some window panes are missing and some siding cracked. The building is a hodgepodge of construction with a small open breezeway separating two rooms. The entire structure is in poor condition. Moving this structure is not an option, as the condition is so poor that it will not withstand and significant outside forces imposed on it by moving. Additionally the breezeway is a weak point in the structure. Even moving it in two pieces is not an option for this structure. Similarly, tearing it down and then rebuilding it somewhere else is not an option as the wood framing is well past its useful life. My recommendation is to demolish this building.

The second, rear, building is of wood frame construction, it has a wooden post and pier block foundation, plywood siding, and tarpaper roof. The building is 16x12.5 and in fair condition. There is considerable paint missing, but otherwise relatively sound. I recommend preserving or moving this outbuilding due to its small size and relative remaining lifespan.

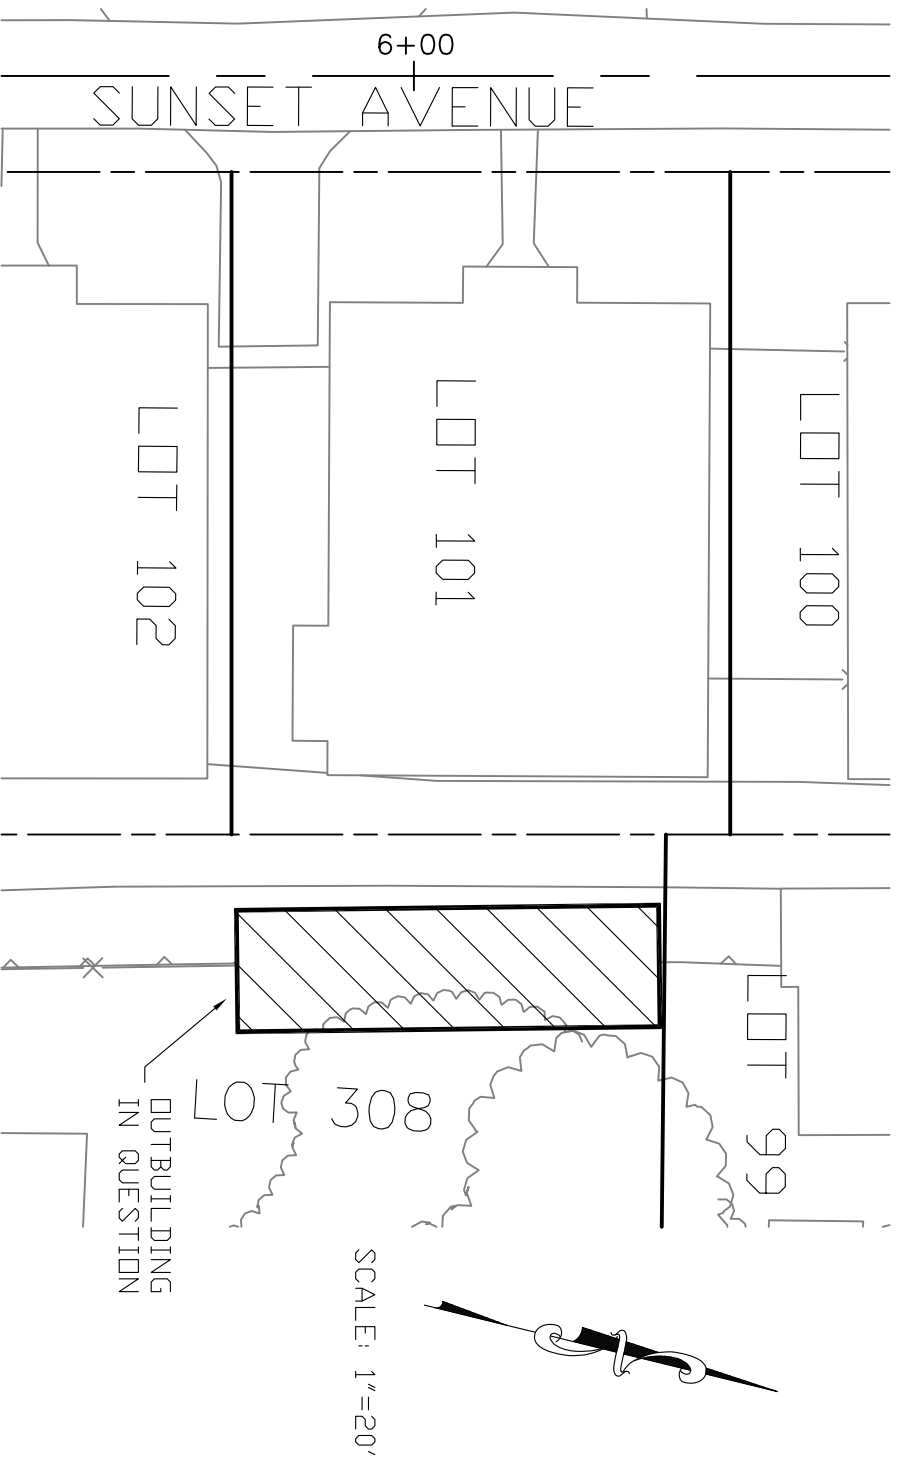
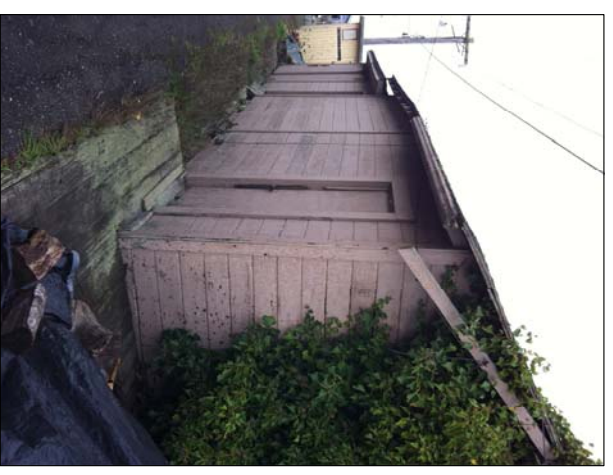
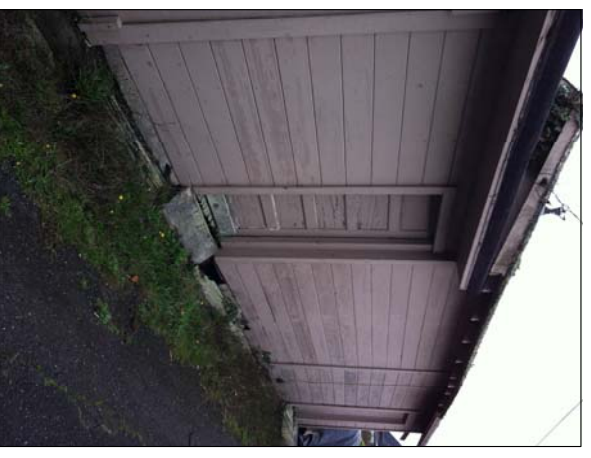
SHEET 6 OF 9

Lot 308 Sunset Ave (plot plan sheet 6)

This building is of wood frame construction, it has a wooden foundation on one half of the structure and is supported by a combination cantilever wood bracing system along the back side for the other half of the building. The walls consist of horizontal tongue & groove wood siding, and shake and tarpaper roof. The building is completely located off of lot 92. The outbuilding is long and narrow, measuring 44x13. It has two separate roof structures, the shake part is in poor condition with lots of moss and broken fascia. The building is in poor condition with and the foundation systems outlined above have all but failed. The building, as it sits is a hazard and unsafe for occupancy and usage. My recommendation is to remove this building due to its unsafe condition and failing foundation systems.

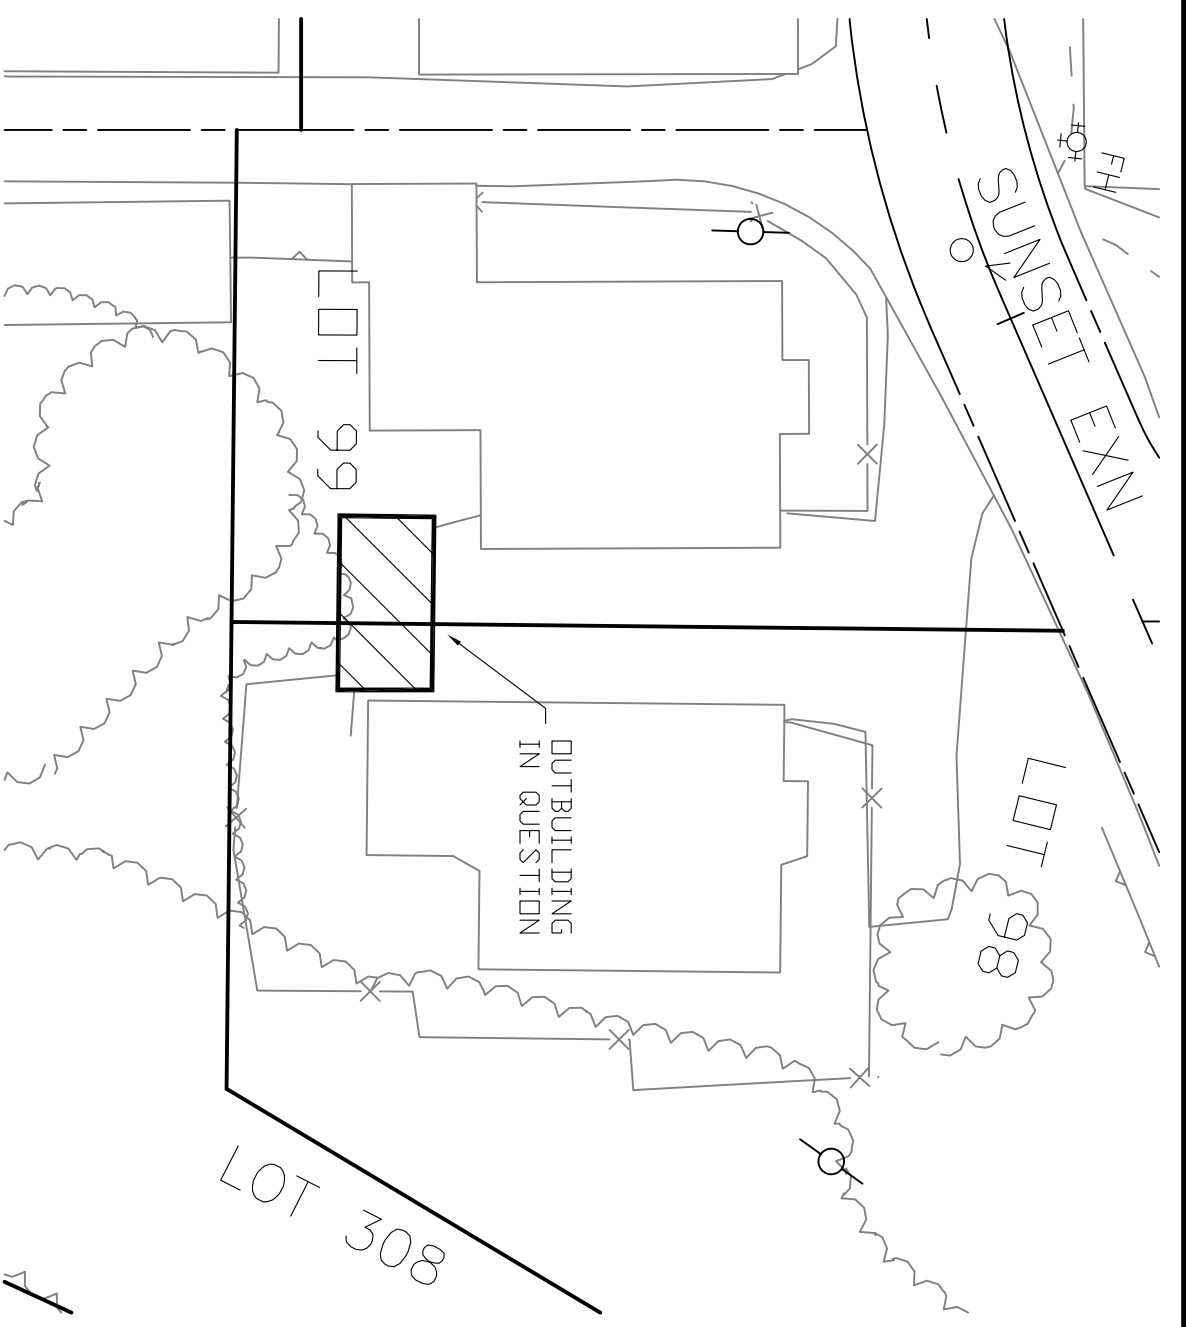
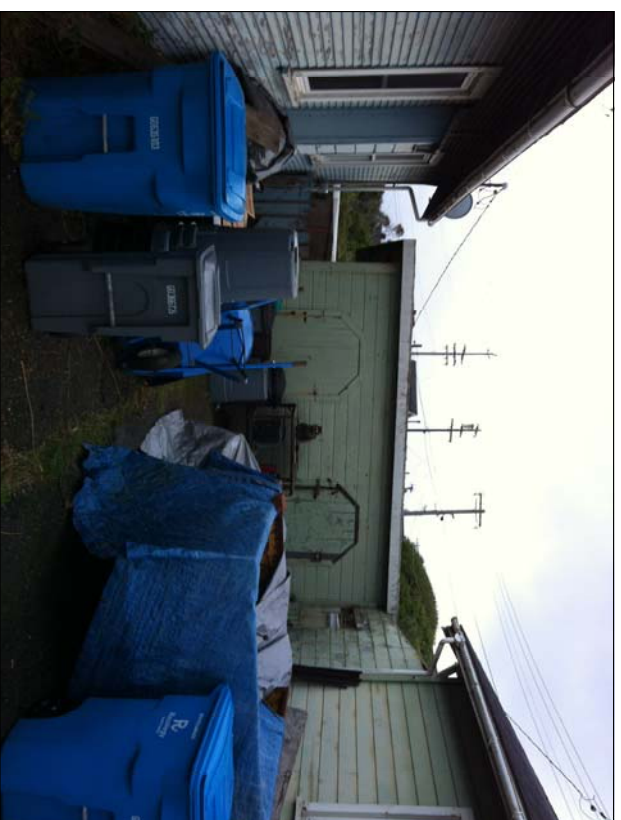
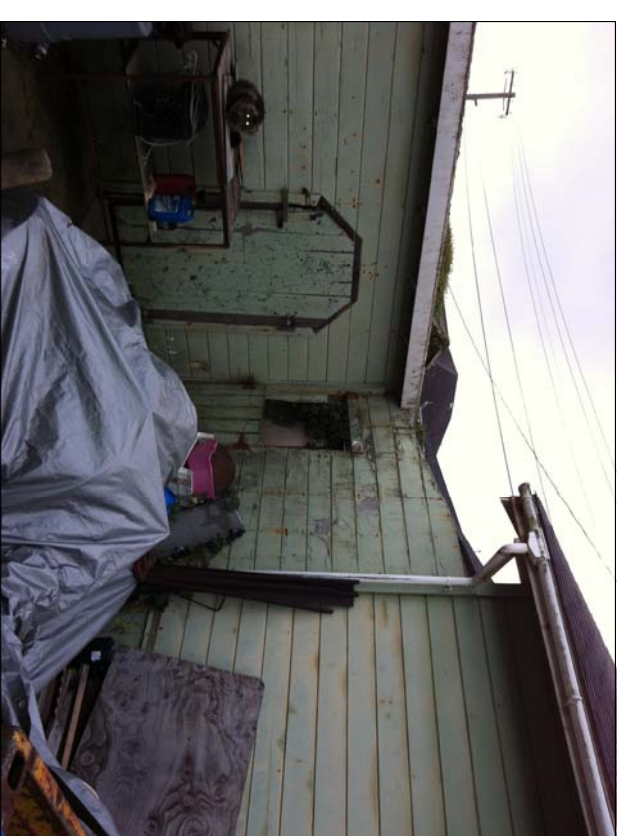
SHEET 7 OF 9

Lot No.'s 98 & 99 Sunset Extension (plot plan sheet 7)

This building is of wood frame construction, it has a wooden post and pier block foundation, horizontal tongue & groove wood siding, and tarpaper roof. It is small, measuring 18x11 and located on two lots. The building appears to have been built at some point and time by the residents whom lived in the home and lacks any normal or reliable building systems, that would suffice to hold it together to be moved. The roof is completely ruined, and growing significant moss, in some areas 2-3 inches thick. The sides are not square and the building is not plumb. Tearing this structure down and rebuilding it is not considered realistic as it would be rebuilt with the same issues as explained herein. I recommend removing the building from the site in its' entirety.
