January 28, 2013

DRAFT REVIEW FOR REVIEW ONLY- Updated

Subject: 12-201, Town Of Samoa, Contributing Outbuilding Study

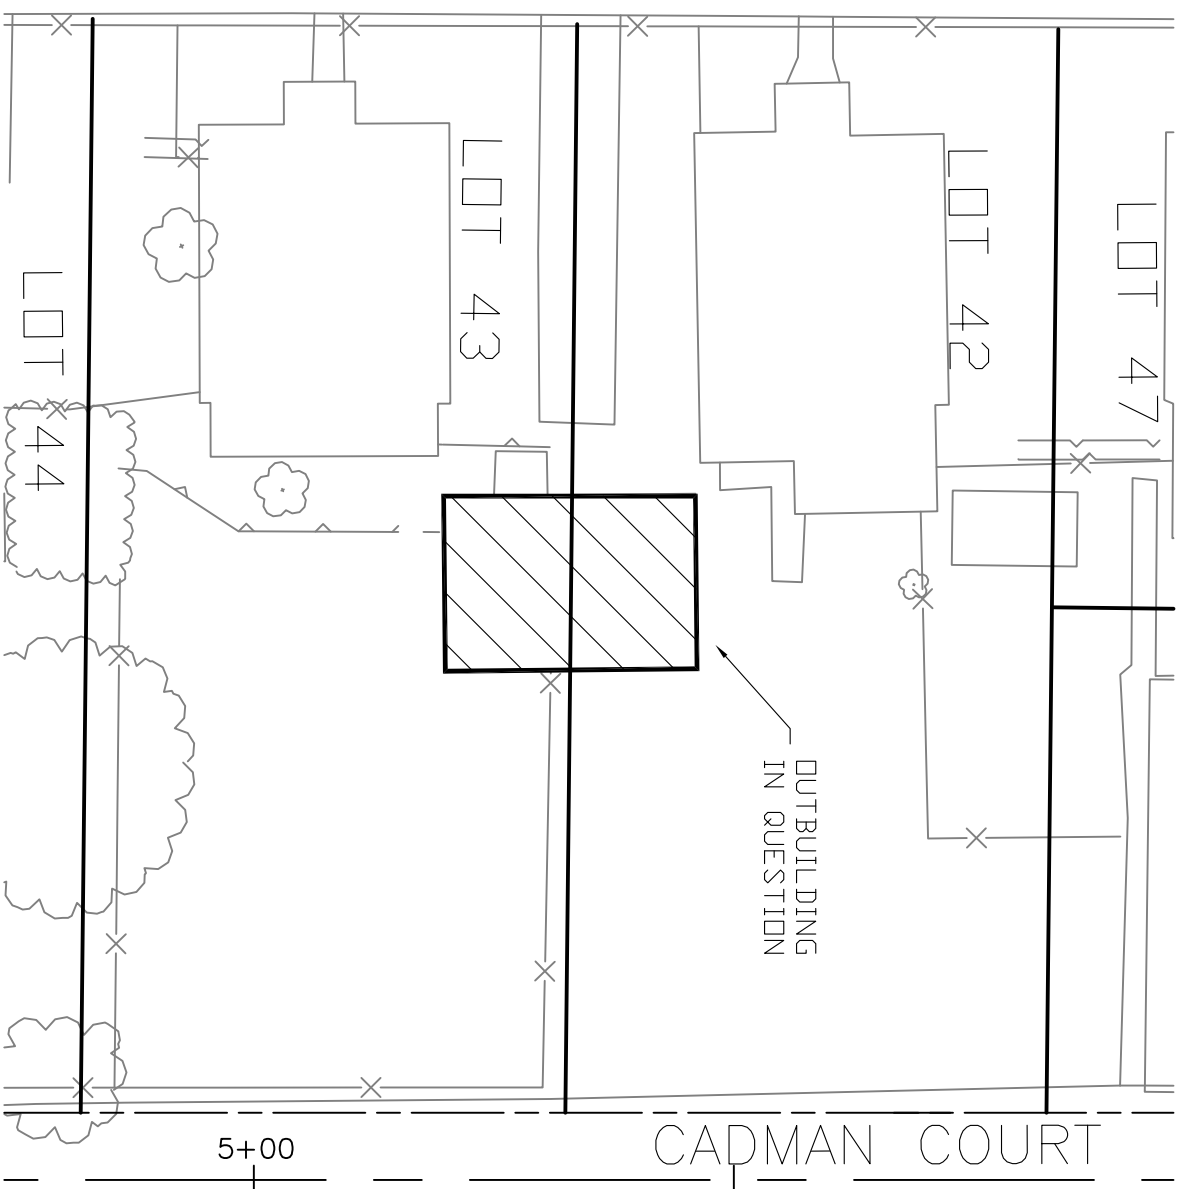
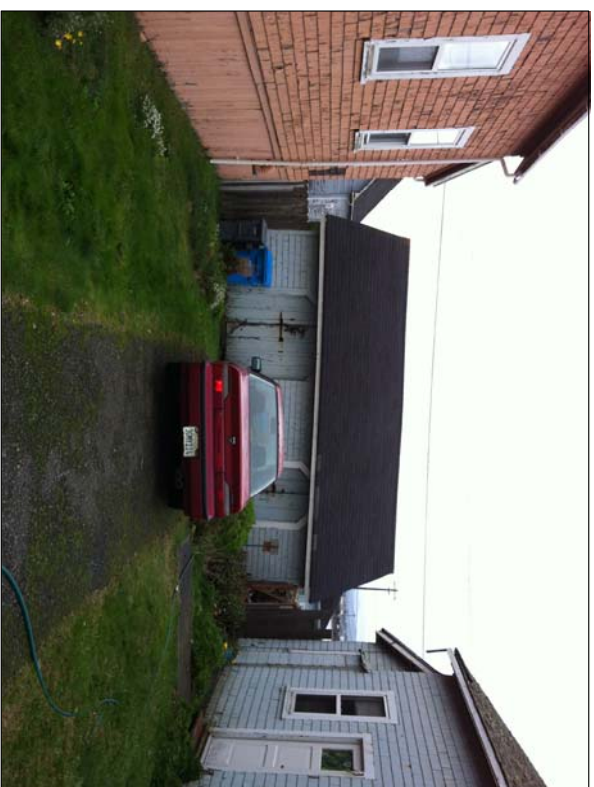
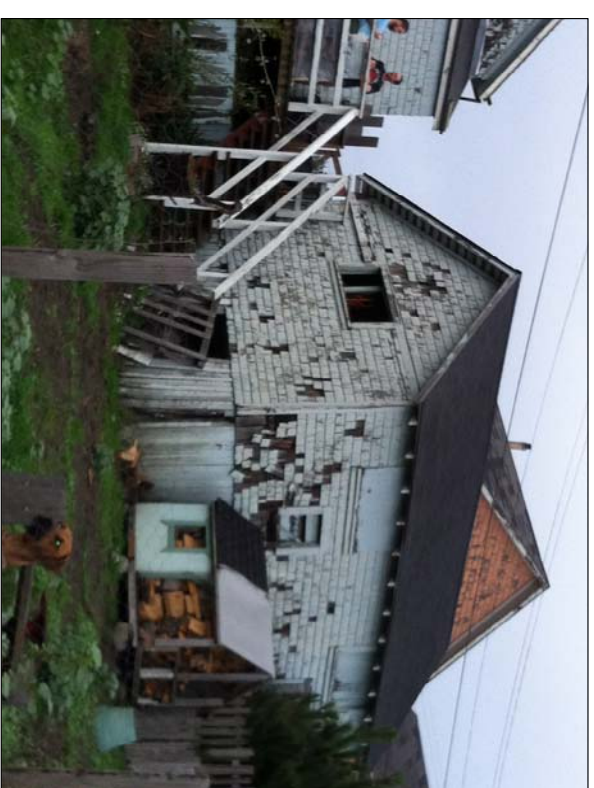
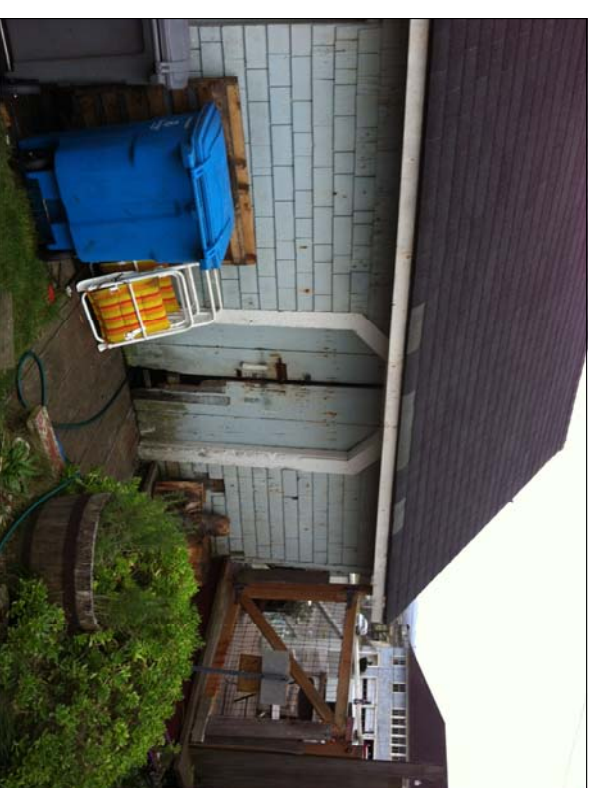
SHEET 8 OF 9

Lot No's 42 & 43 Cadman Court (plot plan sheet 8)

This building is of wood frame construction, it has a wooden post and pier block foundation, which varies from the front to the back of the building due to topography. It has shake siding, and shingled roof. It measures 26x18 and is located on two separate lots. The roof is in good condition. The windows are missing or have been boarded. The shake siding is in poor condition, many shakes are missing or loose and paint has peeled. The foundation is elevated due to the slope of the terrain, and based on my inspection is no longer structurally sound. My recommendation is to demolish this outbuilding due to its declining condition.

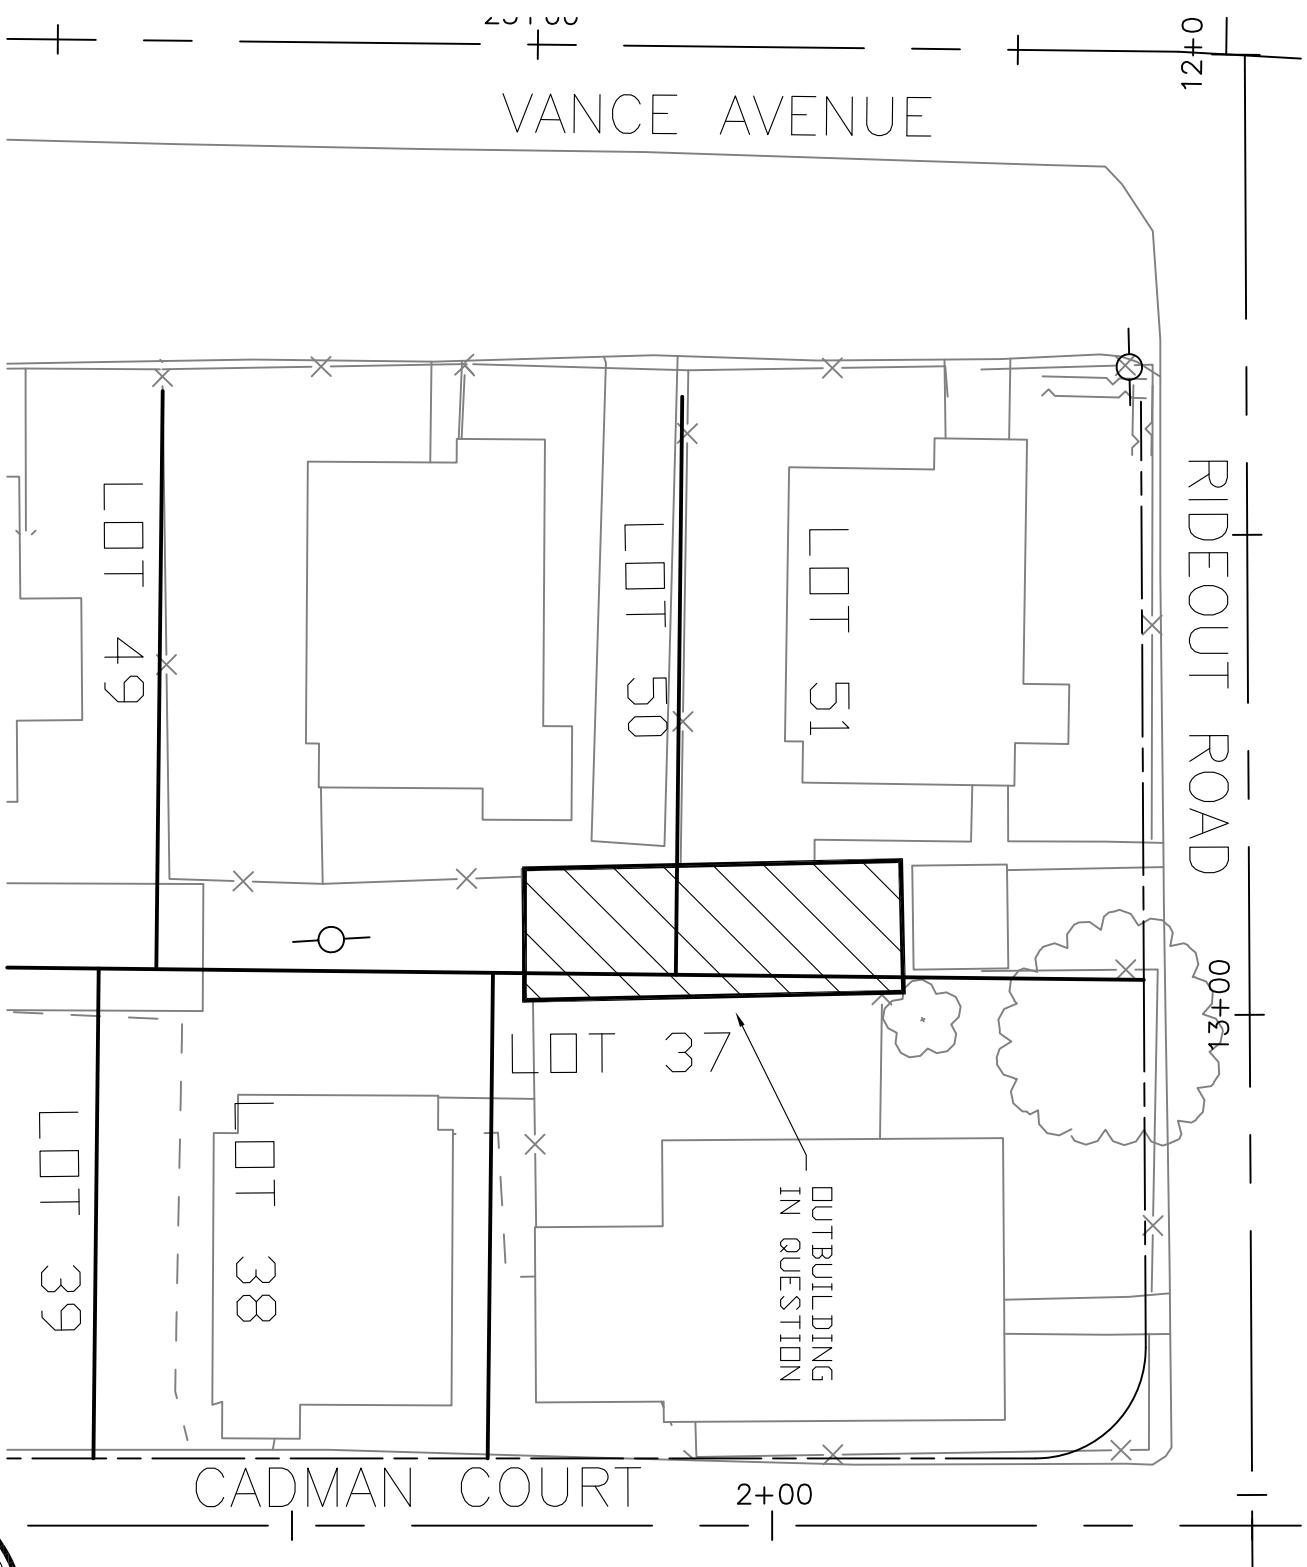
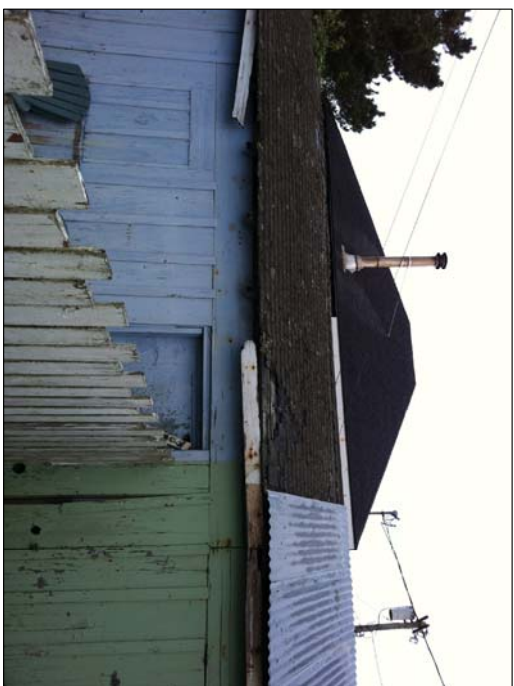
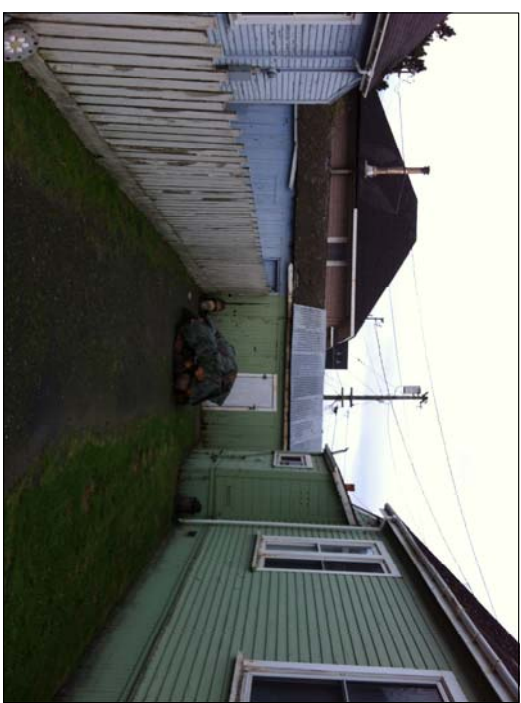
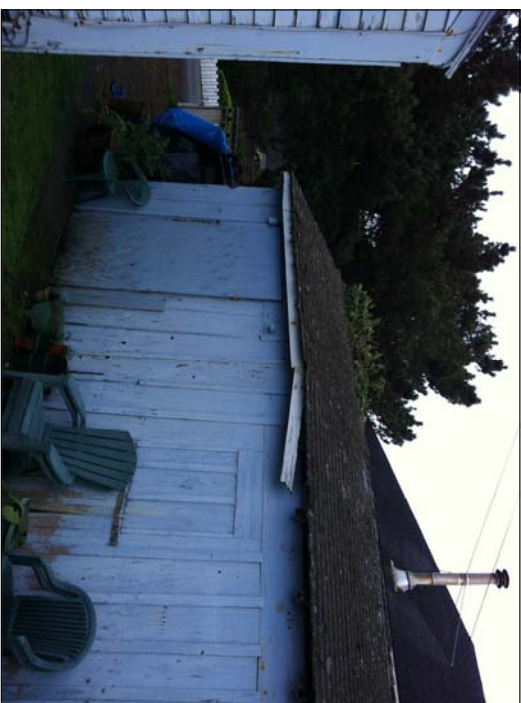
SHEET 9 OF 9

Lot No.'s 37, 50 & 51 Vance Ave (plot plan sheet 9)

This building is of wood frame construction, it has a wooden post and pier block foundation, vertical board and batten siding, and partial shake and partial corrugated metal roof. It is located on two lots and measures approximately 39.5x14. The roof is in poor condition with rotted shakes and broken fascia. The paint is in poor condition. The

walls of this structure a no longer plumb and beginning to fall in on themselves. The roof trusses inside the building are failing, and the foundation is also in very poor condition. The building materials are literally rotting away and could not be reused. I recommend demolishing this outbuilding due to its deteriorated condition. Its size is also a detriment towards relocating it.
