**SUPPLEMENTAL FAULT RUPTURE HAZARD EVALUATION  
HOLLYWOOD COURTHOUSE  
5925 HOLLYWOOD BOULEVARD  
LOS ANGELES, CALIFORNIA**

**PREPARED FOR:**  
Judicial Branch Capital Program Office  
Design and Construction Unit  
2255 North Ontario Street, Suite 220  
Burbank, California 91504

**PREPARED BY:**  
Ninyo & Moore  
Geotechnical and Environmental Sciences Consultants  
475 Goddard, Suite 200  
Irvine, California 92618

June 15, 2015  
Project No. 402132007

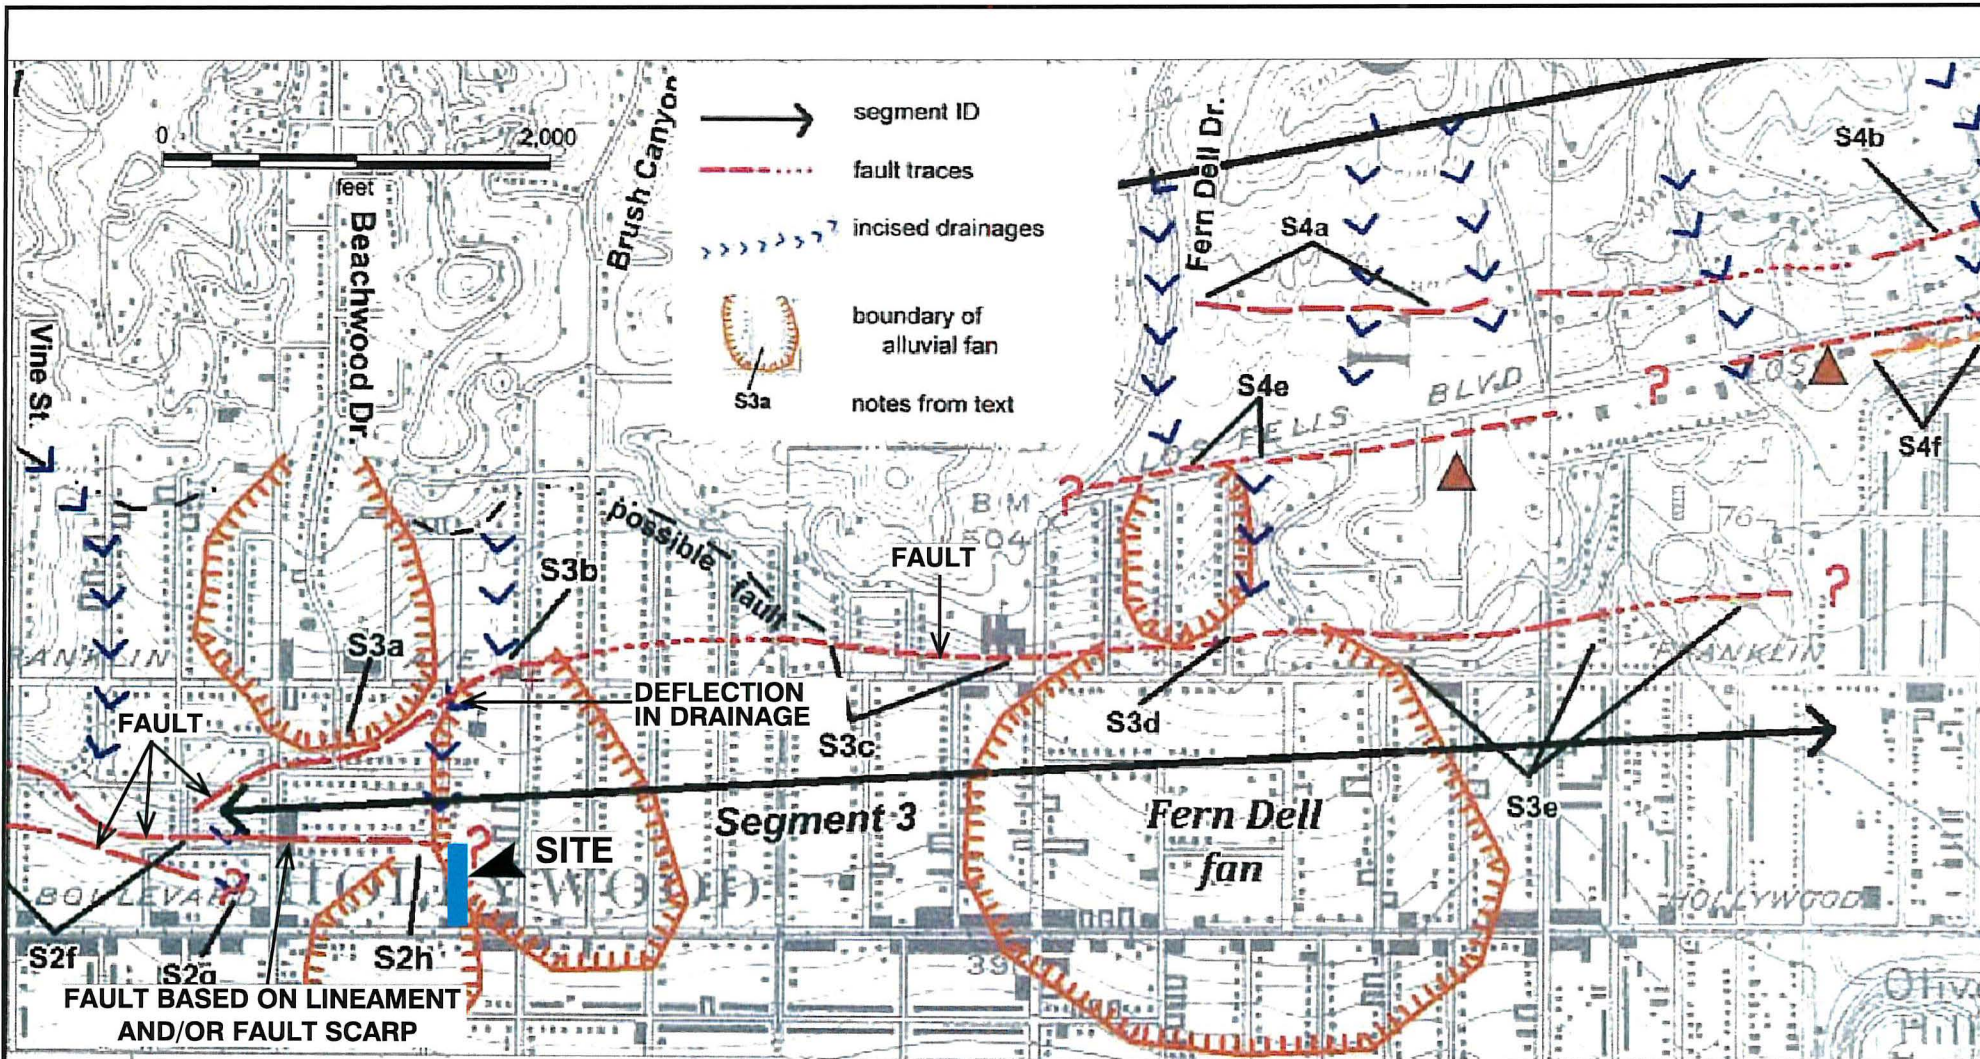
<b>Ninyo &amp; Moore</b>		<b>GEOMORPHIC FEATURES</b>	FIGURE <b>4</b>
PROJECT NO. 402132007	DATE 6/15

of fault related features were observed at the site including the parking lot south of the existing building. A vegetation lineament and/or possible fault scarp was reported by others near the north end of the site along Carlos Avenue (CGS, FER 253, 2014a). In addition, a deflection of a north-south drainage tributary was also reported farther north of the site, as shown on Figure 4 and observed in a 1928 photograph.

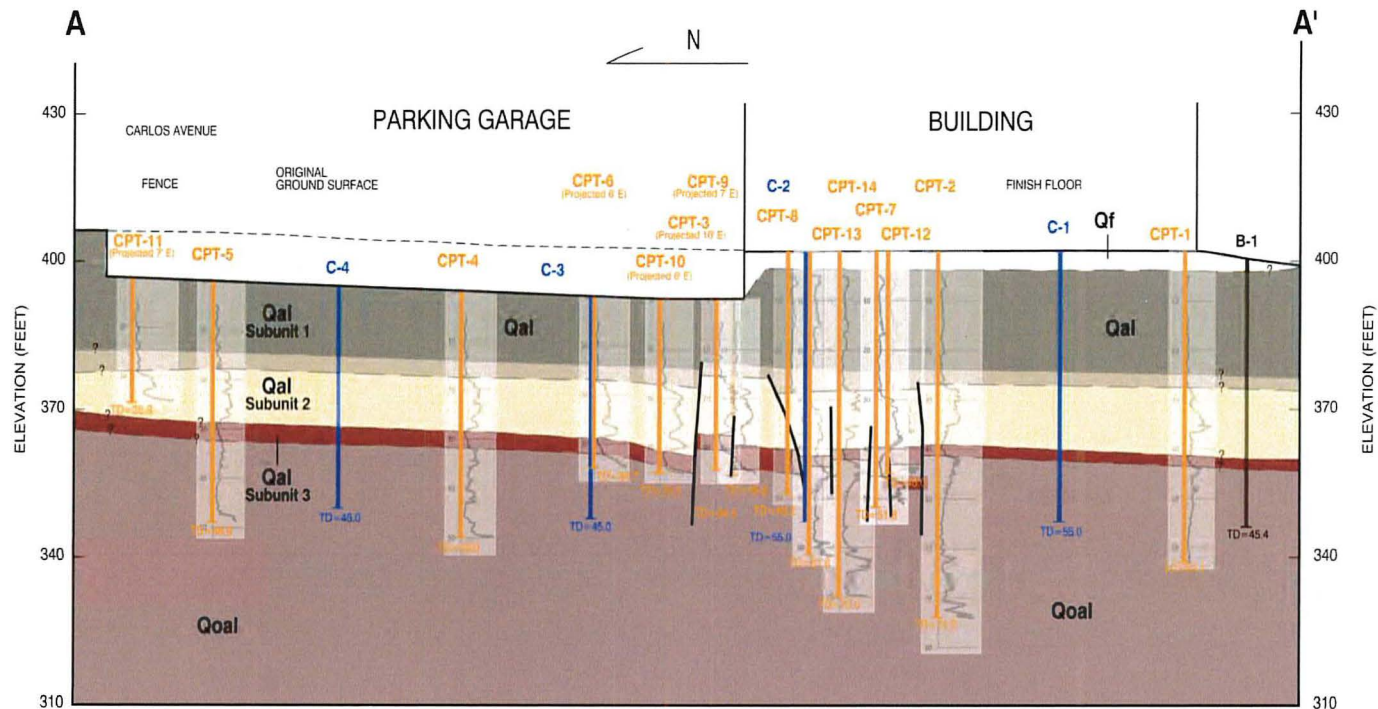
**10**

Based on the results of our supplemental fault rupture hazard evaluation, it is our opinion that no active (Holocene age) faults cross the southern portion of the subject property (parking lot) nor are faults recognized at depth on the older Pleistocene deposits beneath the southern portion of the property. Furthermore, it is our opinion that the risk of future fault rupture within the design life of the project is low and building setbacks are not warranted. The bases for our opinions are summarized below.
