**AN EVALUATION OF THE EXISTING TREES
CASTILLEJA SCHOOL
1310 BRYANT STREET
PALO ALTO, CALIFORNIA**

**SITE OBSERVATIONS:
APRIL 13, 21, 2016
REPORT: JUNE 13, 2016**

**An Inventory of the Existing Trees
Castilleja School
1310 Bryant Street
Palo Alto, California**

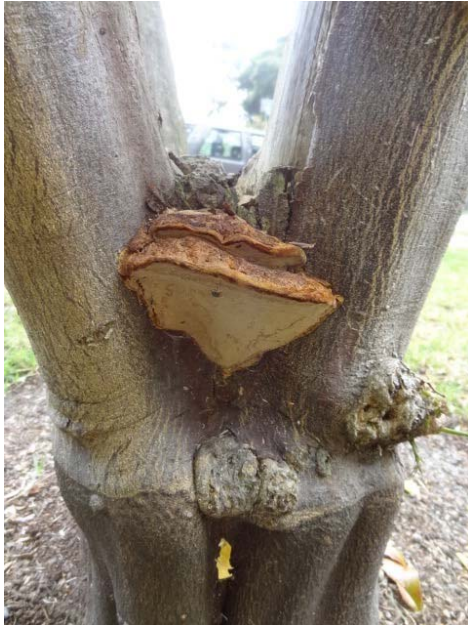
The lemon Tree # 46 and the blackwood acacia Tree # 61 both have a heart rot disease called Artist's Conk (*Ganoderma applanatum*). This disease slowly destroys the interior wood until the tree falls down, in most cases. There is no treatment for this disease. However, Tree # 46 is small and would not likely cause significant damage should it fall.

The disease seen in the photo to the left on the Lemon Tree # 46 is more advanced.

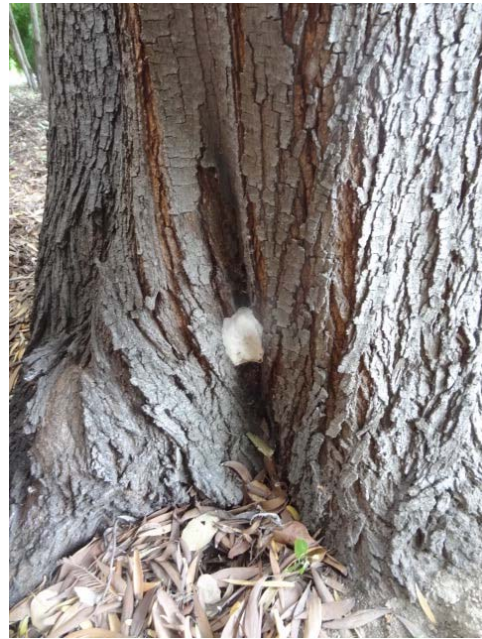
The fruiting body (the mushroom cap) on the blackwood acacia (*Acacia melanoxylon*) Tree # 61 appears to indicate that this is a relatively immature infection on this tree. It appears that this tree has a few years (10-15 years estimated) before it would require removal. I suggest that this tree be inspected in 5 years to monitor the disease development.

The white spot in the photo to the right is the presumed immature formation of this disease on Tree # 61. It appears it will take several years before this disease would advance sufficiently to cause this tree to fall. For a few years, I suggest that it be monitored.

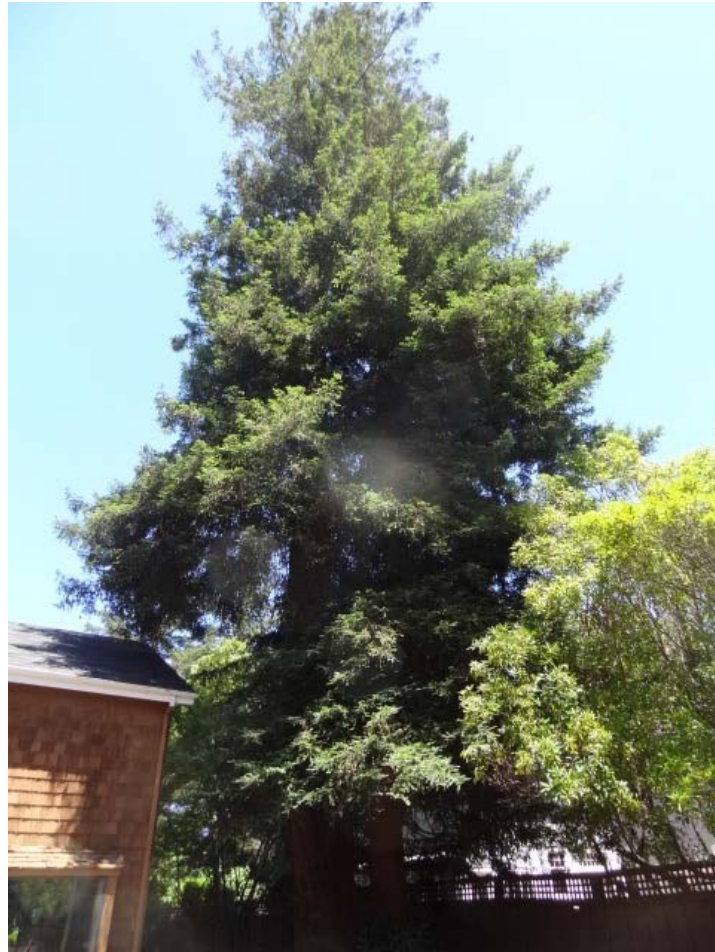
Coast Redwood Tree # 112

Tree # 112 is a large Coast redwood (*Sequoia sempervirens*). The root collar is severely decayed. I estimate that approximately ½ of the buttress root structure has been reduced to cubical brown root. I consider this tree Hazardous and recommend its removal, regardless of construction. Photos of the decay is included in the attachments.

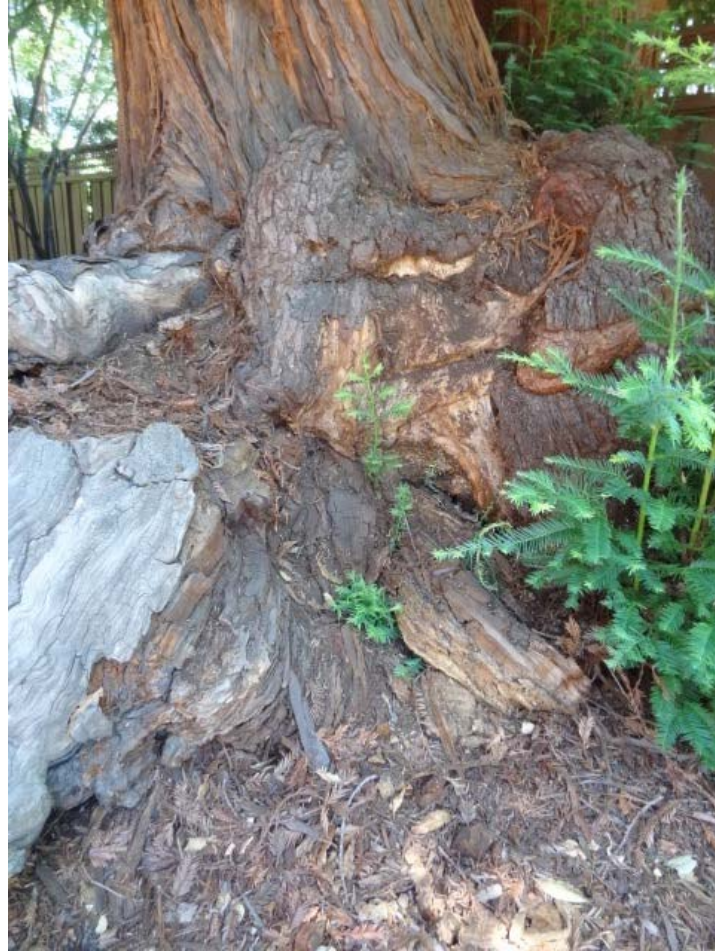
Decayed Wood of Tree # 112

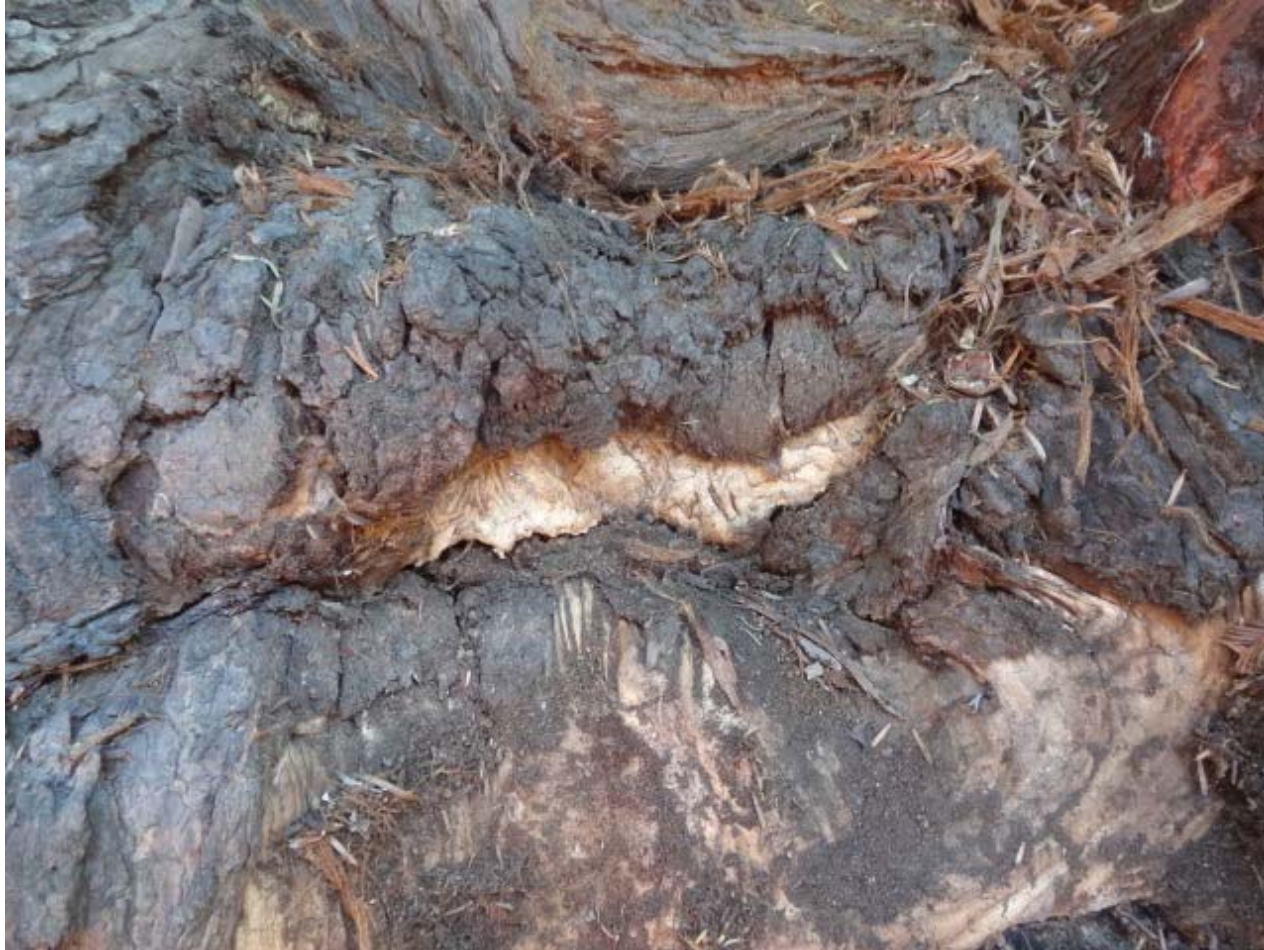
Visible Decay Conk
