Appendix FEIR-2

Relocation Study

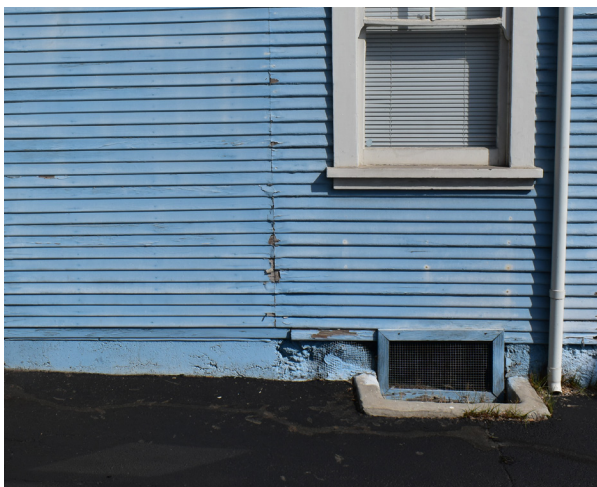
Figure 13: Visible clapboard siding seam.

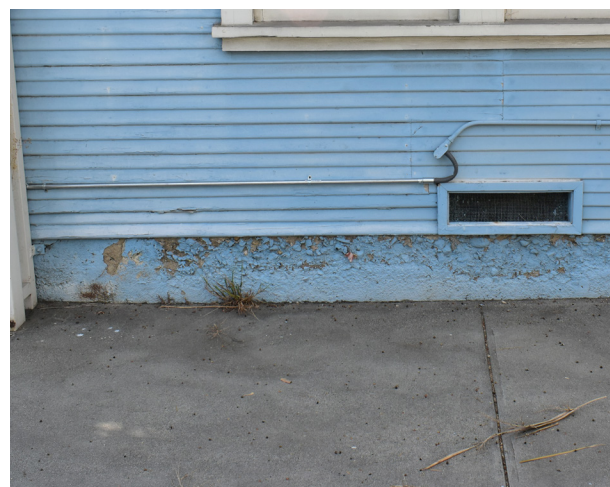
Figure 14: Concrete footing w/ visible aggregate

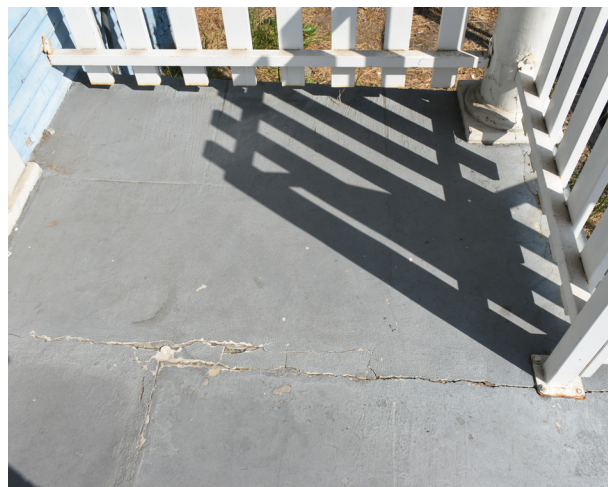
Figure 15: Cracked concrete front porch.

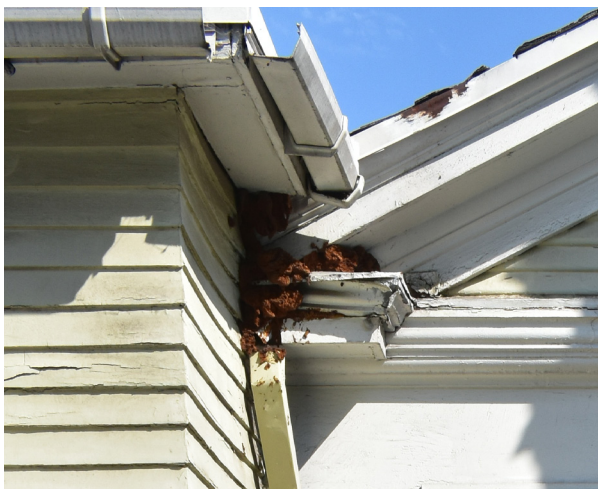
Figure 16: Damaged cornice return and plain frieze.

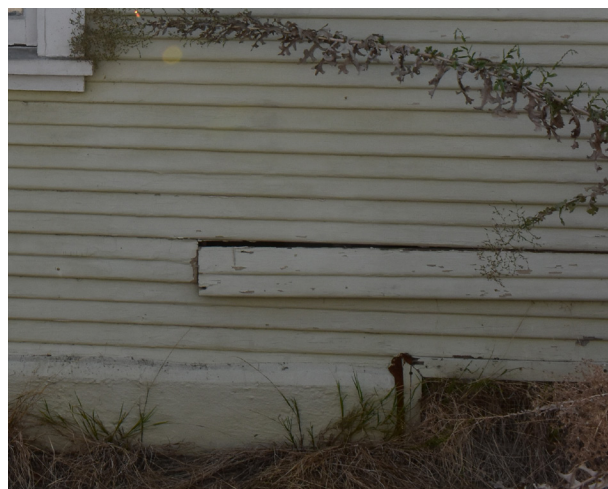
Figure 17: Damaged clapboard siding.

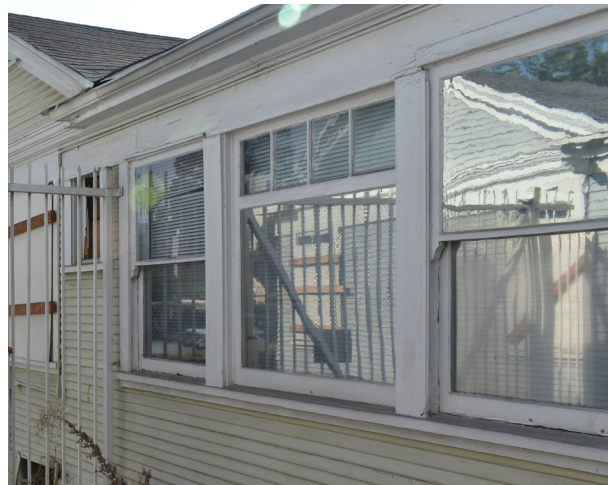
Figure 18: Original wood windows.

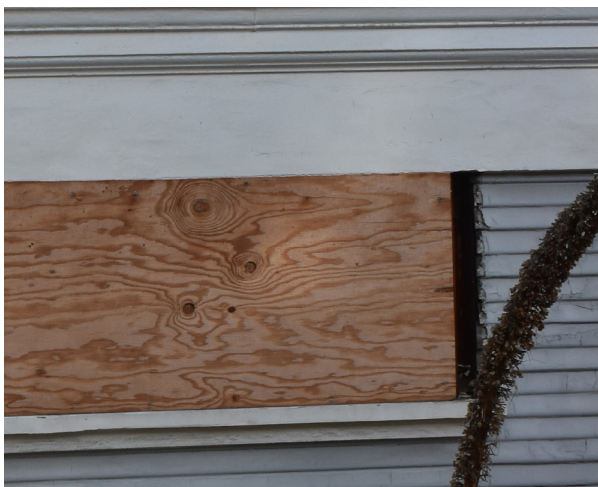
Figure 19: Original wood window, missing trim.

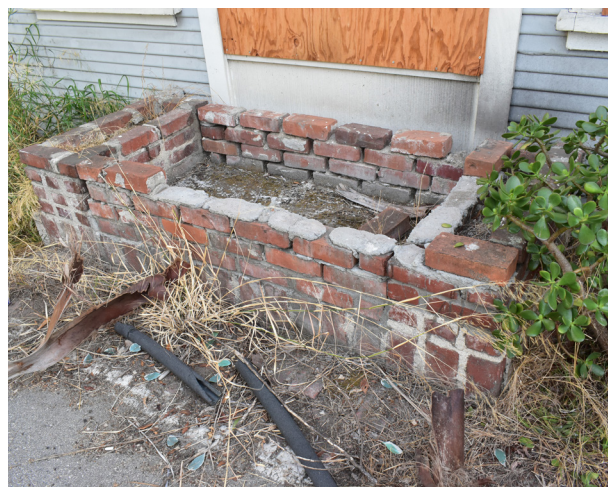
Figure 20: Remains of original brick chimney.

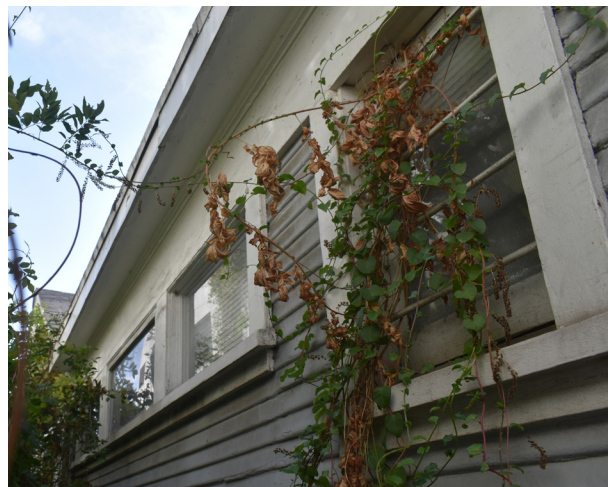
Figure 21: Vegetation attaching to building.

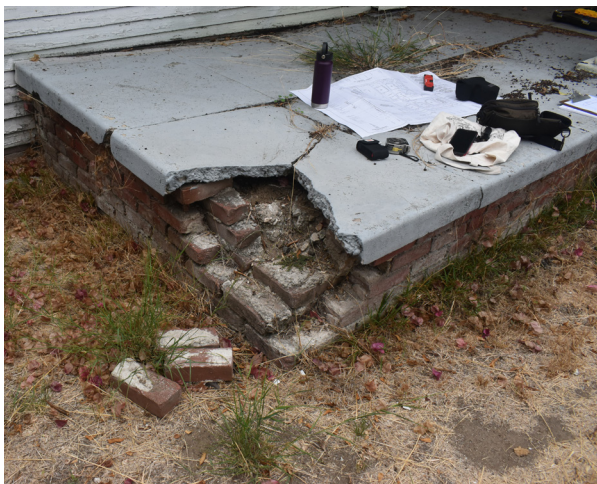
Figure 22: Damaged front porch.

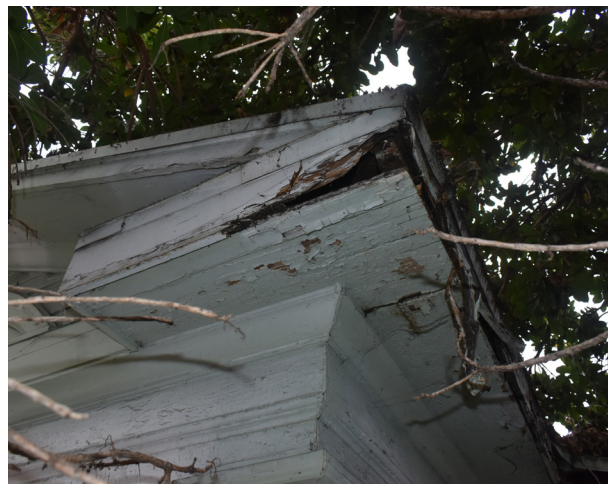
Figure 23: Damaged boxed eaves.

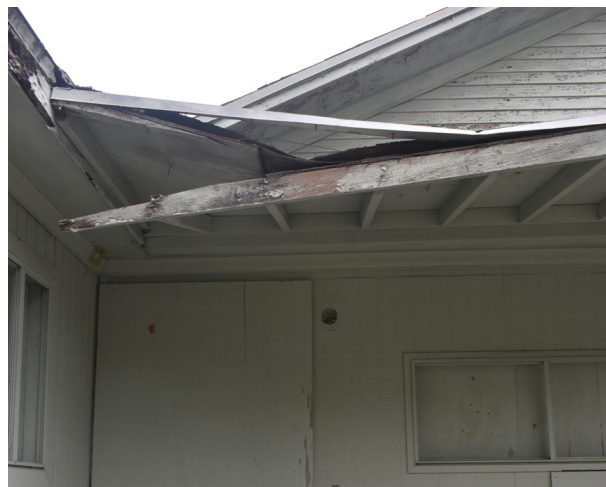
Figure 24: Roof collapsing over side porch.

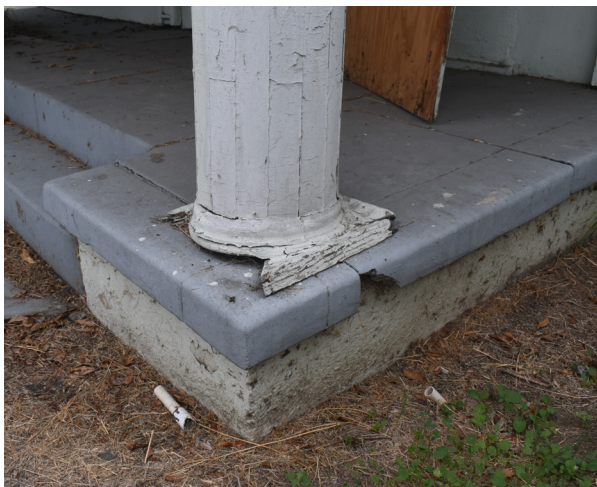
Figure 25: Damaged column base.

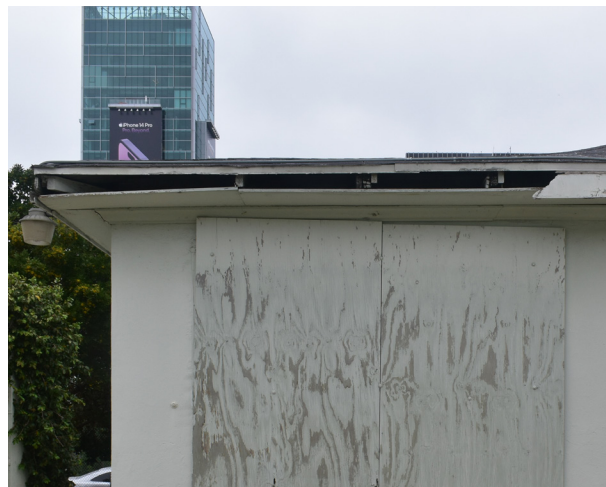
Figure 26: Missing fascia board on boxed eaves.

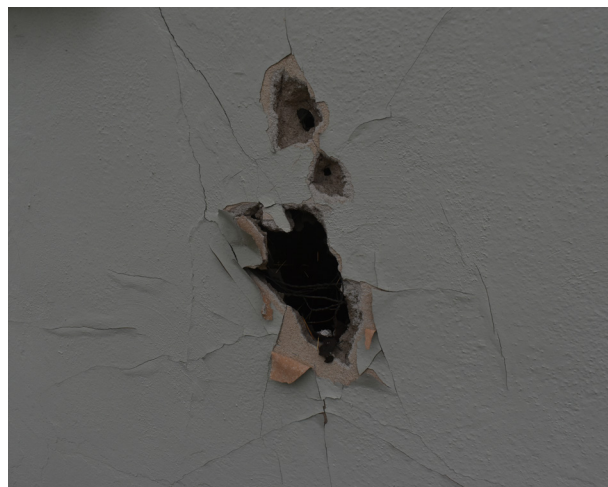
Figure 27: Holes in exterior stucco.

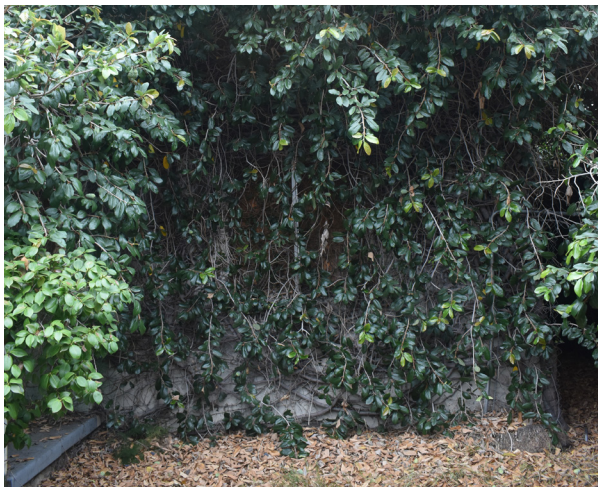
Figure 28: Vegetation over stucco.

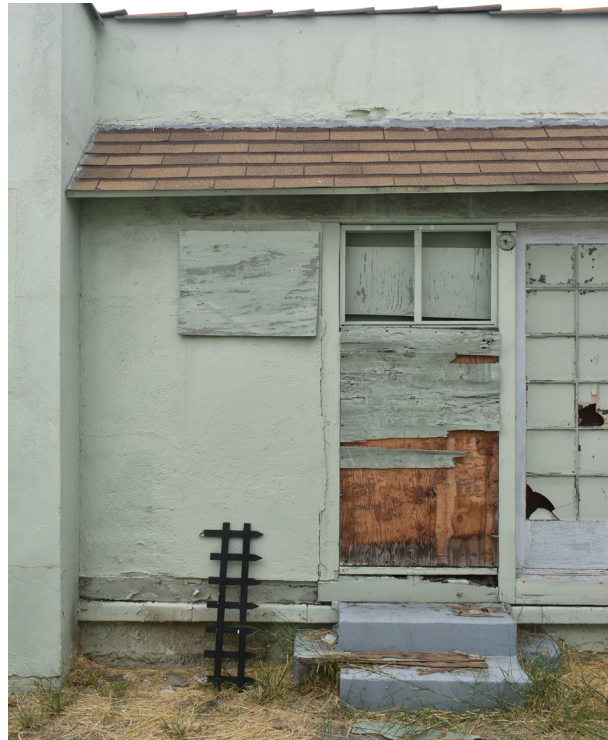
Figure 30: Infilled side porch.

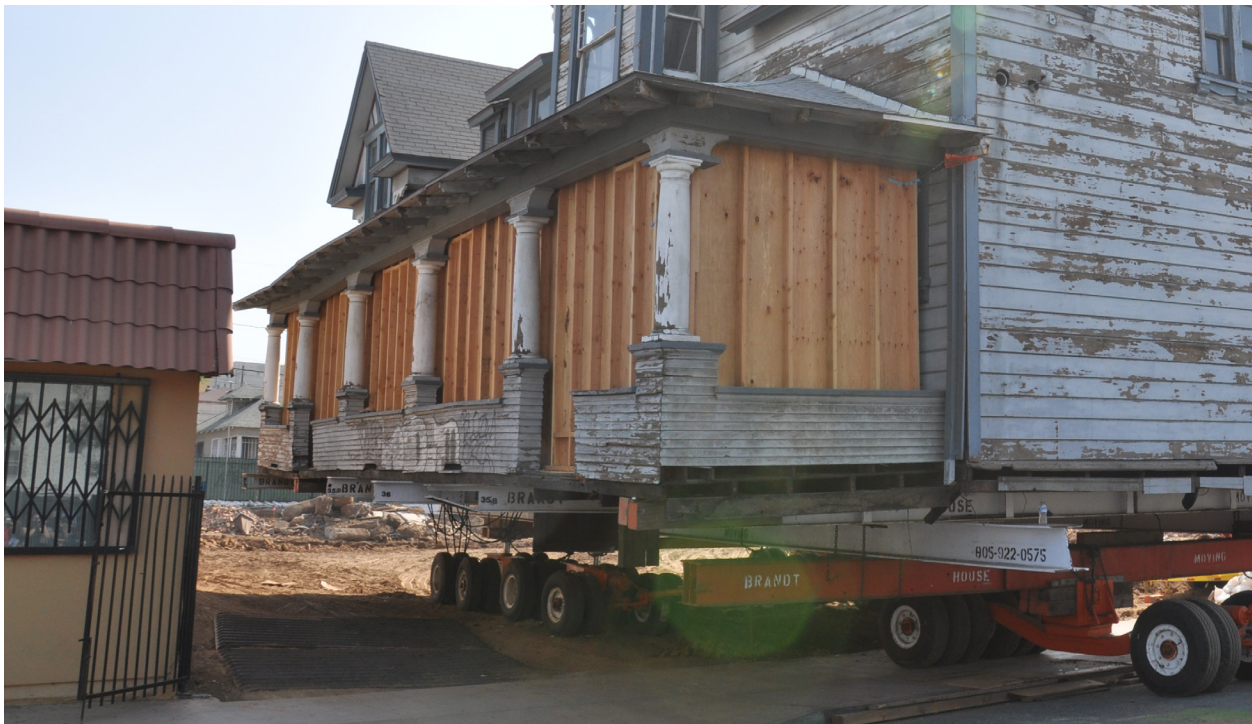
Figure 31: House relocation showing stabilization wall for moving
