PRELIMINARY ARBORIST REPORT

Tree Inventory, Tree Descriptions and Preliminary Recommendations Relative to Proposed Construction

Red Morton Park YMCA & Senior Center

1455 Madison Avenue, Redwood City, California

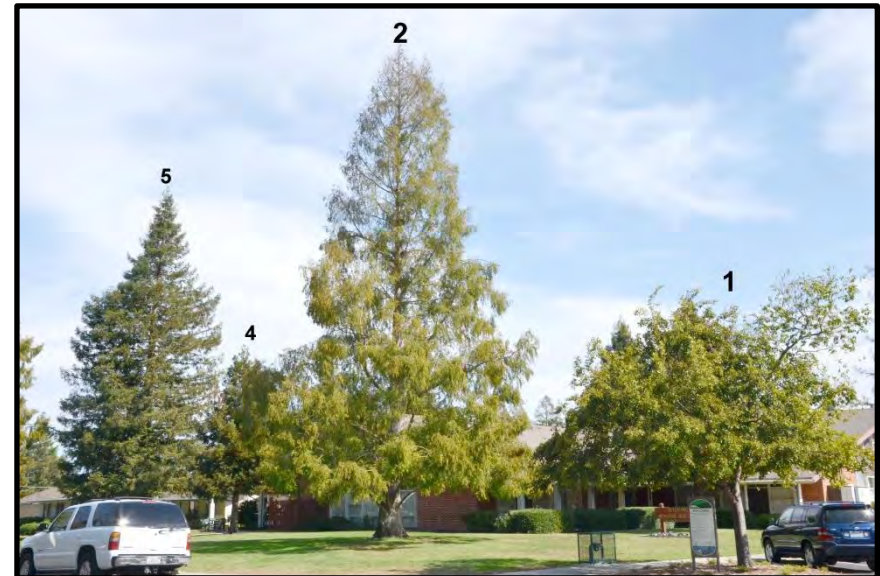
Cover photo: the northwest corner of the site, with **trees #1 – 5** labeled. **Tree #2** is a large dawn redwood; quite a nice specimen tree. All photos in this report were taken by D. Ellis on October 7, 2015.

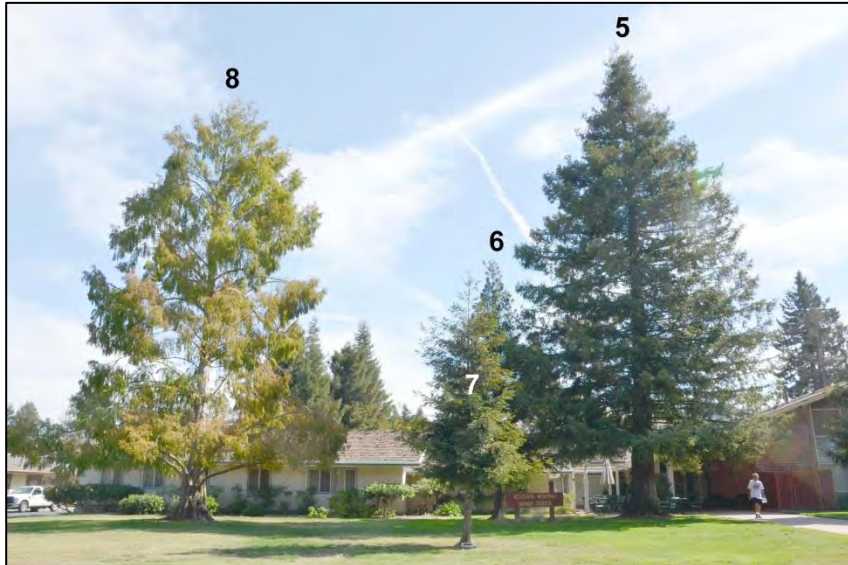
Upper photo: northeast perimeter of the site along Madison Avenue. **Coast redwoods #5, 6 and 7** and **dawn redwood #8**.

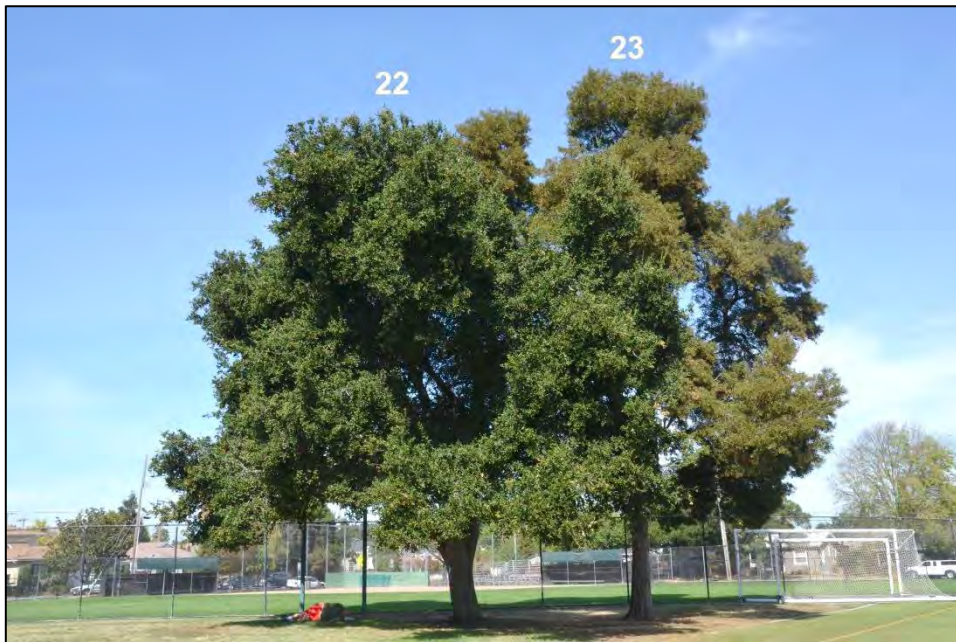
Sandwiched between playing fields
lose to Madison Avenue, **coast**
live oak #22 and **black**
acacia #23.

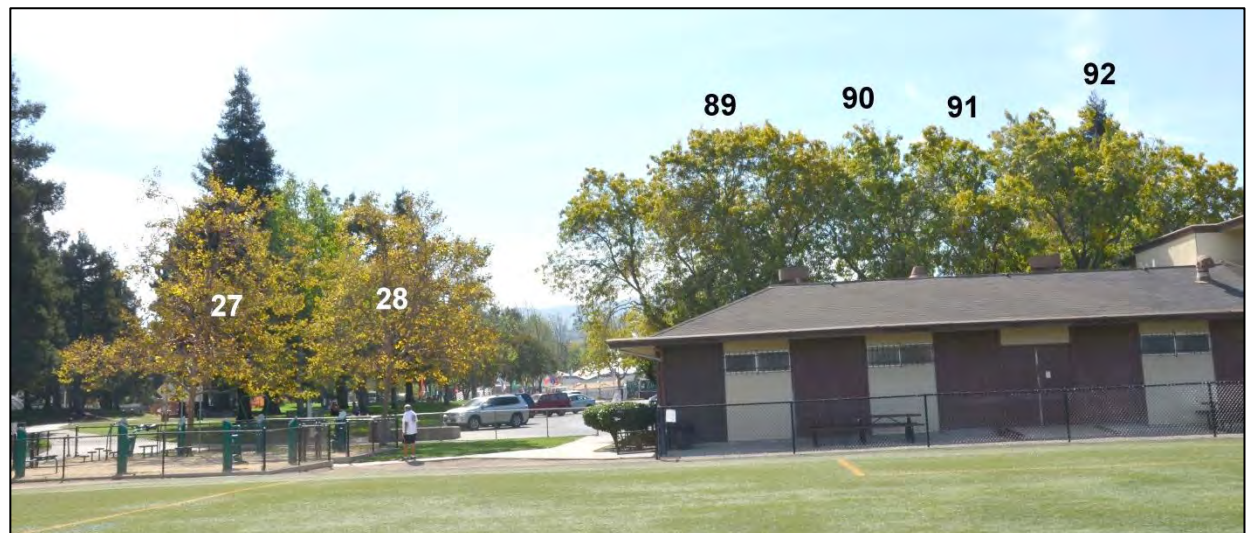
Looking toward the south
perimeter of the site with
London planes #27 and 28,
and **Modesto ash #89 - 92**
behind a building.

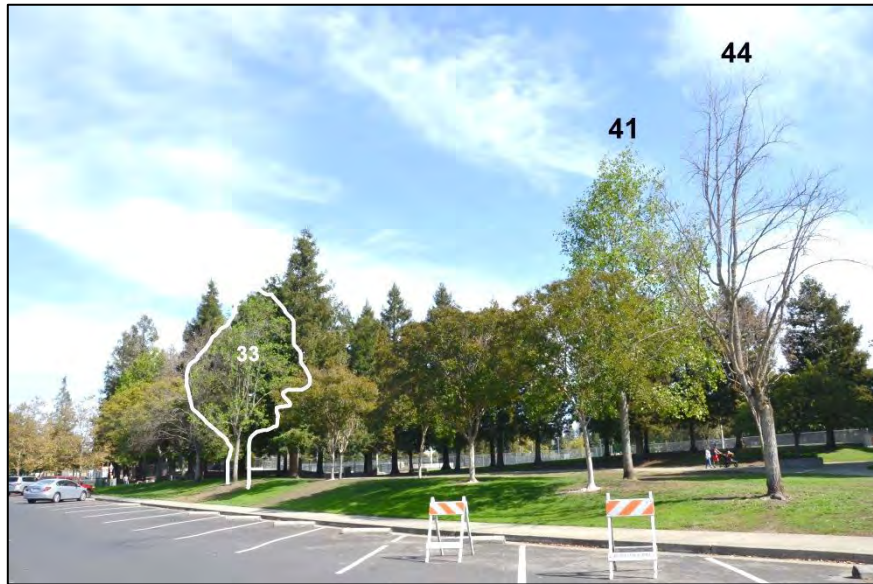
Upper left photo: southeast perimeter of the site. **Tulip trees #33, 41 and 44** are labeled. Tree #44 is dead.

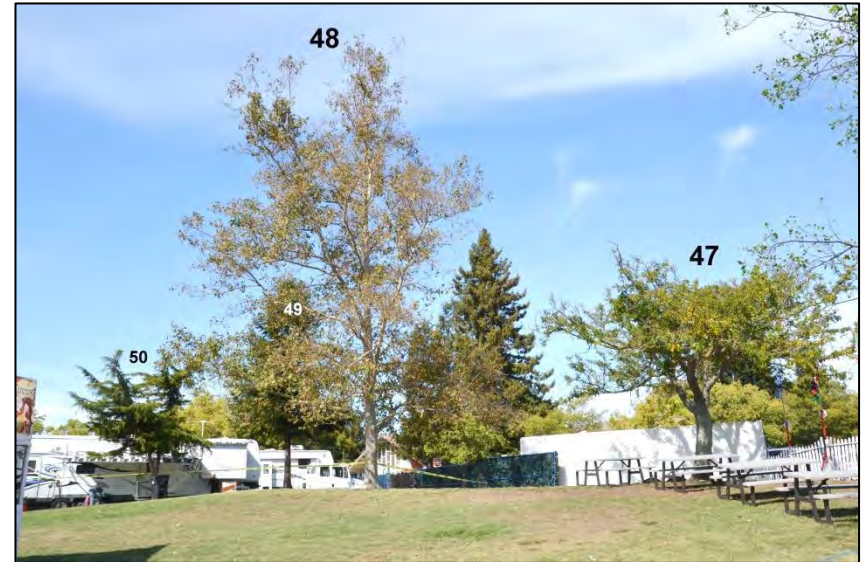
Upper right: south corner of the site. **Honeylocust #47, California sycamore #48, redwood #49** and **juniper #50** are labeled.

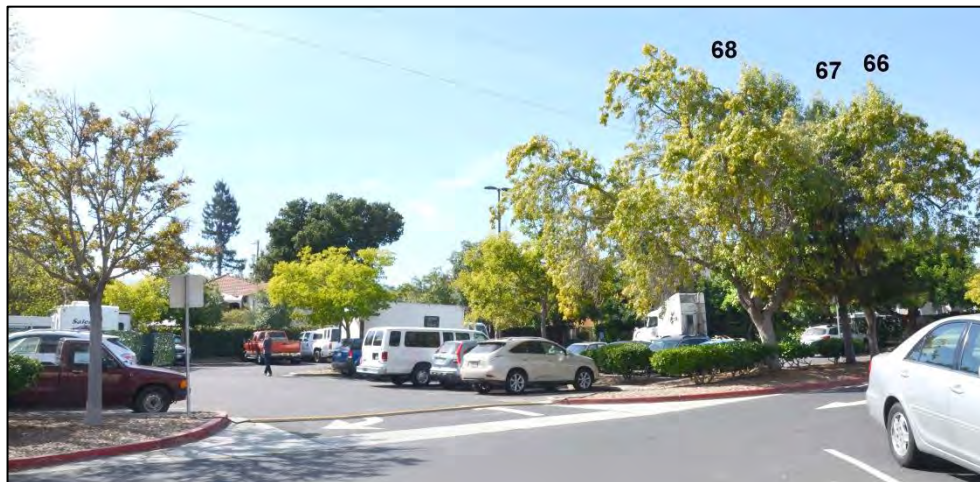
64	carob tree	21	20*25	100	80	Fair	Roots causing large rifts in the parking lot pavement.	5	11	26
65	Chinese hackberry	9	16*15	60	60	Fair		5	5	7
66	Modesto ash	12 (3)	30*35	60	50	Fair/Poor	Trunk and large branch decay.	5	6	9
67	<i>Pinus radiata</i> , Monterey pine	10	25*15	70	60	Fair/Poor	Hidden between 2 trees.	5	5	8
68	Modesto ash	18	35*40	80	50	Fair	Side clearance pruning away from overhead electric wires.	4	9	18

Lower left: southwest perimeter of site, entrance to parking area. **Modesto ash #66 and 68** with **Monterey pine #67** hidden between.

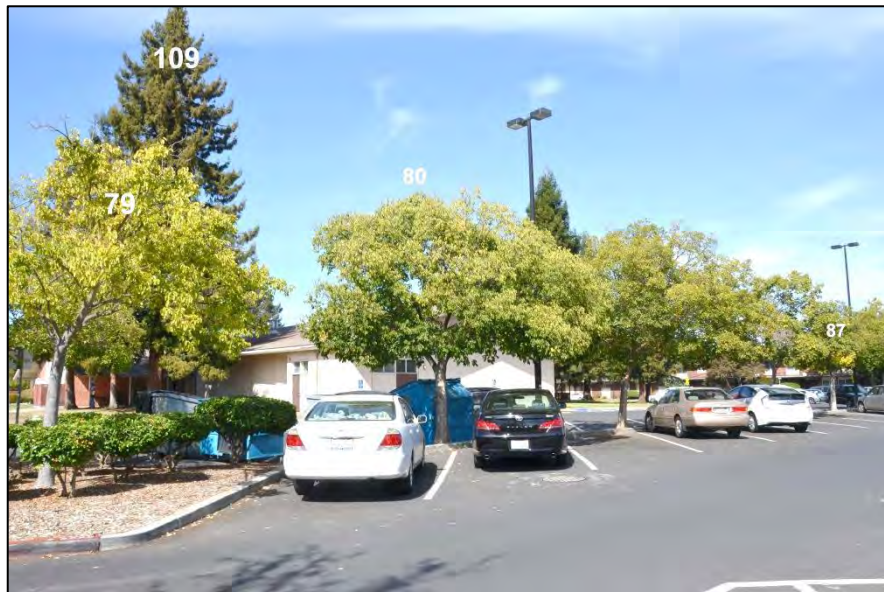
84	Chinese hackberry	9	18*20	85	70	Fair/Good		5	5	7
85	Chinese hackberry	8	20*20	80	60	Fair/Good		5	5	6
86	Chinese hackberry	5	16*10	60	40	Fair/Poor	Large trunk canker.	5	5	5
87	Chinese hackberry	7	20*15	60	40	Fair/Poor	Large sunscald trunk canker.	5	5	5
88	Chinese hackberry	6	15*18	70	50	Fair	Trunk canker.	5	5	5
89	Modesto ash	19	45*35	85	60	Fair/Good		5	10	19
90	Modesto ash	14	50*40	80	50	Fair		4	7	11
91	Modesto ash	23	40+45	75	40	Fair	Bolt installed through trunk and a large cracked scaffold branch.	6	12	23

Upper left: southeast perimeter parking area. **Redwood #109** and **Chinese hackberry #79 - 87** are labeled.

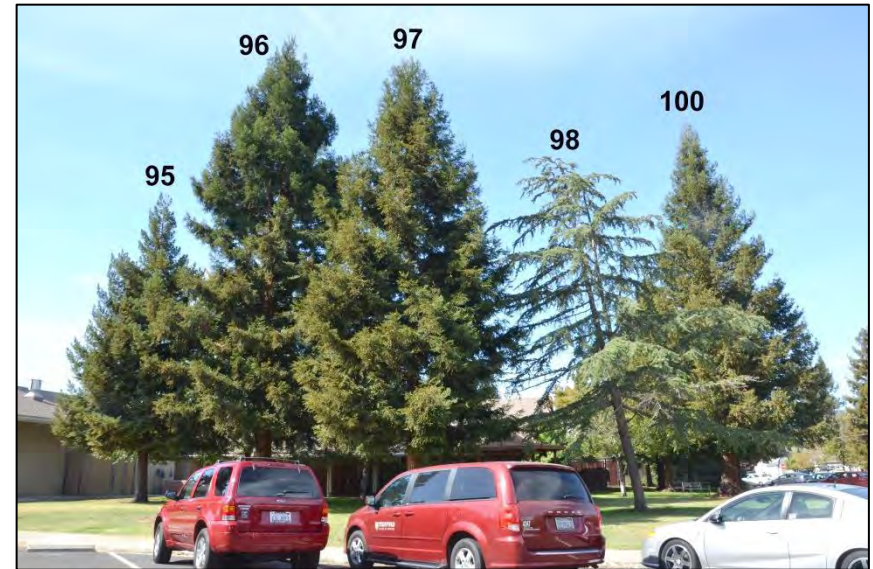
Upper right: east side of the main building with **redwoods #95 - 97 and 100**, and **blue Atlas cedar #98**.

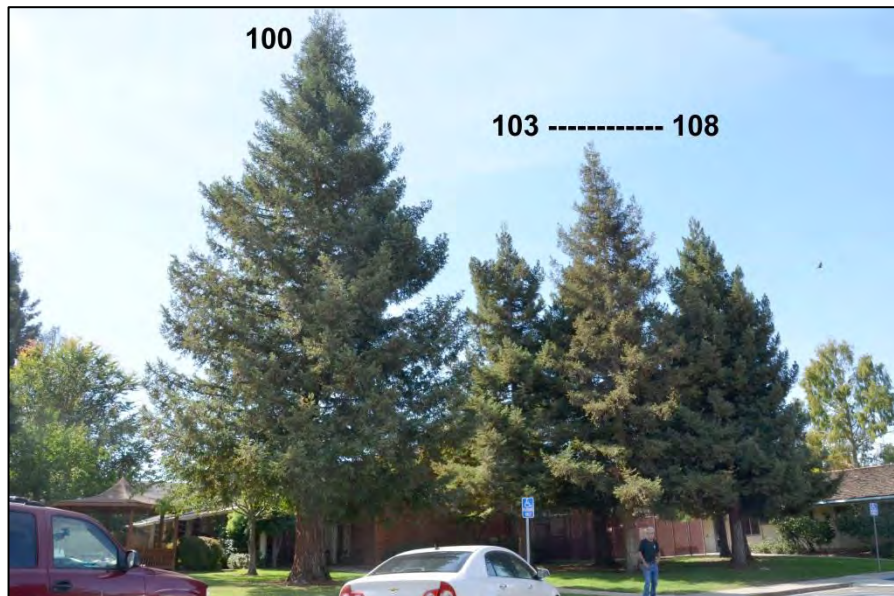
Lower left: north side of the main building with **redwoods #100 and 103 - 108**.

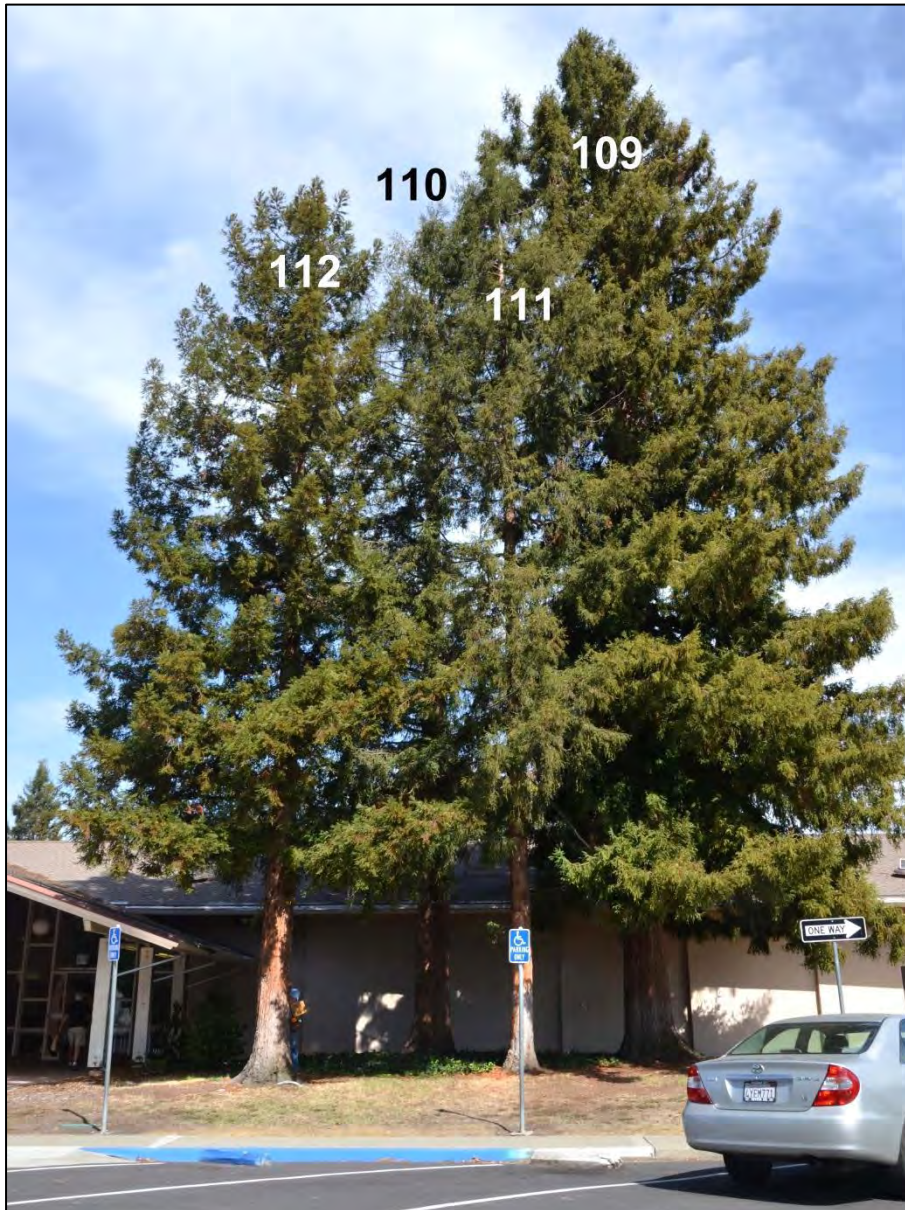
Redwoods #109 - 112 on the south side of the main building. The condition of these redwoods is not as good as for the previous redwoods. These trees look drought stressed and it appears that the lawn area in which the trees are located is no longer being irrigated. Redwood #109 is the largest tree and in the best condition, probably because its root system is more shaded by the building and its larger canopy.
