# City of Fontana

## Arborist Report- Jurupa Ave/Juniper Ave

### Tree Evaluation

711 Fee Ana Street  
Placentia, CA. 92870  
Job Delgadillo  
ISA Certified Arborist – WE 11537A  
September 19, 2018

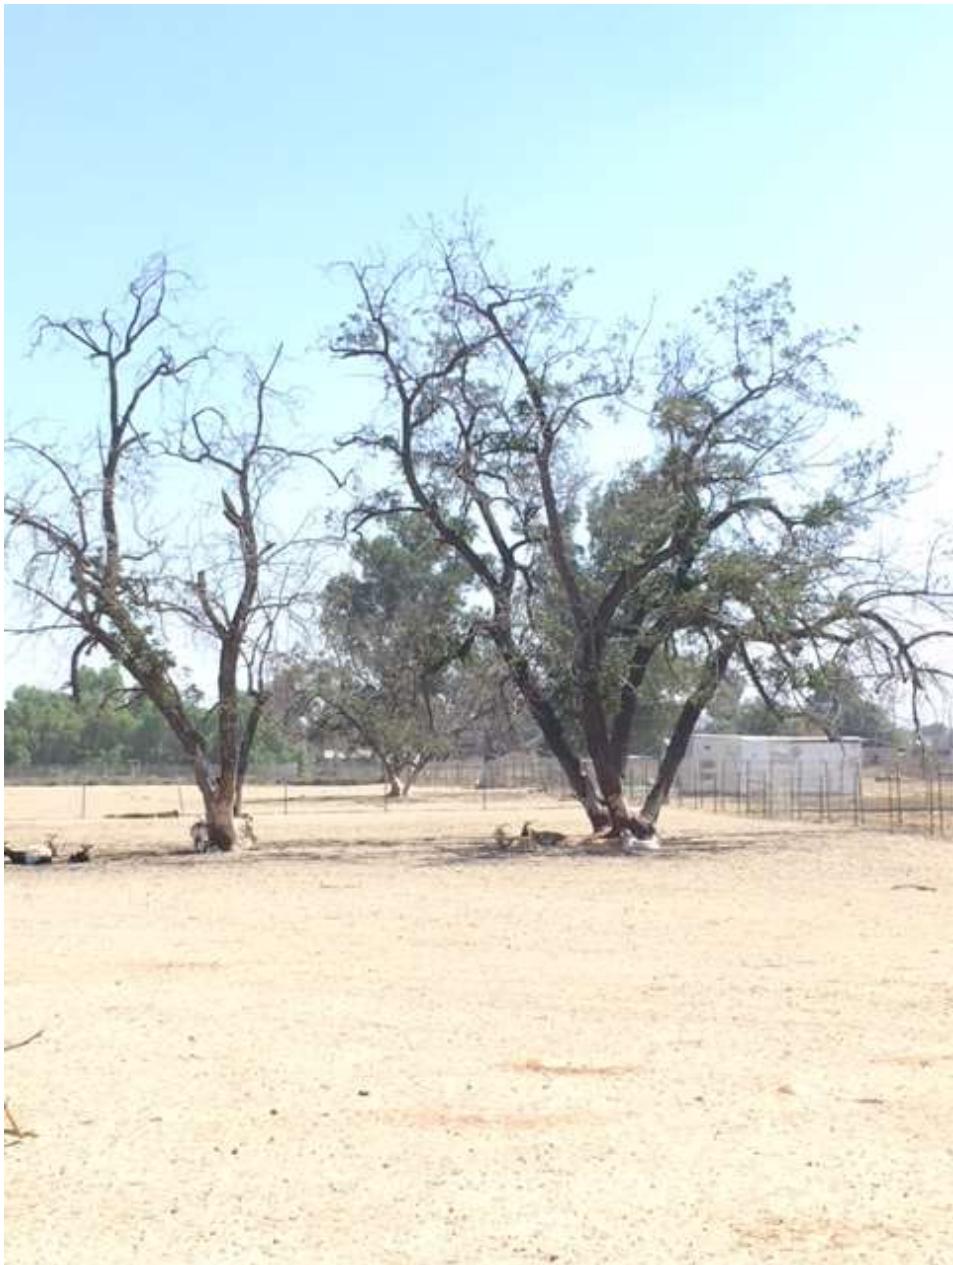
There are multiple Eastern Black Walnut trees onsite, and most of them are in poor condition. Majority of these Walnut trees are dead and the rest are in severe decline. This is most likely due to no irrigation and improper maintenance which led to the infestation of pests.

**Dead and Declining Walnut**

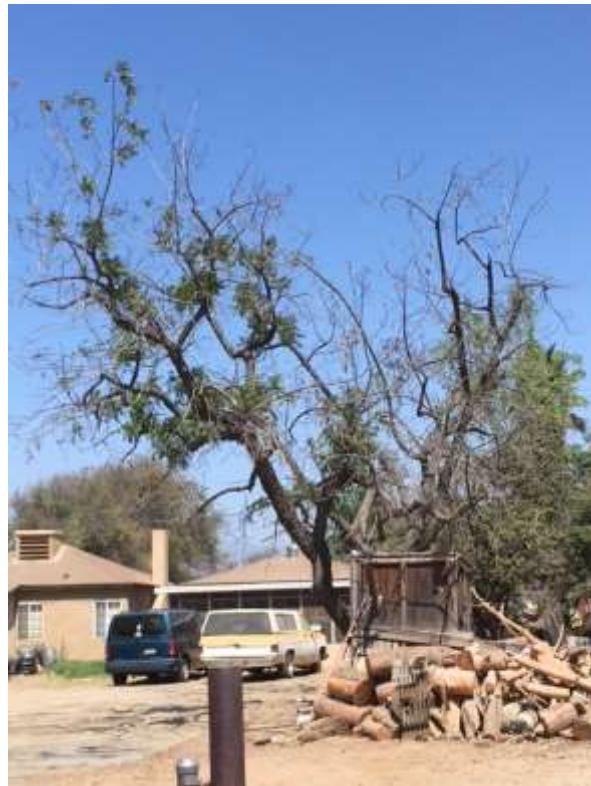
**Walnut in Severe Decline**

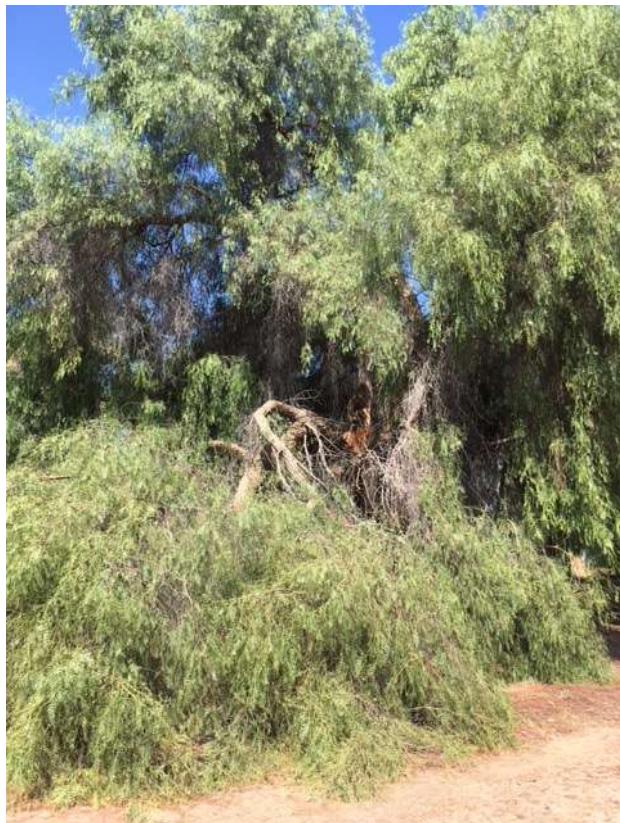
**Failed CA Pepper Limb**

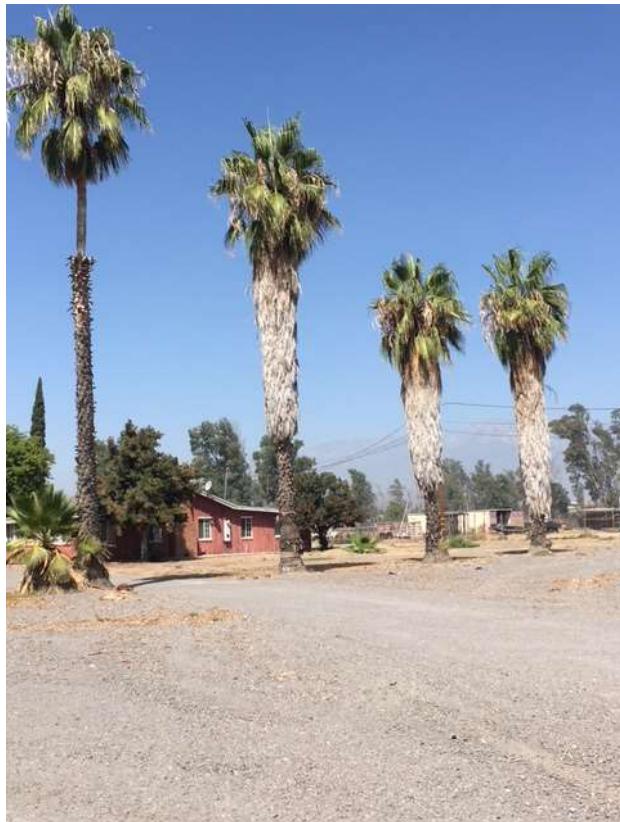
**Unmaintained Palms**

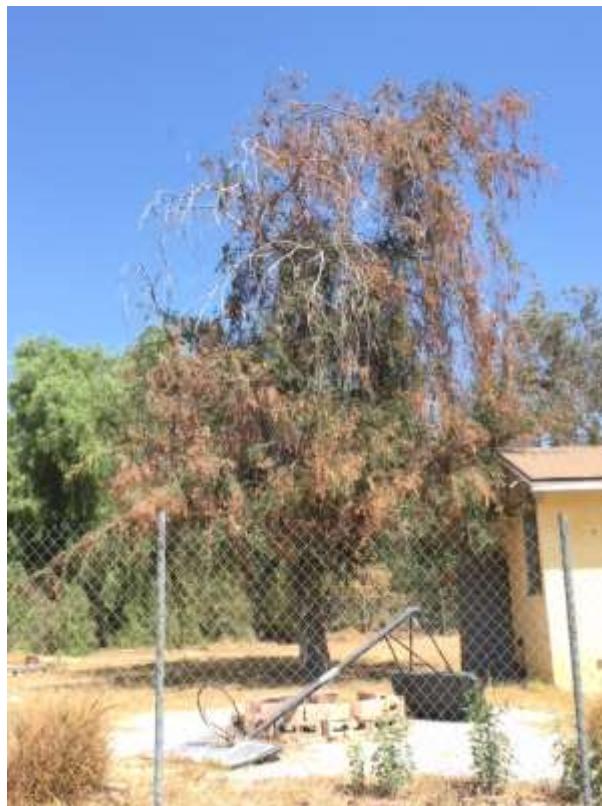
**Tree in Decline**
