**Appendix B: Arborist Report**

October 24, 2018

Subject: **Arborist Report**  
Catalina II, Santa Clara CA

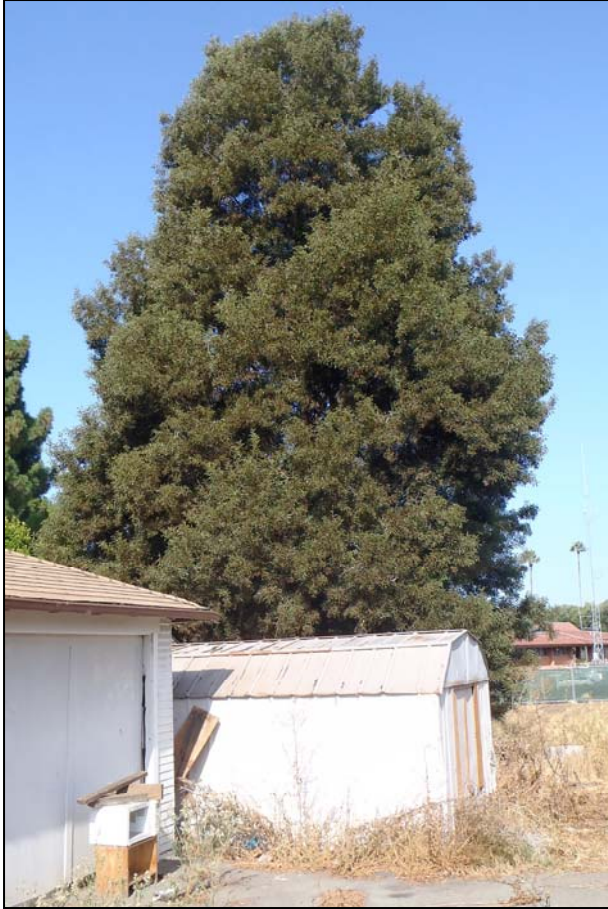
- Mexican fan palm #57 was located in the rear yard of the 1433 address along with #56. The fan palm was young and in excellent condition.
- Blackwood acacia (*Acacia melanoxydon*) #58 was the largest and most significant tree on the sites. It was semi-mature, measuring 20" in trunk diameter, and in good condition (Photo 1, following page). It had a slight lean to the north and included bark was present between the stems. The presence of included bark can predispose the tree to a stem failure.

**Photo 1:** Looking north at blackwood acacia #58. Tree #58 was the largest diameter tree assessed, at 20". It was in good condition with a full crown. However, the presence of included bark between the main stems predisposes the tree to a stem failure. Trees #86, 88 and 89 are examples of small-diameter evergreen ash that are in fair condition and have been outcompeted by their larger neighbors.

<b>Tree No.</b>	<b>Common Name</b>	<b>Trunk Diameter</b>	<b>Protected?</b>	<b>Recommendation for Action</b>
54	Loquat	6,3	No	Remove, within new building
55	Nectarine	5	No	Remove, within new road
56	Avocado	5	No	Remove, within grading
57	Mexican fan palm	18	Yes	Remove, within grading
58	Blackwood acacia	20	Yes	Remove, within new road
59	Evergreen ash	5,4,4	Yes	Remove, within new building
60	Evergreen ash	5,5,4,4	Yes	Remove, within new building
61	Almond	10,8,7,7,4,4	Yes	Remove, within new building
