**COMPREHENSIVE TREE REPORT AND EVALUATION**

**Prepared for Mr. Jim Banker, Monte Vista Assets  
8628 Hillside Rd. – Rancho Cucamonga, CA 91701**

**Prepared by Daryl A. Monson – Certified Arborist # WE 0991A**

**January 10, 2019**

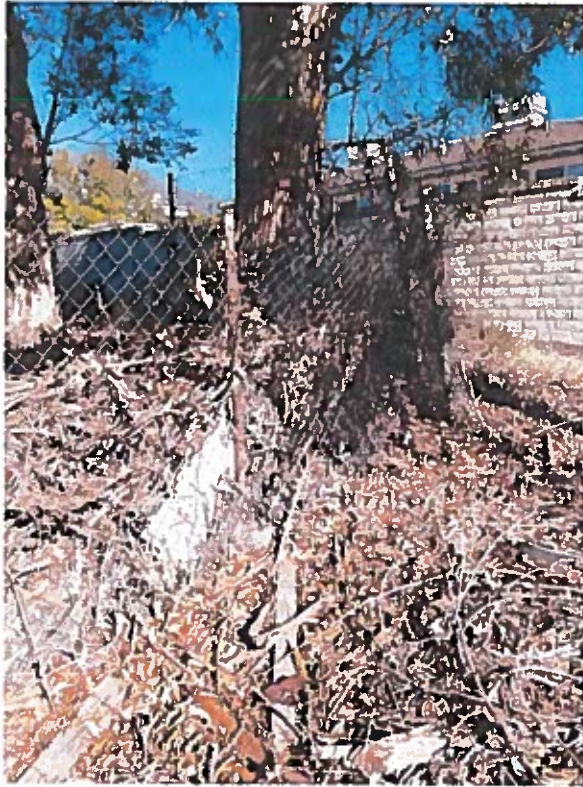
**Trees # 1 & 2 ~ Southeast View, Debris Built up**

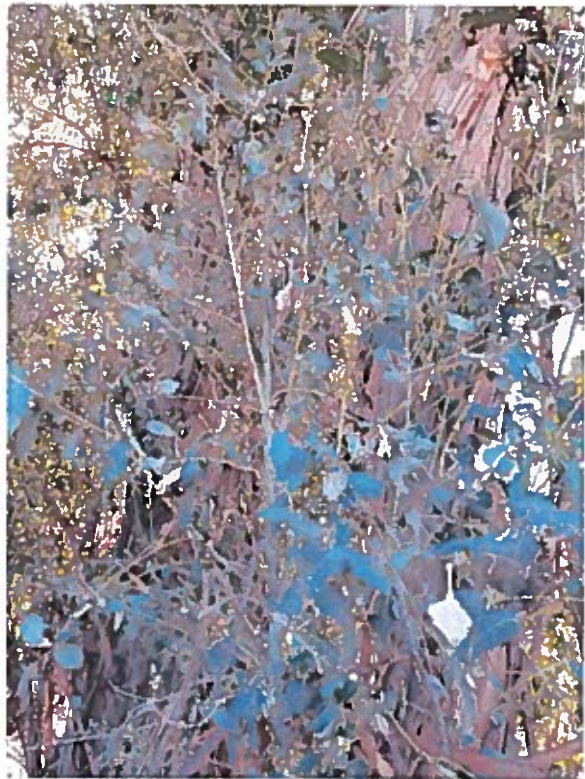
**Tree # 5 ~ South View, Lerp Pysllid**

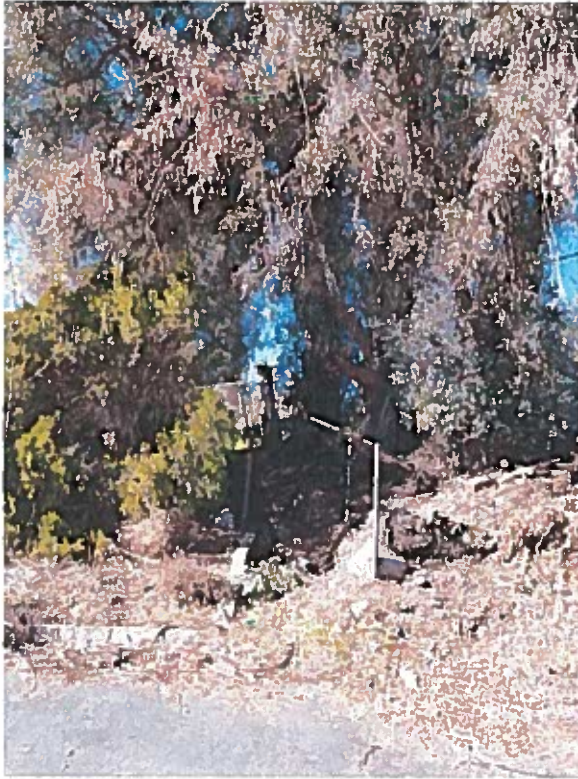
**Trees # 1-5 ~ South View, Debris Built Up**

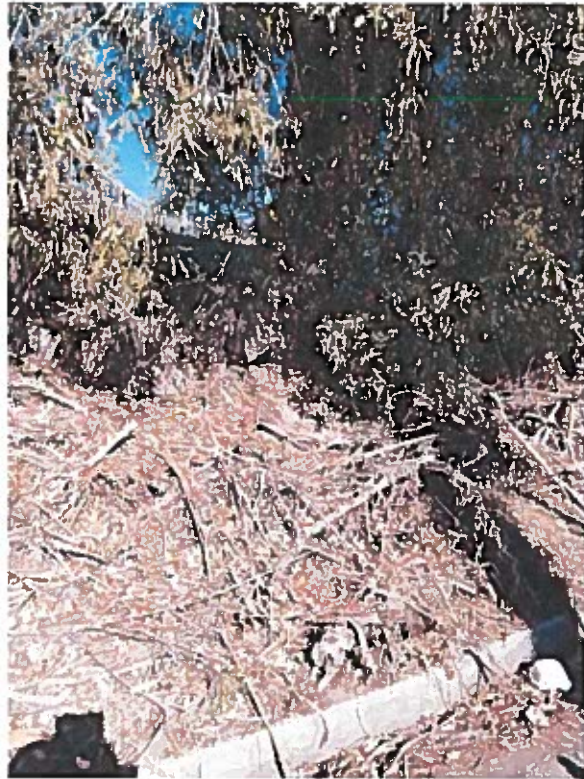
**Trees # 1-5 ~ South View, Debris Built Up**

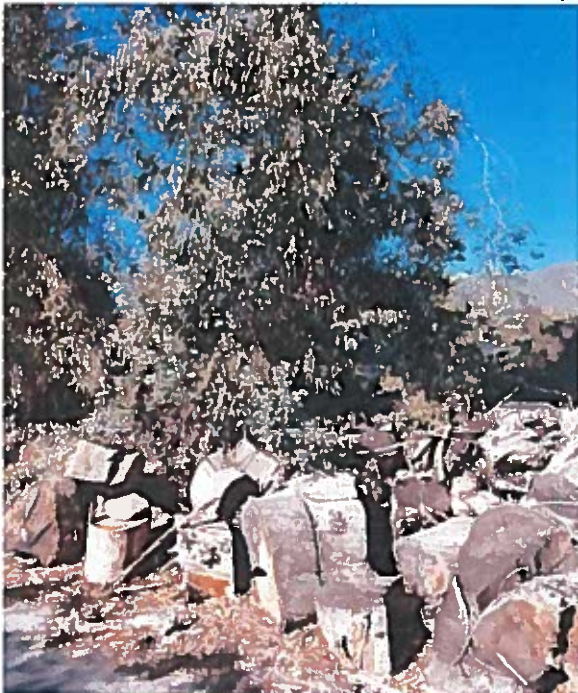
**Tree # 6 ~ South View, Wood/Debris**

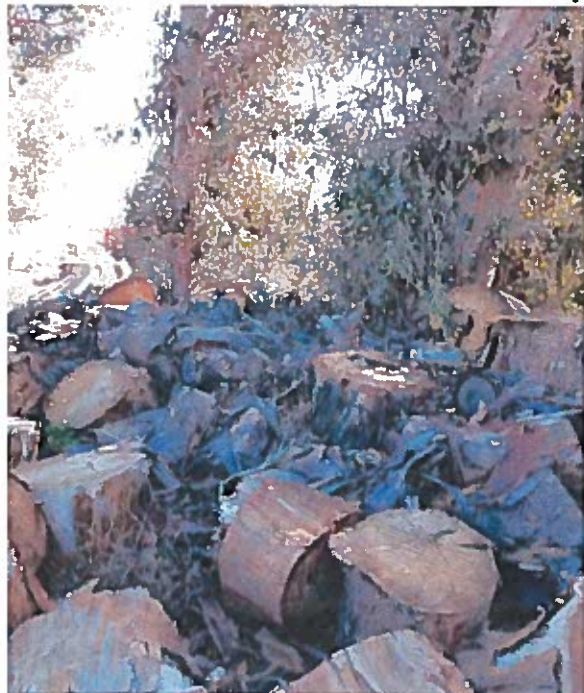
**Trees # 6 - 8 ~ South View, Wood/Debris**

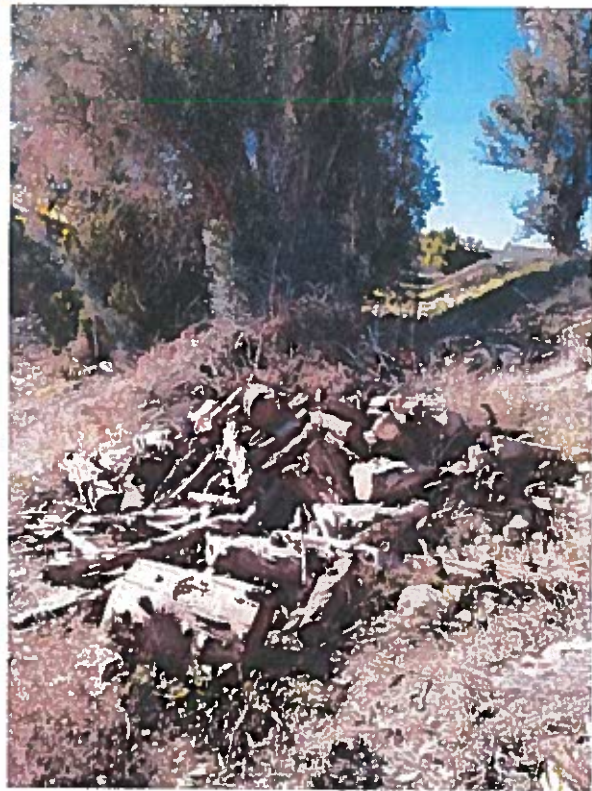
**Trees # 6 – 8 ~ South View, Debris**

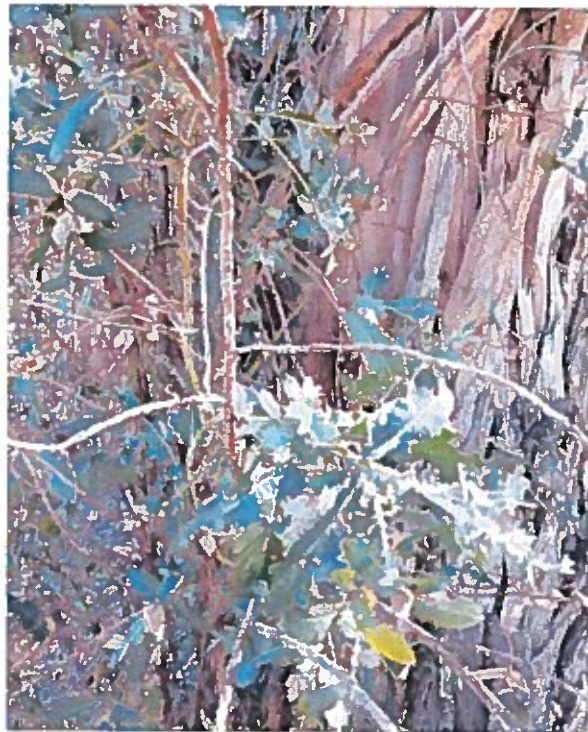
**Tree # 9 ~ South View, Lerp Psyllid**

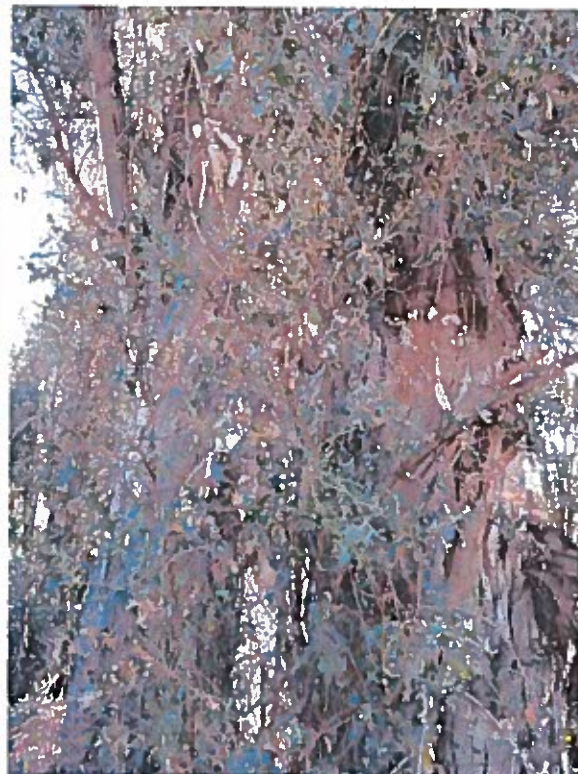
**Trees # 9-10 ~ Up Close, Lerp Psyllid**

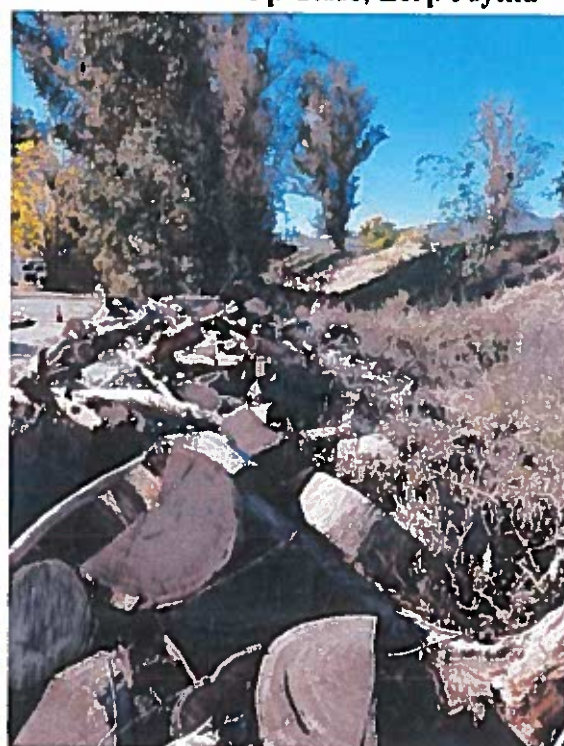
**Trees # 9 – 19 ~ South View, Wood/Debris**

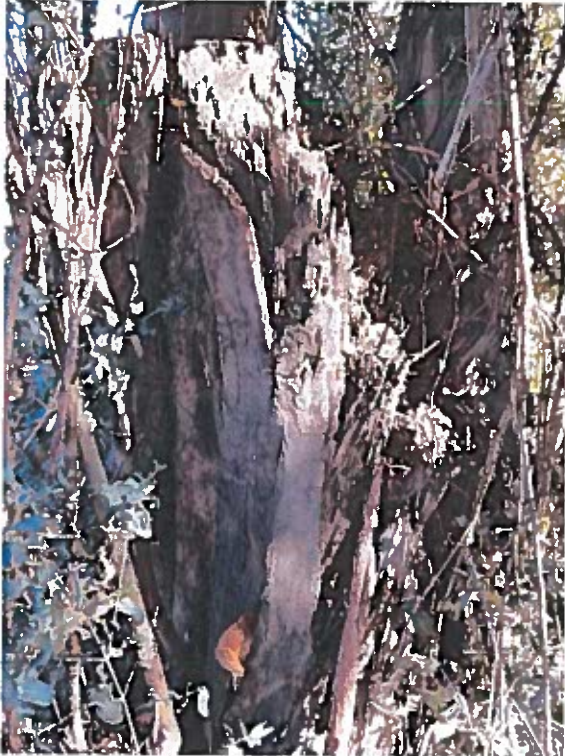
**Tree # 13 ~ South View, Dead – Removal**

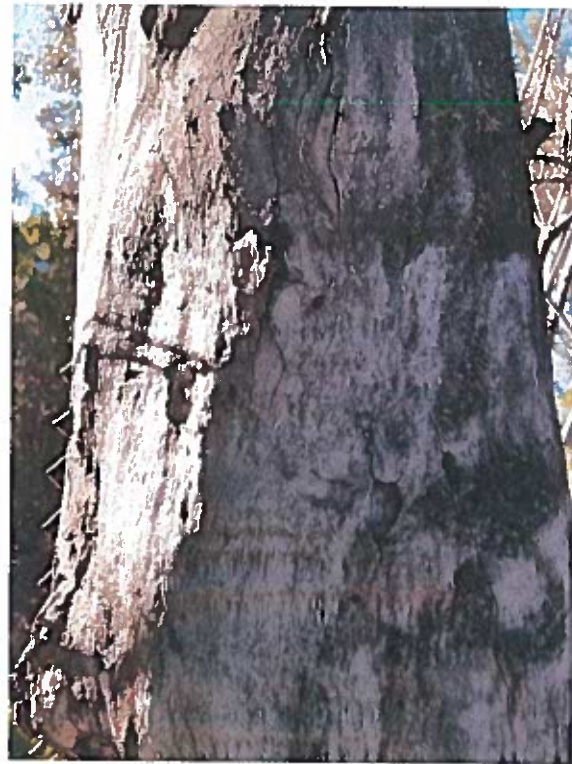
**Tree # 18 ~ Up close, Pest damage**

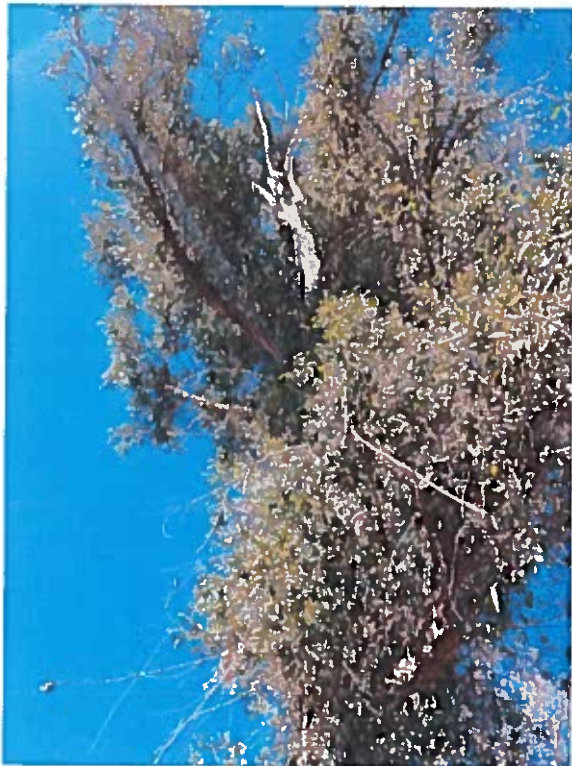
**Tree # 18 ~ West View, Fair Condition**

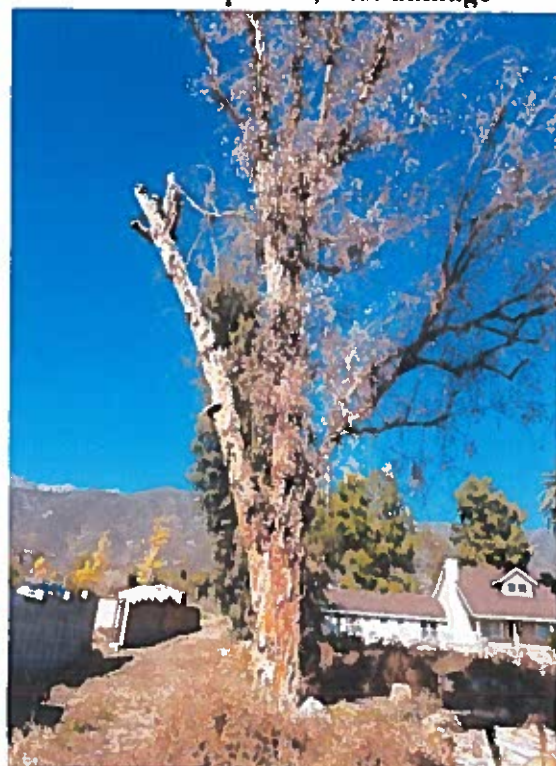
**Tree # 19 ~ West View, Dead – Removal**

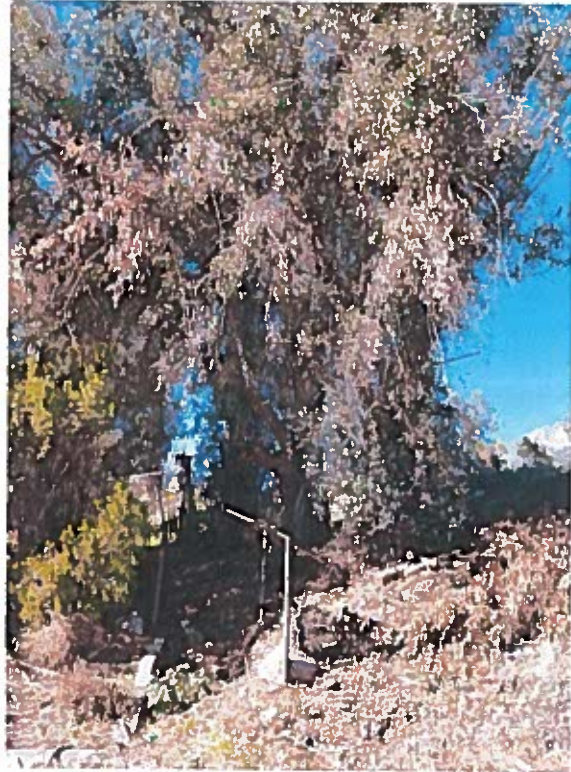
**Trees # 9 – 13 ~ South View, Debris Built Up**

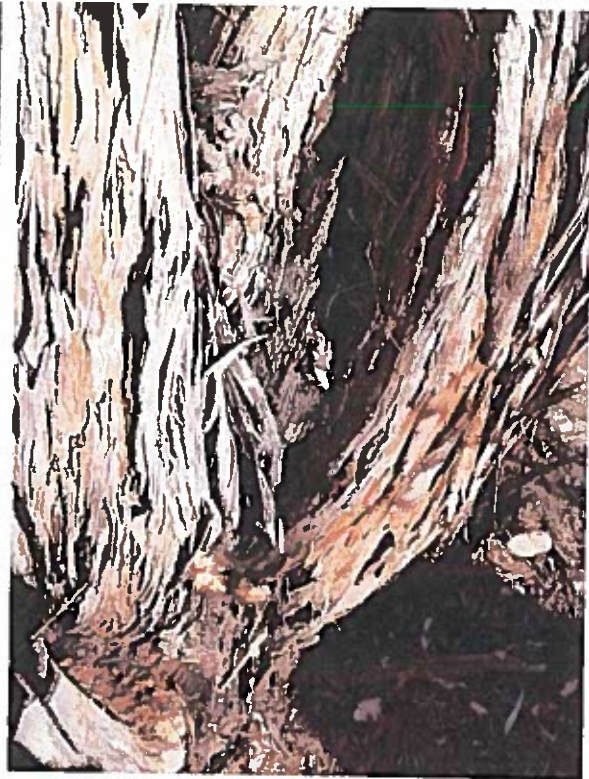
**Tree # 23 ~ West View, Fair Condition**

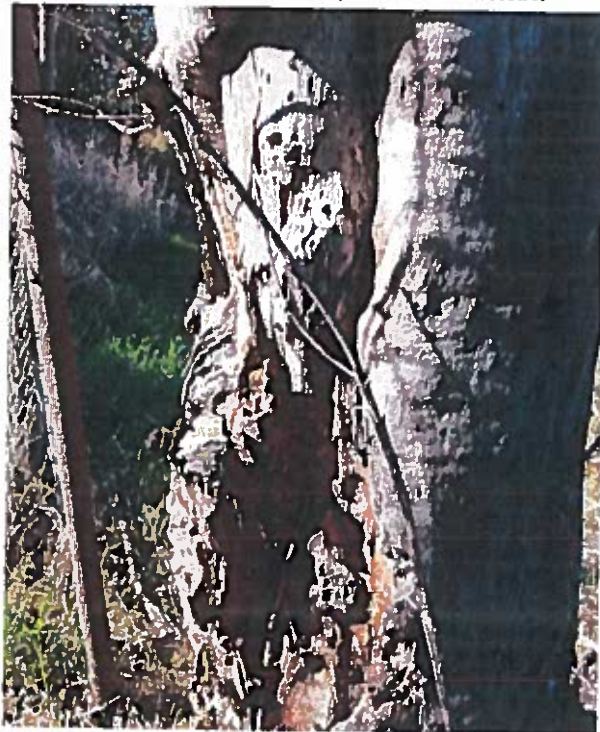
**Trees # 17 ~ South, Dead w/ Bees - Removal**

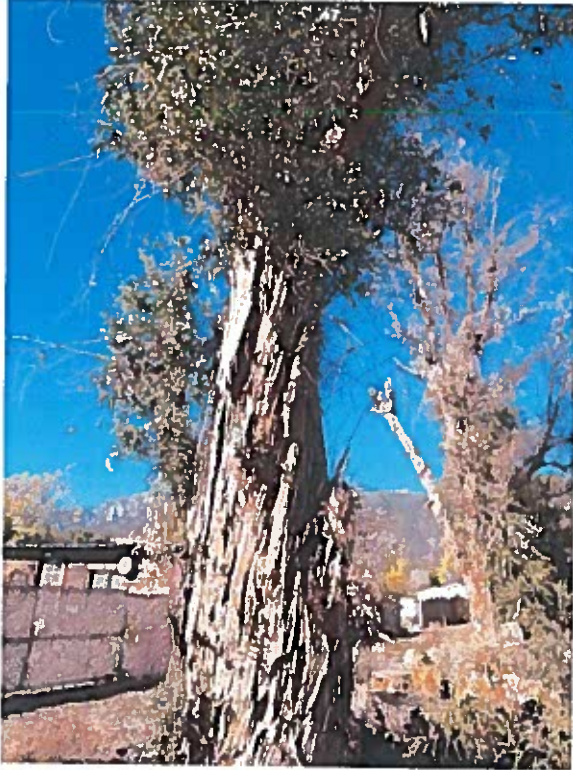
**Trees # 18 & 19 ~ West View, Removals**

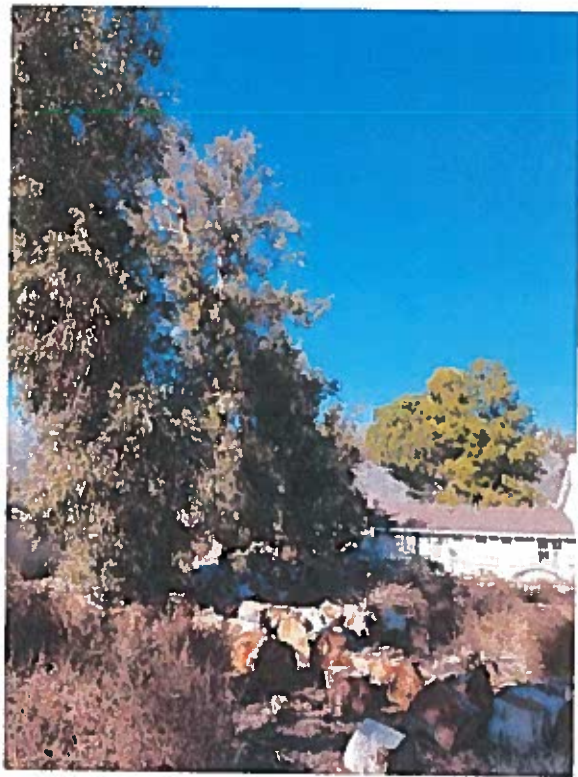
**Trees # 20 – 23 ~ West View, Debris**
