# Seismic Report (Probable Maximum Loss)

3175 Airway Avenue

3175 Airway Avenue  
Costa Mesa, California

EBI Project No. 1319000059

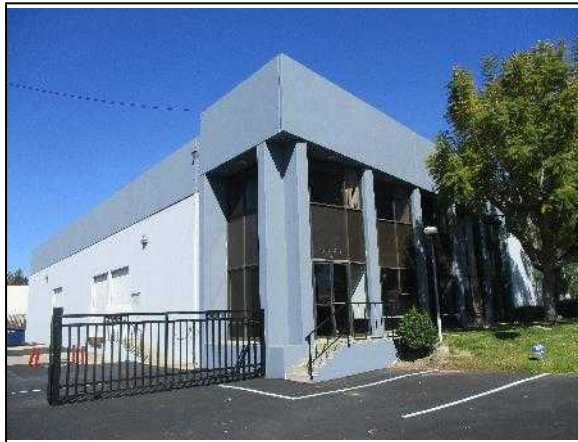
1. View of Subject Property from street. Note storefront system at south east corner.

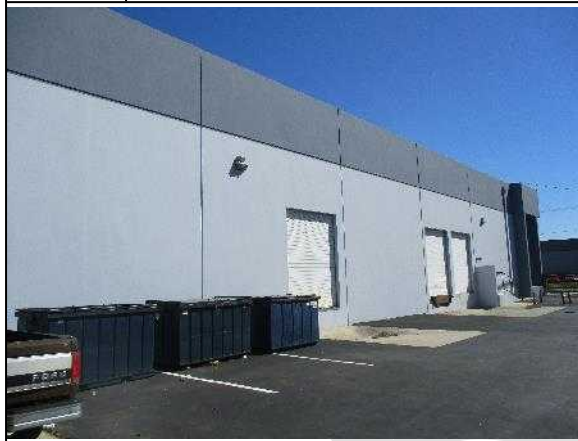
2. Representative façade with some loading dock doors.

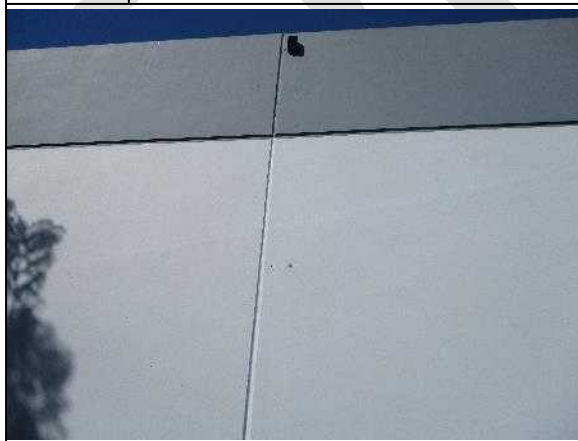
3. Exterior concrete tilt-up wall panels.

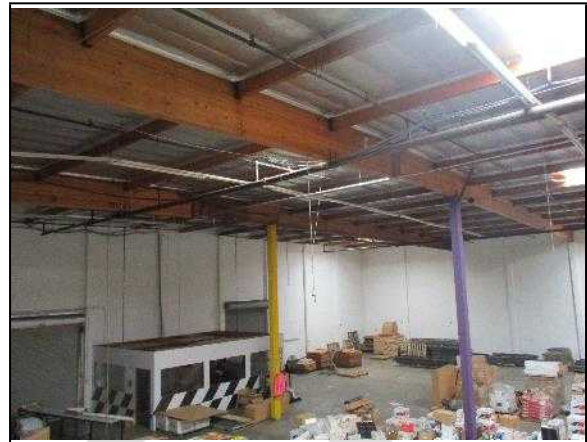
4. Interior of warehouse space.

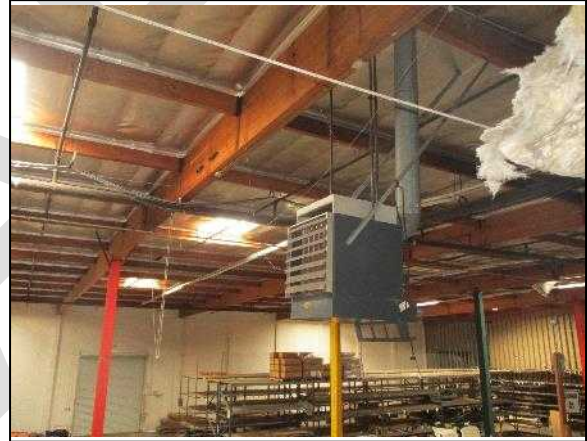
5. Underside of roof framing. Note diagonal bracing of HVAC unit.

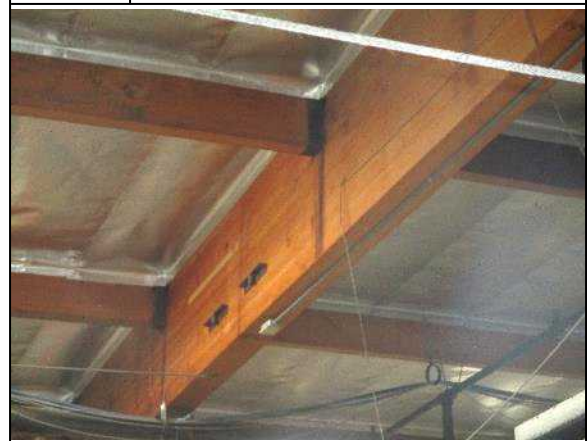
6. Wood purlins and glue-laminated girder.

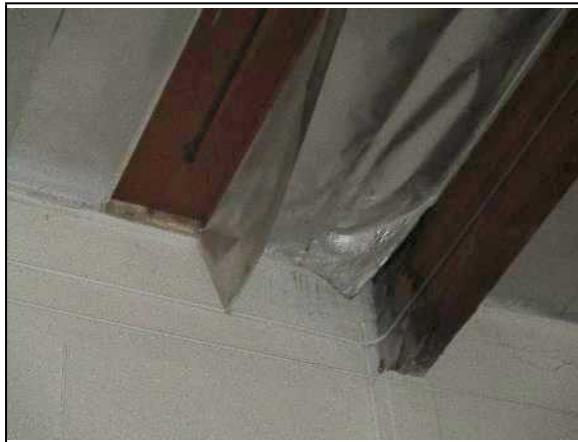
- EBI could not observe or verify any substantial positive wall tie anchorage connecting the wood framed roof to the exterior concrete walls; under these conditions, the heavy walls have the potential to separate from the roof and floors during a code level seismic event.

7. Glue-laminated girder on concrete pilaster at exterior wall.

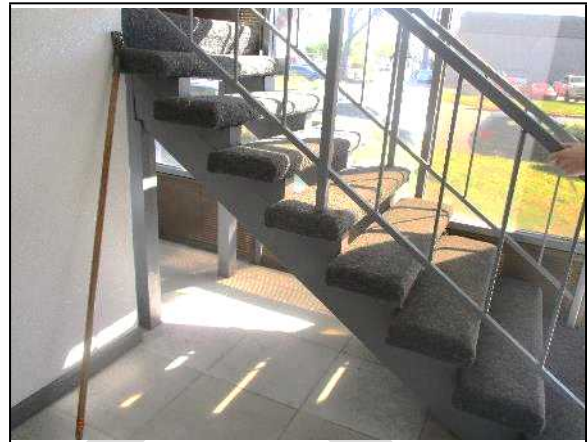
10. Wood framed stairs to office mezzanine.

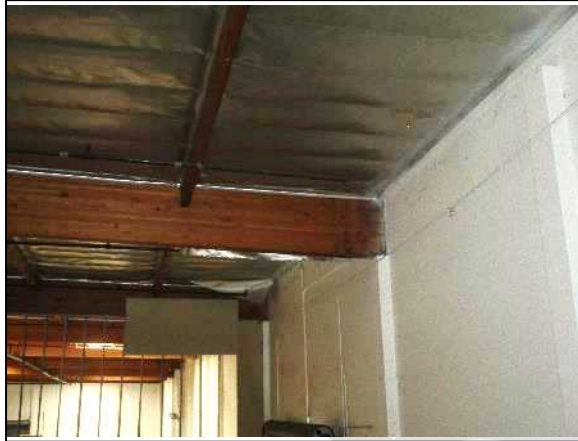
8. Glue-laminated girder on concrete pilaster at exterior wall.

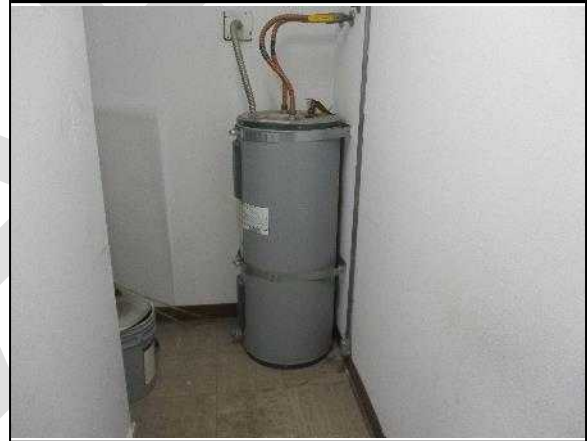
11. Hot water heater in south east office portion with seismic straps.

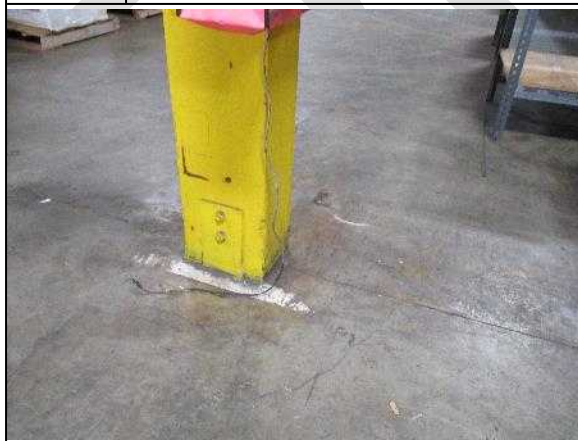
9. Base of interior wood column to concrete floor slab.

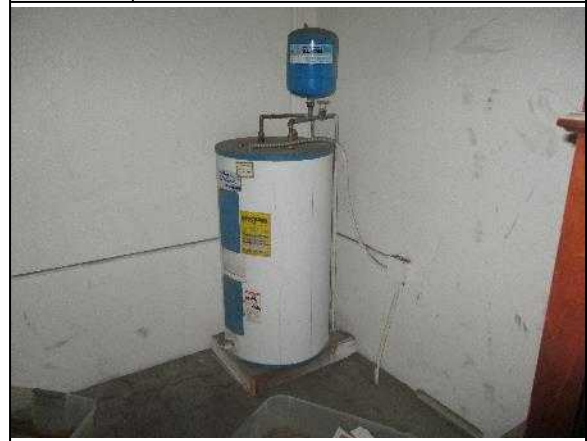
12. Hot water heater in north west office portion. Note no seismic straps.
