January 7, 2019

SCST No. 170213N
Report No. 1R

Subject: GEOTECHNICAL UPDATE
9046 LA JOLLA SHORES LANE
LA JOLLA, CALIFORNIA

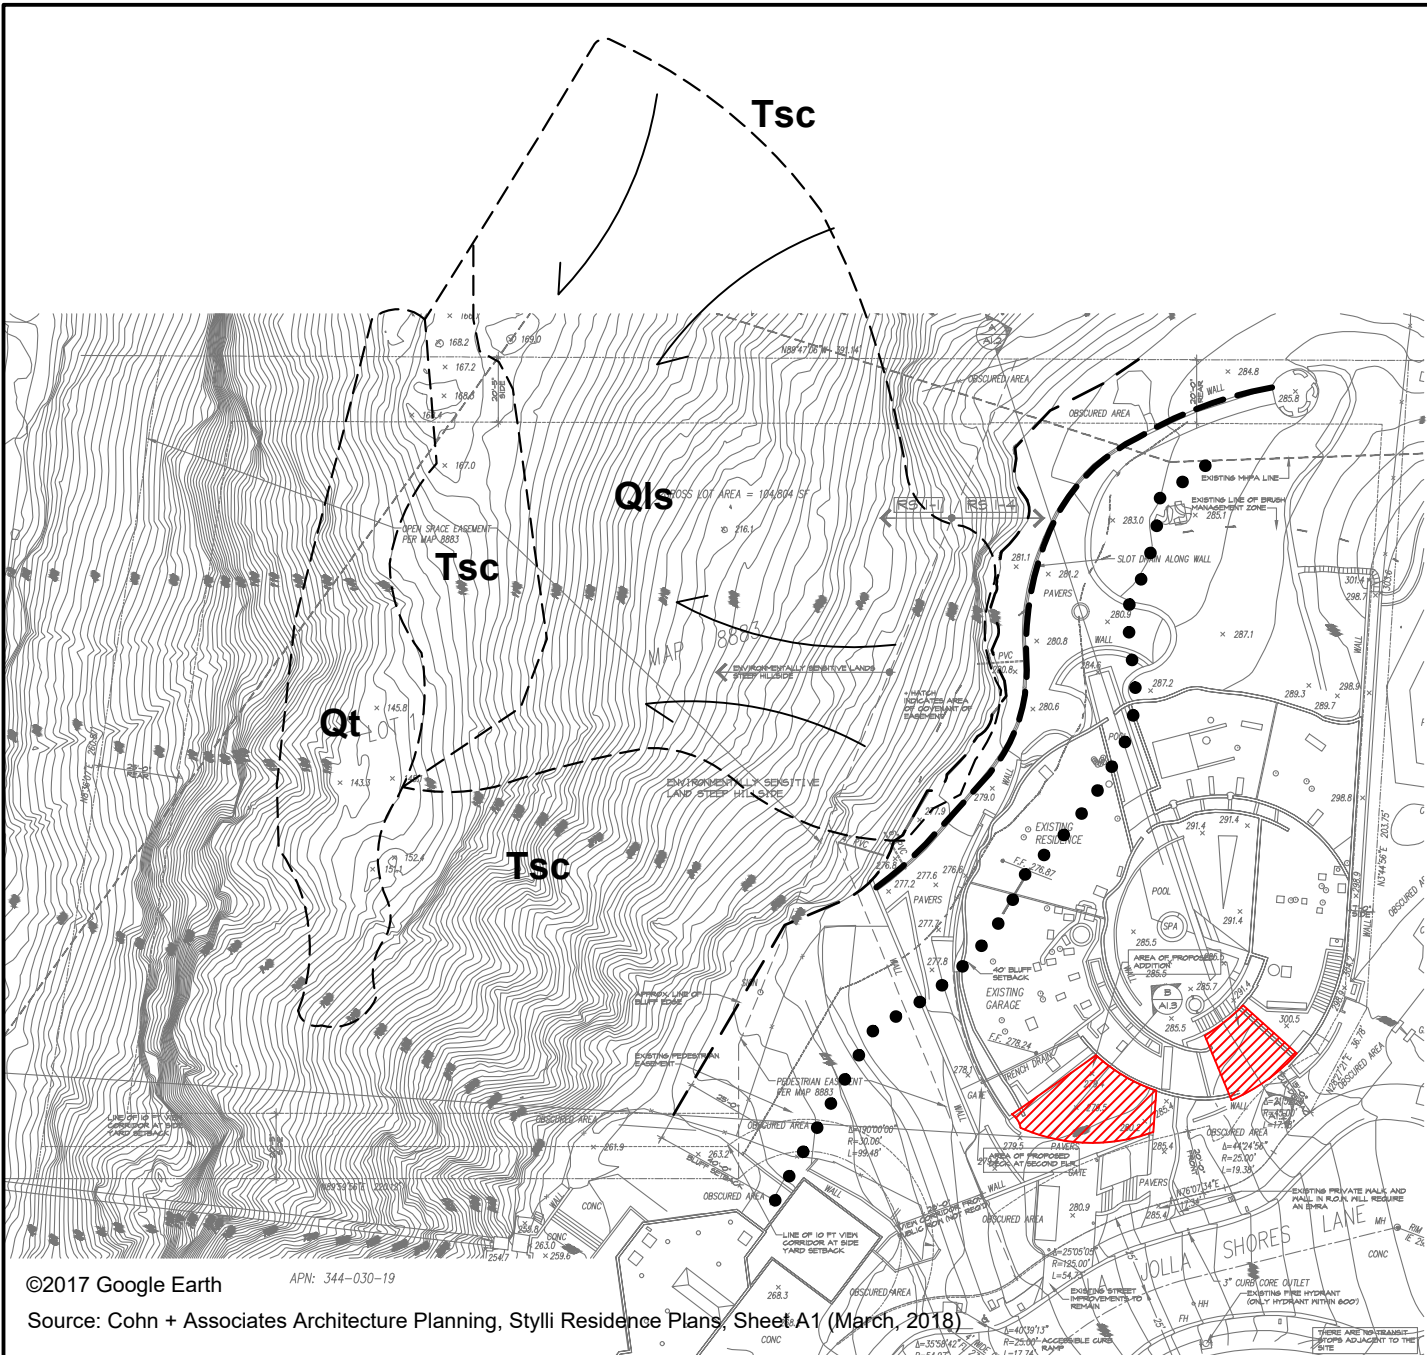
Figure:
2

A site reconnaissance was performed by a California-Certified Engineering Geologist on April 18, 2017. Based on the reconnaissance, we observed no major cracks in the stucco exterior of the house or in the concrete patio. Reference 1 shows the post-repair bluff top, which is considered a baseline for future measurements. Measurements of the current edge of bluff to the building columns on the west side of the house range from 17 feet to 35 feet. The nearest bluff-edge-to-shear wall measurement was about 3 feet. Using Google Earth images, it appears there may have been a few feet of bluff top retreat due to scarp erosion. There was no evidence of extension or vertical offsets to suggest impending slope failure or creep. A map of the Top of Bluff from our observations and available data is presented in Figure 2.

The proposed additions to be occupied are located well behind of the existing bluff top and (approximately 100 feet) behind setbacks recommended in the original geotechnical report (Reference 3 and Figure 2). Our evaluation indicates that there may have been a few feet of bluff top retreat due to scarp erosion, but the site has otherwise not been observed to have changed since our understanding of the site following the shear pin wall and grade beam construction. Therefore, based on the site conditions and distance to the bluff setbacks, it is our opinion that the proposed additions will not affect the stability of the bluff. If new foundations are needed for the proposed improvements, they will need to consist of deep foundations, constructed in accordance with the design parameters in the original geotechnical report, Reference 3. With the exception of the seismic design parameters summarized above, the foundation design recommendations in Reference 3 are considered applicable.
