Arborist Report

**Assessment of Four (4) Remaining Trees
At and Adjacent to the Active Demolition Site at
493 Forbes Blvd.
South San Francisco, California**

Walter Levison, Consulting Arborist (WLCA)

4/24/2020

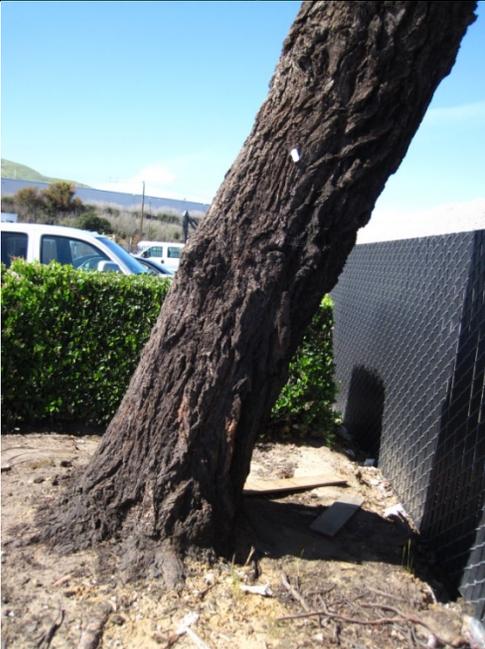
Tag #	Image	Tag #	Image
11

<p>Lean to the southeast.</p>	11

1. Remove tree #11 for safety purposes (neighbor-owned tree west of 493 Forbes). If the tree cannot be removed, then maintain protection in the form of a trunk buffer wrap per the image at right, and/or chain link fencing protection along the property line. The tree is currently not irrigated, but would benefit significantly from regular (1x/weekly) heavy irrigation over the open soil root zone.

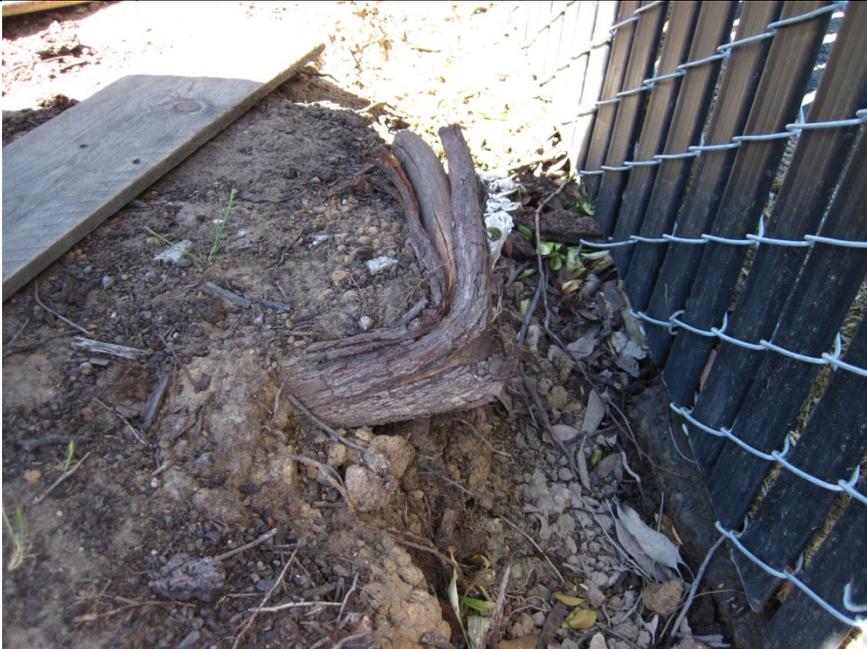
<p>Roots along the property line appear to have been deflected by a historical curb that was demolished recently.</p>

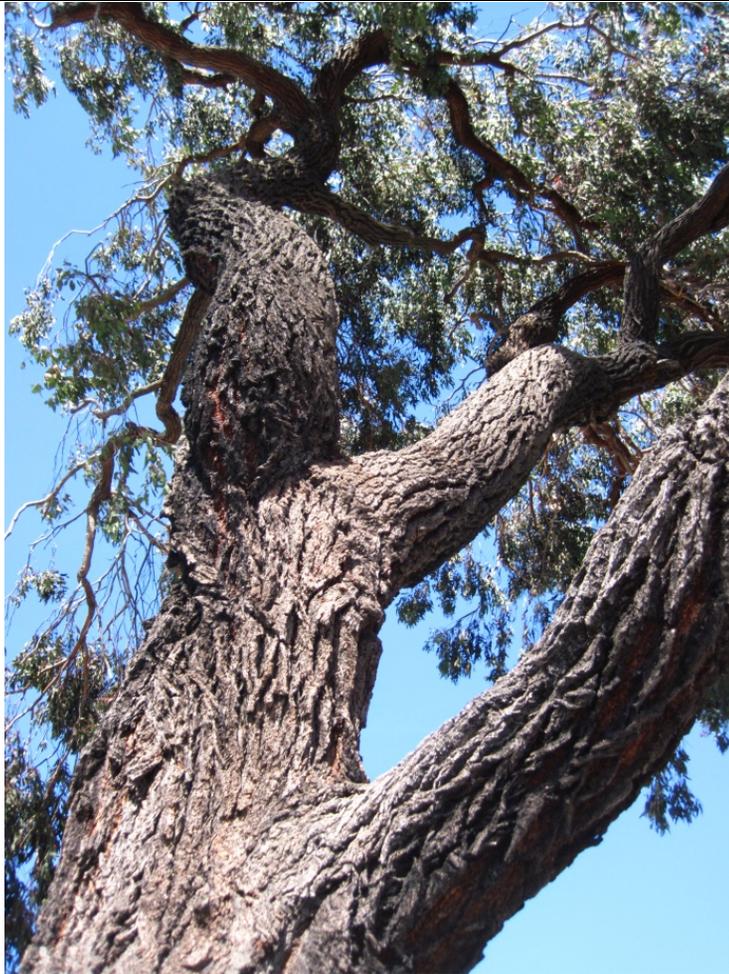
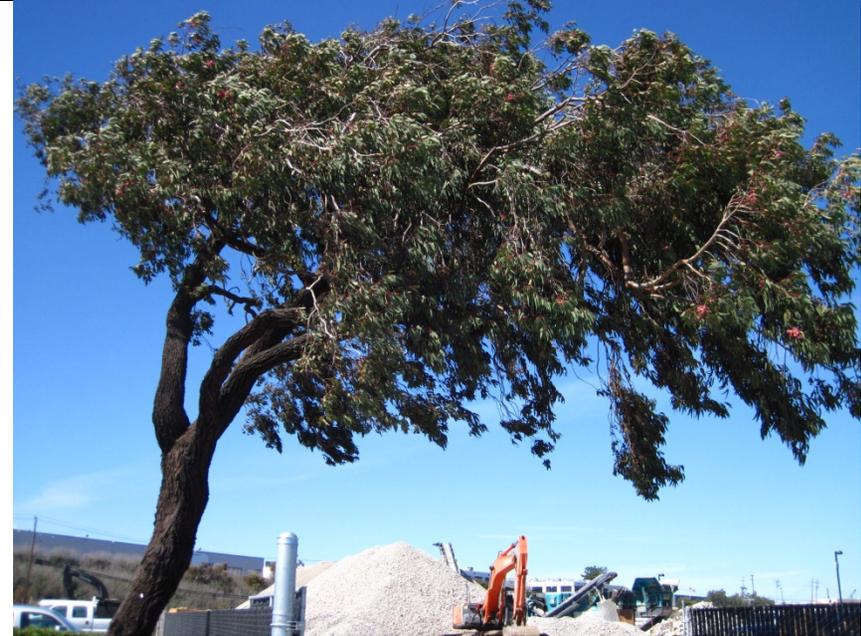
11

Tree #11 is a neighbor-owned red ironbark eucalyptus (*Eucalyptus sideroxylon*) located just west of the existing property line fence (see attached tree map by WLCA). It is of large enough diameter that it is considered a **protected tree** per the City of South San Francisco tree ordinance under the 15.3 inch diameter rule for “other species”. The tree is in fair overall condition, with a significant lean and lopsided canopy extending into the property survey area. The tree may or may not be an elevated risk of failure and impact with ground targets on 493 Forbes. The tree may or may not need to be removed for safety purposes. See WLCA’s analysis of tree condition in section 9.0 tree data table below.

Canopy lopsided southeast over 493 Forbes.

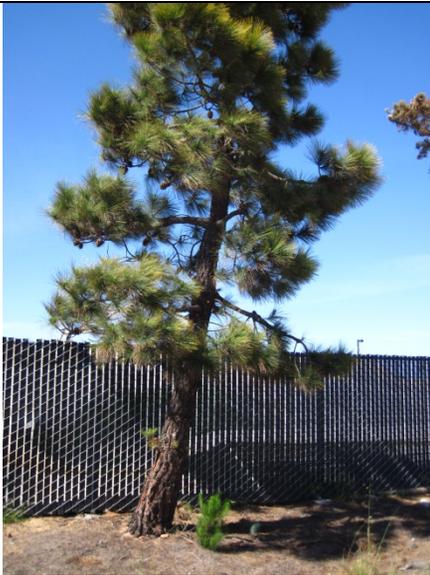
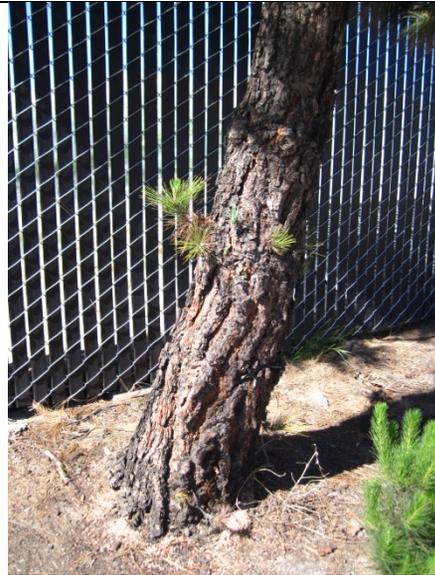
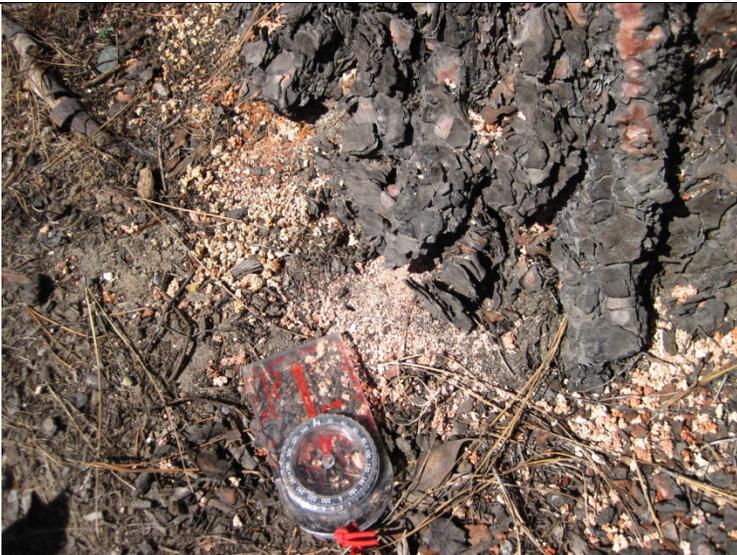
<p>12</p>

Tree #12 is a Canary Island pine (*Pinus canariensis*) in poor overall condition that appears to be within the 493 Forbes private property bounded area (i.e. north of the property line nearest Forbes Blvd). The tree is **not protected** under any of the various diameter thresholds noted in the city tree ordinance, and can therefore be removed at this time, unless there is a special planning division condition or project approval that requires its protection during construction (see section 3.0 below for information on protected trunk circumference and diameter thresholds). The tree exhibits visible evidence of extensive feeding by red turpentine bark beetles which may eventually kill the tree. This tree is assumed to be proposed for removal as part of the ongoing active demolition and construction at this location.

2. Remove tree #12 (a private tree in poor overall condition, smaller in diameter than threshold for “protected tree”). This tree does not appear to require a tree removal permit, unless there is a planning division project condition of approval that requires for some reason that it be retained and protected in place (PIP).

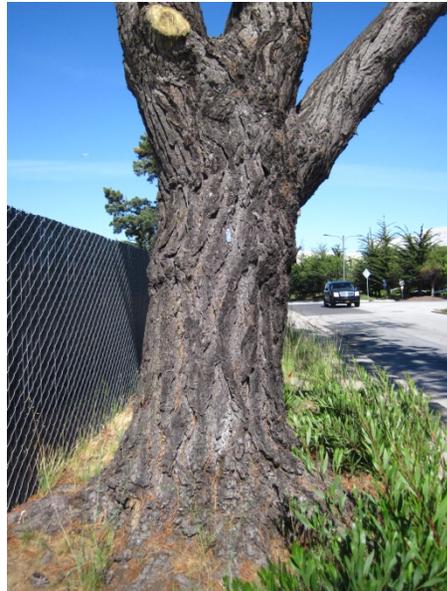
Tree #13 is a Monterey pine (*Pinus radiata*) of large enough diameter that it is considered to be a **protected tree** per the city tree ordinance governing tree specimens on private lands. This tree has an overall condition rating of zero percent, which means that it is in **dead condition**, and needs to be removed as soon as possible to avoid an elevated risk of tree part failure and impact with ground targets such as vehicles, pedestrians, and construction personnel on or adjacent to the 493 Forbes property within 1 year of the date of writing. Risk of branch or limb failure and impact with the above noted targets within 1 year is “moderate” on a scale from “low” to “extreme” (international TRAQ tree risk rating system¹). The tree appears to be **jointly-owned** between the City of South San Francisco and the private lot owner (493 Forbes Blvd.), given that its trunk (mainstem) cross section straddles across the property line that runs parallel to Forbes Blvd. (see tree map by WLCA, attached to the end of this report). Bark beetle pitch tubes and frass was found to be present along the lowermost 6 feet of the mainstem.

<p>Red turpentine bark beetle frass and pitch tubes. This tree will likely die prematurely due to this attack.</p>	<p>13</p>

3. Remove tree #13, a dead tree that is jointly-owned by the City of South San Francisco and the owner of the lot known as 493 Forbes Blvd. Although the tree is a protected-size specimen, a tree that is verified to be in dead condition should be considered an elevated risk of tree part or total tree failure and impact with ground targets (TRAQ risk rating system), and as such is likely deemed a “hazard” or similar designation per the City’s own tree removal permitting criteria system, which may or may not allow for a “waived fee” type over-the-counter removal permit issuance. Contact City Staff to verify and determine a course of action for removal permitting.

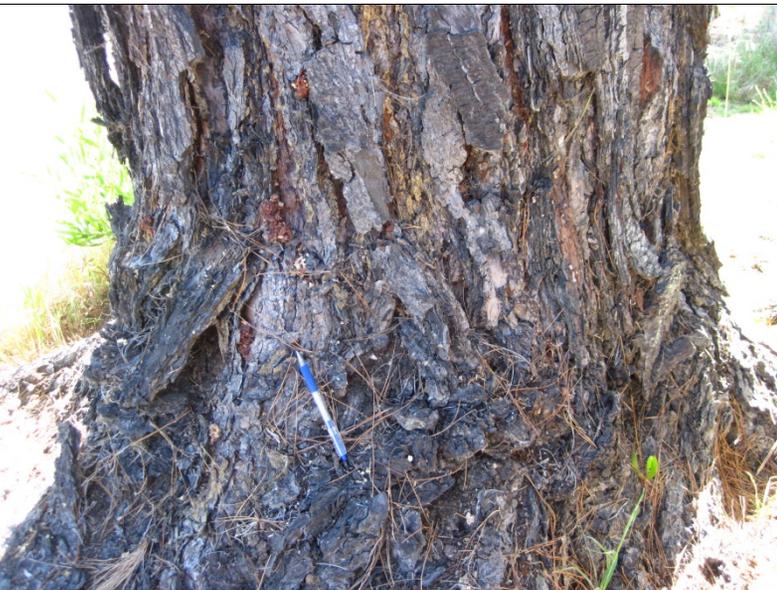
<p>Close-up of bark beetle pitch tube near base of tree #13.</p>
13

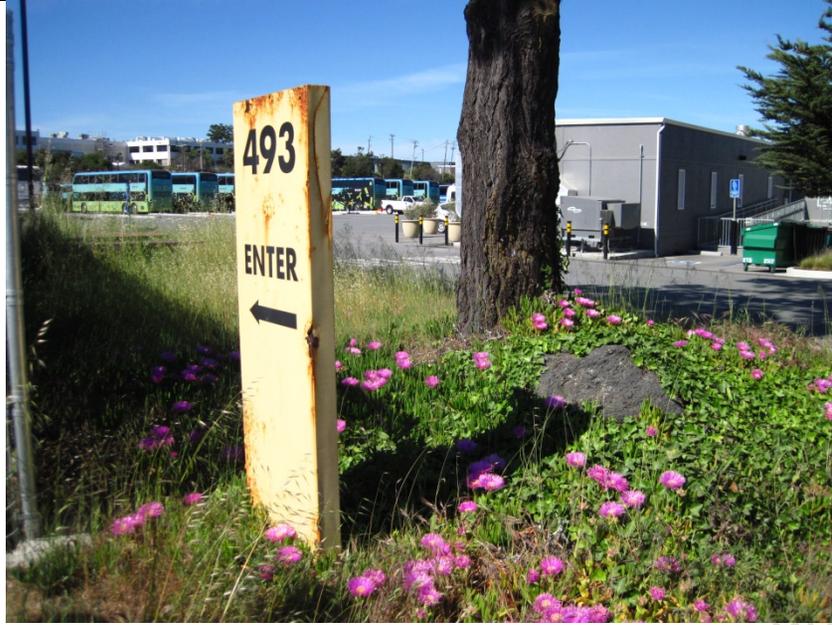
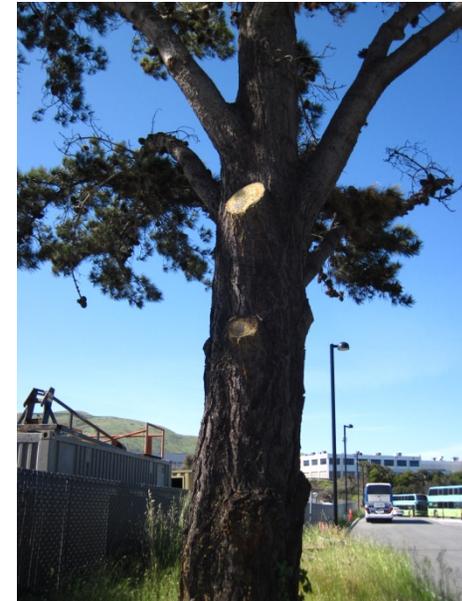
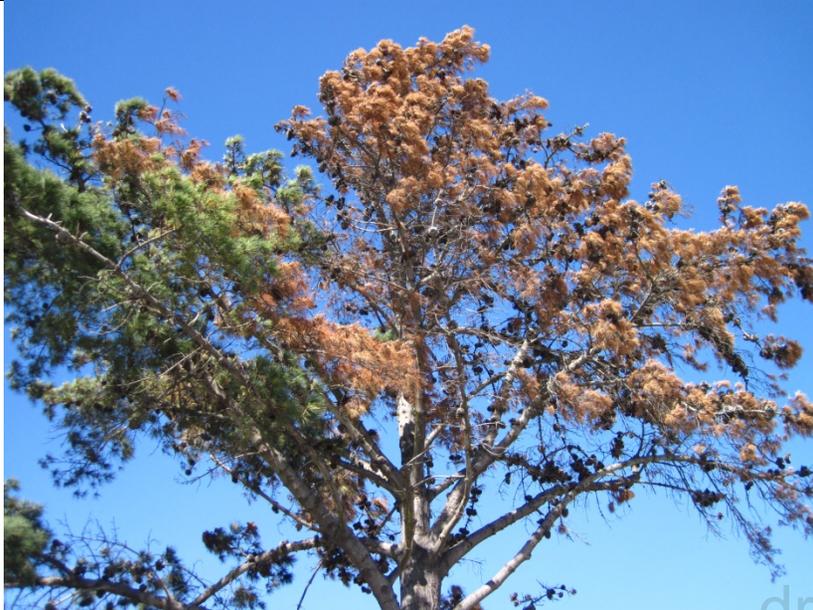
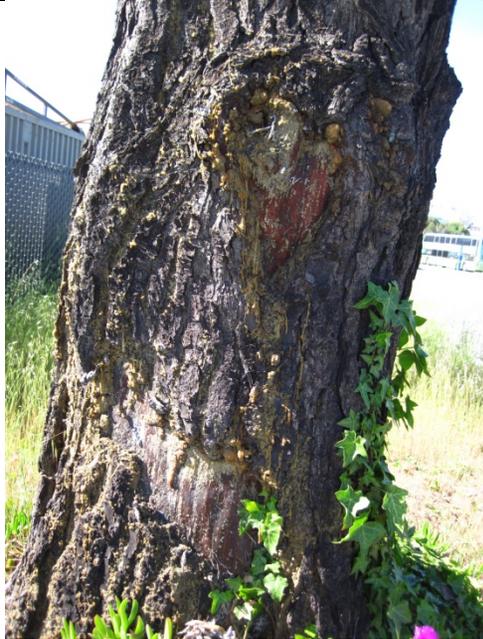
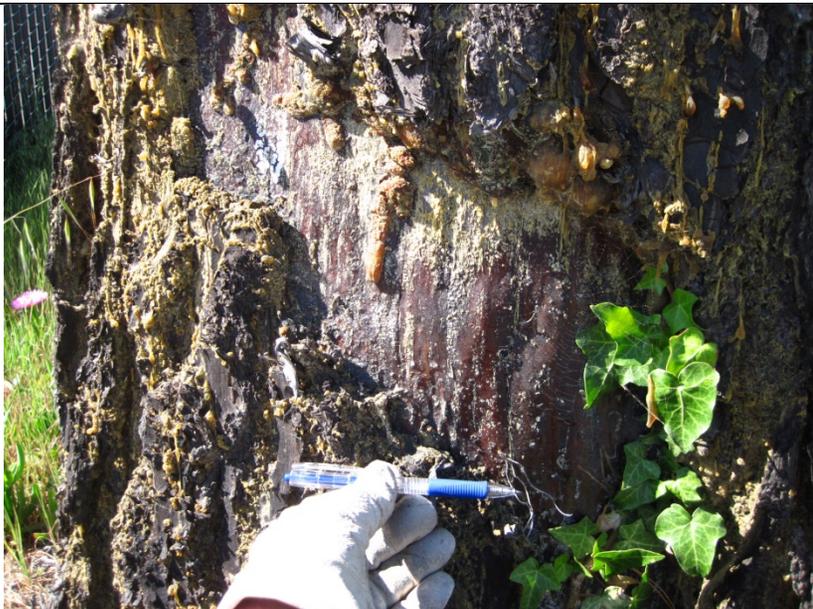
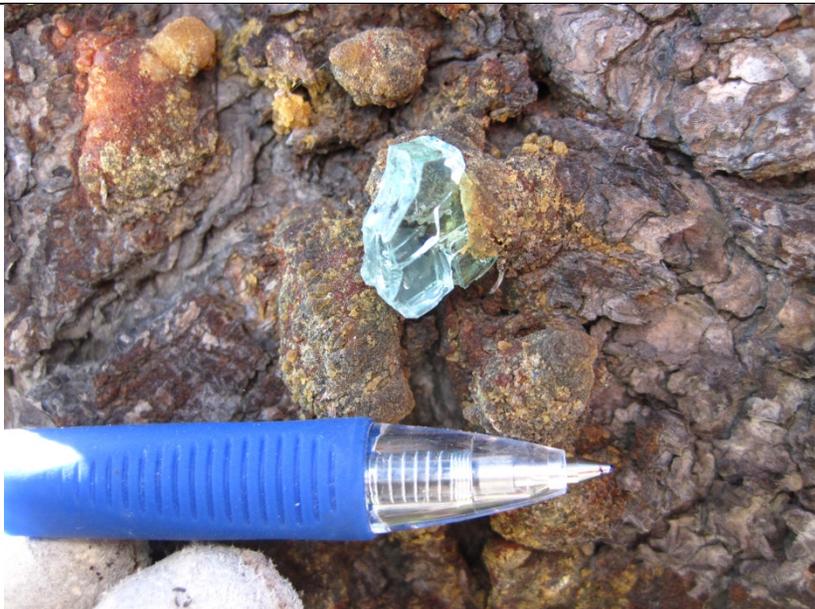
14

Tree #14 is also a Monterey pine (*Pinus radiata*) of large enough diameter that it is considered to be a **protected tree** per the city tree ordinance governing tree specimens on private lands. This tree has an overall condition rating of 10% out of a possible 100%, which means that it is in very poor condition, but realistically **almost dead**, and needs to be removed as soon as possible to avoid an elevated risk of tree part failure and impact with ground targets such as vehicles, pedestrians, and construction personnel on or adjacent to the 493 Forbes property within 1 year of the date of writing. Risk of branch or limb failure and impact with the above noted targets within 1 year is “moderate” to “high” (depending on the diameters of the branches and limbs most likely to fail²) on a scale from “low” to “extreme”, given that the Genentech Transportation Department is located literally adjacent to the east side of the 493 Forbes demolition and construction site, with hundreds of passenger buses entering and exiting all day along the north-south oriented property entrance driveway over which this tree’s canopy extends (refer again to the international TRAQ tree risk rating system³). Over time, the tree’s risk rating for tree part failure and impact with passenger buses may increase to “high” as the wood tissues become increasingly desiccated. The tree appears to be **owned by Genentech**, with the

4. Remove tree #14 for safety purposes as soon as possible. This tree is in 10% overall condition (“very poor”): a rating designation that ranges from 6% to 20% overall condition. 10% condition means that the tree is at the lower end of the “very poor” rating range of values, and is nearing death. As with trees #11 and #13, this tree is also a protected-status tree, and may or may not be removable by over-the-counter permit given its condition rating of 10%. This tree appears to be on land owned by Genentech, and is located on the driveway of the Genentech Transportation Division services driveway where hundreds of passenger buses travel daily. Contact the property owner to discuss a removal strategy. As with tree #13, risk of tree part or total tree failure will increase over time as the wood tissues desiccate. Current risk of tree part or total tree failure and impact with Genentech buses within 1 year of the date of writing is “moderate” to “high” (the rating varies due to the various diameters of tree limbs and branches that are likely to fail over the driveway of the Genentech Transportation Department).

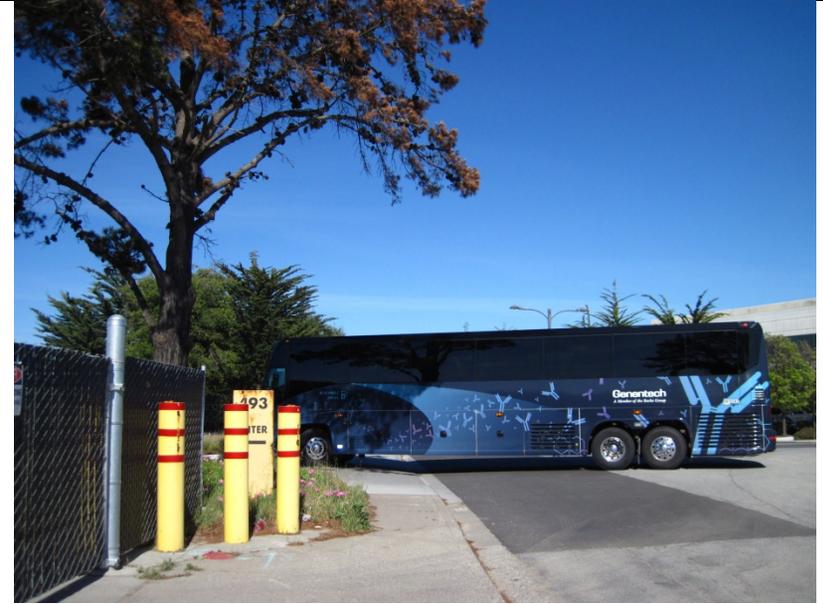
14

Buses ingress and egress under the canopy of tree #14 all day.

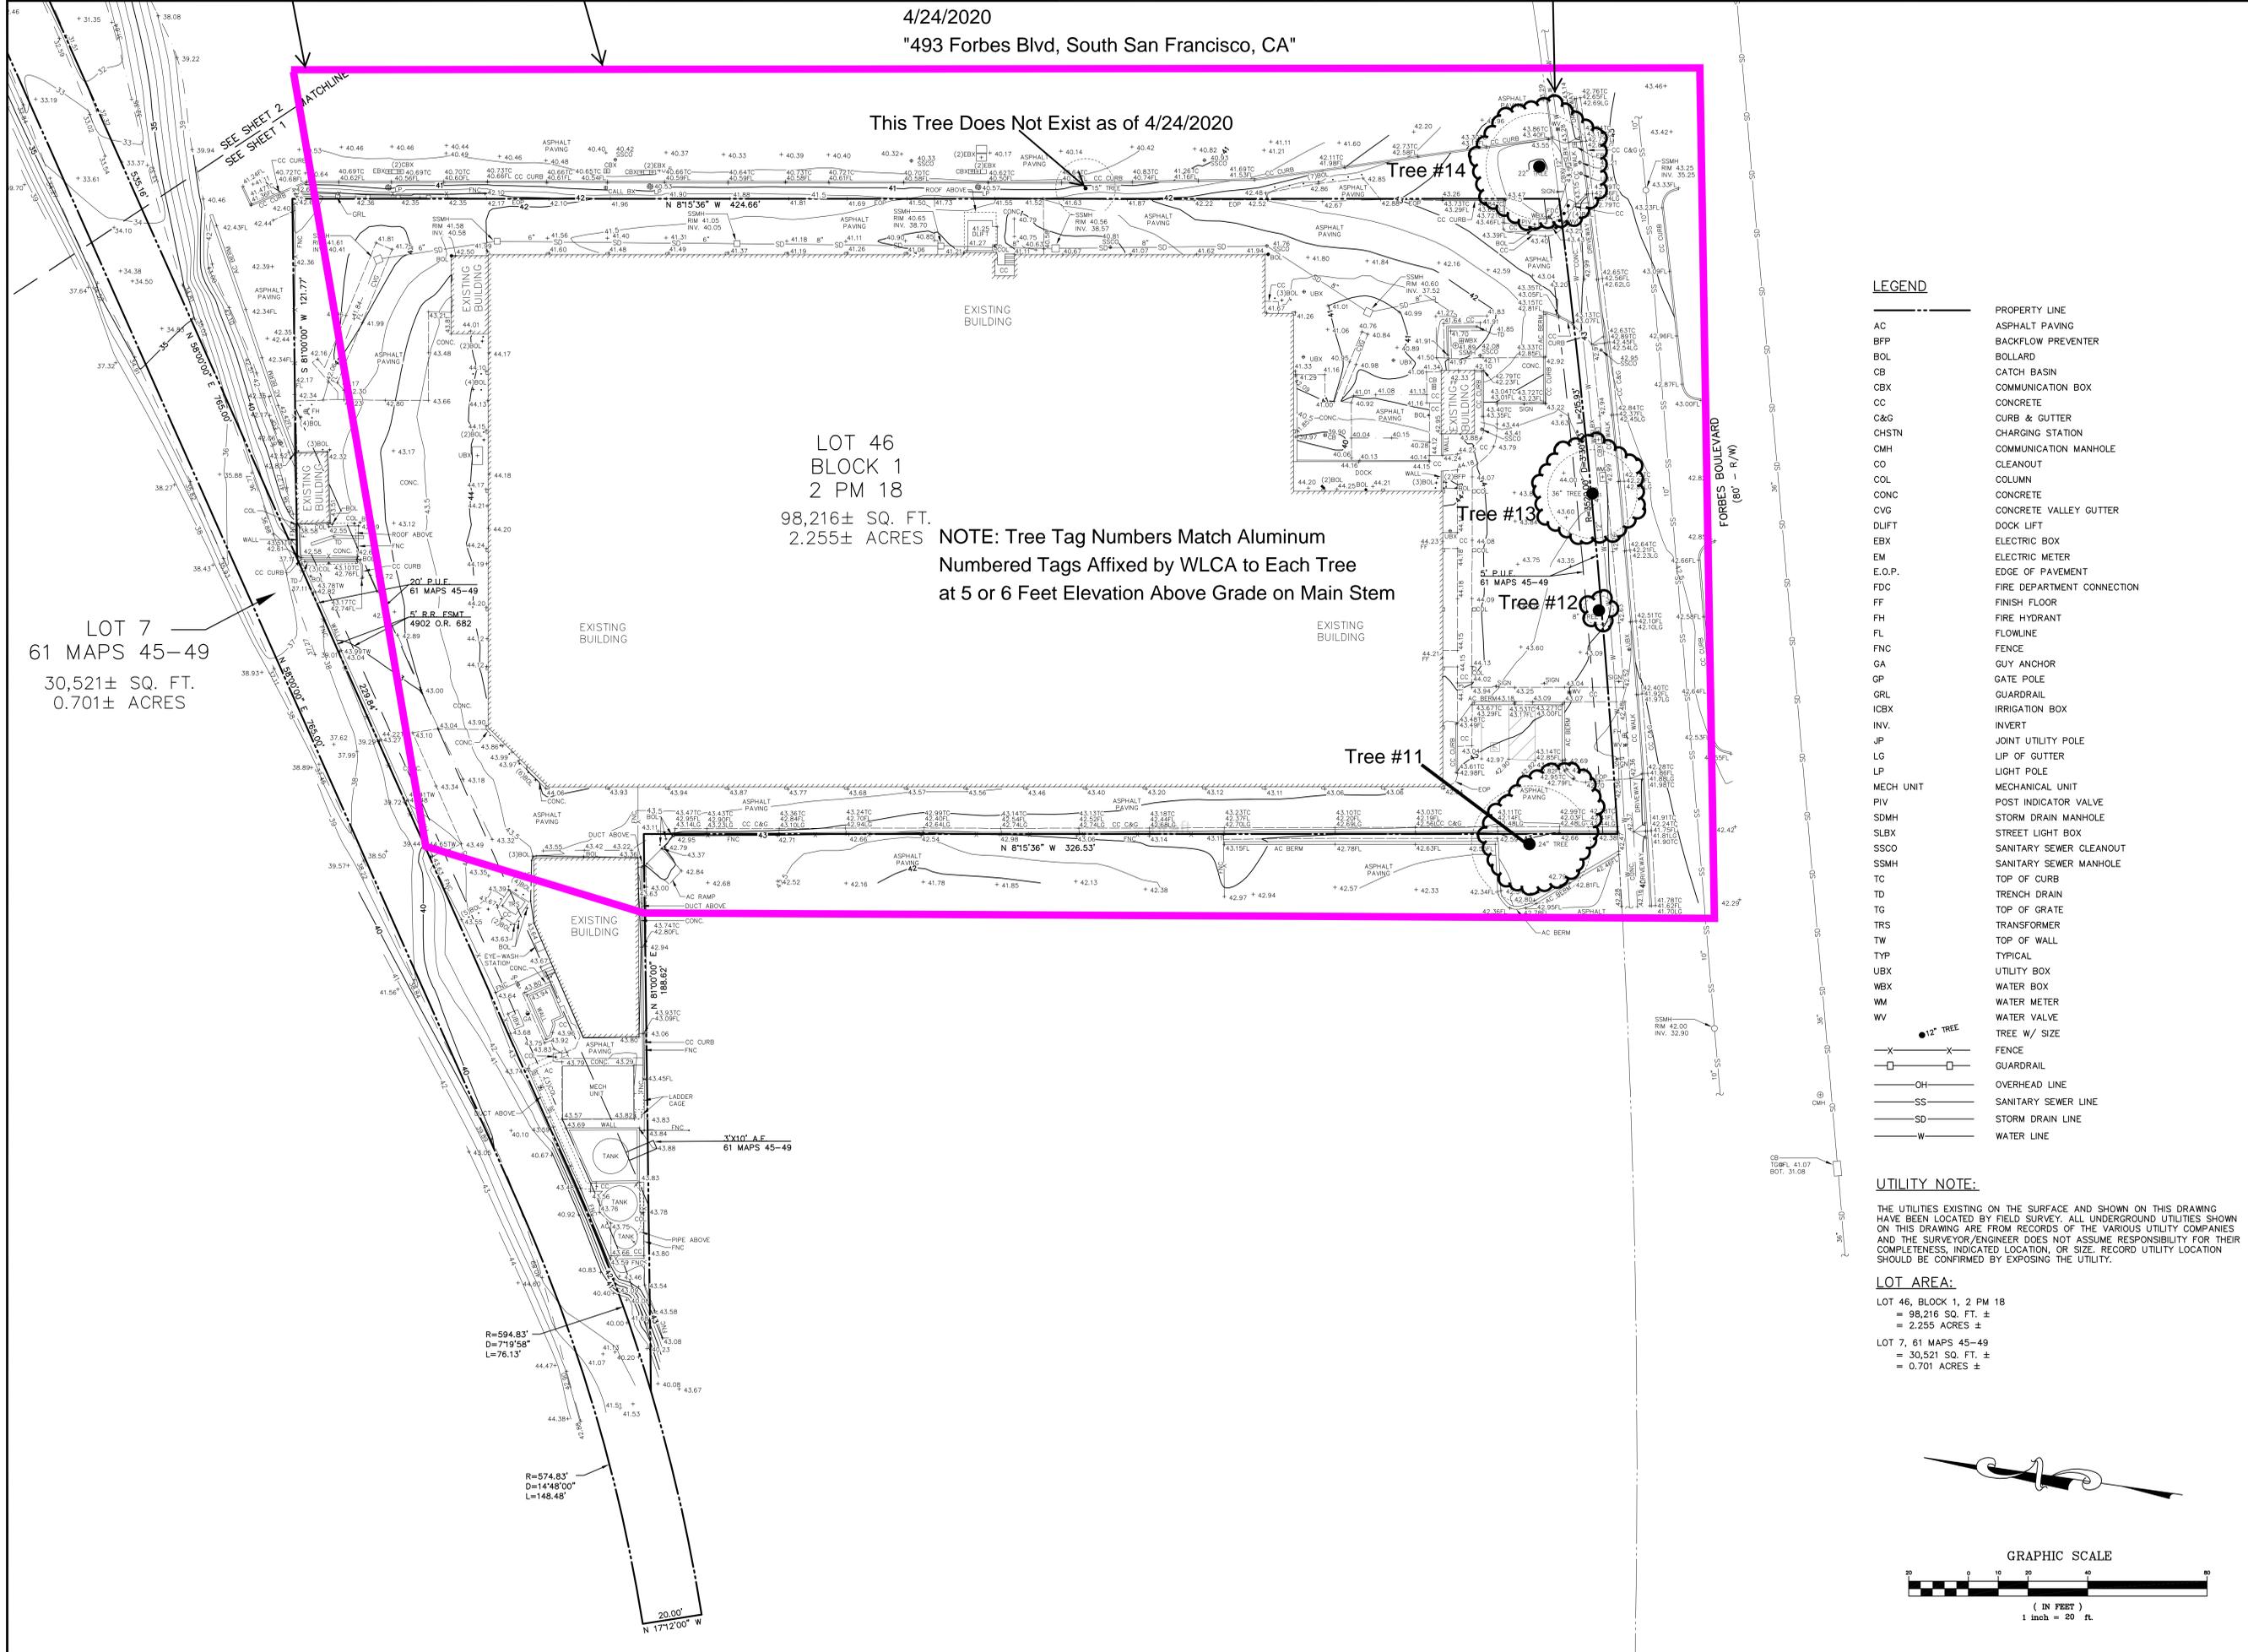
Tree Location Map / Walter Levison, Consulting Arborist (WLCA)

This Tree Does Not Exist as of 4/24/2020
