CERTIFIED ARBORIST REPORT

March 19, 2019
Revised October 31, 2019

PROJECT LOCATION:
9th Street and Vineyard
Rancho Cucamonga, CA

PREPARED FOR:
Environmental Project Manager
Jericho Systems
47 N. 1st Street
Redlands CA 92373

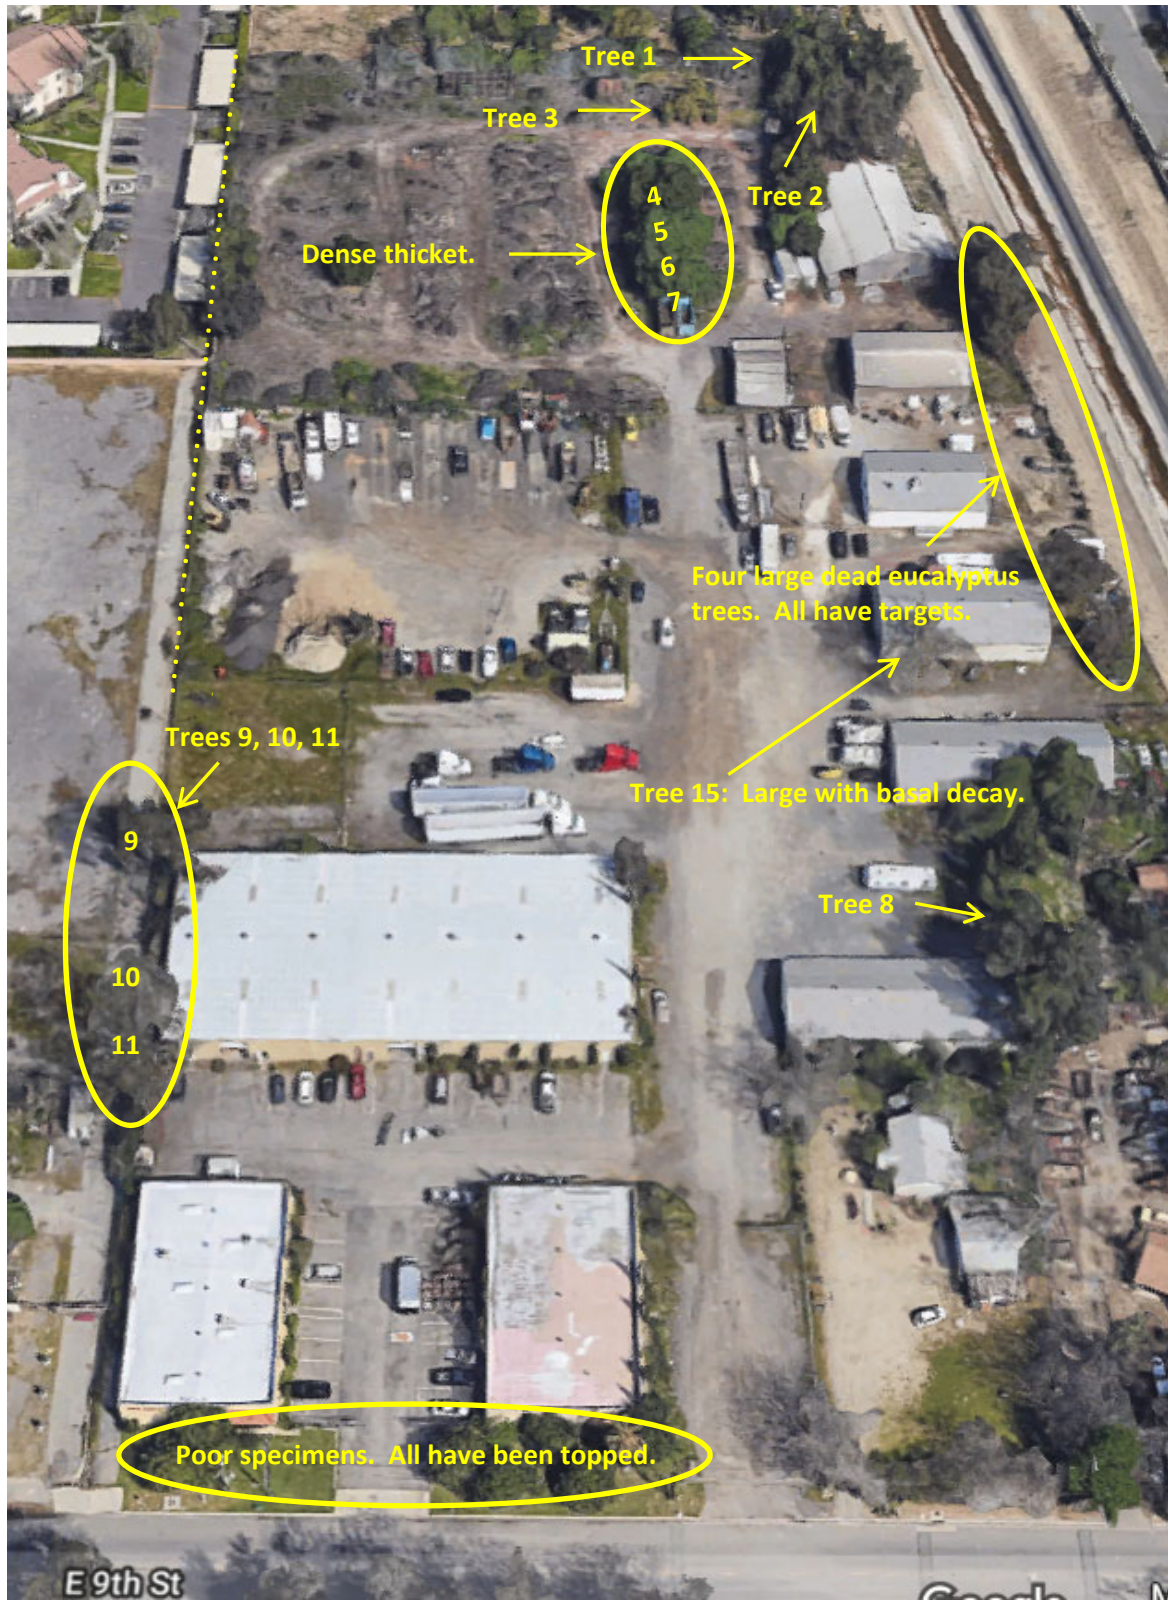
A yellow oval around trees 4, 5, 6, and 7 on Map 2 and referred to as a Dense Thicket is marked with yellow flagging tape tied to woody material around the perimeter. At the north end of this dense cluster is Tree 4, an ash tree that suffered root failure and fell over years ago. Its diameter is difficult to measure, but exceeds 20 inches. The tree is a very poor specimen and in any site development scenario, removal would be recommended. Of all the trees in this thicket, only two are fine specimens (Trees 5 and 6) and meet the criteria for heritage trees.

To the east and just south of trees 4, 5, 6, and 7, along the eastern boundary near Cucamonga Creek, are four dead eucalyptus trees. These are shown on Map 2 surround by an oval. These dead trees have stucco buildings as targets.

Some trees recommended for removal have targets to avoid. These targets are infrastructure such as buildings, fences, or both. Examples are the four eucalyptus trees along the east boundary, as well as Tree 15, a sycamore with decay. Similar to other removals near targets, careful removal to avoid damaging infrastructure is recommended. Removing buildings first may simplify such removals. Conversely, removing trees first may simplify building demolition and removal.
