Subject: Water Storage Pond Embankment Stabilization, Shadow Light Ranch, APN 223-061-038, Garberville, California

**Recommendations to Reconstruct Lower Pond Embankment, Lower Pond, Shadow Light Ranch,
Garberville, California**

Embankment Repair Options - Lower Pond

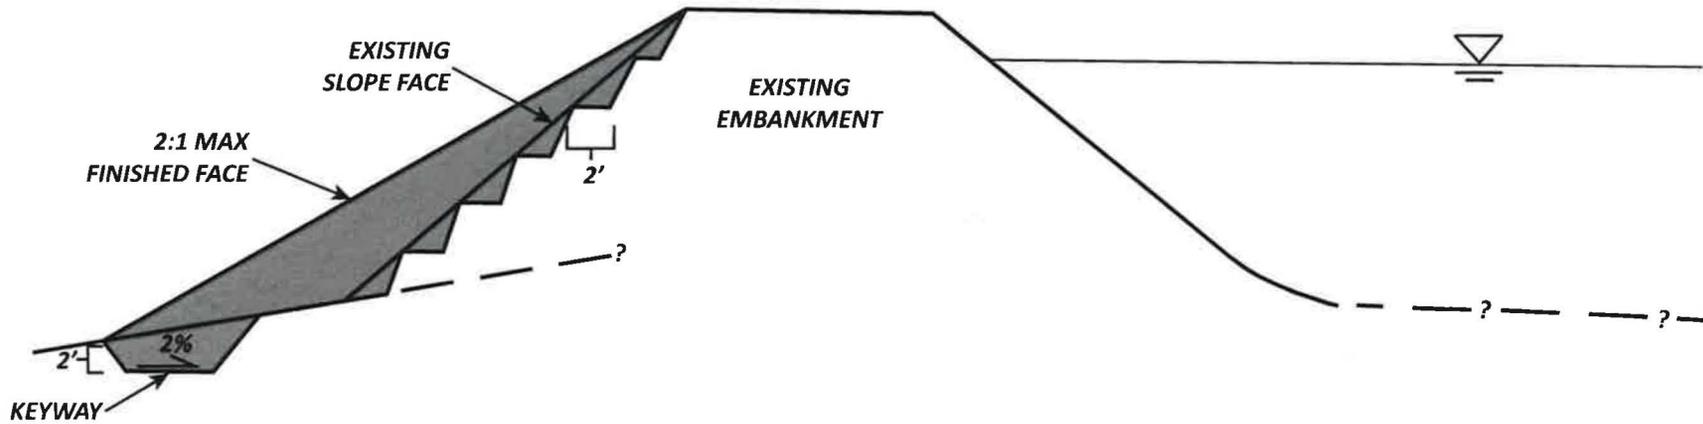
A) ADD FILL TO THE EXISTING OUTBOARD SLOPE FACE TO CREATE 2:1 SLOPE

- The outer embankment face is overly steep (on the order of 1:1 to 1½:1 [horizontal to vertical] in most areas).
- There is an erosion scar on the existing outboard embankment face at the outlet of an abandoned spillway (two disconnected side-by-side corrugated plastic pipes). The erosion scar extends from the crest to the toe of the embankment, is about 2 feet deep, and as much as 8 feet wide near the base of the slope.

The outer embankment face needs to be reduced to a slope no steeper than 2:1. Reducing the slope gradient of the embankment face may occur by one of the following methods, which are depicted in Figure 1:

- adding additional fill material to the existing embankment face, thus maintaining the current crest position, but requiring the toe of the embankment to move outward from its current position;
- maintaining the current position of the embankment toe and laying the slope back, which would require moving the embankment crest back and rebuilding the embankment within the current pond footprint (thus reducing the size of the pond); or
- some combination of the two.

- Regardless of the approach to the reconstruction of the embankment (adding to the existing outer embankment face versus laying it back), the geometry of the schematic drawing shown in the attached Figure 1 should be used as a guide. The schematic shows keyway- and bench-based construction, and defines the placement of compacted soil lifts. The ultimate design may vary depending on the approach chosen (fill soils may be placed on the outboard embankment face, the inboard embankment face, or both), but it will inevitably include some areas where new fills soils will contact existing fill or native soils. These areas should be adequately prepared and benched.
