LETTER OF TRANSMITTAL

Subject: Hotel Veranda — Existing Near-Surface Soil Conditions in the East
Portion of the Site

Our Job No: 644.1.13

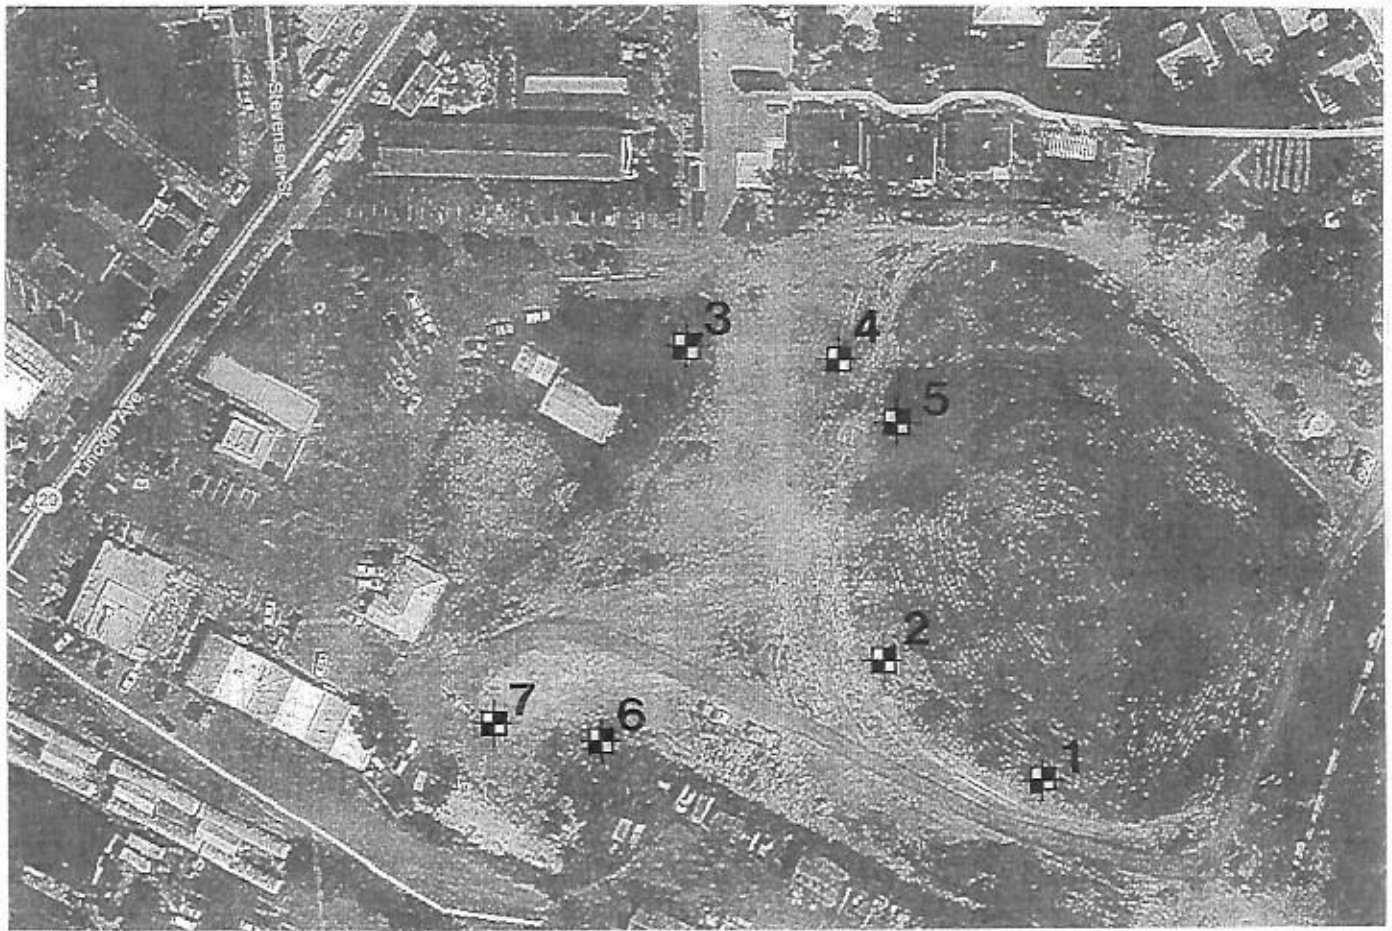
**TEST PIT LOCATION PLAN
AND SITE VICINITY MAP**

In general, the soils encountered in the test pits consisted of existing fills and natural clayey, silty and sandy soils. Based on our field observations, we judge that the soils encountered in Test Pits 1 through 5 can be considered as having a low rate of infiltration because of the presence of the hard, compacted subgrade layer (Layer "C" on Plate 2) that would impede downward movement of water. In Test Pits 6 and 7, the soils can be considered to have a moderate rate of infiltration because of the absence of the above-mentioned compacted subgrade layer.
