El Paseo & 1777 Saratoga Avenue

Tree Report

April 22, 2020

Tree Report
El Paseo & 1777 Saratoga Avenue
San Jose CA

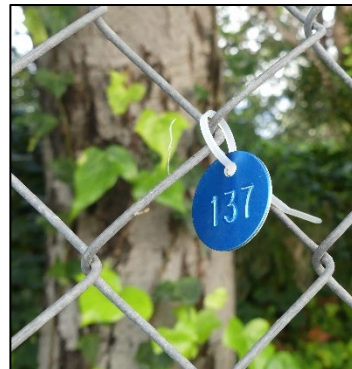
Some trees could not be directly accessed. Trees #123 – 130, 132 – 135, and 137 – 140 were located behind the fence on the south side of the site. Because trees could not be directly accessed, tags were attached to the fence (Photo 1). Chinese pistache #155 – 158 were located off-site and were not tagged. Information was recorded and the tree location recorded on a map.

Photo 1. Trees along the south property line were behind a fence. The tree tag was attached to the fence rather than the trunk.

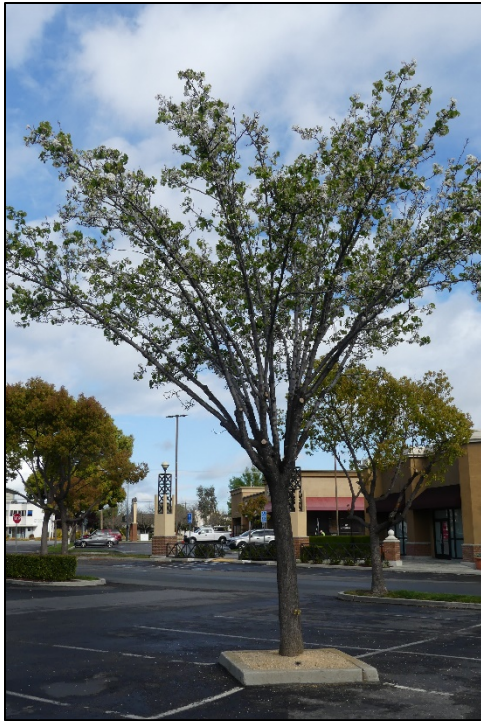
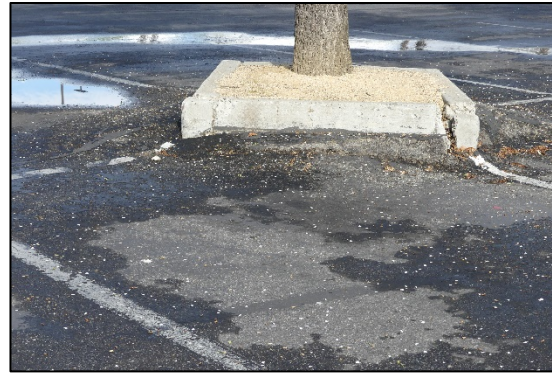
Callery pear was the most frequently occurring species with 61 trees (Photo 2, following page). Pears were confined to the large parking area where they were located in small planting spaces. Trees were young and semi-mature in development. Several trees appeared to have been planted within the last year or two. Trunk diameters ranged from 2 to 15 in. Approximately 80% of pears were 9 in. or less in diameter. Condition of pears was generally fair (44 trees). Ten trees were in poor condition while six were good. Tree #2 was in excellent condition. The primary factor influencing tree condition was overall tree structure, particularly the presence of multiple stems arising at one point on the trunk. In some cases, tree roots had displaced adjacent pavement.

Photo 2. Most Callery pear trees were installed in 4 ft. by 4 ft. cutouts in the central parking area. **Left.** The typical pear had multiple stems that arose at one point on the trunk. **Above:** roots from some pears had severely displaced nearby pavement.

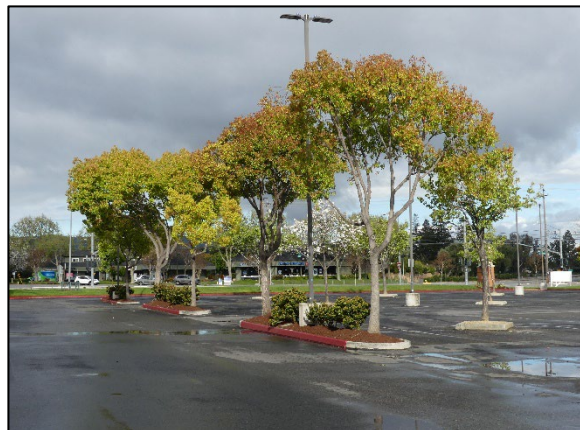
Thirty-two (32) camphor trees were also located in the large parking lots, usually at the end of travel lanes (Photo 3). The size of the planter varied. Turf and ground cover plants were commonly present. Camphors were young and semi-mature in development. Trunk diameters ranged from 2 to 15 in. Approximately 70% of camphors were 9 in or less in diameter.

Photo 3. Typical camphor trees. Note variability in size and form.

Tree condition was variable with 18 of 32 trees in fair condition. Most trees lacked vigor. Eight trees were poor while four were in good condition. Camphors #51 and 73 were in excellent condition. Both were recently planted. Factors influencing condition included overall form and structure, history of over-thinning, and thin canopies of foliage.

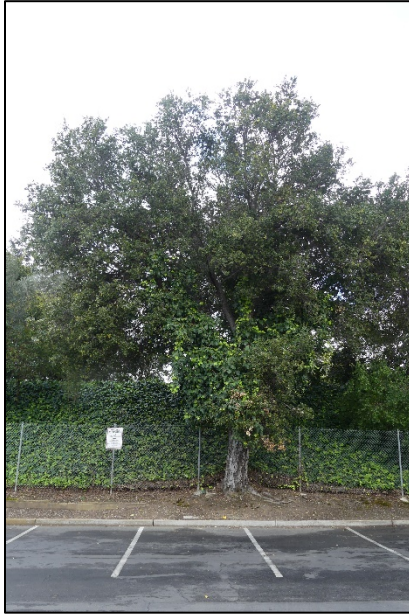
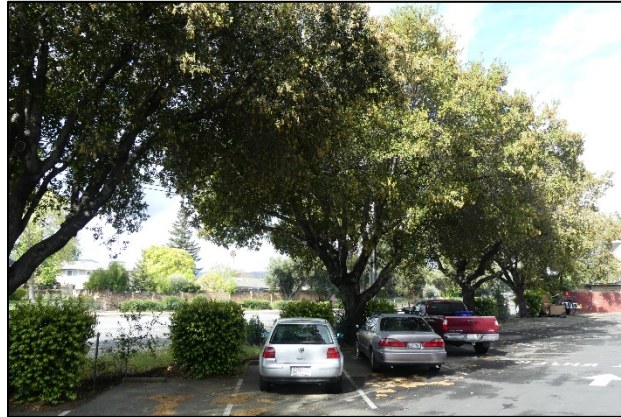
Seventeen (17) coast live oaks were evaluated (Photo 4). Trees #122, 123, 126, 133, 134, 135, 137, 138, and 139 were located at the south end of the site. Most were behind the existing chain-link fence. Trees were variable in size. Coast live oaks #122 and 139 were large mature trees (30 and 24 in., respectively) located on flat ground. Other oaks were semi-mature in development, located on the hillside behind the fence. Tree condition was either good (#138, 139) or fair (7 trees).

Photo 4. Coast live oak trees. **Left:** tree #139 was 24 in. and in good condition, located on the south side of the site. **Above:** trees #142 – 147 were between the existing parking lot and the Lawrence Expressway.

Trees #142 – 147 and 149 were located at the north end of the site (Photo 4). Trees #142 – 147 for a long row at the edge of the existing parking lot and parallel to the Lawrence Expressway. Trees were mature in development with trunk diameter between 18 and 24 in. On the east, tree crowns had been lifted to provide clearance for parking. On the west, crown size had been controlled in order to provide clearance to nearby overhead electrical lines. Tree condition was either good (5 trees) or fair (2). Coast live oak #149 was 11 in., located at the very north end of the site. Condition was fair.

Included among trees recommended for removal were coast live oaks #142 – 147 and Canary Island pine #148, all of which are located along the Lawrence Expressway on the north parcel. These trees are noted as “remove?” because their retention would require design adjustments. A final decision about retention of these trees should be made after more detailed site, grading and utility plans have been prepared.

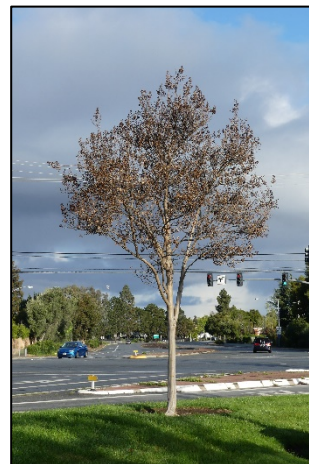
Sixteen (16) crape myrtles were located in a planting strip along Quito Road (Photo 5). Trees were 2 to 4 in. in diameter and semi-mature in development. Tree condition was generally fair (12 trees) while four trees were in good condition. All crape myrtles lacked vigor which was most likely due to stress during recent periods of drought.

Photo 5. Typical crape myrtle tree. Trees of this species lacked vigor, likely due to drought stress.

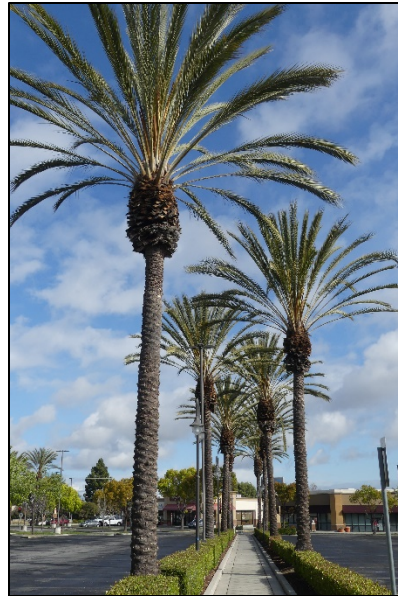
Ten date palms were present. Trees #88 – 95 for a long row in the center of the large parking area (Photo 6). These palms were in good condition with approximately 25 ft. of clear trunk. Palms #30 and 120 were near existing retail stores. Tree #30 was in poor condition due to the presence of a large trunk wound. Palm #120 was in good condition.

Photo 6. Looking north at palms #88 – 95.

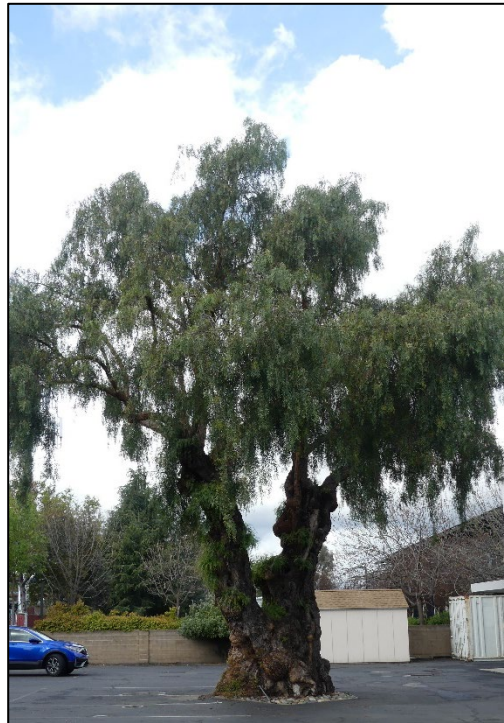
- Atlas cedar #121 was a large (36 in.) mature tree located in the southwest corner of the site near Quito Road. Tree condition was very poor and little foliage was present.
- Brisbane box #97 was a newly planted tree installed in the large parking area. Tree structure was good but health was fair due to dead leaves.
- Calif. pepper #124 was 10 in. and in poor condition. Located on the hillside on the south end of the site, it had been suppressed in development by adjacent trees. Pepper #151 was a huge tree in the parking area on the north side of the site (Photo 7). Trunk diameter was 72 in. and condition was fair.

Photo 7. Looking north at Calif. pepper #151.
