Phase I and II Environmental Site Assessment for 18616 Rorimer Street and 18631 Pacato Road La Puente, California

Prepared for: The Olson Company 3010 Old Ranch Parkway, Suite 100 Seal Beach, California 90740

Prepared by: Stantec Consulting Services Inc. 735 E. Carnegie Drive, Suite 280 San Bernardino, California

Project No.: 185804267

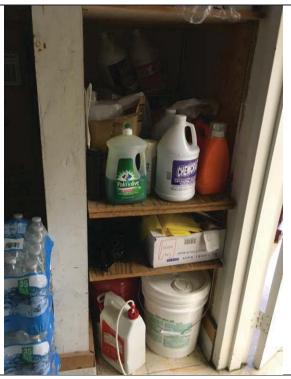
Photo #7 View of cleaning supplies in closet of the dining room of the fellowship hall.

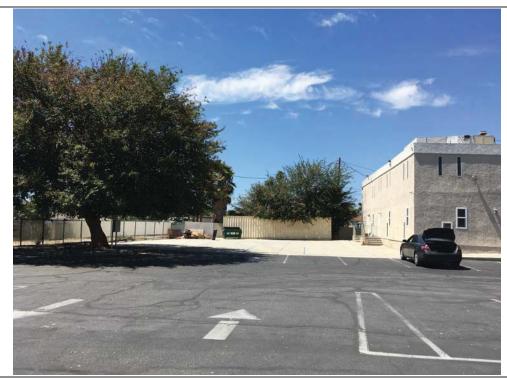
**Photo #14** View of dumpster and conex storage container in the southern portion of the Property.
