Preliminary Geological Hazards Study

City of San Diego Task 15GT15 - Water and Storm Drain
Group 968
San Diego, California

Project No.: 200055.2

Subject: Preliminary Geologic Hazards Study (9 sites)

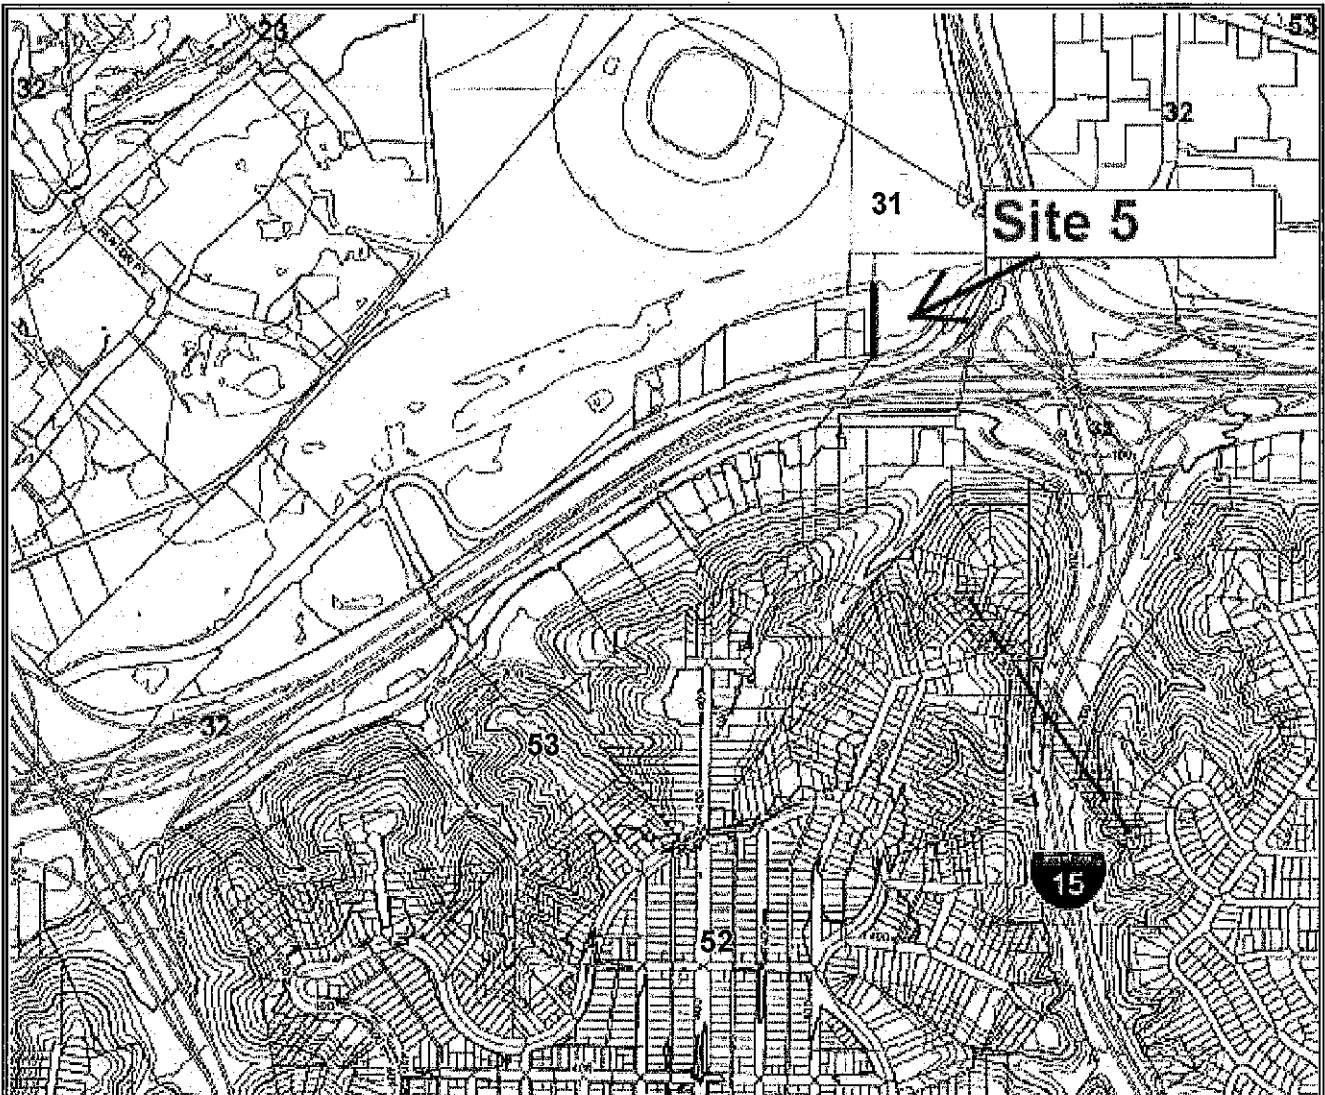
FIGURE 3D

The site is located in the City of San Diego's Geologic Hazards Category 31 based upon sheet 21 of the City's Seismic Safety Study Geologic Hazards and Faults (2008). Geologic Category 31 is "Potential Ground Failure, Liquefaction - High Potential, shallow groundwater major drainages, hydraulic fills" (Figure 3D). The Mission

Mitigation Recommendation for Site 5: A geotechnical investigation is recommended to confirm groundwater and characterize the subsurface soils prior to final design for the Site 5 water main replacement improvements.

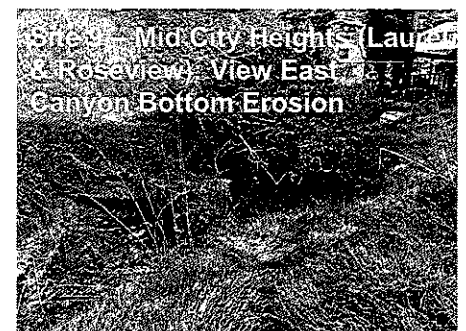
Site 9 - Mid City Heights (Laurel & Roseview): View East Canyon Bottom Erosion
