# **Barry Building ADA Upgrade Requirements**

## INTRODUCTION

At the request of Alston & Bird, LLP, Gruen Associates evaluated the ADA compliance requirements of the Barry Building and prepared this report. The Barry Building was constructed in 1951 and was designated as a Los Angeles Historic-Cultural Monument in 2007. The codes referenced in this report are from the 2019 California Building Code and the 2019 California Historical Building Code.

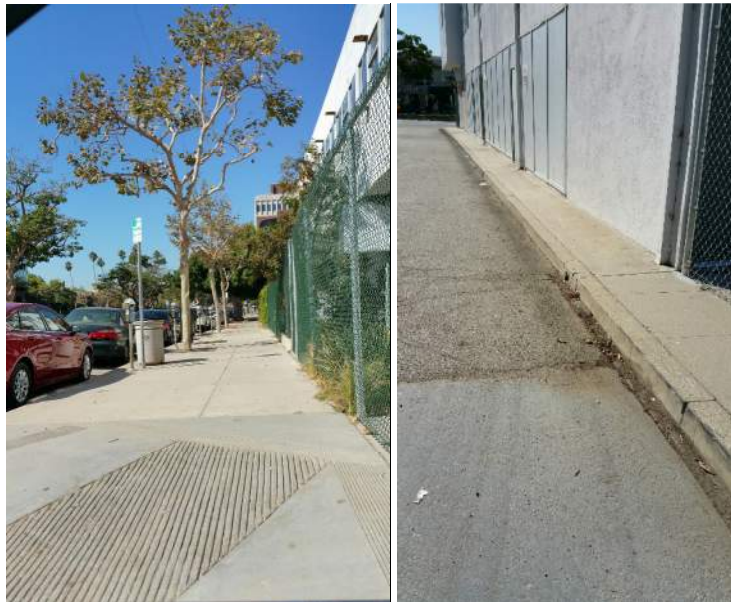
There is no passenger drop-off or a loading zone provided at the street or along the alley. This is not a code violation. If there is no passenger loading zone provided, then CBC Section 11B-503 does not apply.

The south sidewalk is lined with metered parking spaces. The east sidewalk has no passenger loading zone either.

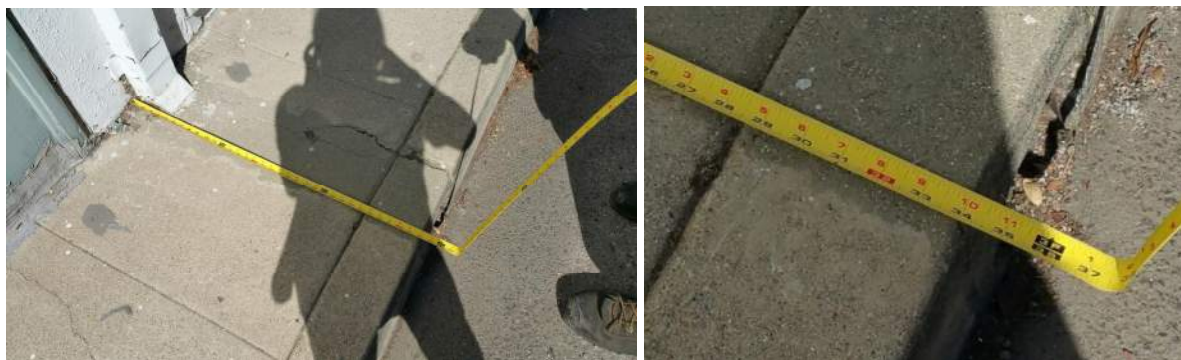
**The East sidewalk is 34" wide only. This is not in compliance with CBC Section 11B-403.5.** This sidewalk is not a legal sidewalk for public access to the building and it is not an accessible route.

The east sidewalk width is 34".

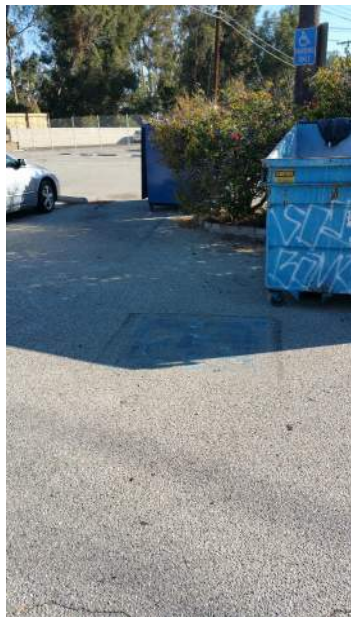
The sign posted in front of the stall is missing the lettering required in CBC Section 11B-502.6.2.

The accessible parking space has a faded marking and a pole mounted sign.

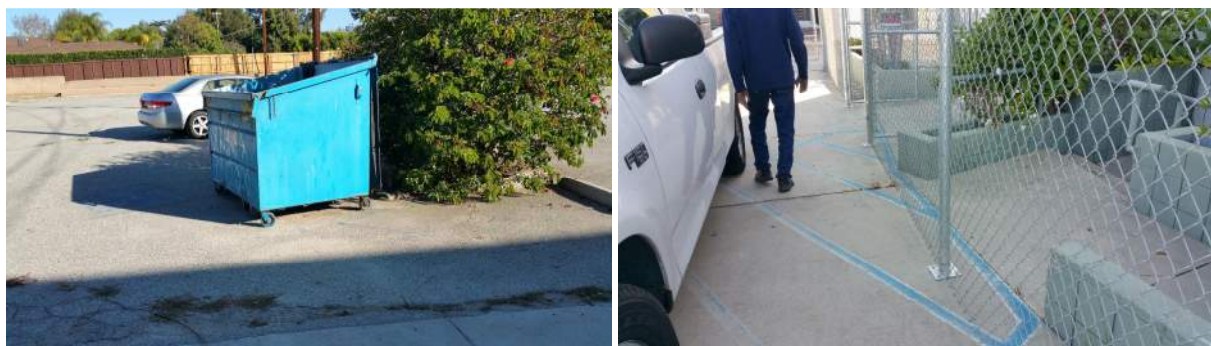
**The paving adjacent to the ADA stall shows the asphalt cracks and settlement, which may not be in compliance with CBC Section 11B-502.4.**

The accessible route marking terminates at the passageway and the ramp leading to the CMU Addition.

The cracked asphalt adjacent to the accessible parking space and the marking leading to the building's rear entrance and the CMU Addition.

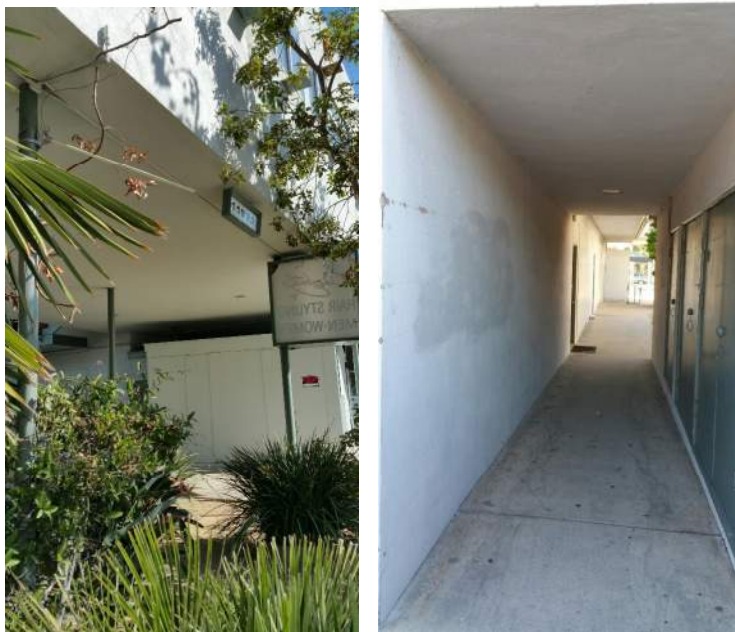
The site arrival point is in the rear parking lot and the only accessible route is through a passageway. Such accessible route does not coincide with and is not in the same area as the general circulation paths because the building's main entrance is in the front. The front entry is accessed by the pedestrians from the street, the meter parking, the sidewalk and the public transportation. **This may not comply with CBC Section 11B-206.3.**

The contrast between the front entrance and the accessible entrance from the rear parking lot.

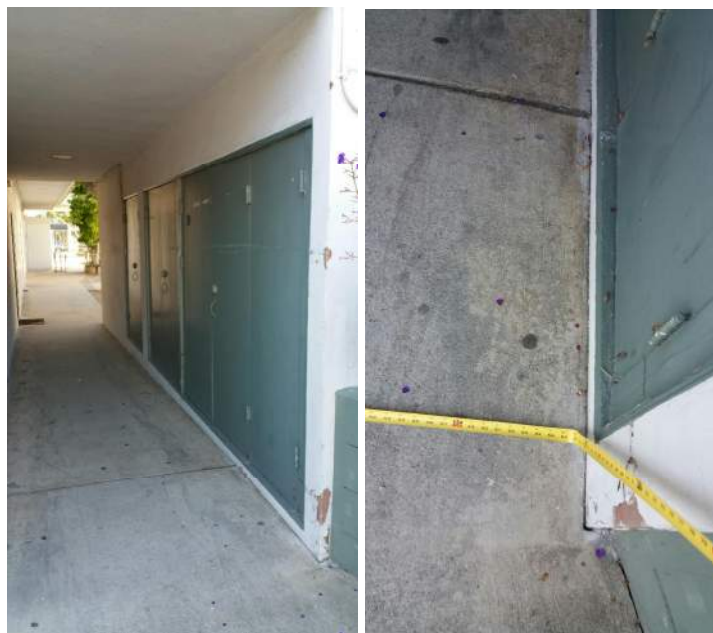
The only accessible building entrance is the 5' wide passageway which is next to the electrical closets and a service ramp. **This may not comply with CBC Section 11B-206.3.**

The Accessible Route/Building Entrance adjacent to the electrical closets and the service area.

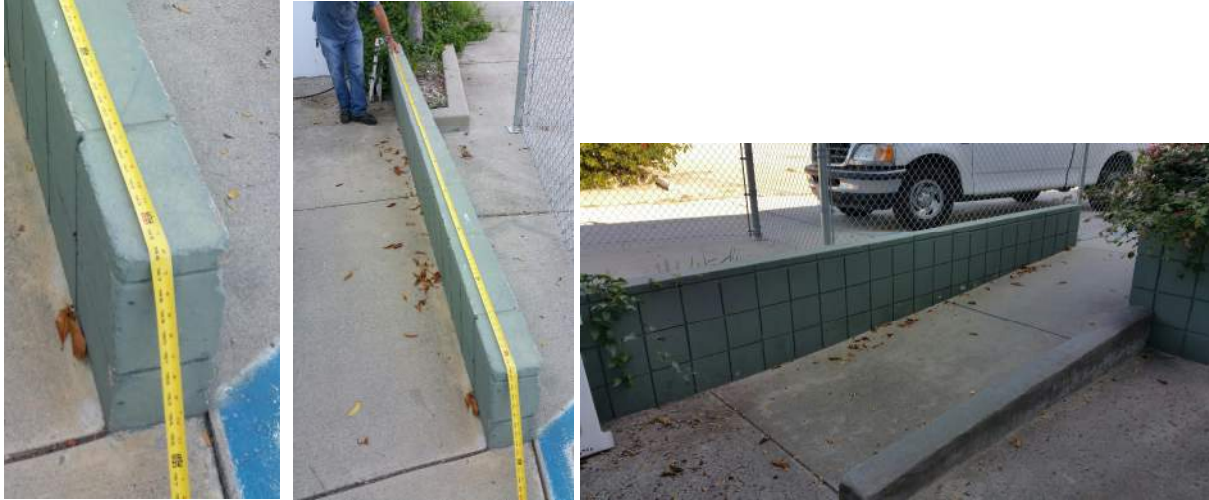
The ramp to the CMU Addition also leads to a north wing tenant's door. The ramp's slope is greater than 5% based on 10" rise and 12' length. **If the ramp is an accessible path as marked, it is not in compliance with CBC Section 11B-505.2 due to the lack of handrails.**

The ramp to CMU Addition and the North Wing Tenant Door has a greater than 5% slope (12' long with 10" rise).

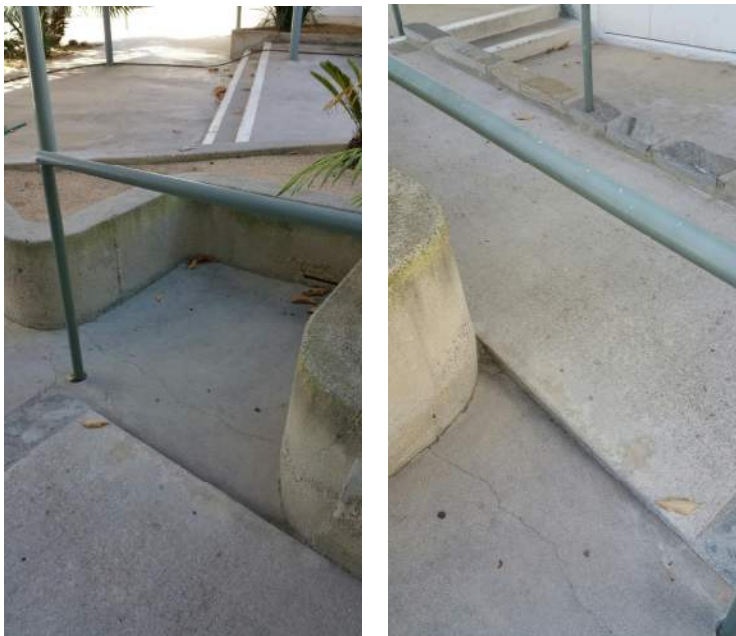
**A portion of the courtyard ramp is missing the edge protection to be in full compliance with CBC Section 11B-405.9**

Courtyard ramp is missing the edge protection on one side.

- Add a floor mounted handrail at the steps between the two courtyard levels, one on each end for each set of steps.
- Fill in the missing edge protection at the courtyard ramp by adding a concrete curb or a welded steel plate between the posts.

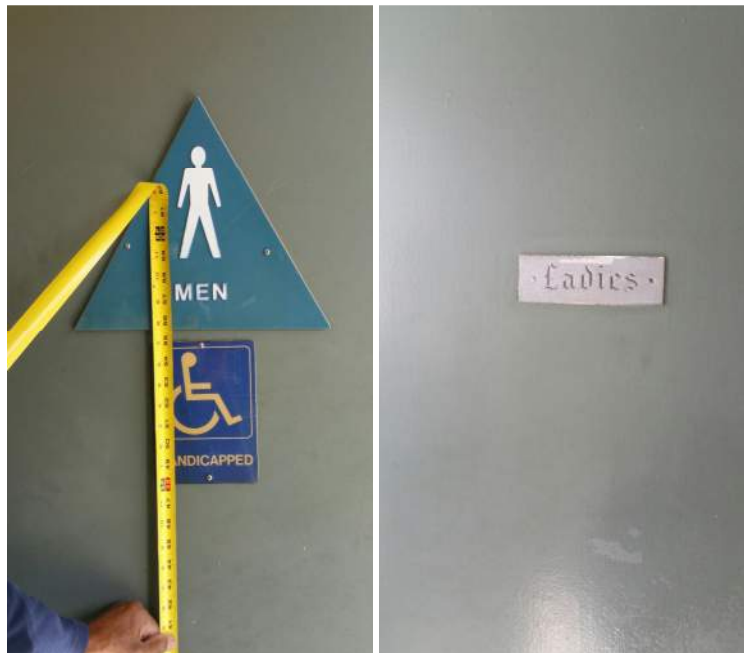
Only the men’s restroom is in the accessible route. The only women’s restroom is on the second floor, which is not accessible. There is no accessible, single unisex restrooms in the building. **This is not in compliance with CBC Section 11B-213.2.**

The only men’s restroom is accessible. The only women’s restroom is in a floor that is not accessible.

- Upgrade the men's room on the first floor to compliance. Relocate all accessories and fixtures that are not mounted at the right place.
- Upgrade the women's room on the second floor to compliance. Relocate all fixtures and accessories that are not mounted at the right place. Enlarge the entry doorway to provide the required strike side clearance or provide a button activated automatic door. Replace the door threshold with an ADA compliant type.
- Add a unisex single restroom at the ground floor.
- Add a unisex single restroom at the second floor.
- Install code compliant signs for all restrooms.
- Add a wall mounted drinking fountain at the first floor in a new alcove. As an alternative, provide a freestanding ADA compliant dual fountain in the courtyard.

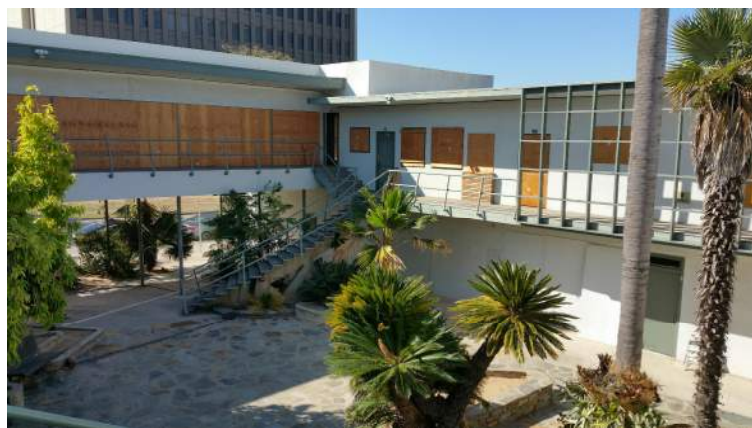
The second floor is not accessible and the building is over 3,000 sf per story. **This may not comply with CBC Section 11B-206.2.3.** Exception 1.2 applies *if a reasonable portion of all facilities and accommodations normally sought and used by public in such a building are accessible to and usable by persons with disabilities.* The first floor is 50% of the overall building area, so it may not satisfy the definition of a reasonable portion. The women’s restroom is a facility normally sought and used by the public, but is not available on the first floor.

Only 50% of the building area is accessible. The first floor does not offer an accessible women’s restroom.

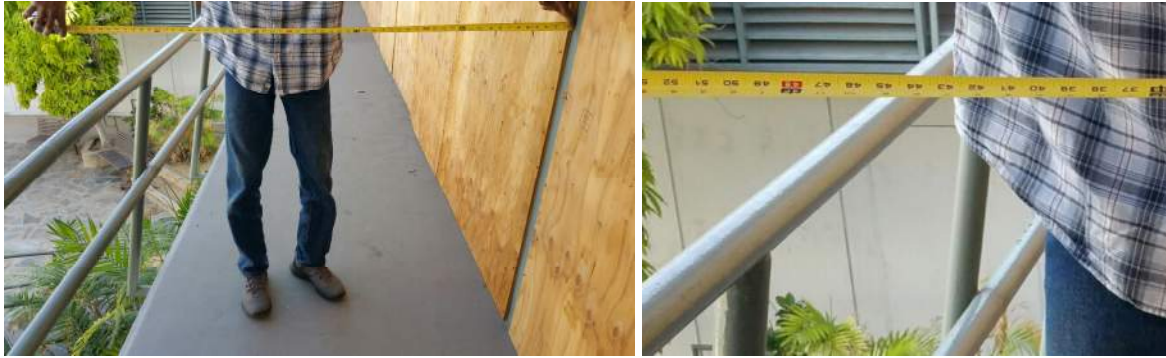
The second floor balcony is 50" wide. It is not wide enough to provide an Area of Assisted Rescue because a minimum of a 44" exit width and additional 24" wheelchair space will be required. **If 1009.7 Area of Assisted Rescue cannot be satisfied, then the second floor is not in compliance with CBC Section 11B-207.**

The balcony width is 50". The slanted railing reduces the balcony's clear width.

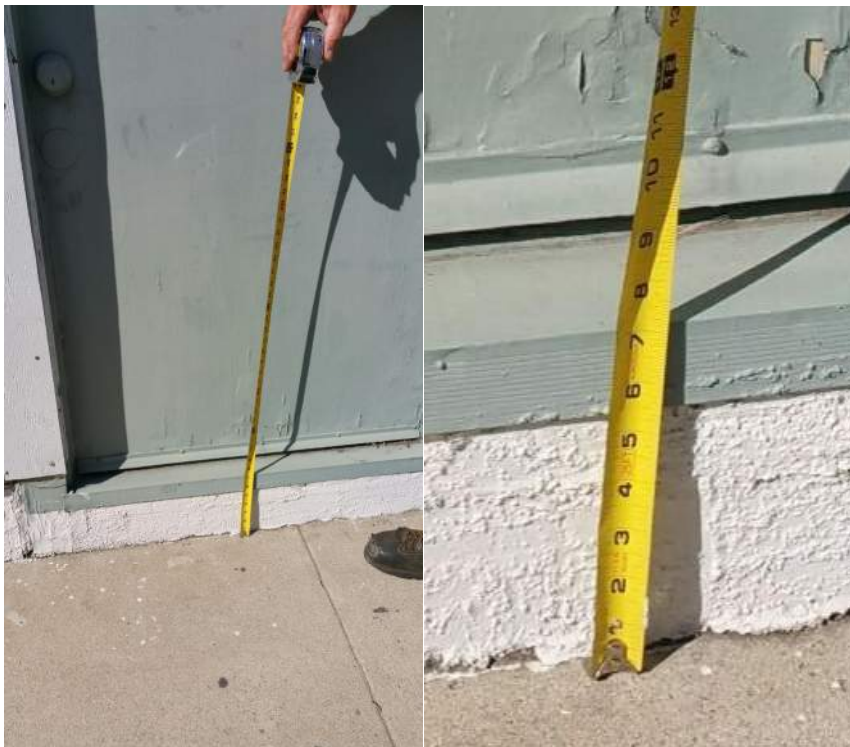
The door threshold is not in compliance with CBC Section 11B-303.2.

A few doors at the east elevation have a straight drop at the sidewalk which exceeds the maximum allowed, such as the 7" shown.

- Modify exterior doorways at the east elevation to create only a ½" height change. Depress the concrete floor in the unit to create a concrete ramp at the doorway. Modify or replace the existing door and frame to the increased height. If the ramp has greater than 5% slope provide handrails. Alternatively these doors could be fixed in place and made inoperable if exiting through the courtyard can handle the exiting load and required exit separations for larger tenants.

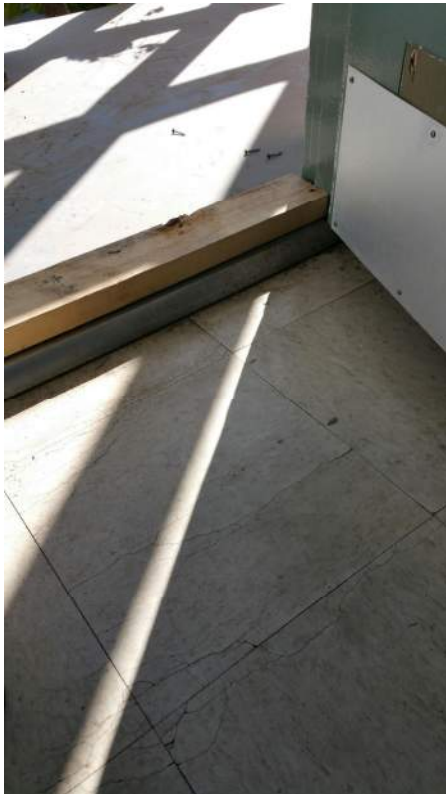
**The door threshold is not in compliance with CBC Sections 11B-404.2.5 & 11B-303.3.**

The women's restroom door threshold has a bevel that exceeds the 1:2 slope.

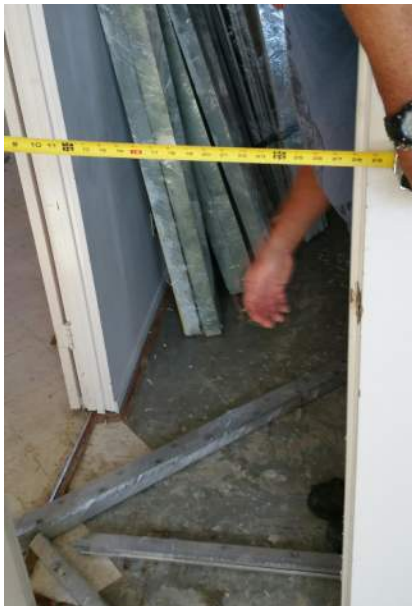
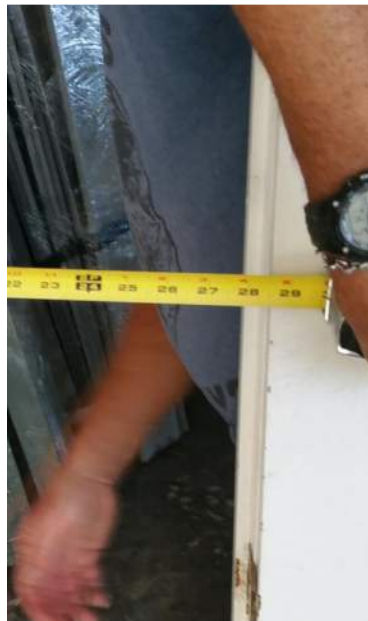
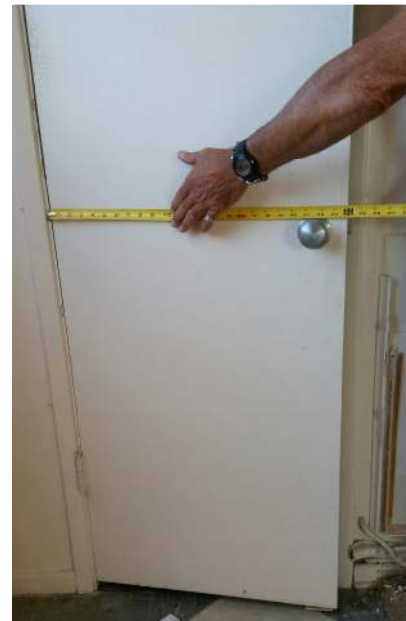
**The door width is not in compliance with CBC Section 11B-404.2.3.**

The tenant interior doors are only 28" and 24" wide.

- For all tenant interior steps provide the required handrails on both sides of the steps.
- Other than reach-in closet doors, for all interior doors that are less than 32" wide, replace with new door and frame of minimum 32" width so the clear opening width is 29.5" min. to meet the Historic Bulding Code requirement

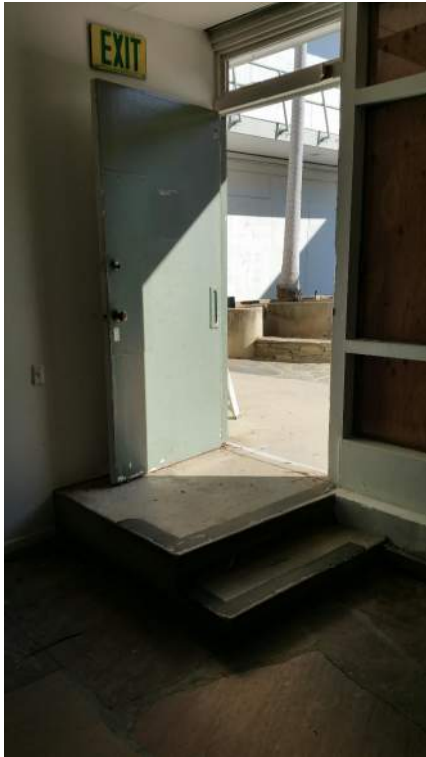
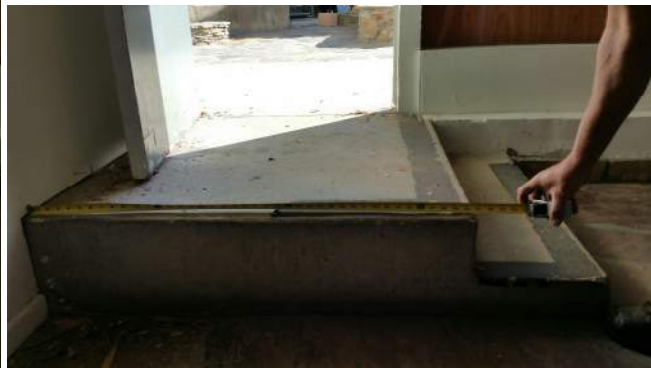
**The door landing is not in compliance with CBC Section 11B-404.2.4.4**

A first floor tenant's interior does not have a level landing at the entry door maneuvering space.

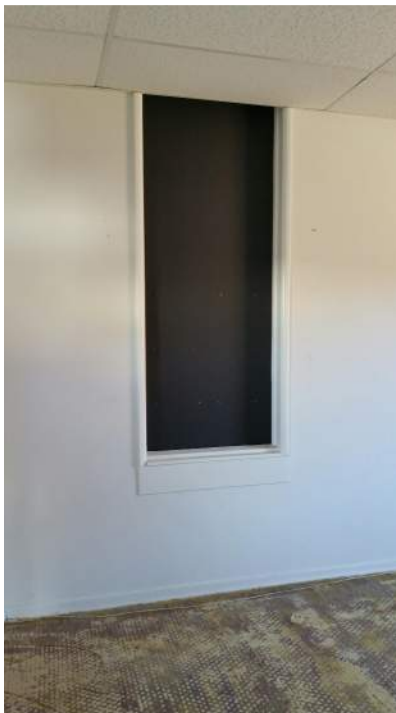
A second floor tenant's interior does not have a landing at a door. The door may have not be used due to the lack of a door knob.

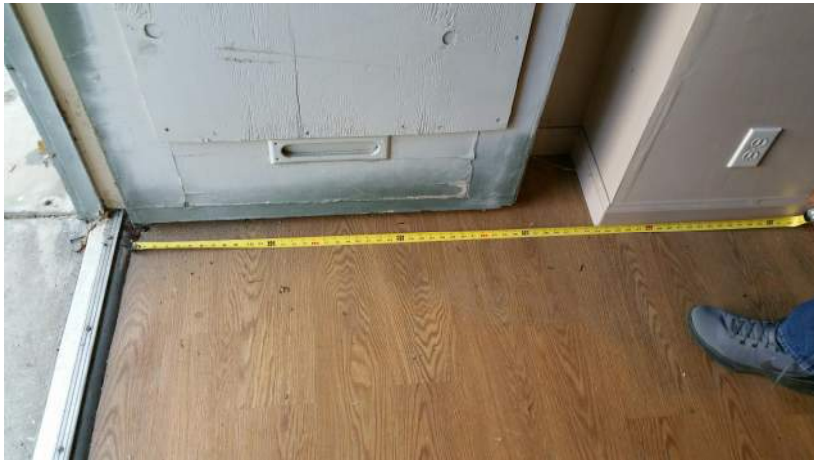
**The door maneuvering clearance is not in compliance with CBC Section 11B-404.2.4.1**

A first floor tenant's entry door only has 42" deep maneuvering clearance due to a projected wall.

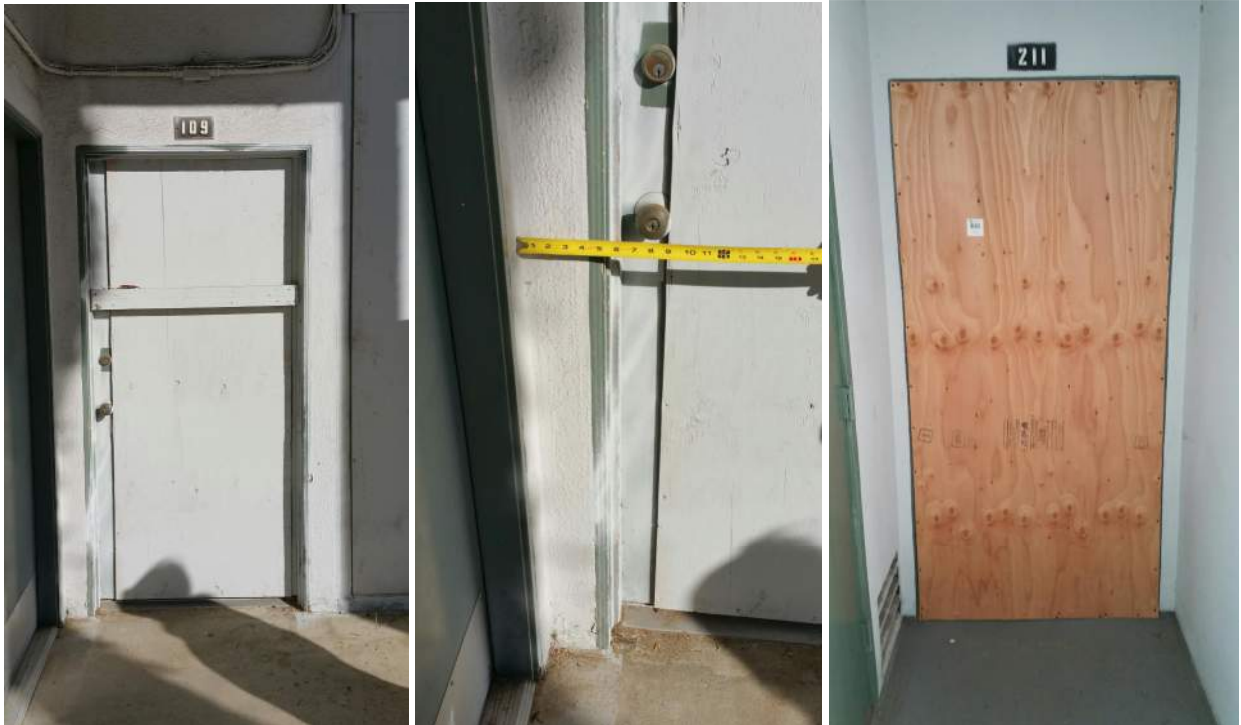
A first floor tenant's door does not have the code required 12" push side clearance.

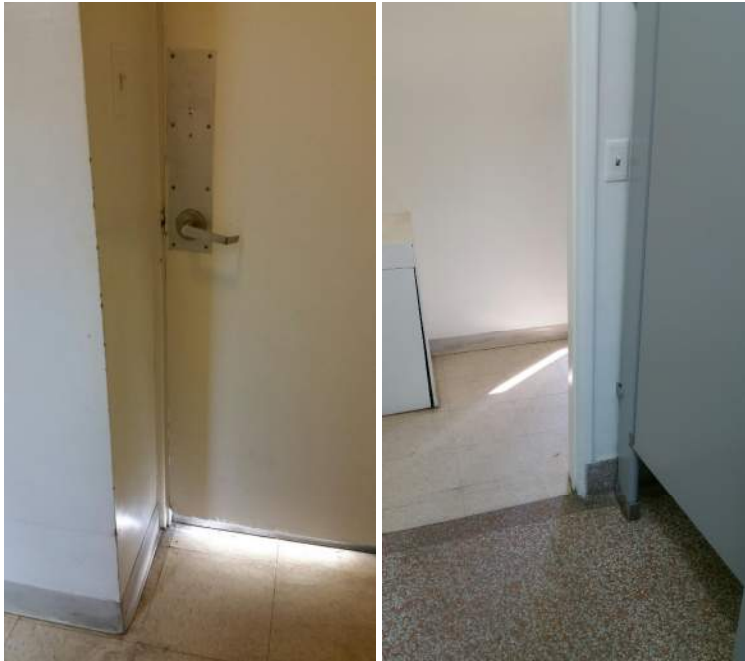
**The door maneuvering clearance is not in compliance with CBC Section 11B-404.2.4.1 at a restroom.**

The women's restroom does not have pull side and push side clearance at the entry and the vestibule door.

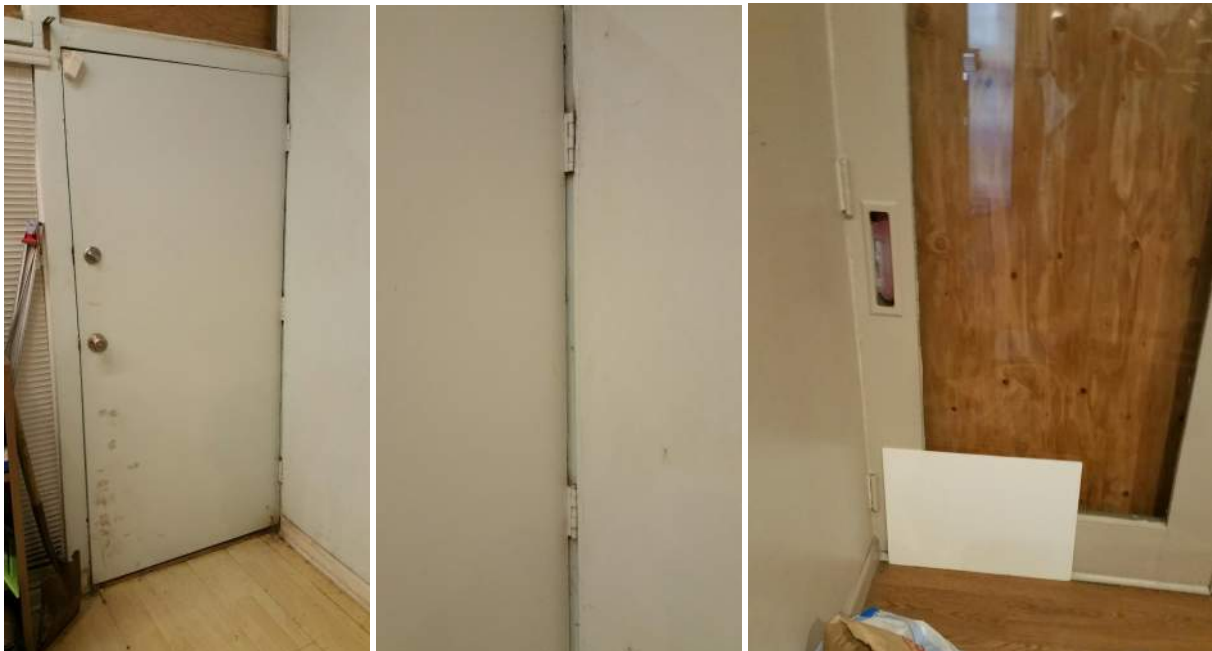
**The door opening degree is not in compliance with CBC Section 11B-404.2.3.**

Some of the first floor tenant doors cannot open 90 degrees due to the door jamb installed into the wall.

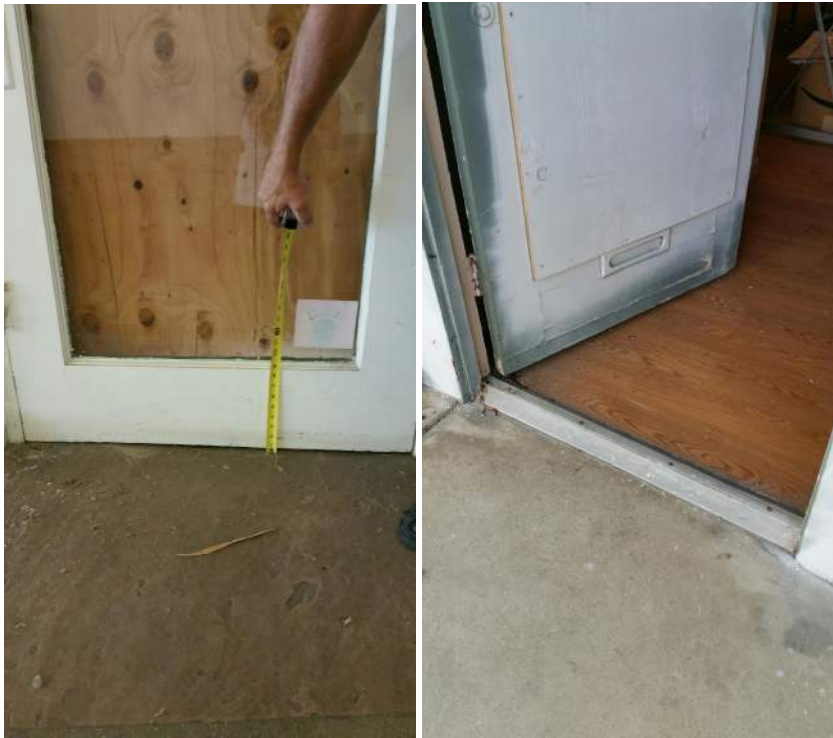
**The door bottom is not in compliance with CBC Section 11B-404.2.10.**

The original glass door's bottom is less than 10" high. The mail slot is not a smooth surface for a wheelchair.

- For the doors that has a door mail slot mounted below 10", remove the slot, patch and refinish the door.
- For the wood door with a vertically mounted mail slot above 10" height, provide an alternative mail receiving system. Remove or fill in the current slot in the door.
- Adjust all switches and outlets not in the right height to within the required reach range.
- For a unit with the steel and wood windows that have the operating parts all above the reach range, modify or replace at least one window with the operating parts within the required reach range.
- For any of the above modifications alternative means or mitigations can be discussed with the building official.

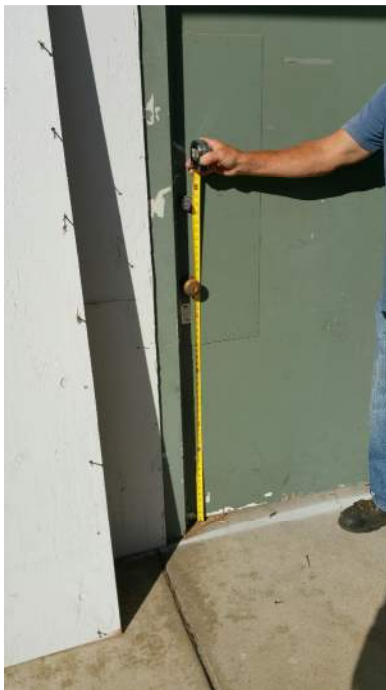
**The door hardware mounting height is not in compliance with CBC Section 11B-404.2.7 & 11B-309**

A first floor tenant's lock is mounted at 46" above floor.

- Change all door handles to a lever type.
- For door hardware mounted outside the reach range, relocate or replace with new hardware. Modify door as required so the new hardware can be installed in right range.

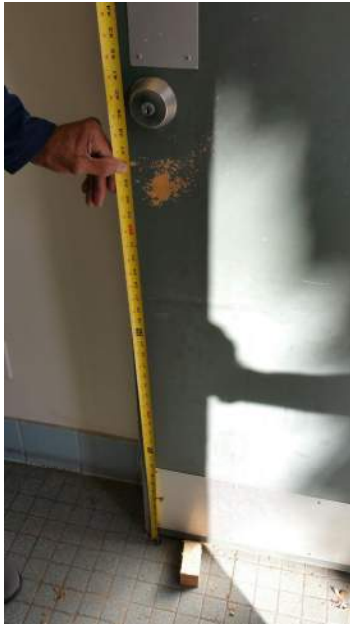
**The door hardware type is not in compliance with CBC Section 11B-404.2.7 and 11B-309.4.**

The first floor men's restroom does not have a lever activated lock. The push plate is accessible if the door is not latched and remains unlocked.

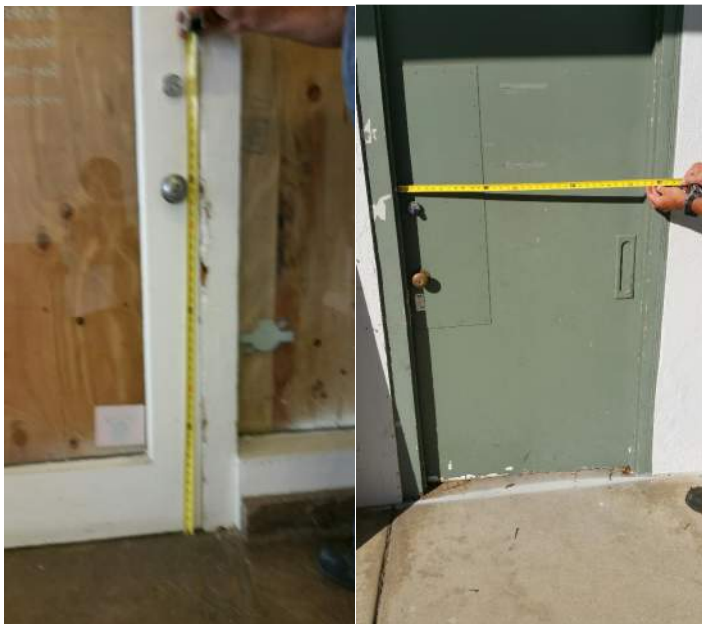
**The door hardware type is not in compliance with CBC Section 11B-404.2.7 and 11B-309.4.**

The original wood framed glass doors and the exterior wood doors all have non-lever type hardware.

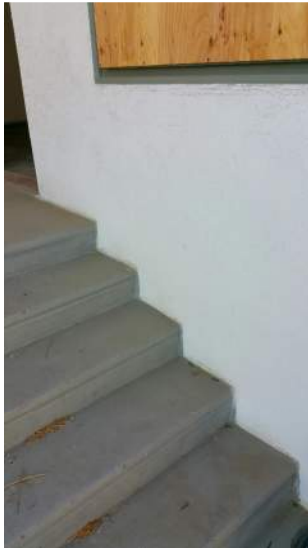
**The four second floor stairs are not in compliance with CBC Section 11B-504.4.1 due to the lack of the contrasting stripes.**

The four second floor stairs do not have a handrail on the wall side. They also do not have the contrasting stripe at the top approach and at all the treads.

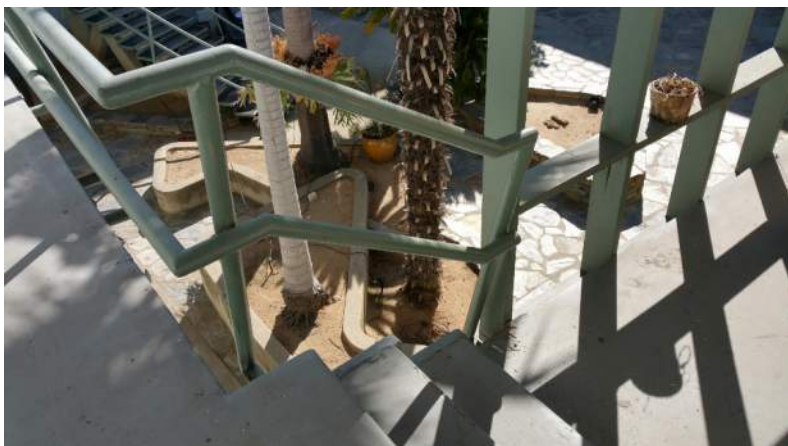
**The four second floor stairs do not have handrail extensions at the bottom landing; therefore, they are not in compliance with CBC Section 11B-505.10.3.**

A second floor stair is missing a handrail extension at the bottom landing.

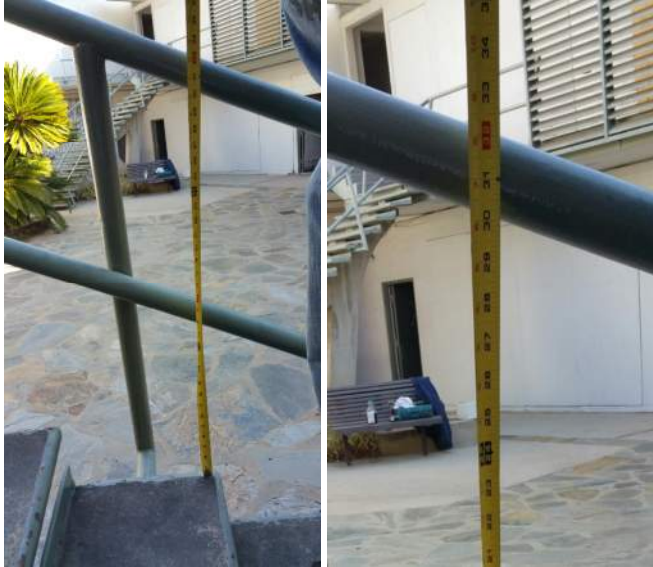
**The two main stairs connecting the first floor and the second floor have handrails less than 34” high; therefore, they are not in compliance with CBC Section 11B-505.4.**

The main stair’s handrail is 32” high measured from the nosing.

- Replace the existing stair's steel guardrails with new ones of the right height. The design should be in the same spirit as the current railing design but the gaps need to be limited to 4" max. Provide new stair handrails with top and bottom handrail extensions integrated into the guardrail.

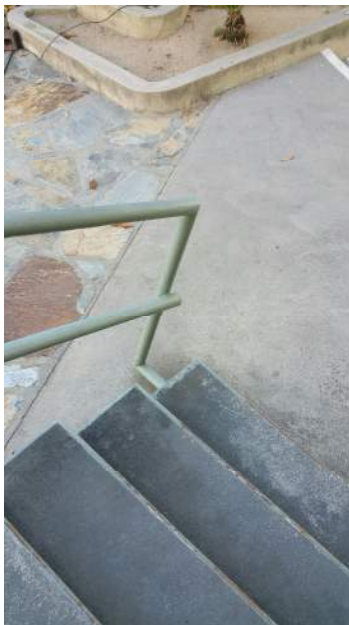
**The two main stairs do not have contrasting stripes; therefore, they are not in compliance with CBC Section 11B-504.4.1.**

The main stair’s handrail has no extension at the bottom and no contrasting stripes at the treads.

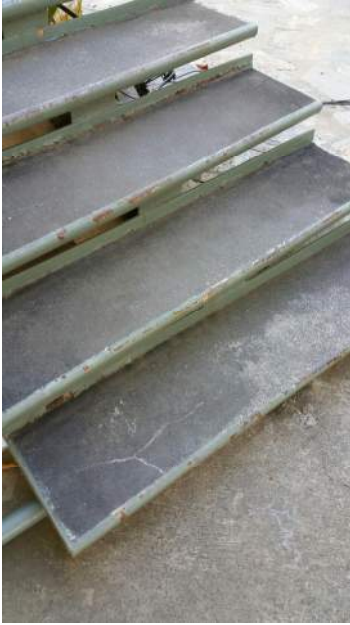
The two main stairs connecting the first and second floors have open risers; therefore, they are not in compliance with CBC Section 11B-504.3.

Main stairs have open risers.

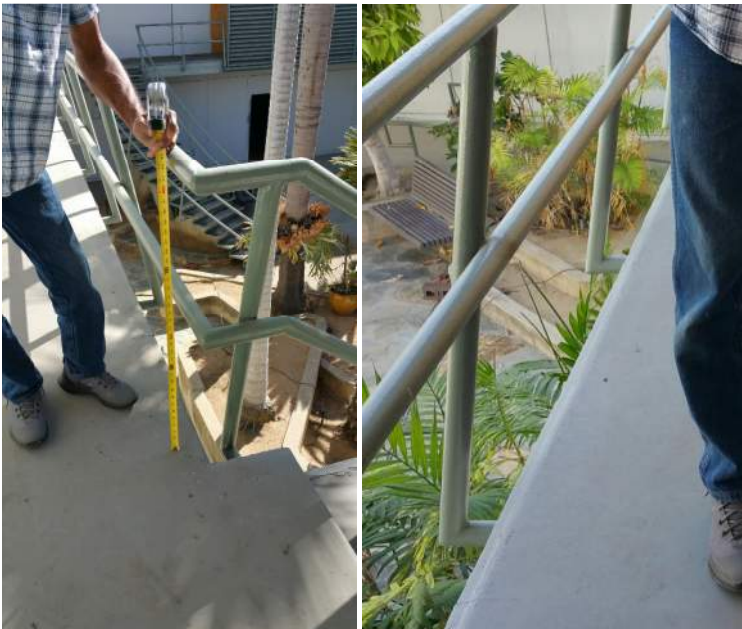
The second floor's balcony guardrail height is 32". This is not in compliance with CBC Section 1015.3 (Chapter 10). The handrail configuration does not offer the edge protection or a barrier at the balcony edge. **CBC Section 11B-405.9 or 11B-405.9.2 (handrail for ramp) may apply due to concern of the wheel entrapment.**

The balcony guard rail height and the lack of the edge protection.

- Replace the existing second floor balcony guardrails with new ones of the right height. The design should be in the same spirit as the current railing design but the gaps need to be limited to 4" max.

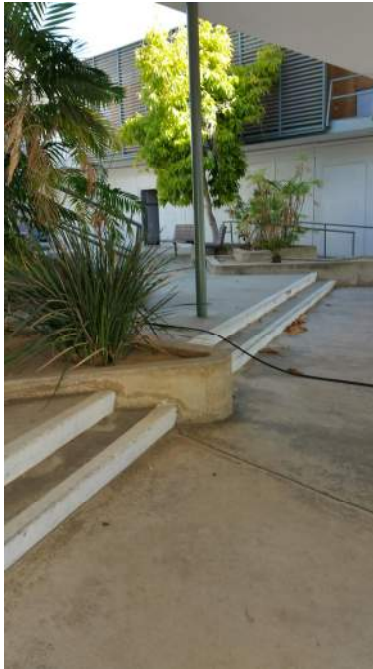
**The courtyard steps do not have handrails; therefore, the courtyard steps are not in compliance with CBC Section 11B-504.6.**

The courtyard steps have no handrails.

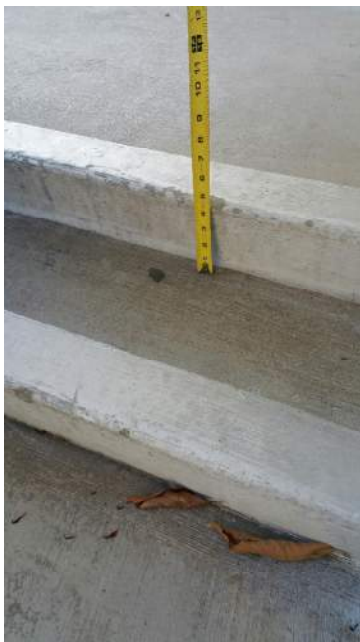
**The courtyard step's contrasting stripe is not in full compliance with CBC Section 11B-504.4.1.**

The contrasting stripe placed on both the treads and the risers, while only the treads require it.

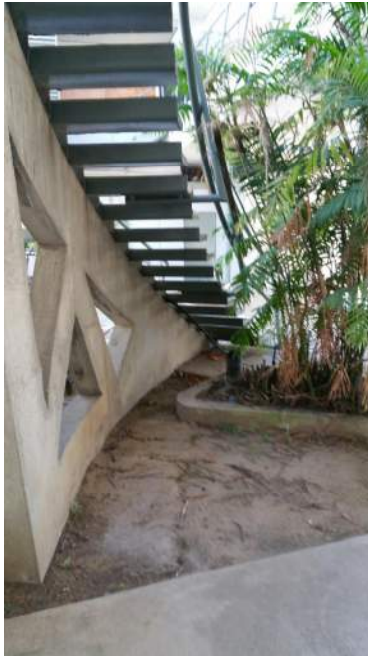
**A barrier shall be provided where the vertical clearance is less than 80" high, per CBC Section 11B-307.4.**

The space under one of the main stairs has less than 80" vertical clearance and does not have a barrier.

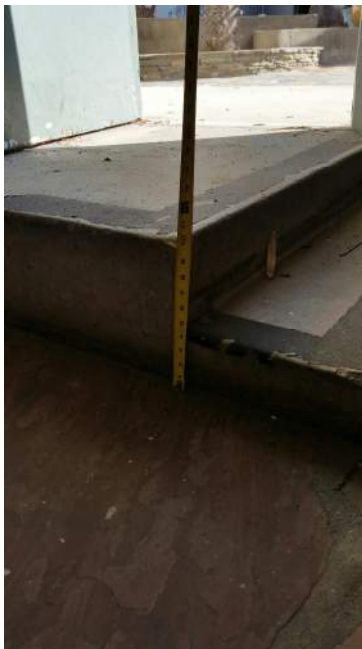
**The stair does not have handrails; therefore, it is not in compliance with CBC Section 11B-504.6**

One concrete stair inside a unit has a 6" and 4" tall risers. The stair does not have handrails.

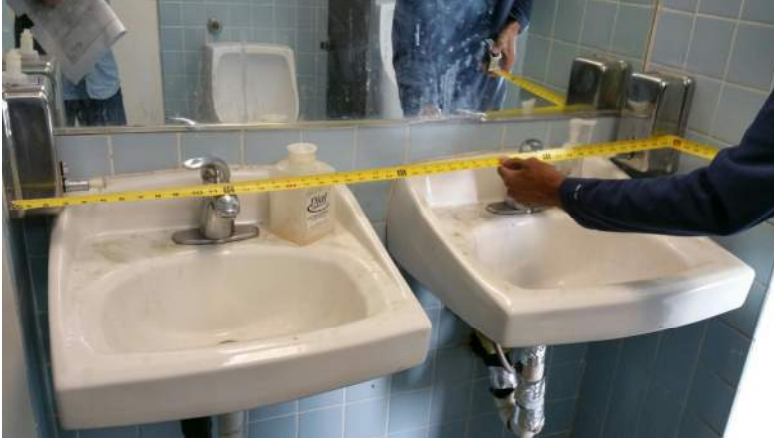
The first floor men's restroom lavatories do not have the required clearance from the adjacent wall to the center of the fixtures; **therefore, it is not in compliance with CBC Section 11B-606.6.**

The distance from the adjacent wall to the center of the fixture is only 12" for each lavatory.

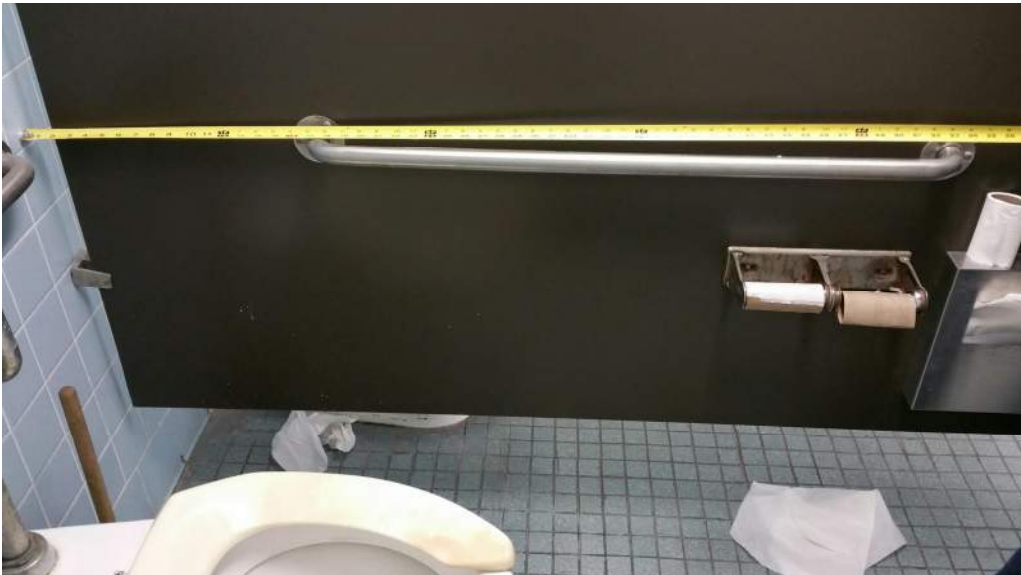
The side wall grab bar shall be 42" long minimum, located 12" maximum from the rear wall. **The ADA stall side grab bar is not in compliance with CBC Section 11B-604.5.1.**

The distance from the rear wall to the end of the grab bar is 17" and the grab bar length is 36".

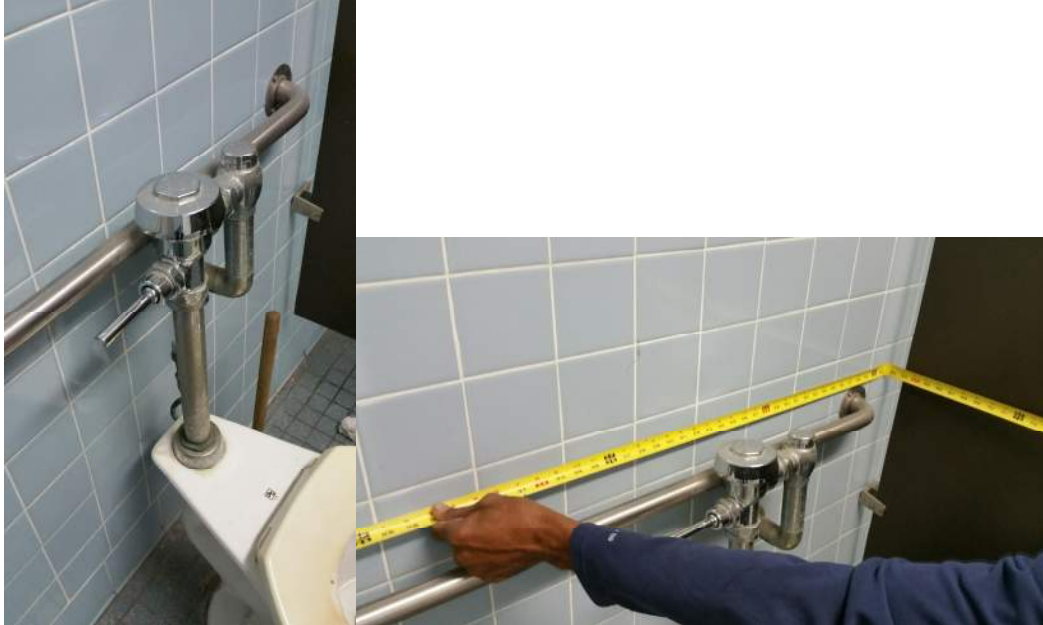
The rear wall grab bar shall be 36" long min and extend from the center line of the water closet 12" min on one side and 24" min on the other side. Exception 2: Where an administrative authority requires flush controls for the flush valves to be located in a position that conflicts with the location of the rear grab bar, then the rear grab bar shall be permitted to be split or shifted to the open side of the toilet. **The rear grab bar may conflict with the flush valve and is not located per CBC Section 11B-604.5.2.**

The rear grab bar is not split or shifted to the open side at the flush valve.

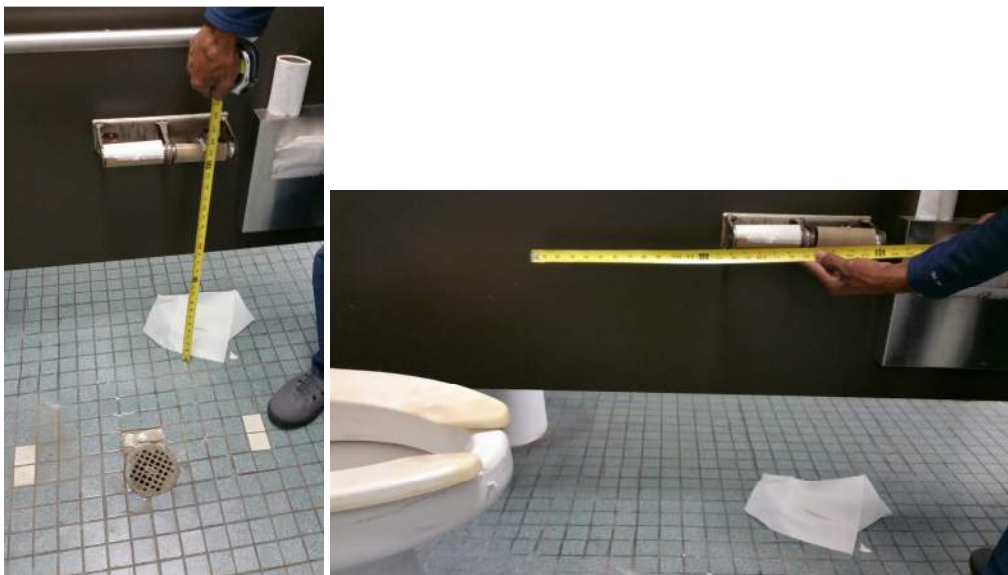
The toilet paper dispenser shall be 7" minimum and 9" maximum in the front of the water closet measured to the center line of the dispenser. The outlet of the dispenser shall be 14" minimum and 19" maximum above the finish floor. **The toilet paper dispenser mounting is not in compliance with CBC Section 11B-604.7.1.**

The toilet paper dispenser is 19" in front of the water closet and is 24" above floor at the outlet.

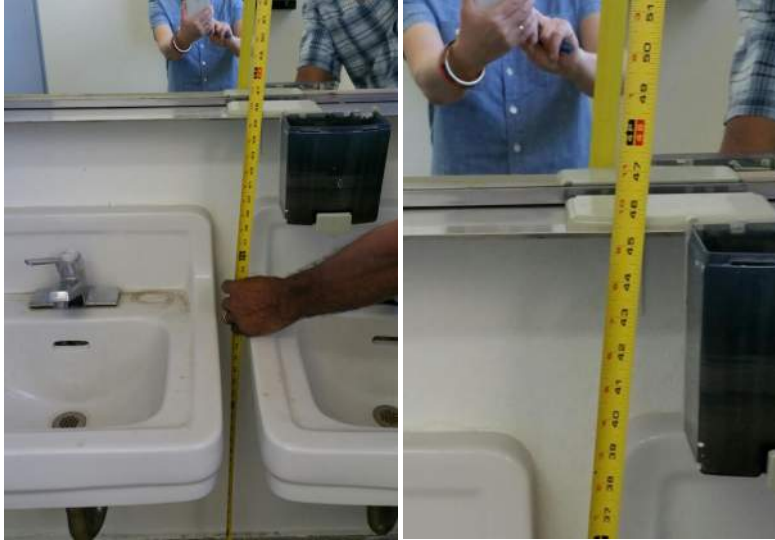
The women’s restroom lavatories are spaced close to each other and to the adjacent wall. **The mirror height is more than 40” above the floor; therefore, it is not in compliance with CBC Section 11B-603.3.**

The mirror height is 45” above the floor.

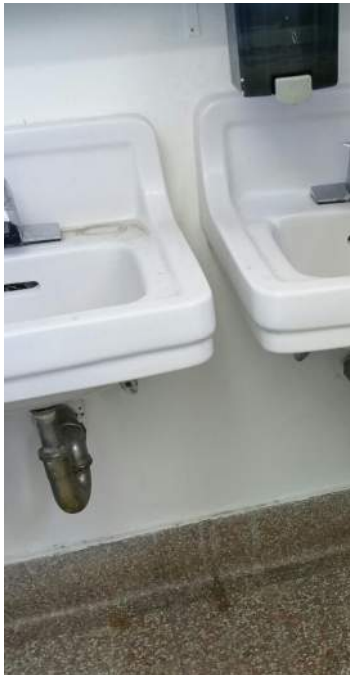
**The women’s restroom water supply and the drain pipes under the lavatory are not insulated; therefore, it is not in compliance with CBC Section 11B-606.5.**

There is no insulation for the water supply and the drain pipes.

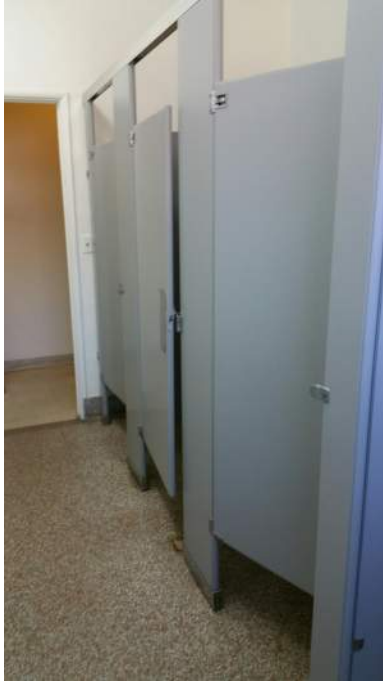
The second floor women’s restroom has three regular stalls, no ADA stall or the minimum ADA clearance outside the stalls. **It is not in compliance with CBC Sections 11B-213.2 and 11B-603.2.**

There are three regular toilet stalls. There is no ADA stall or the minimum ADA clearance outside the stalls.

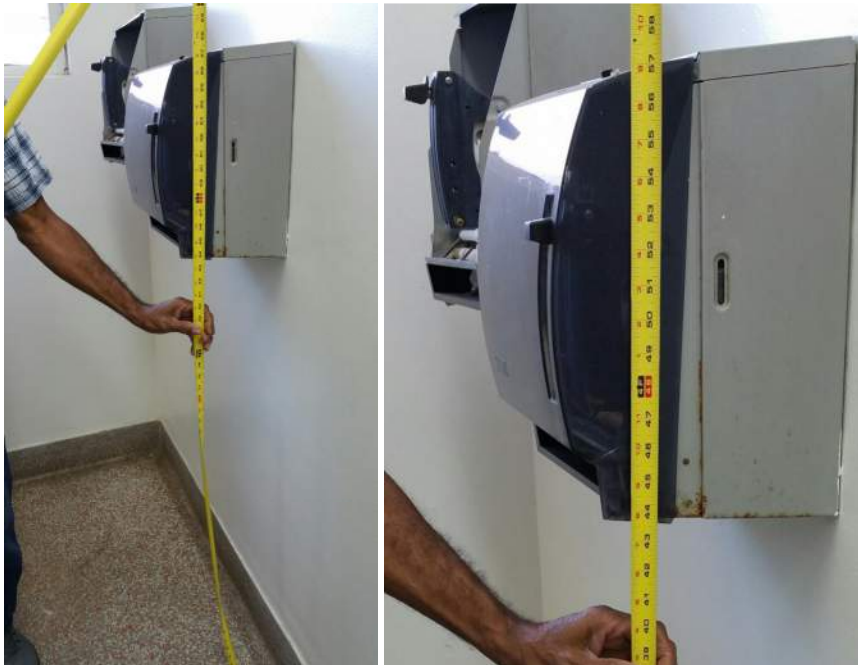
**The second floor women’s paper towel dispenser has operable part higher than 40” above the floor; therefore, it is not in compliance with CBC Section 11B-603.5.**

The paper towel dispenser’s highest operable part is at 53” above the floor.

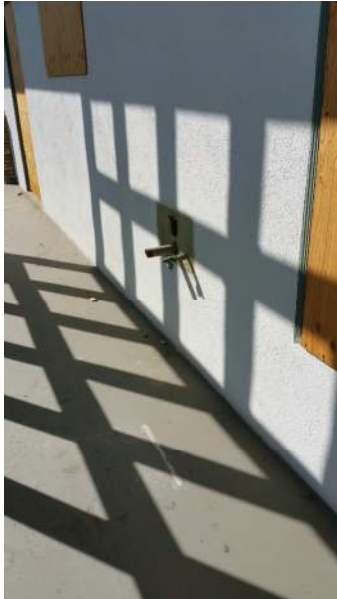
Currently, there is no drinking fountain on the site. The plumbing code requires drinking fountains. **CBC Section 11B-202.4 requires drinking fountains to be in the Accessible Path of Travel.**

A removed drinking fountain was spotted at the second floor balcony which is not accessible.

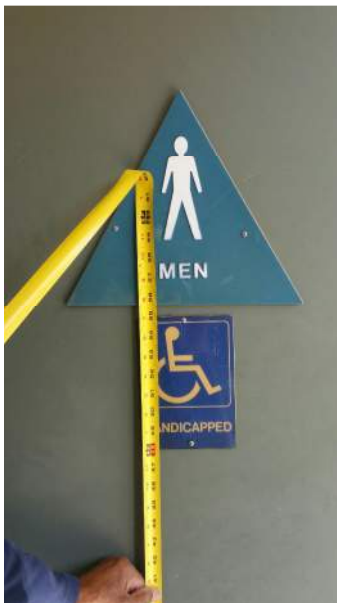
ISA should not contain HANDICAPPED letters. The door mounted triangular or the circular restroom sign normally does not have Braille letters. A tactile room sign should also be located alongside the door at the latch side. The Braille letters should be positioned on the room sign below the corresponding tactile letters. **The men's restroom sign is not in full compliance with CBC Section 11B-703.**

The ISA symbol does not contain the letter HANDICAPPED. The Braille letters should be on wall-mounted room sign.

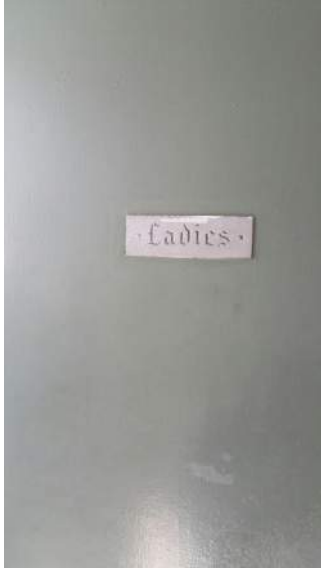
The original ladies' room sign is not the circular symbol nor a pictogram. It is not of raised characters and it does not contain Braille letters. It does not have a color contrast and the type is not San Serif.
