# **Barry Building ADA Upgrade Requirements**

## INTRODUCTION

At the request of Alston & Bird, LLP, Gruen Associates evaluated the ADA compliance requirements of the Barry Building and prepared this report. The Barry Building was constructed in 1951 and was designated as a Los Angeles Historic-Cultural Monument in 2007. The codes referenced in this report are from the 2019 California Building Code and the 2019 California Historical Building Code.

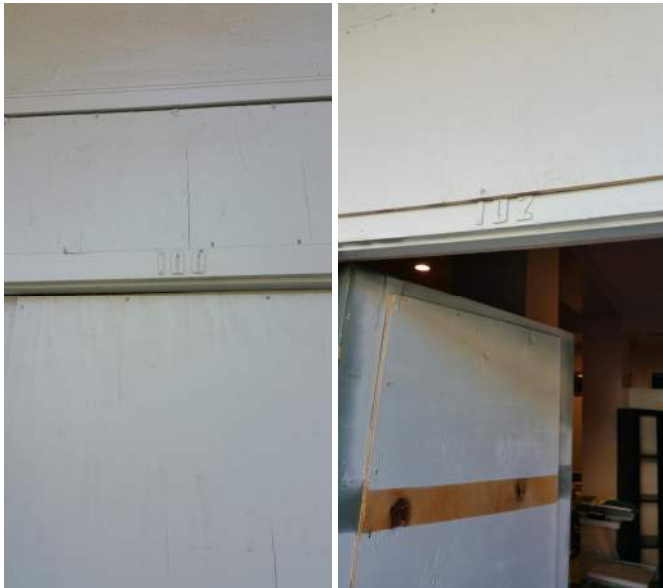
The original suite numbers are mounted above the door and have a low color contrast.

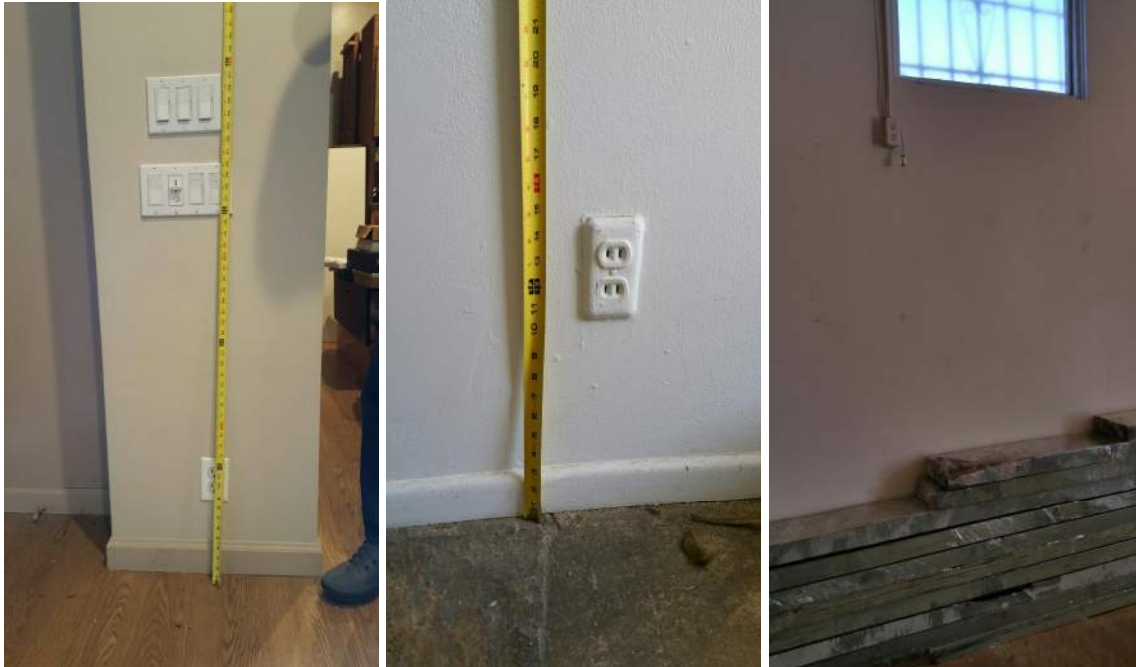
The original outlets are mounted at typical 12" above the floor. One outlet is mounted higher than 48" above the floor.

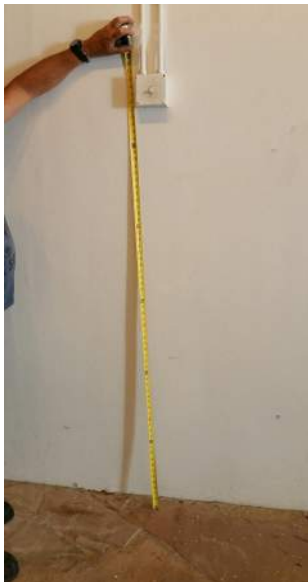
A switch is mounted at 67" above the floor.

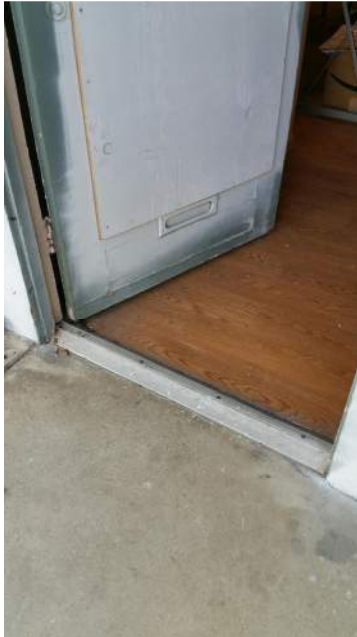
An original mail slot mounted at about 9” from the floor.

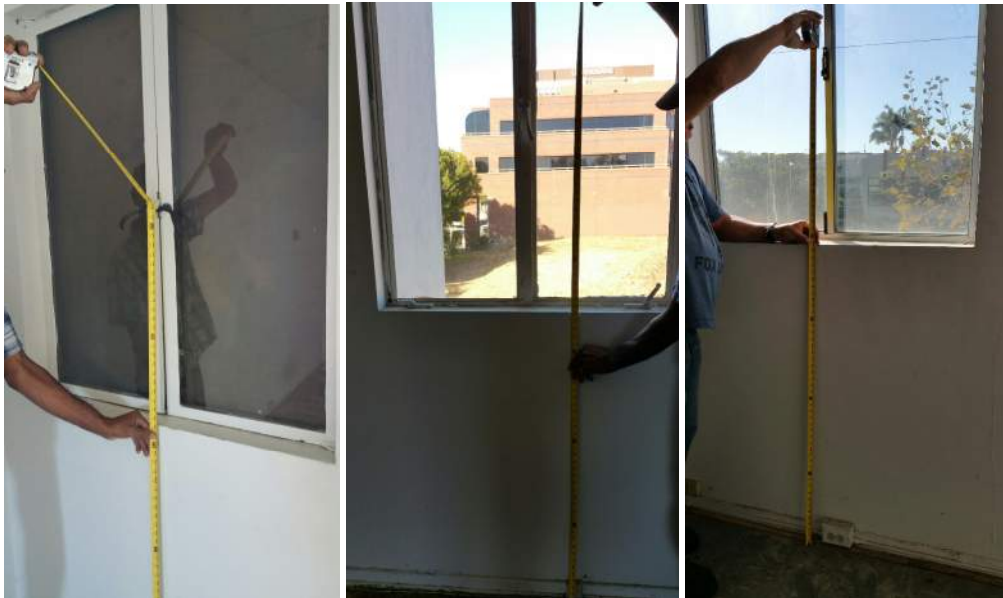
Second floor steel window’s latch is mounted at 62” above the floor.
