11973 San Vicente Boulevard

ASCE 41-13 Seismic Assessment

Los Angeles, California

June 6, 2022

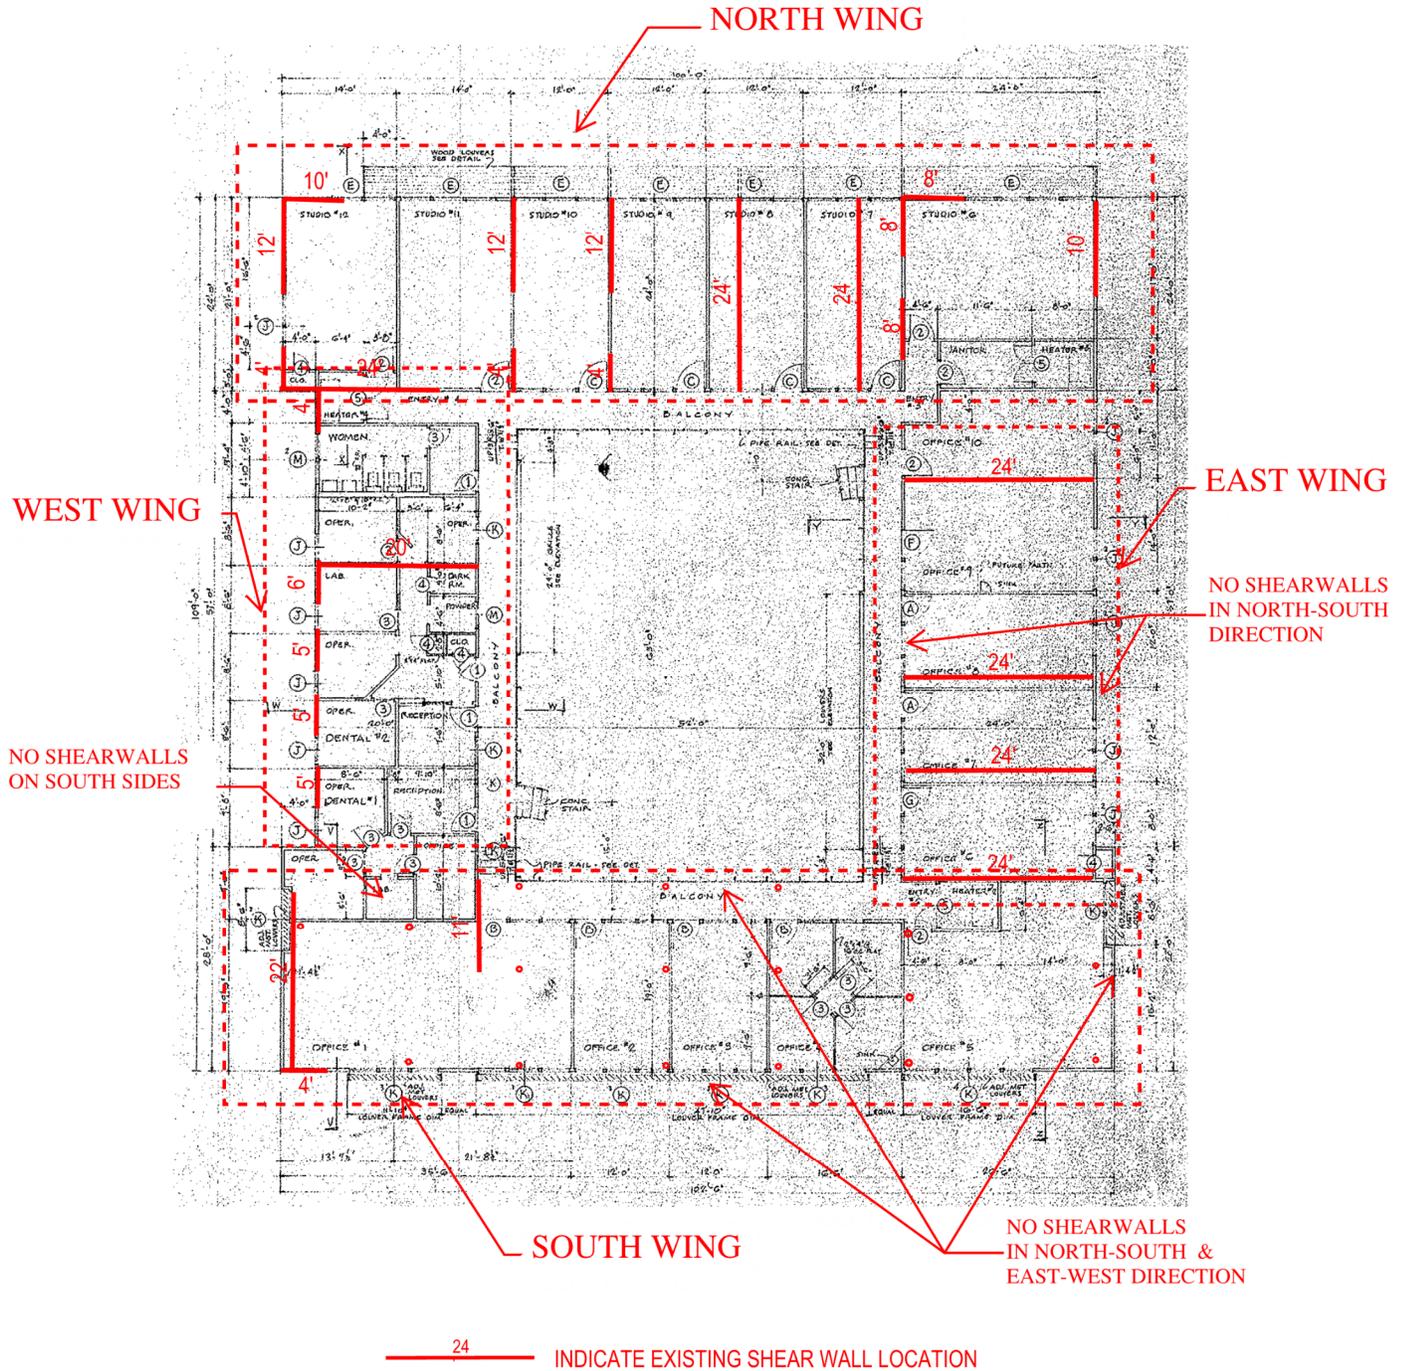
Figure 3.1: Existing Shear Wall Locations

The lateral bracing for this building consists of the horizontal floor and roof diaphragms and the perimeter vertical shear walls. The second floor and roof consist of diagonal sheathing. The nailing pattern for the

sheathing is unknown. This diagonal sheathed floor and roof diaphragm span to the exterior perimeter walls. These exterior walls serve as the vertical shear walls that brace this building. The interior demising walls do not form a complete lateral bracing system as they are discontinuous between floors, and several of these walls have been removed and the wall locations are irregularly distributed.

In the north-south direction, roughly 120 feet of existing walls are located, such that they act as lateral resisting elements. In the east-west direction, roughly 42 feet of existing walls are located, such that they act as lateral resisting elements. The DCR for the walls in the north-south direction is 230% overstressed. The DCR for the walls in the east-west direction is 650% overstressed.

In the north-south direction, there is no existing wall located as a lateral resisting element. The exterior wall along grid H and the interior courtyard wall along grid G do not contain structural elements that can be identified as a lateral resisting element. In the east-west direction, roughly 90 feet of existing walls are located as lateral resisting element. The DCR for walls in the north-south direction cannot be determined since no lateral resisting element can be identified. Significant lateral displacement may be expected in the north-south direction of the east wing during a seismic event. The DCR for walls in the east-west direction is 190% overstressed.

There is no existing wall or lateral resisting element to resist seismic loads from the second floor and roof in either the north-south or east-west directions. As a result, significant lateral displacement may be expected during a seismic event. The steel posts that support this wing will be subjected to this potential lateral displacement. Since the steel posts do not possess any lateral resistance, a possible collapse of this wing can result during a seismic event.

In the north-south direction, roughly 50 feet of existing walls are located, such that they act as a lateral resisting element. In the east-west direction, roughly 40 feet of existing walls are located, such that they act as a lateral resisting element. There is no wall located at the south end of the wing. Significant lateral displacement may be expected in the east-west direction during a seismic event. The DCR for the walls in the north-south direction is 360% overstressed. The DCR for the walls in the east-west direction is 400% overstressed.
