Los Angeles Conservancy Comment Review

Regarding: Barry Building (11973 San Vicente Boulevard, Los Angeles, CA 90049)
Los Angeles Conservancy Comments Review

11973 San Vicente Boulevard

ASCE 41-13 Seismic Assessment

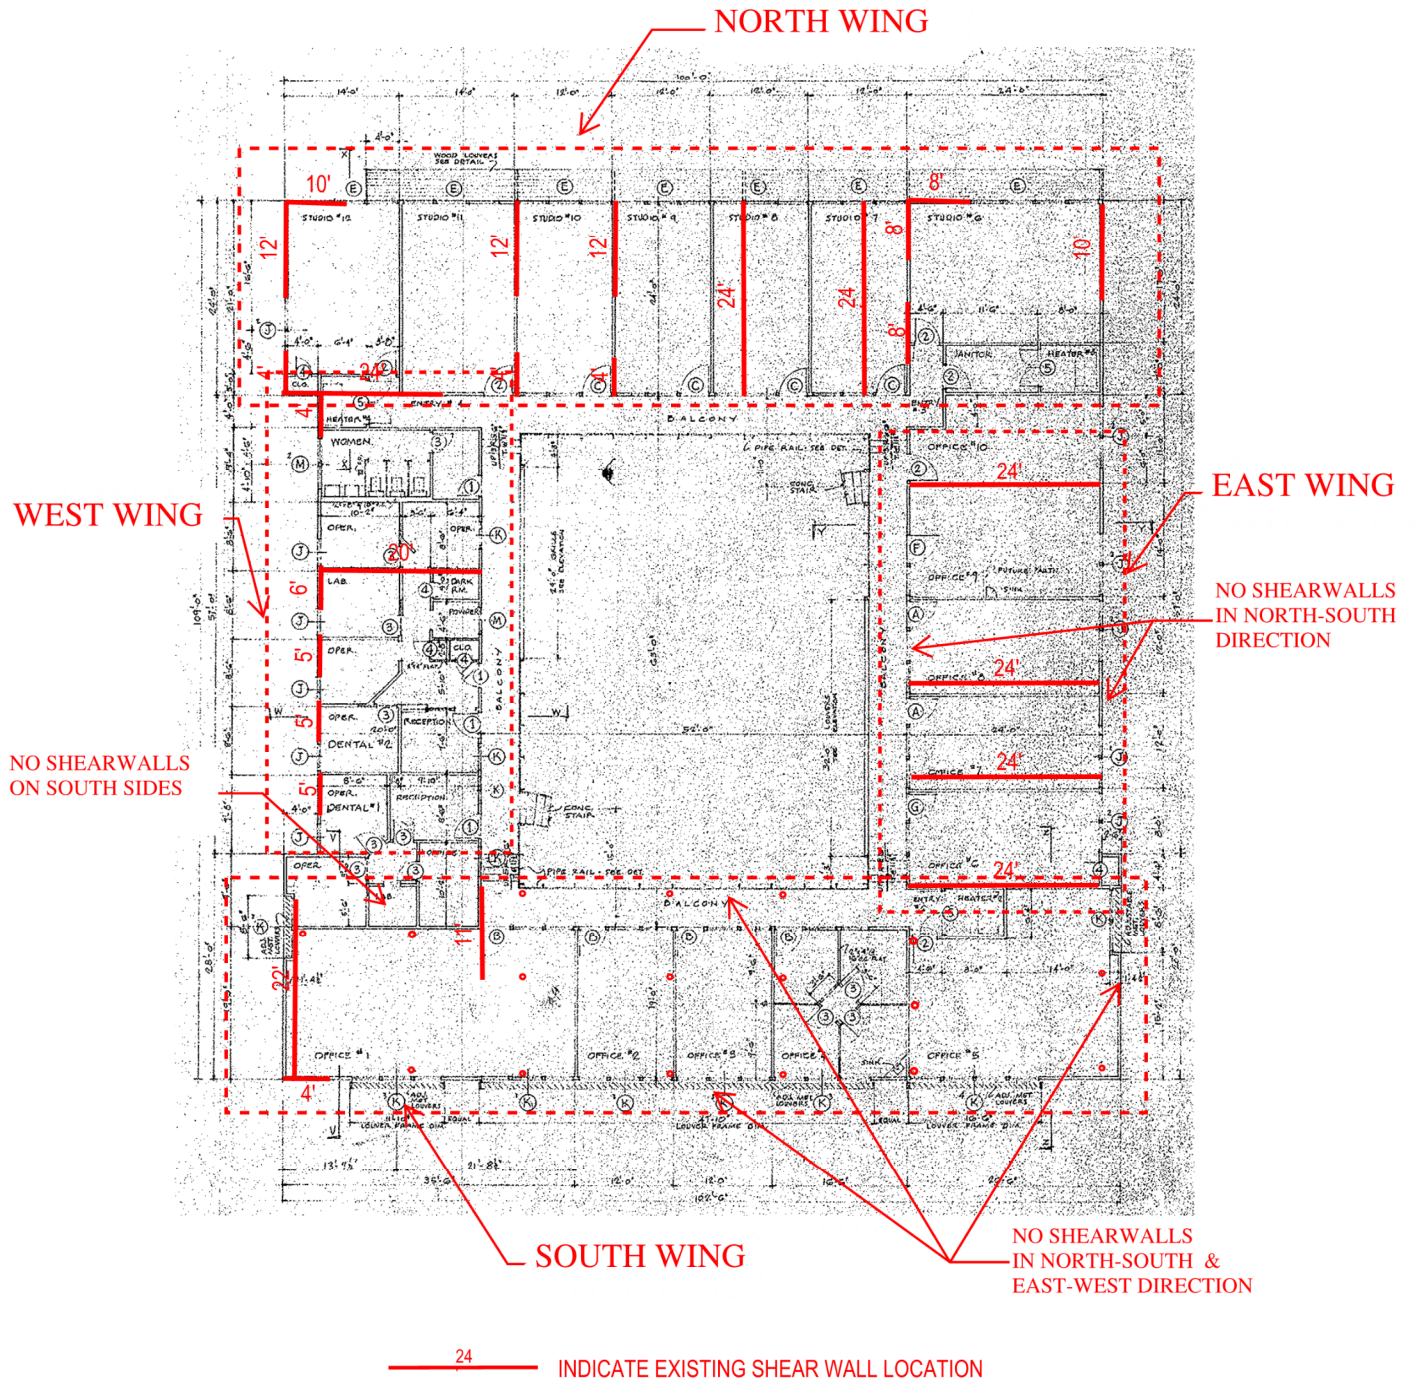
Figure 3.1: Existing Shear Wall Locations

sheathing is unknown. This diagonal sheathed floor and roof diaphragm span to the exterior perimeter walls. These exterior walls serve as the vertical shear walls that brace this building. The interior demising walls do not form a complete lateral bracing system as they are discontinuous between floors, and several of these walls have been removed and the wall locations are irregularly distributed.

In the north-south direction, roughly 120 feet of existing walls are located, such that they act as lateral resisting elements. In the east-west direction, roughly 42 feet of existing walls are located, such that they act as lateral resisting elements. The DCR for the walls in the north-south direction is 230% overstressed. The DCR for the walls in the east-west direction is 650% overstressed.

In the north-south direction, there is no existing wall located as a lateral resisting element. The exterior wall along grid H and the interior courtyard wall along grid G do not contain structural elements that can be identified as a lateral resisting element. In the east-west direction, roughly 90 feet of existing walls are located as lateral resisting element. The DCR for walls in the north-south direction cannot be determined since no lateral resisting element can be identified. Significant lateral displacement may be expected in the north-south direction of the east wing during a seismic event. The DCR for walls in the east-west direction is 190% overstressed.

In the north-south direction, roughly 50 feet of existing walls are located, such that they act as a lateral resisting element. In the east-west direction, roughly 40 feet of existing walls are located, such that they act as a lateral resisting element. There is no wall located at the south end of the wing. Significant lateral displacement may be expected in the east-west direction during a seismic event. The DCR for the walls in the north-south direction is 360% overstressed. The DCR for the walls in the east-west direction is 400% overstressed.

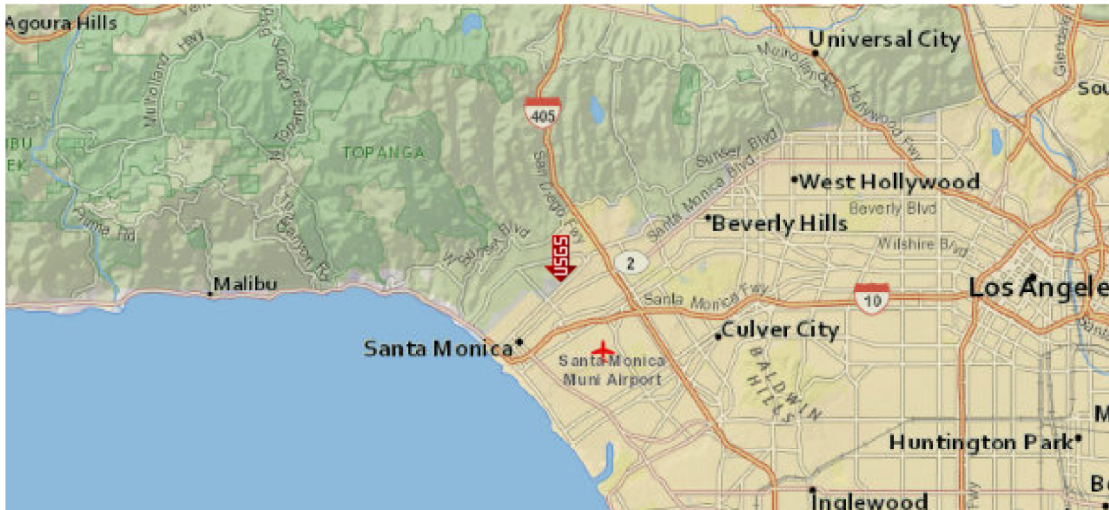
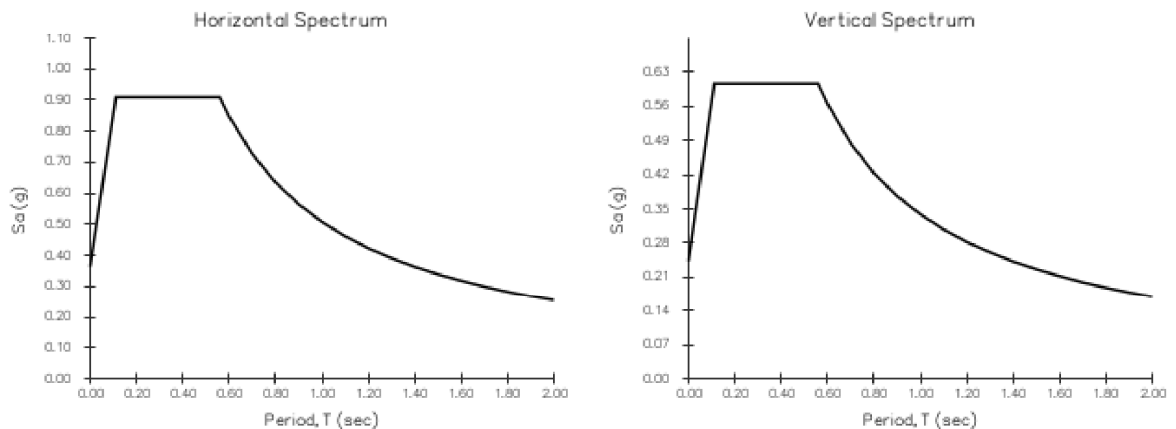
Figure 4.1: Spectral Ordinates per ASCE 41-13

Spectral accelerations were obtained from the USGS for the Basic Safety Earthquake-1E (BSE-1E) hazard level. The BSE-1E hazard level corresponds to an earthquake with an average return period of 225 years or 20% probability of exceedance in 50 years. BSE-1E spectral accelerations are used to evaluate the level of seismicity of the site as required for the Tier 1 Checklist. The ordinates are illustrated in Figure 4.1.

Base on the 0.2 second and 1.0 second spectral accelerations, in accordance with ASCE 41 Table 2-4, the level of seismicity at this site is defined as High. This classification determines the ASCE 41-13 structural checklists required for use in evaluating the building.

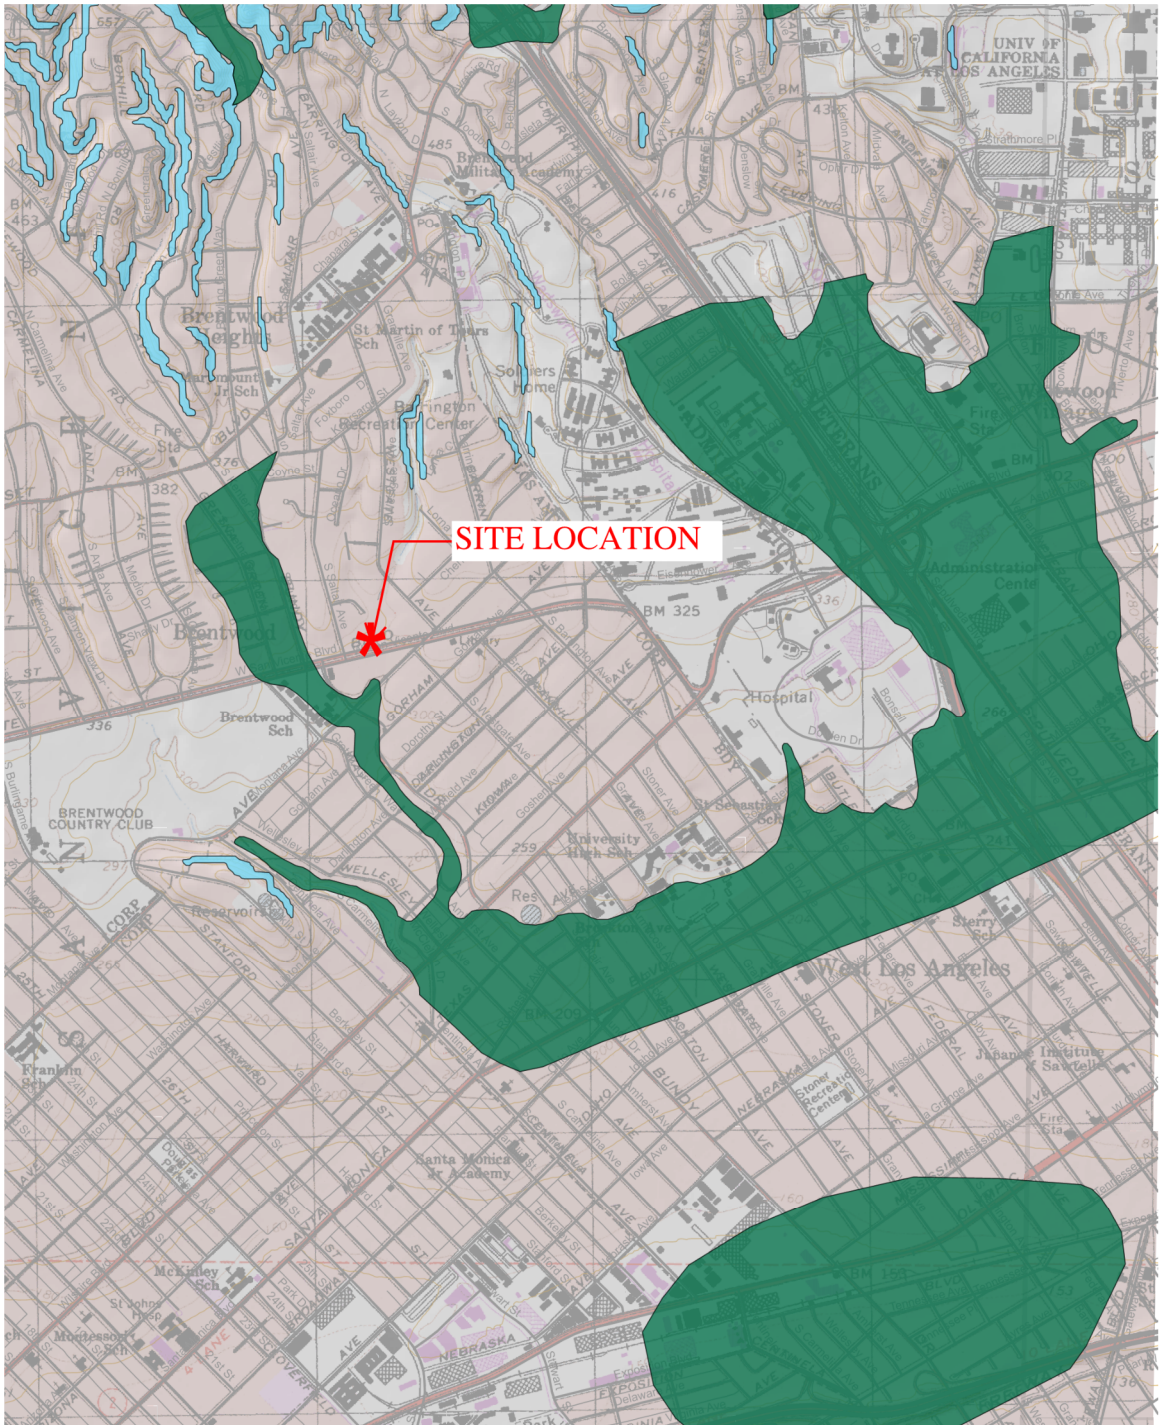
Figure 4.2: State of California Regulatory Map for Seismic Hazards (Beverly Hills Quadrangle)

The state of California has issued a set of regulatory maps detailing regions of potential liquefaction, landside and ground fault rupture. This site is in the Beverly Hills Quadrangle, as shown in Figure 4.2. Areas shown in white have not been identified as locations of potential liquefaction, landside or ground

fault rupture. The map indicates that the site, shown in Figure 4.2, has not been identified as a potential location for any of these seismic or geotechnical hazards.
