ARBORIST REPORT

THE CROSSWINDS AT MORGAN HILL

1105 HALF ROAD

February 12, 2021

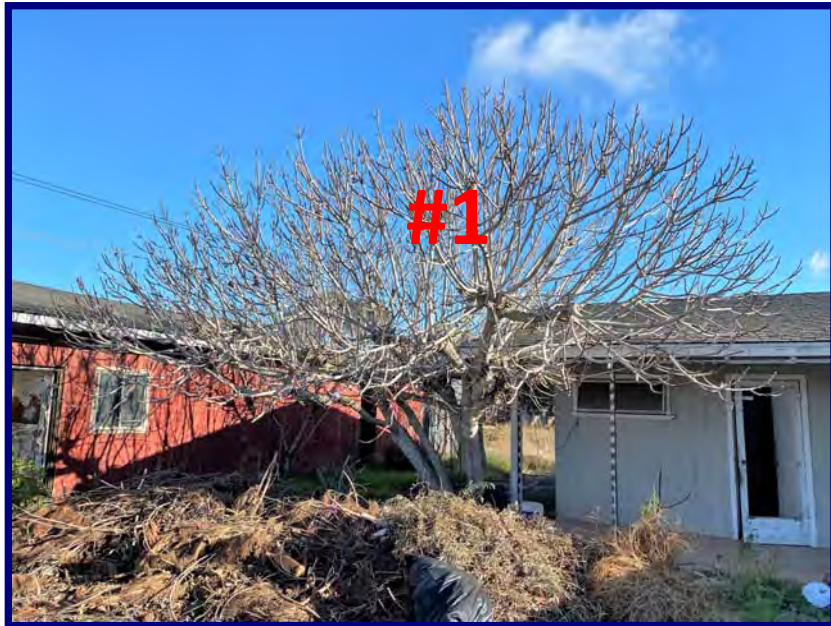
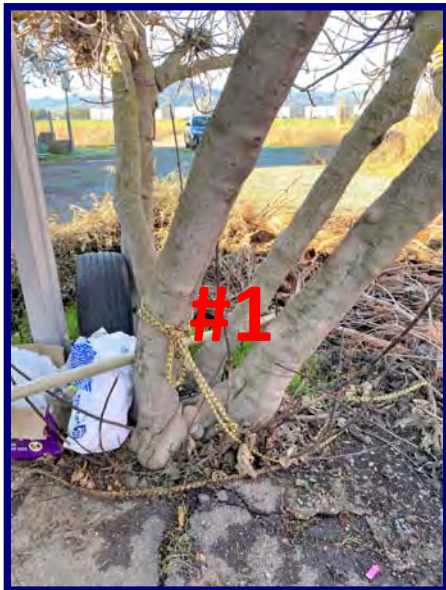
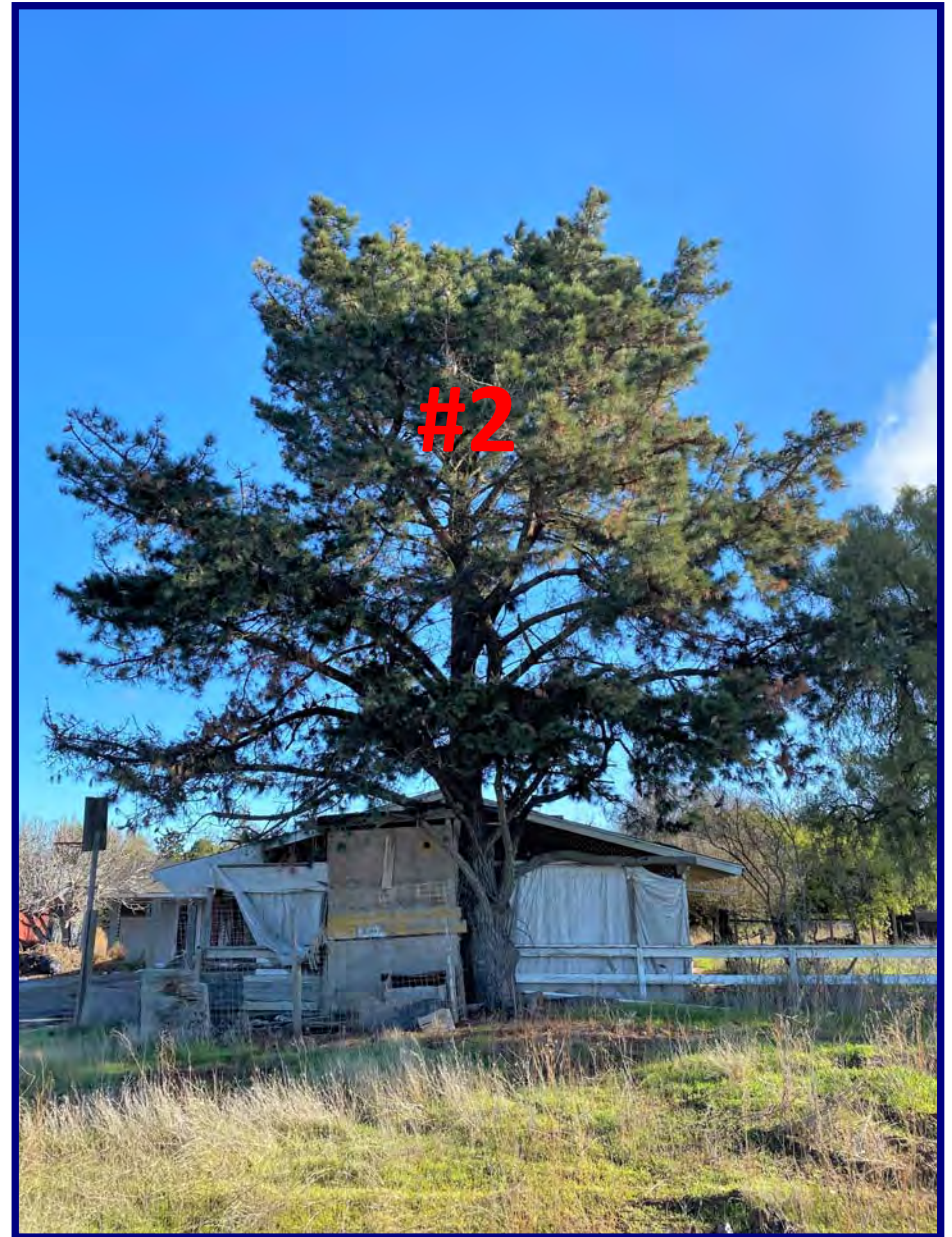
Page C-1: Trees #1 and 2

Comments: Dormant. Multiple trunks represent stump sprouts and form weak attachments. Top has been reduced in past at varying heights between 6 to 9'. Grows SW away from existing structure. Asphalt surrounding base is raised and buckled.

Comments: Tree is partly surrounded by a treehouse. Large girdling root along the trunk's east side. Minor infestation of red turpentine beetles and pitch moth larvae. Large deadwood throughout. Branch dieback is abundant most likely due to pine pitch canker. Branching begins at 4.5' high. A few older, large limbs/branches were cut from the lower trunk.

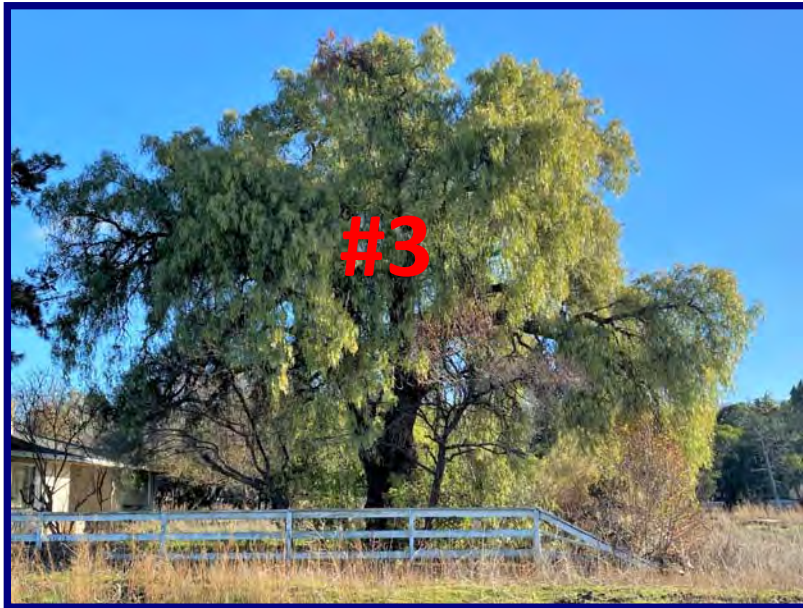
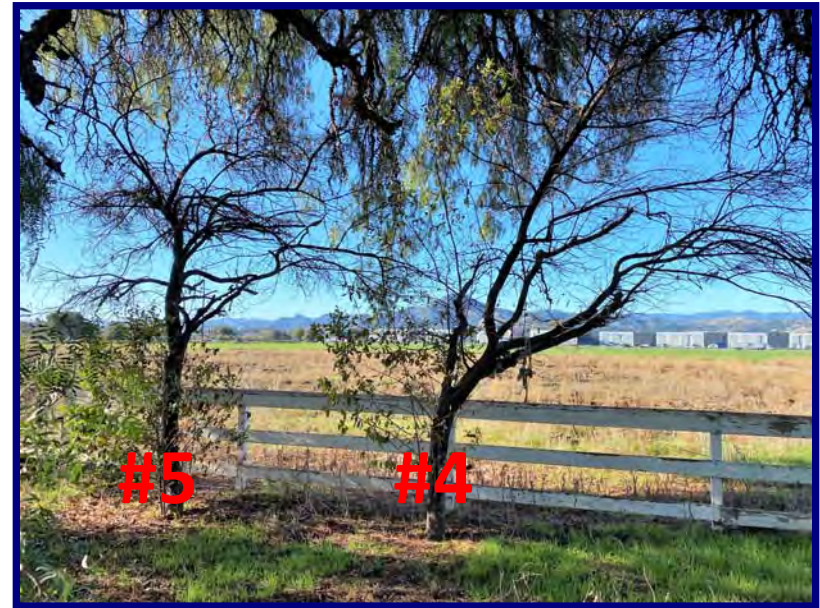
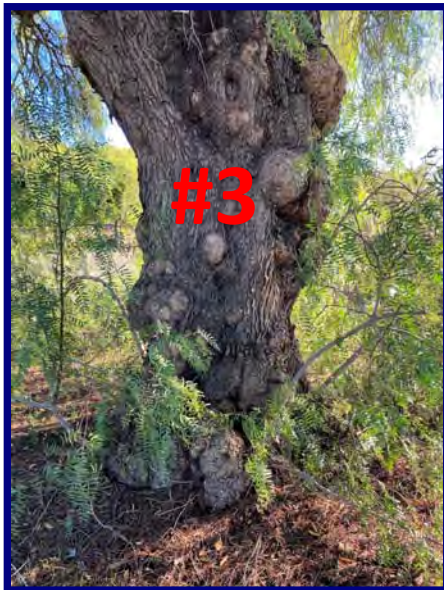
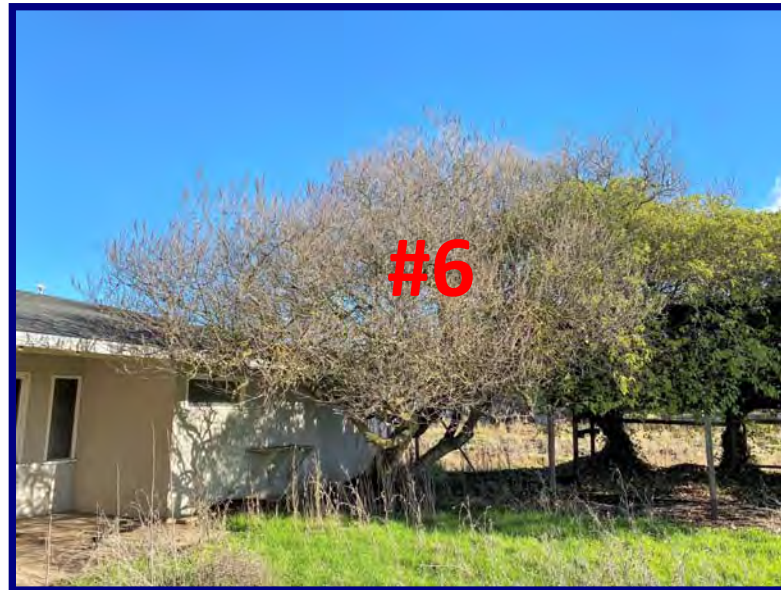
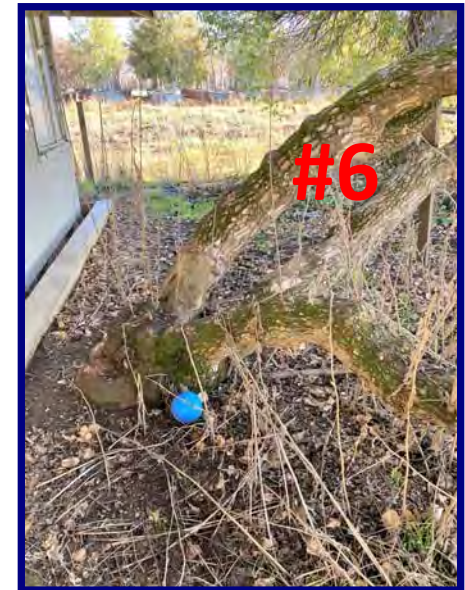
Page C-2: Trees #3 thru 6

Comments: Structure is formed by three codominant leaders emerging at 10' high. Large deadwood throughout, and has a 17" tall by 6" wide by 2+' deep hollow along the trunk's east side at 4'. Has excessive limb weight and some dieback along canopy's top.

Comments: Dead.

Comments: Dormant. Low crown, and the 7" trunk grows horizontal within a few feet above ground. Irregular, asymmetrical and broad form. Bark is missing along the lower sections of all three trunks, some with decay. Grows with a pronounced lean away from the existing home. Ivy grows within the canopy's NE portion.

These two are small ornamental trees which have been dead for some time. They cannot recover and should be removed before the site becomes occupied.

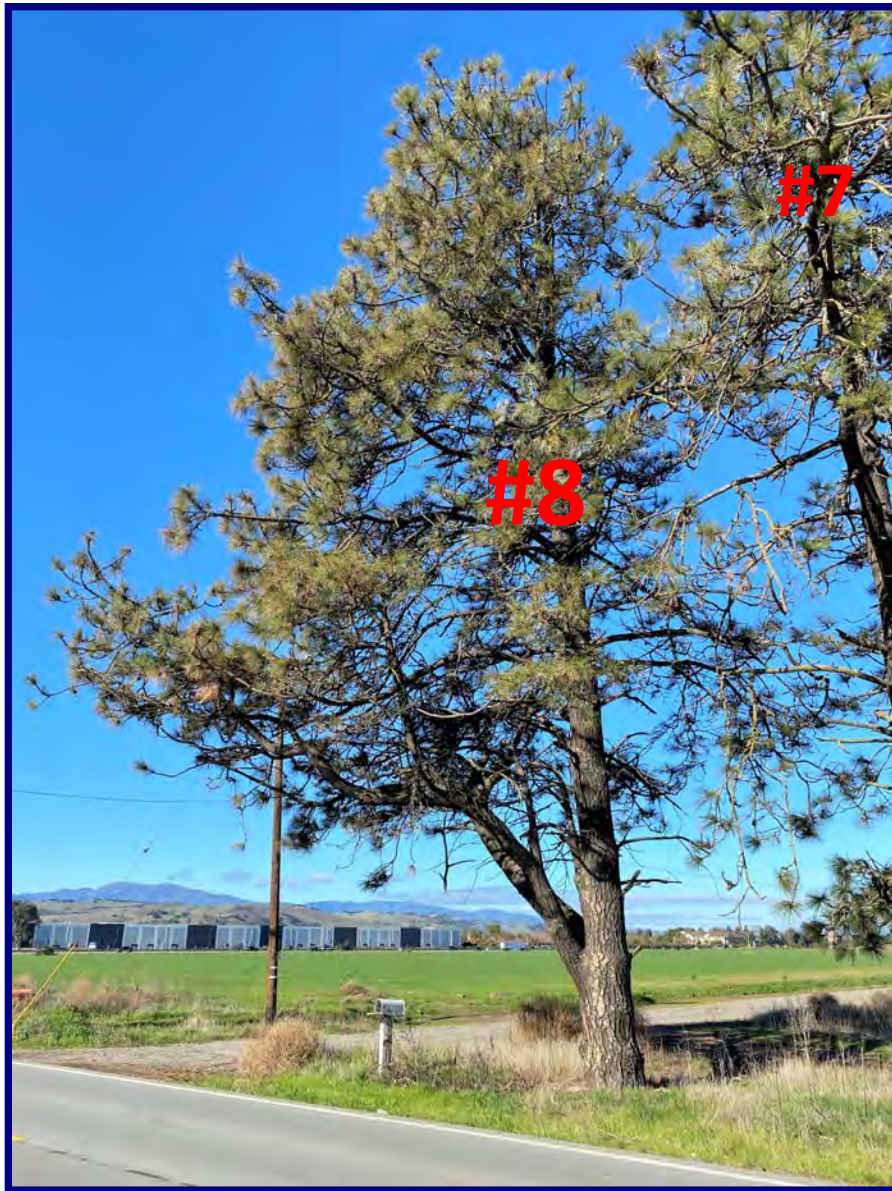
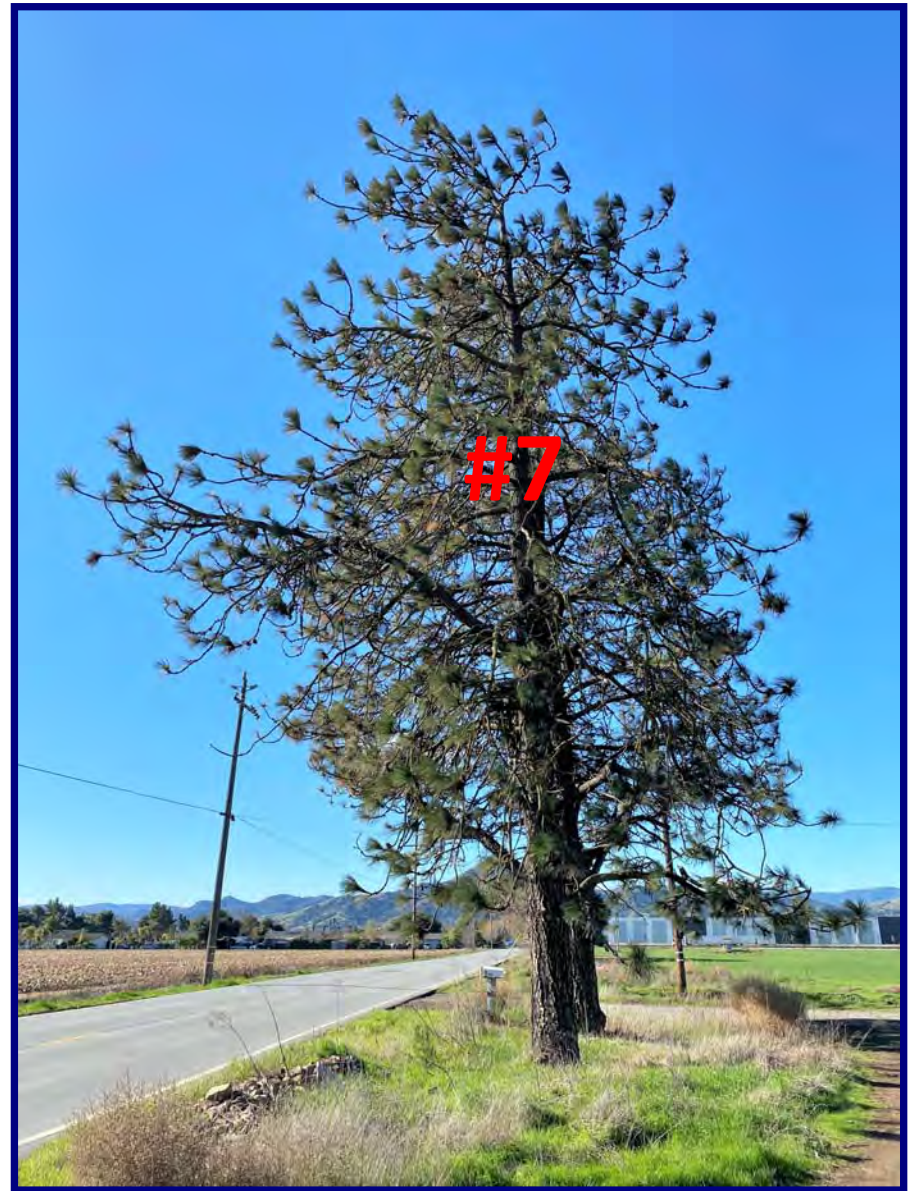
Page C-3: Trees #7 and 8

Comments: Asymmetrical, mostly one-sided canopy away from #8. History of limb failure. Has a very thin, sparse canopy with deadwood and dieback. There is a dead, decaying stump at base (of prior tree). Has an old tag #125.

Comments: Asymmetrical, mostly one-sided canopy away from #7, and its dominant limb structure extends towards SE. Large deadwood and excessive branch weight. Has three competing, multiple tops. Has an old tag #124.
