# Hidden Hills Long Valley Road/ Valley Circle/US-101 On Ramp Improvement Project

## Arborist Report and Tree Protection Plan

**May 2019**

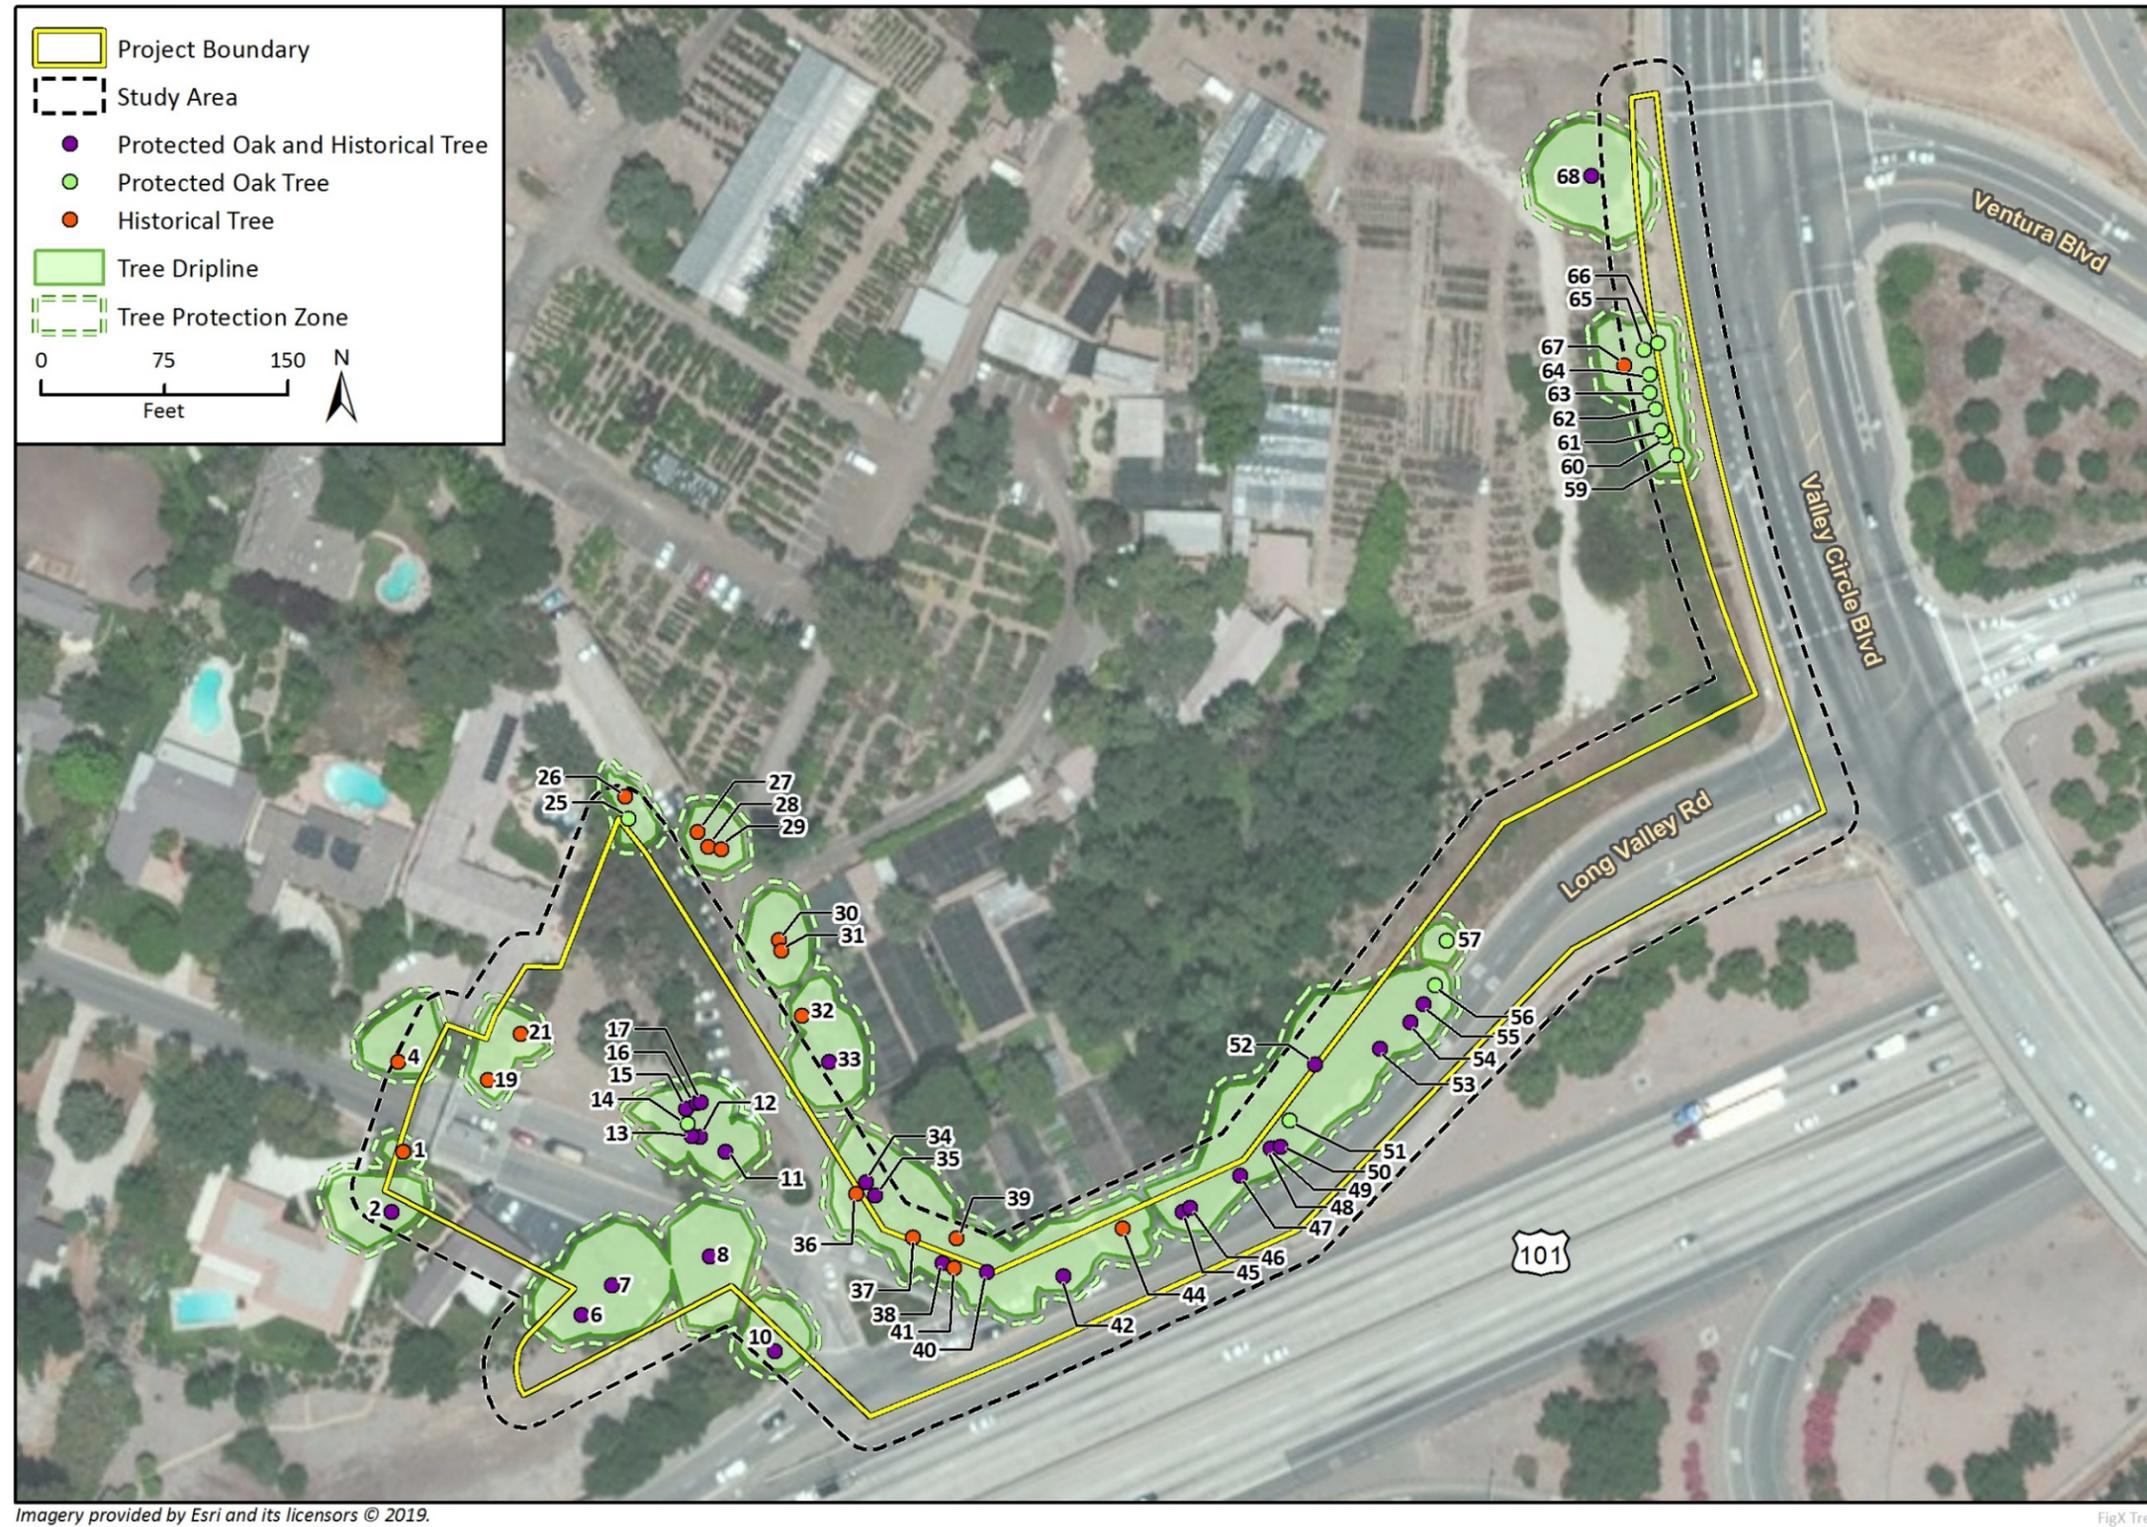
Figure 2 Protected Trees and Study Area

A total of 58 native and non-native trees were observed to have canopies occurring within the study area and are protected by the City of Hidden Hills Ordinance, as shown in Figure 2. A photo of each tree is provided in Appendix A. Appendix B provides the data collected for all protected trees.
