Arborist Report

600 Foothill Blvd.
La Cañada Flintridge, California

June 22, 2020

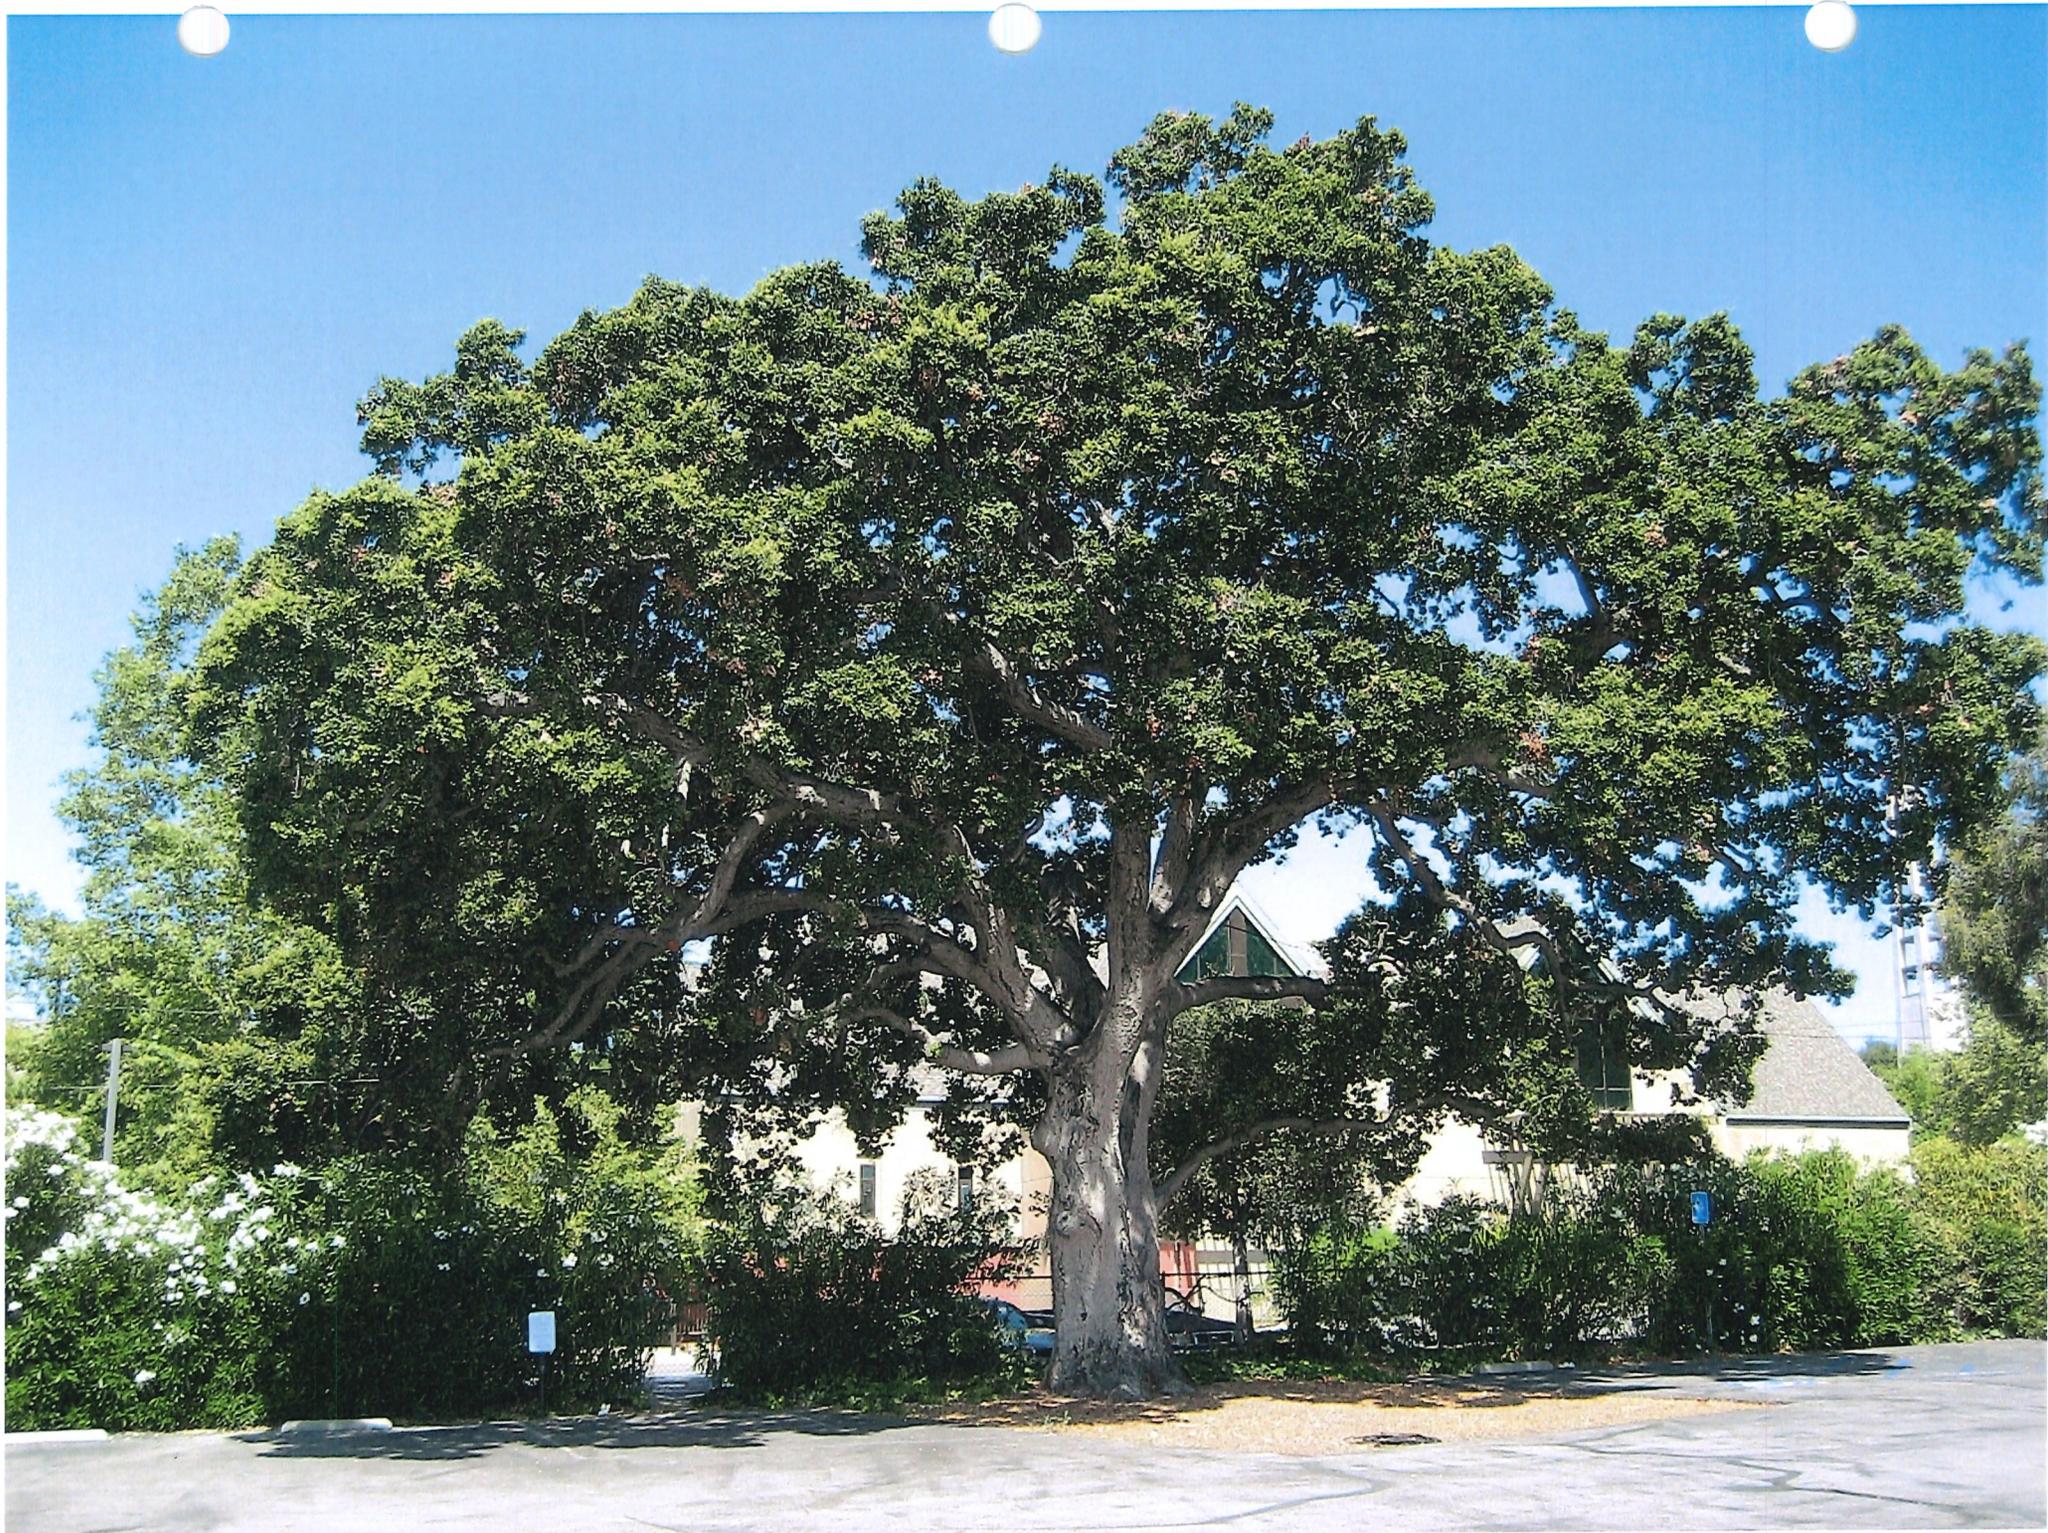
TREE #1

Tree #1 is a Quercus agrifolia or Coast Live Oak. The tree measures 50 inches in diameter at D.B.H. (Diameter Breast Height) as measured 54 inches above the soil grade. The tree has a drip line, which measures roughly 36 feet from the tree's trunk. The spread of the tree is approximately 70 feet. The height of the tree is estimated to be roughly 60 feet tall. The tree is located near the latter one-third of the subject property near the western boundary with the La Cañada Presbyterian Church. It is situated in a tree planter which is bordered by Oleander shrubs and Algerian Ivy on the west side. Ivy climbs the west side of the tree's trunk. The majority of the tree's growing area is covered with asphalt parking area. No irrigation was observed in the planter near the tree. The lower trunk area is intact. No mushrooms, cavities or decay was observed. There is minor Western Sycamore Borer insect damage on the tree's bark tissue along the lower trunk. It is a single-trunk tree which forms 2 co-dominant stems at a point 5.5 feet above the ground. There is included bark tissue at the union of these stems creating weak structure. Four cables were observed in the crown supporting the structure of the Oak. Utility wires run through the tree's crown. The tree's crown is balanced with minor asymmetry. The

west side of the tree's crown growing into the La Cañada Presbyterian Church property does not appear to have been pruned recently. The tree's crown has been pruned and raised. The foliage size and color appear normal. The crown density is fair. Small clumps of brown dead foliage in the crown appear to be the result of Oak Twig Girdler insect damage. New growth is visible on the branch terminals. The tree is in above average health and condition. Rating: B-

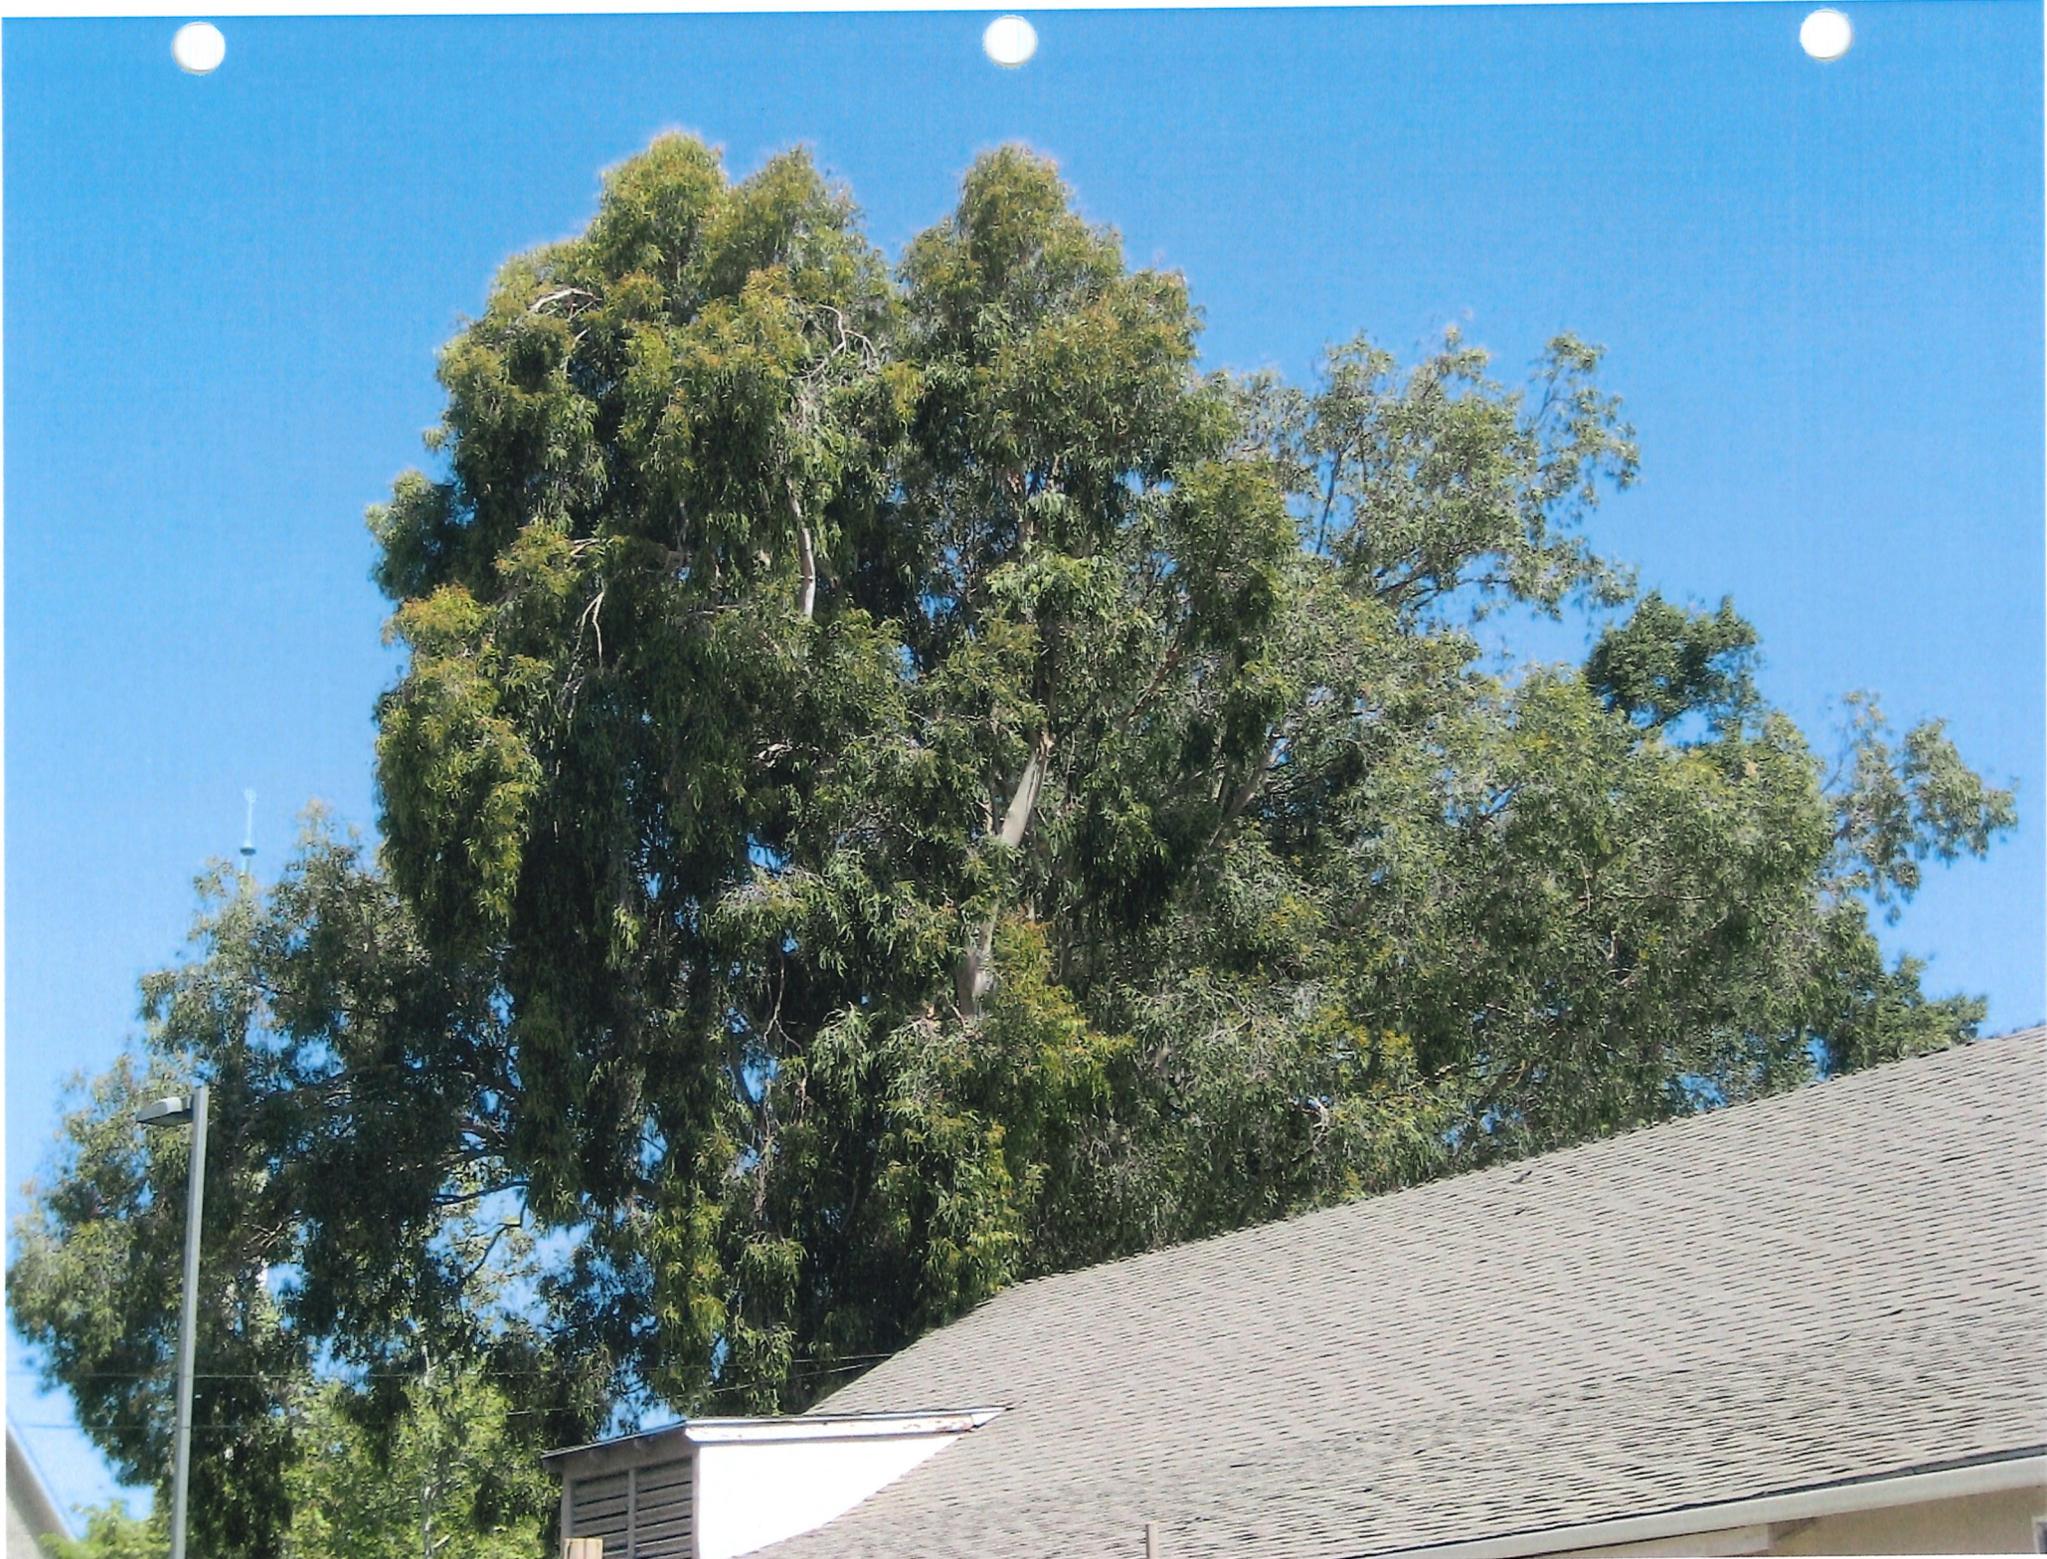
TREE #2

Tree #2 is a Eucalyptus citriodora or Lemon Scented Gum. The tree measures 26 inches in diameter at D.B.H. The tree has a drip line, which measures roughly 29 feet from the tree's trunk. The spread of the tree is approximately 30 feet. The height of the tree is estimated to be roughly 65 feet tall. The tree is located north of Tree #1 near the western boundary of the subject property. It is situated in an irrigated shrub planter bed. Algerian Ivy and Oleander shrubs grow nearby. The trunk bows and leans south away from a second Eucalyptus tree. It leans 30 degrees south. The lower trunk area is intact. No mushrooms, cavities or decay was observed. The tree's crown has been pruned and raised. It is unbalanced and asymmetrical. Crossing, rubbing limbs were observed in the tree's crown. The foliage size and color appear normal. The crown density is fair. The tree is in slightly below average health and condition. Rating: C-

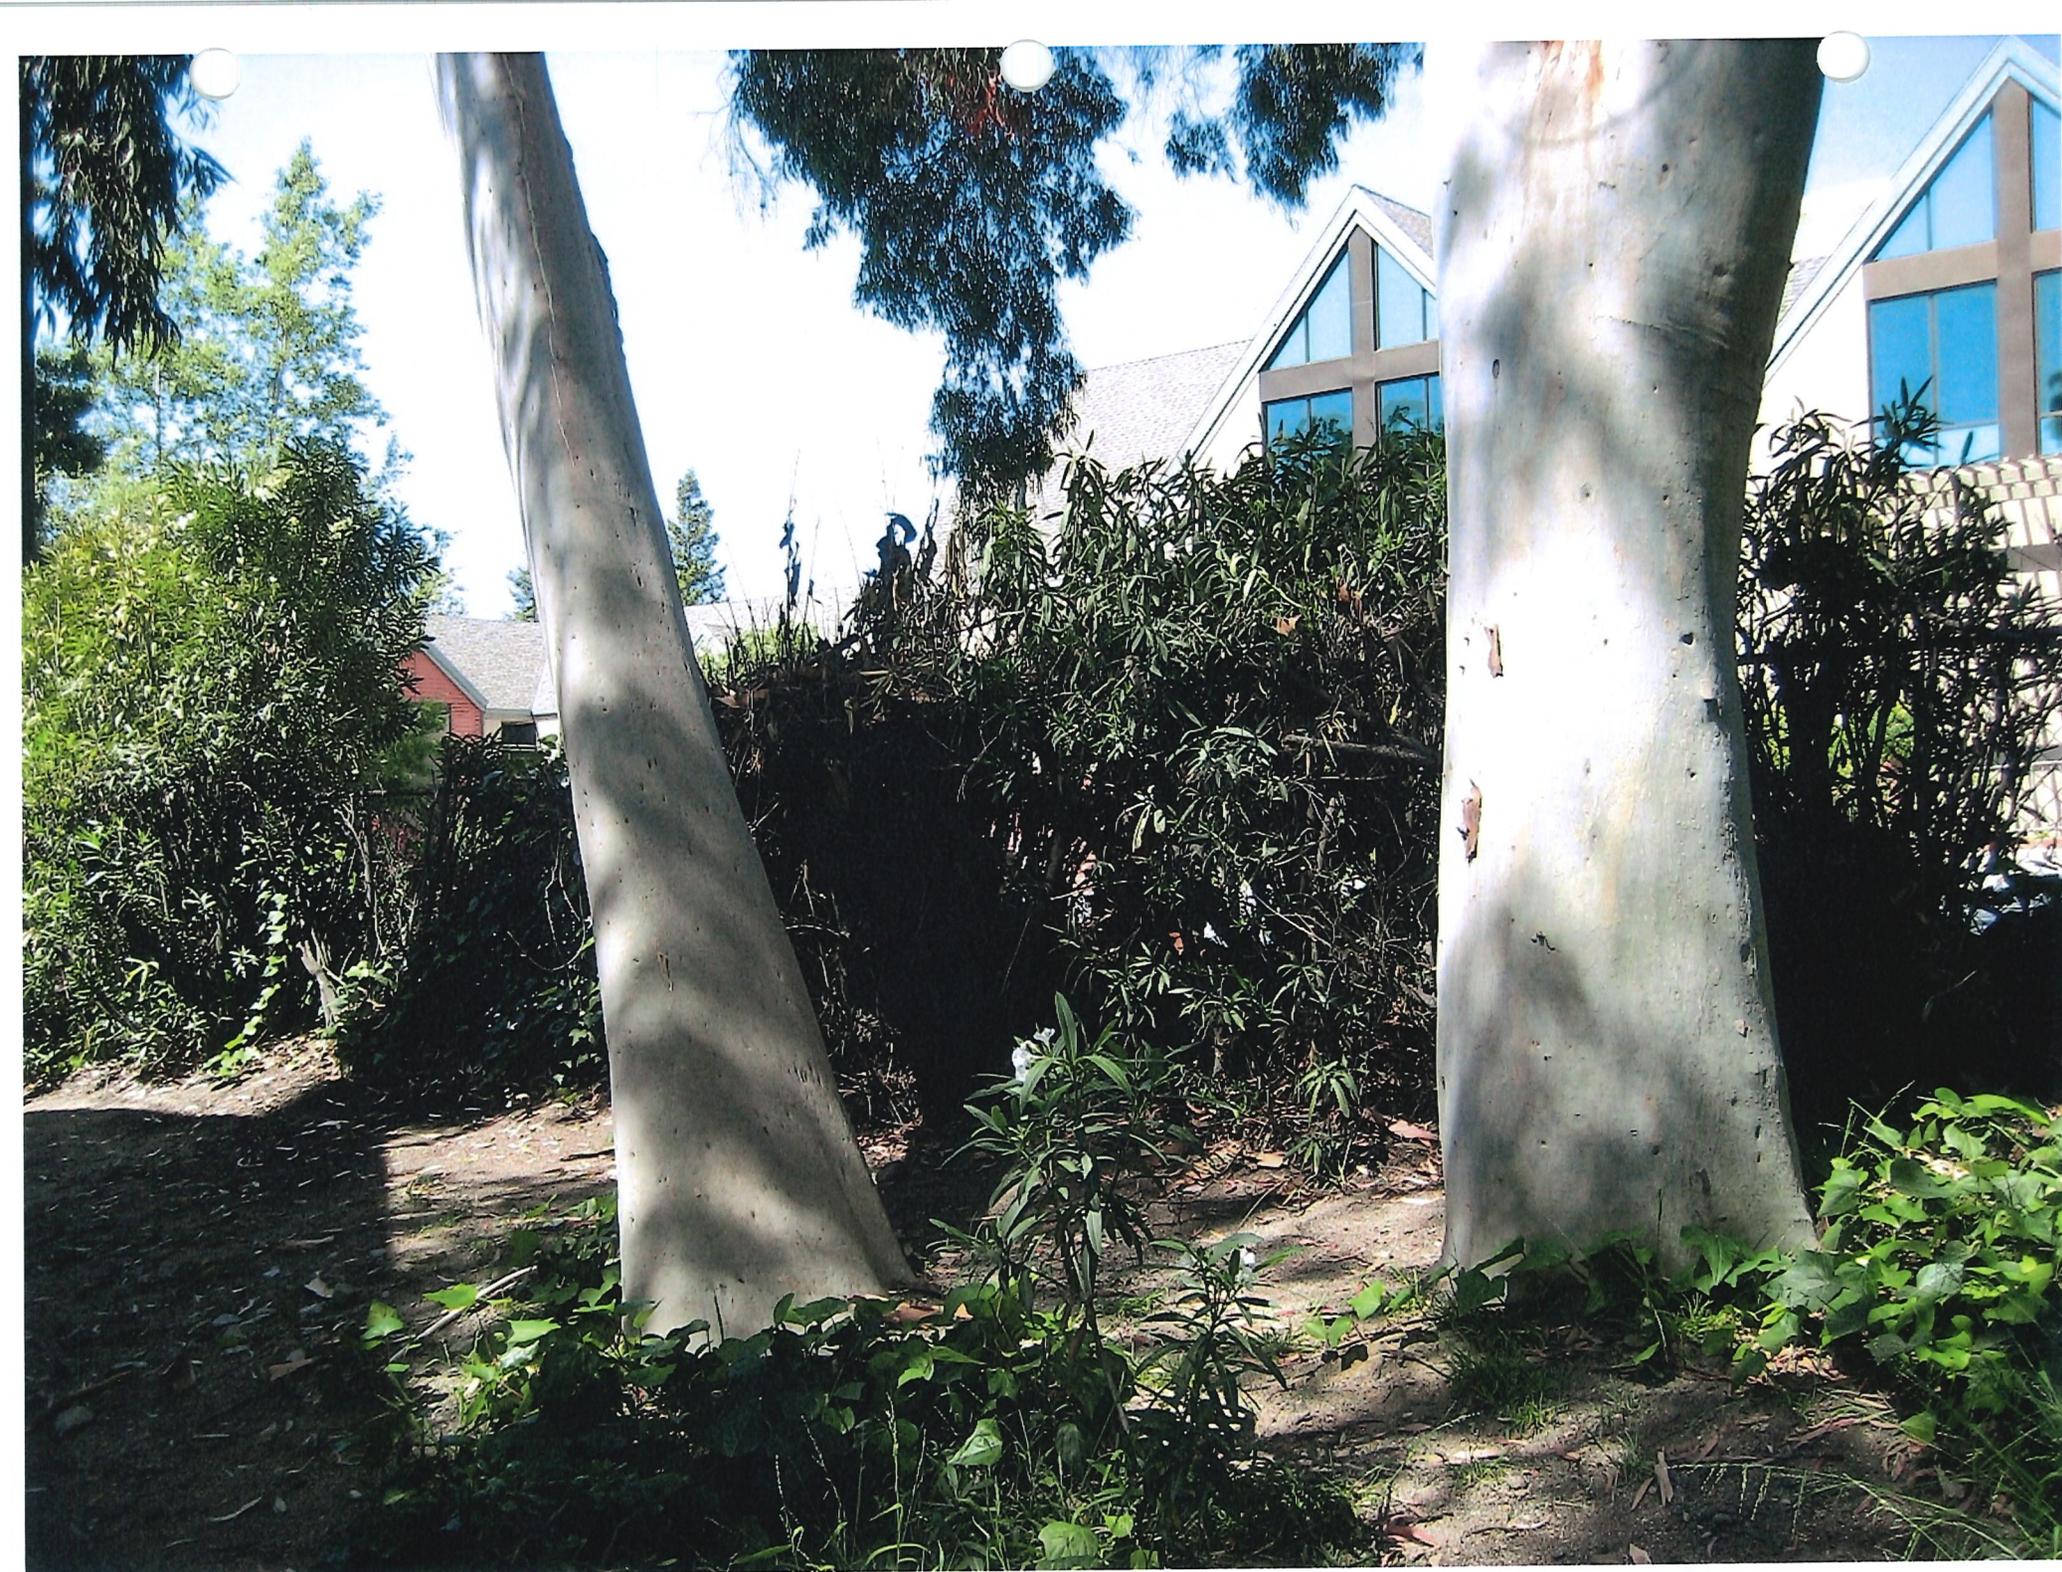
TREE #3

Tree #3 is a Eucalyptus citriodora or Lemon Scented Gum. The tree measures 28 inches in diameter at D.B.H. The tree has a drip line, which measures roughly 34 feet from the tree's trunk. The spread of the tree is approximately 68 feet. The height of the tree is estimated to be roughly 65 feet tall. The tree is located north of Tree #2 near the western boundary of the subject property. It is situated in an irrigated shrub planter bed. Algerian Ivy and Oleander shrubs grow nearby. The lower trunk area is intact. No mushrooms, cavities or decay was observed. The tree's crown has been pruned and raised. It is balanced with minor asymmetry. This single-trunk tree forms two co-dominant stems at a point 10 feet above the ground. There is included bark at the union. There is a crossing stem which has fused with the other stem. The foliage size and color appear normal. The crown density is fair. The tree is in average health and condition. Rating: C

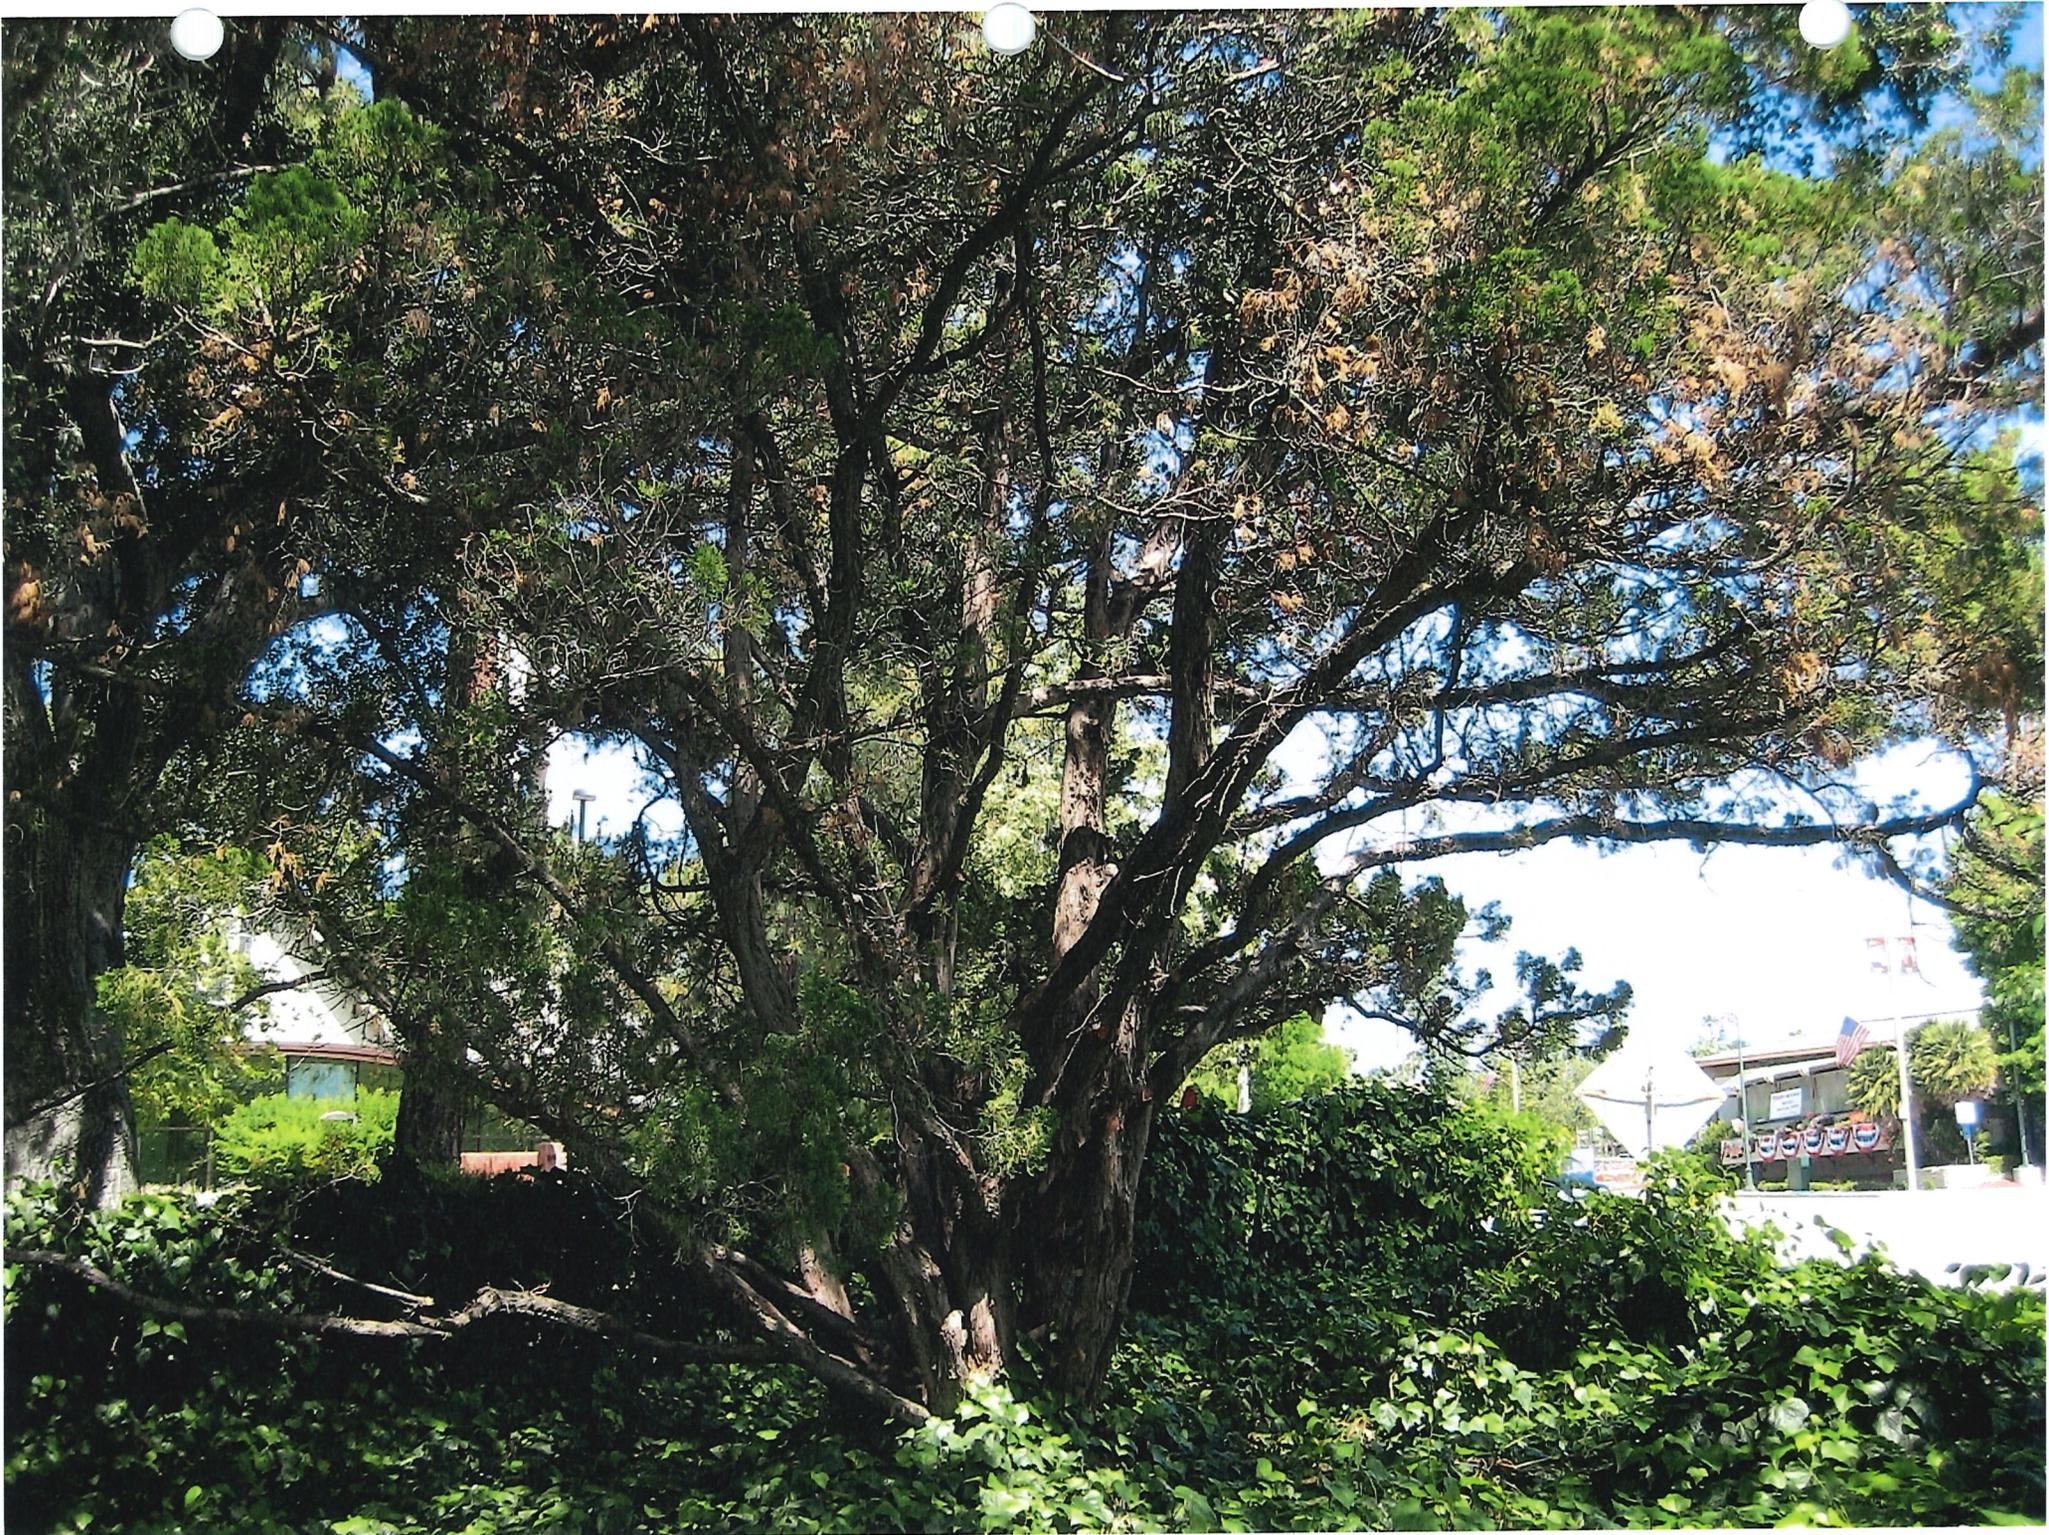
TREE #4

Tree #4 is a Juniperus occidentalis or Western Juniper. The tree measures 3, 3, 3, 3, 3, 5, 5, 8, 8, 9 and 12 inches in diameter at D.B.H. The tree has a drip line, which measures roughly 20 feet from the tree's trunk. The spread of the tree is approximately 40 feet. The height of the tree is estimated to be roughly 45 feet tall. The tree is located north of Tree #3. It is situated in a shrub planter bed surrounded by Algerian Ivy. Ivy covers the root crown or base of the tree. It has a low-growing crown. The lower trunk area is intact. No mushrooms, cavities or decay was observed. It is a multi-trunk tree. It has narrow crotches and weak structure. The tree's crown is crowded, suppressed and shaded by other nearby trees. It is balanced with minor asymmetry. The foliage size and color appear normal. The crown density is sparse. I would estimate that 30% of the tree's crown is composed of dead wood. The tree is in below average condition. Rating: D+

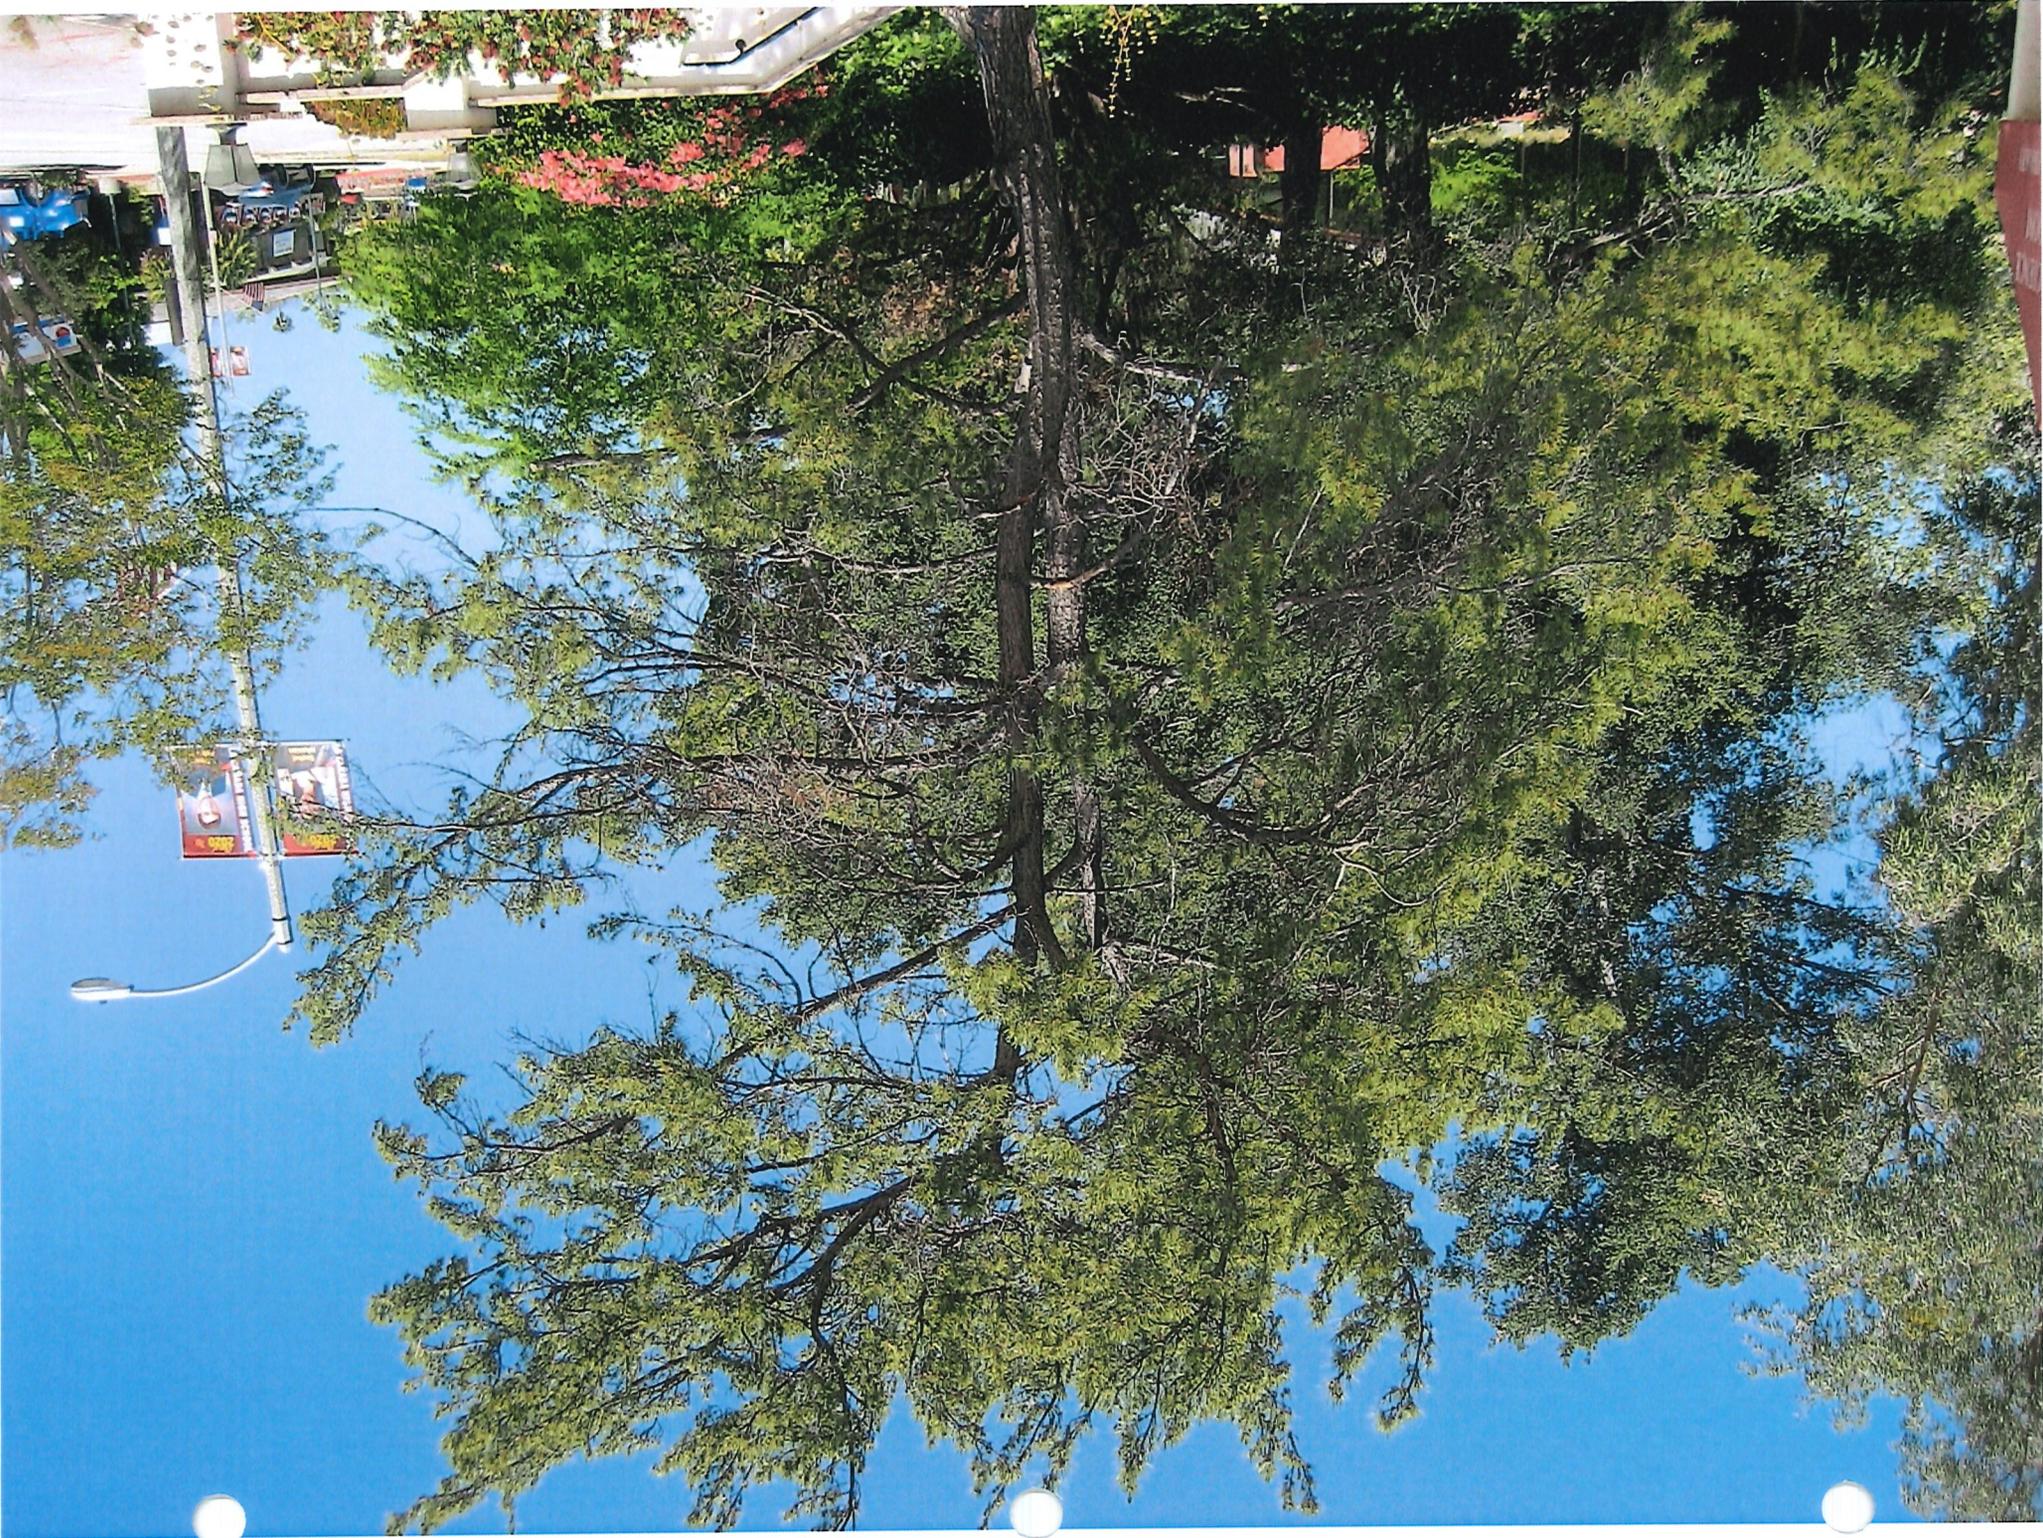
TREE #5

Tree #5 is a Pinus radiata or Monterey Pine. The tree measures 14 and 17 inches in diameter at D.B.H. The tree has a drip line, which measures roughly 28 feet from the tree's trunk. The spread of the tree is approximately 52 feet. The height of the tree is estimated to be roughly 48 feet tall. The tree is located east of Tree #4. It is situated in an irrigated front lawn area. The lower trunk area is intact. No mushrooms, cavities or decay was observed. It is a multi-trunk tree with two co-dominant stems which form a union at a point two feet above the ground. There is included bark at the union creating weak structure. The tree is balanced with minor asymmetry. Surface roots are visible in the lawn. The tree's crown has been pruned and raised. The foliage size is normal however the foliage color is yellow or chlorotic. I would estimate that approximately 30% of the tree's crown is composed of dead wood. The crown density is sparse. The tree is in poor health and condition. Rating: D

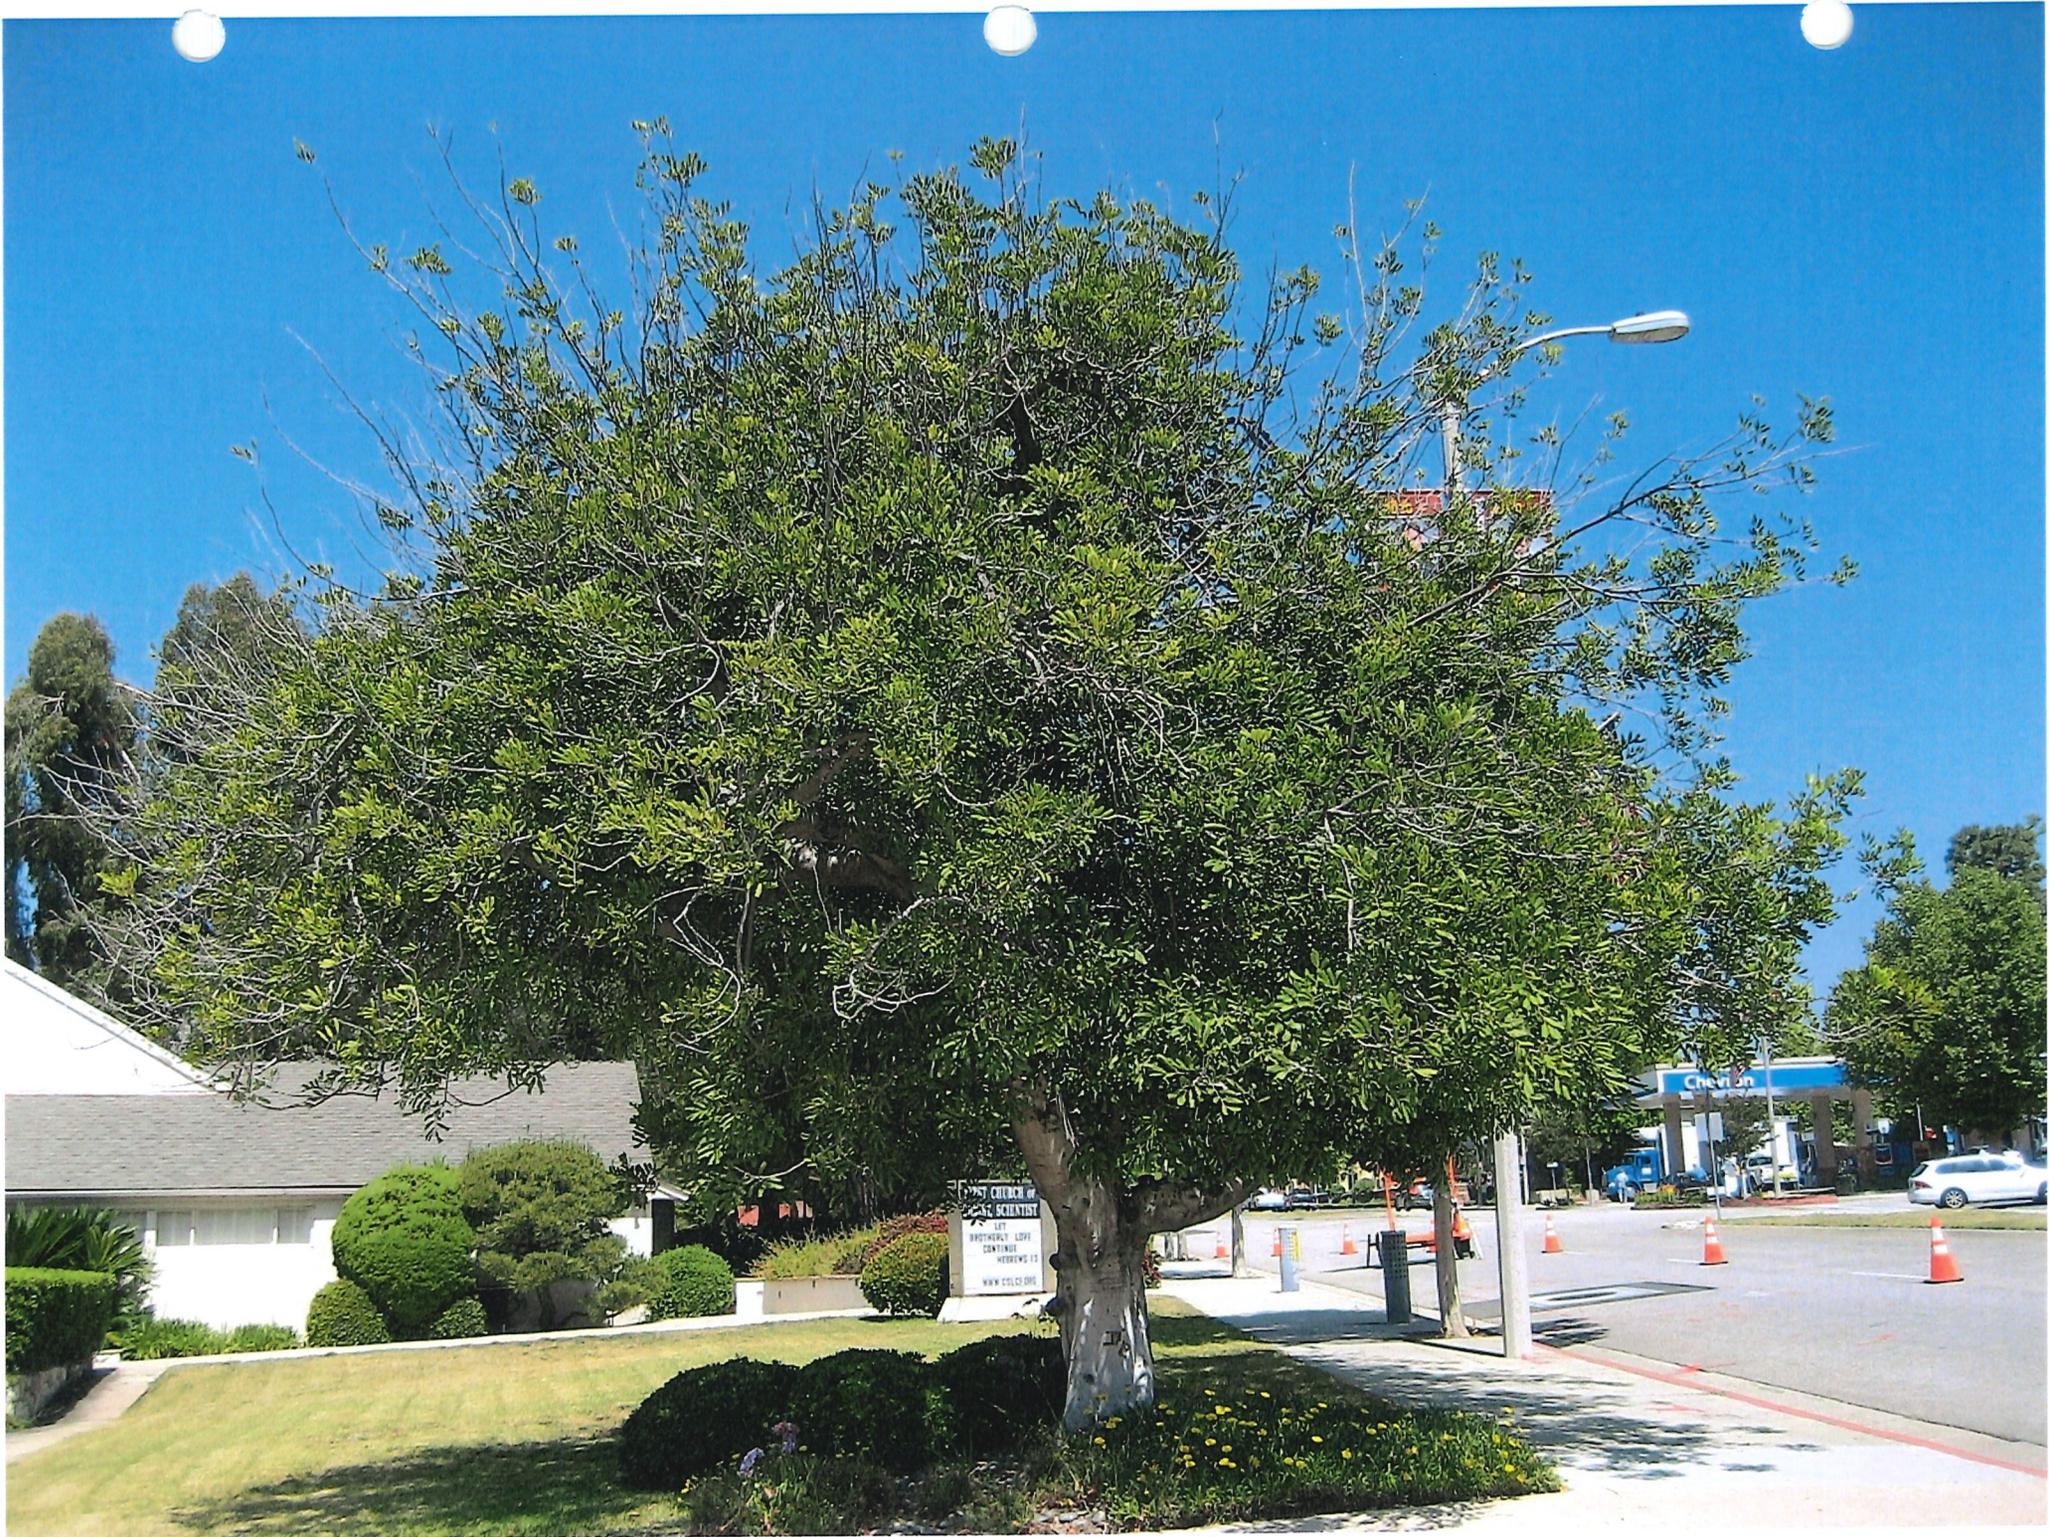
TREE #6

Tree #6 is a Cupaniopsis anacardioides or Carrotwood. The tree measures 10 and 17 inches in diameter at D.B.H. The tree has a drip line, which measures roughly 20 feet from the tree's trunk. The spread of the tree is approximately 33 feet. The height of the tree is estimated to be roughly 25 feet tall. The tree is located near the northeast corner of the subject property. It is situated in a shrub planter bed. Gazania and Pittosporum shrubs grow nearby. The lower trunk area is intact. No mushrooms, cavities or decay was observed. It is a multi-trunk tree whose stems form a union at a point 4 feet above the ground. The tree is unbalanced with the majority of the crown on the west side. The tree's crown has been pruned and raised. The foliage size is and color appear normal. There is crown die-back at the top. The crown density is fair. The tree is in slightly below average health and condition. Rating: C-
