Arborist Report

600 Foothill Blvd.
La Cañada Flintridge, California

June 22, 2020

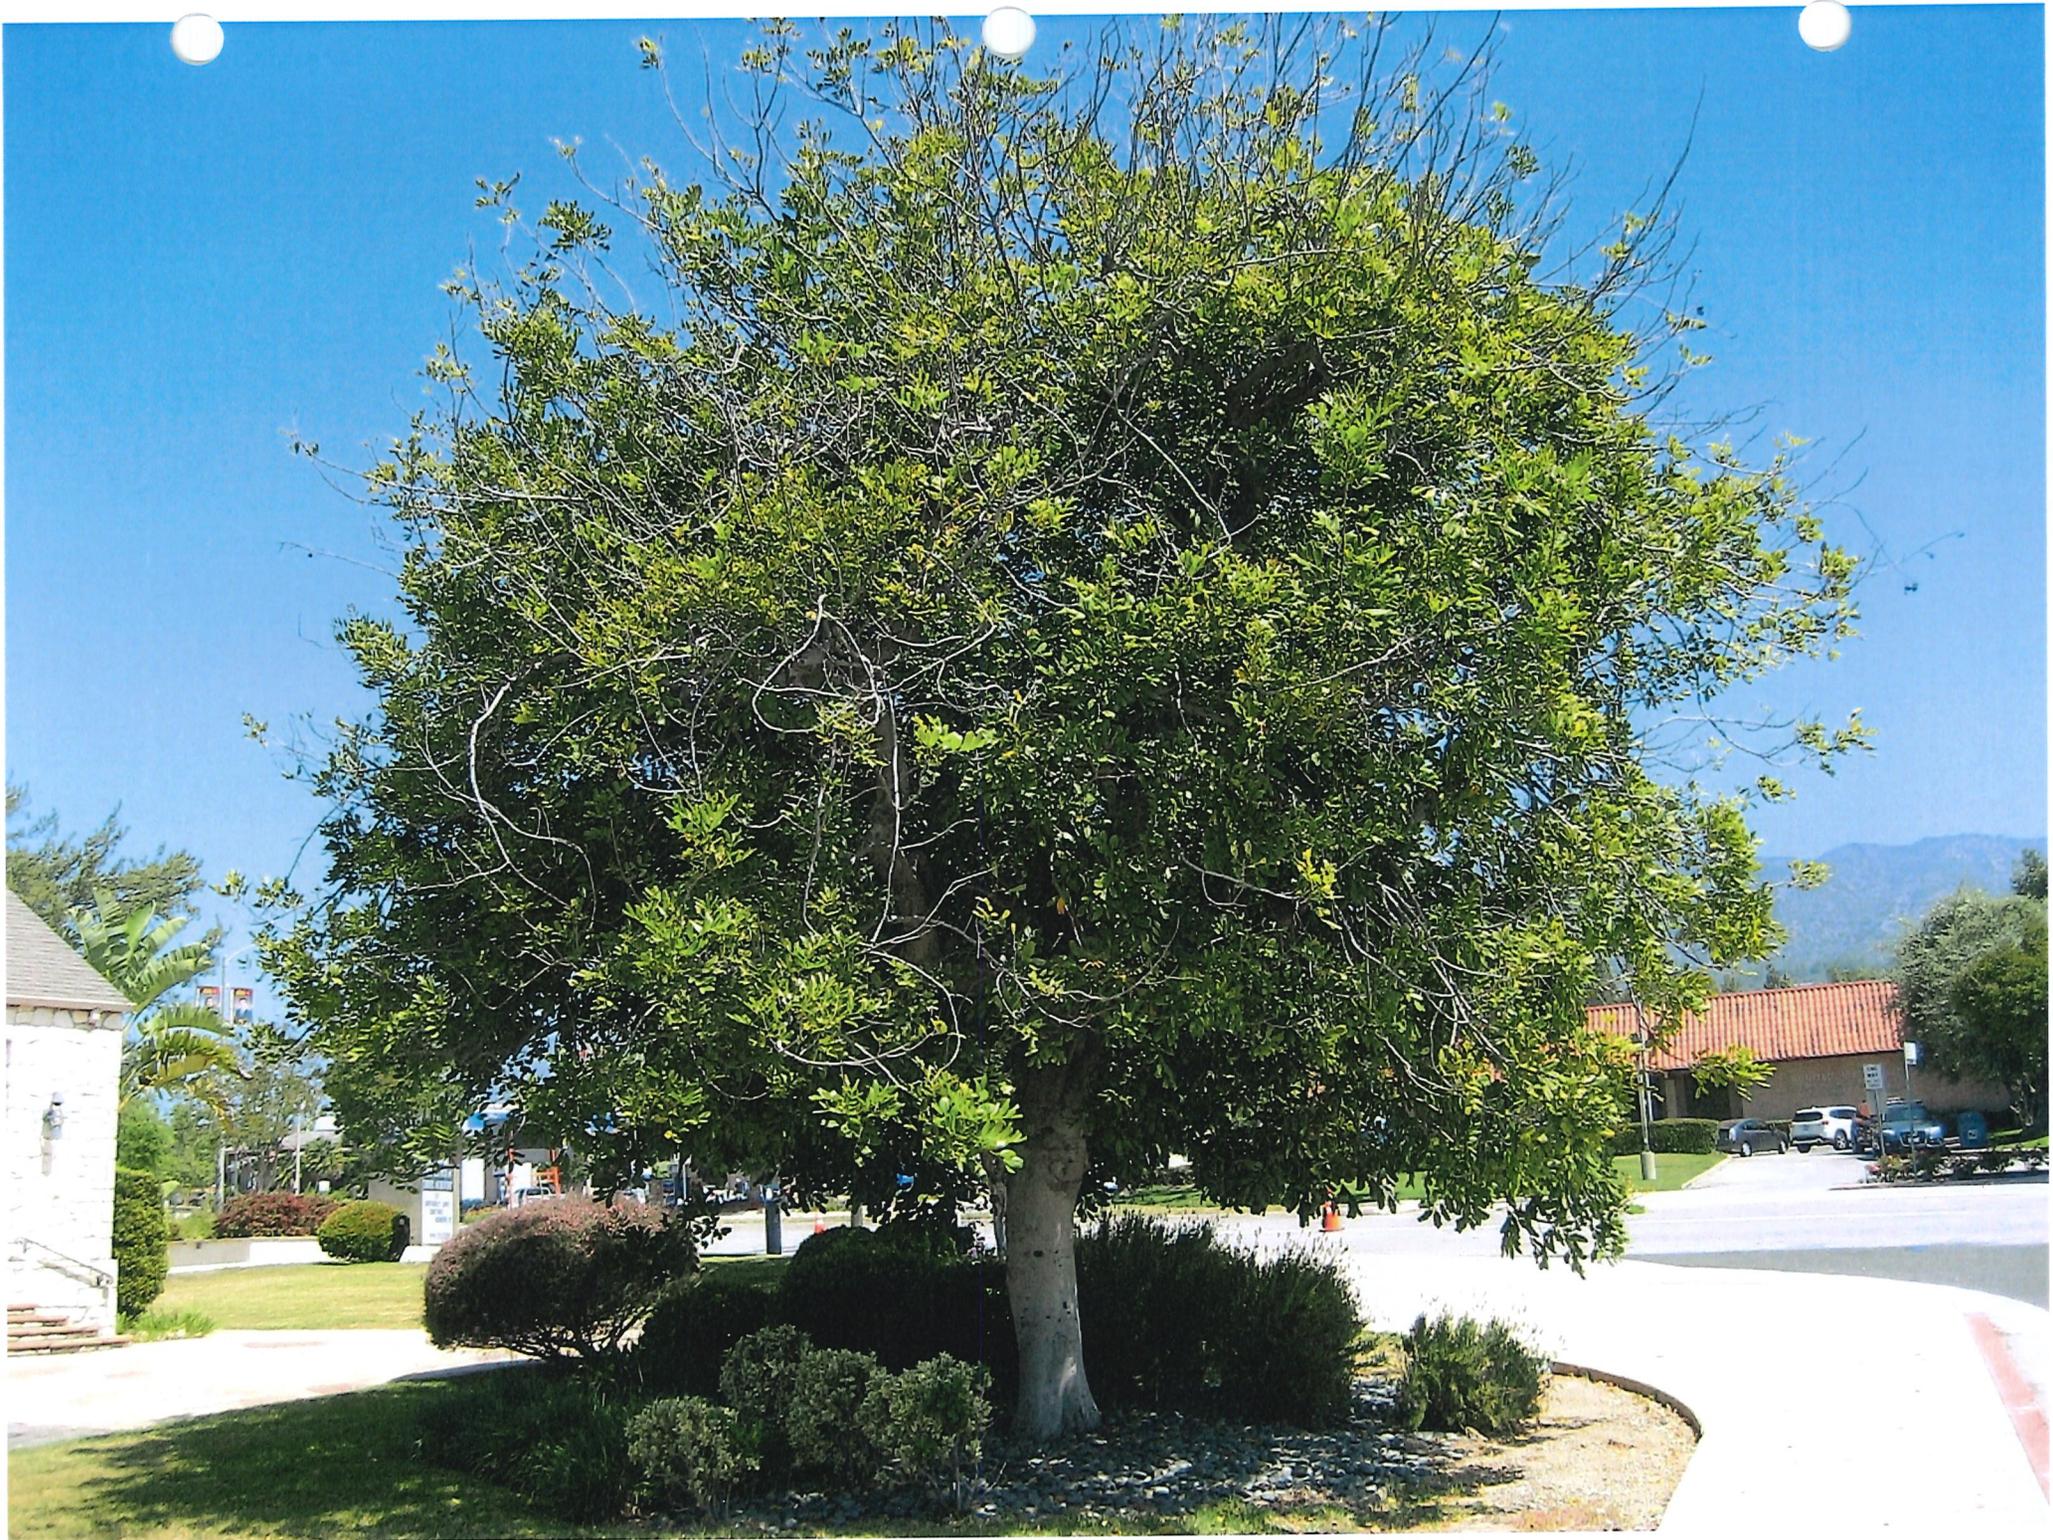
TREE #7

Tree #7 is a Cupaniopsis anacardioides or Carrotwood. The tree measures 12 inches in diameter at D.B.H. The tree has a drip line, which measures roughly 16 feet from the tree's trunk. The spread of the tree is approximately 30 feet. The height of the tree is estimated to be roughly 25 feet tall. The tree is located southeast of Tree #6 near the intersection of Woodleigh Lane and Foothill Blvd. It is situated in a shrub planter bed. Lavender, Society Garlic and other shrubs grow nearby. The lower trunk area is intact. No mushrooms, cavities or decay was observed. The tree is balanced with the minor asymmetry. The tree's crown has been pruned and raised. The foliage size is and color appear normal. Crown die-back was observed. The crown density is fair. The tree is in slightly below average health and condition. Rating: C-

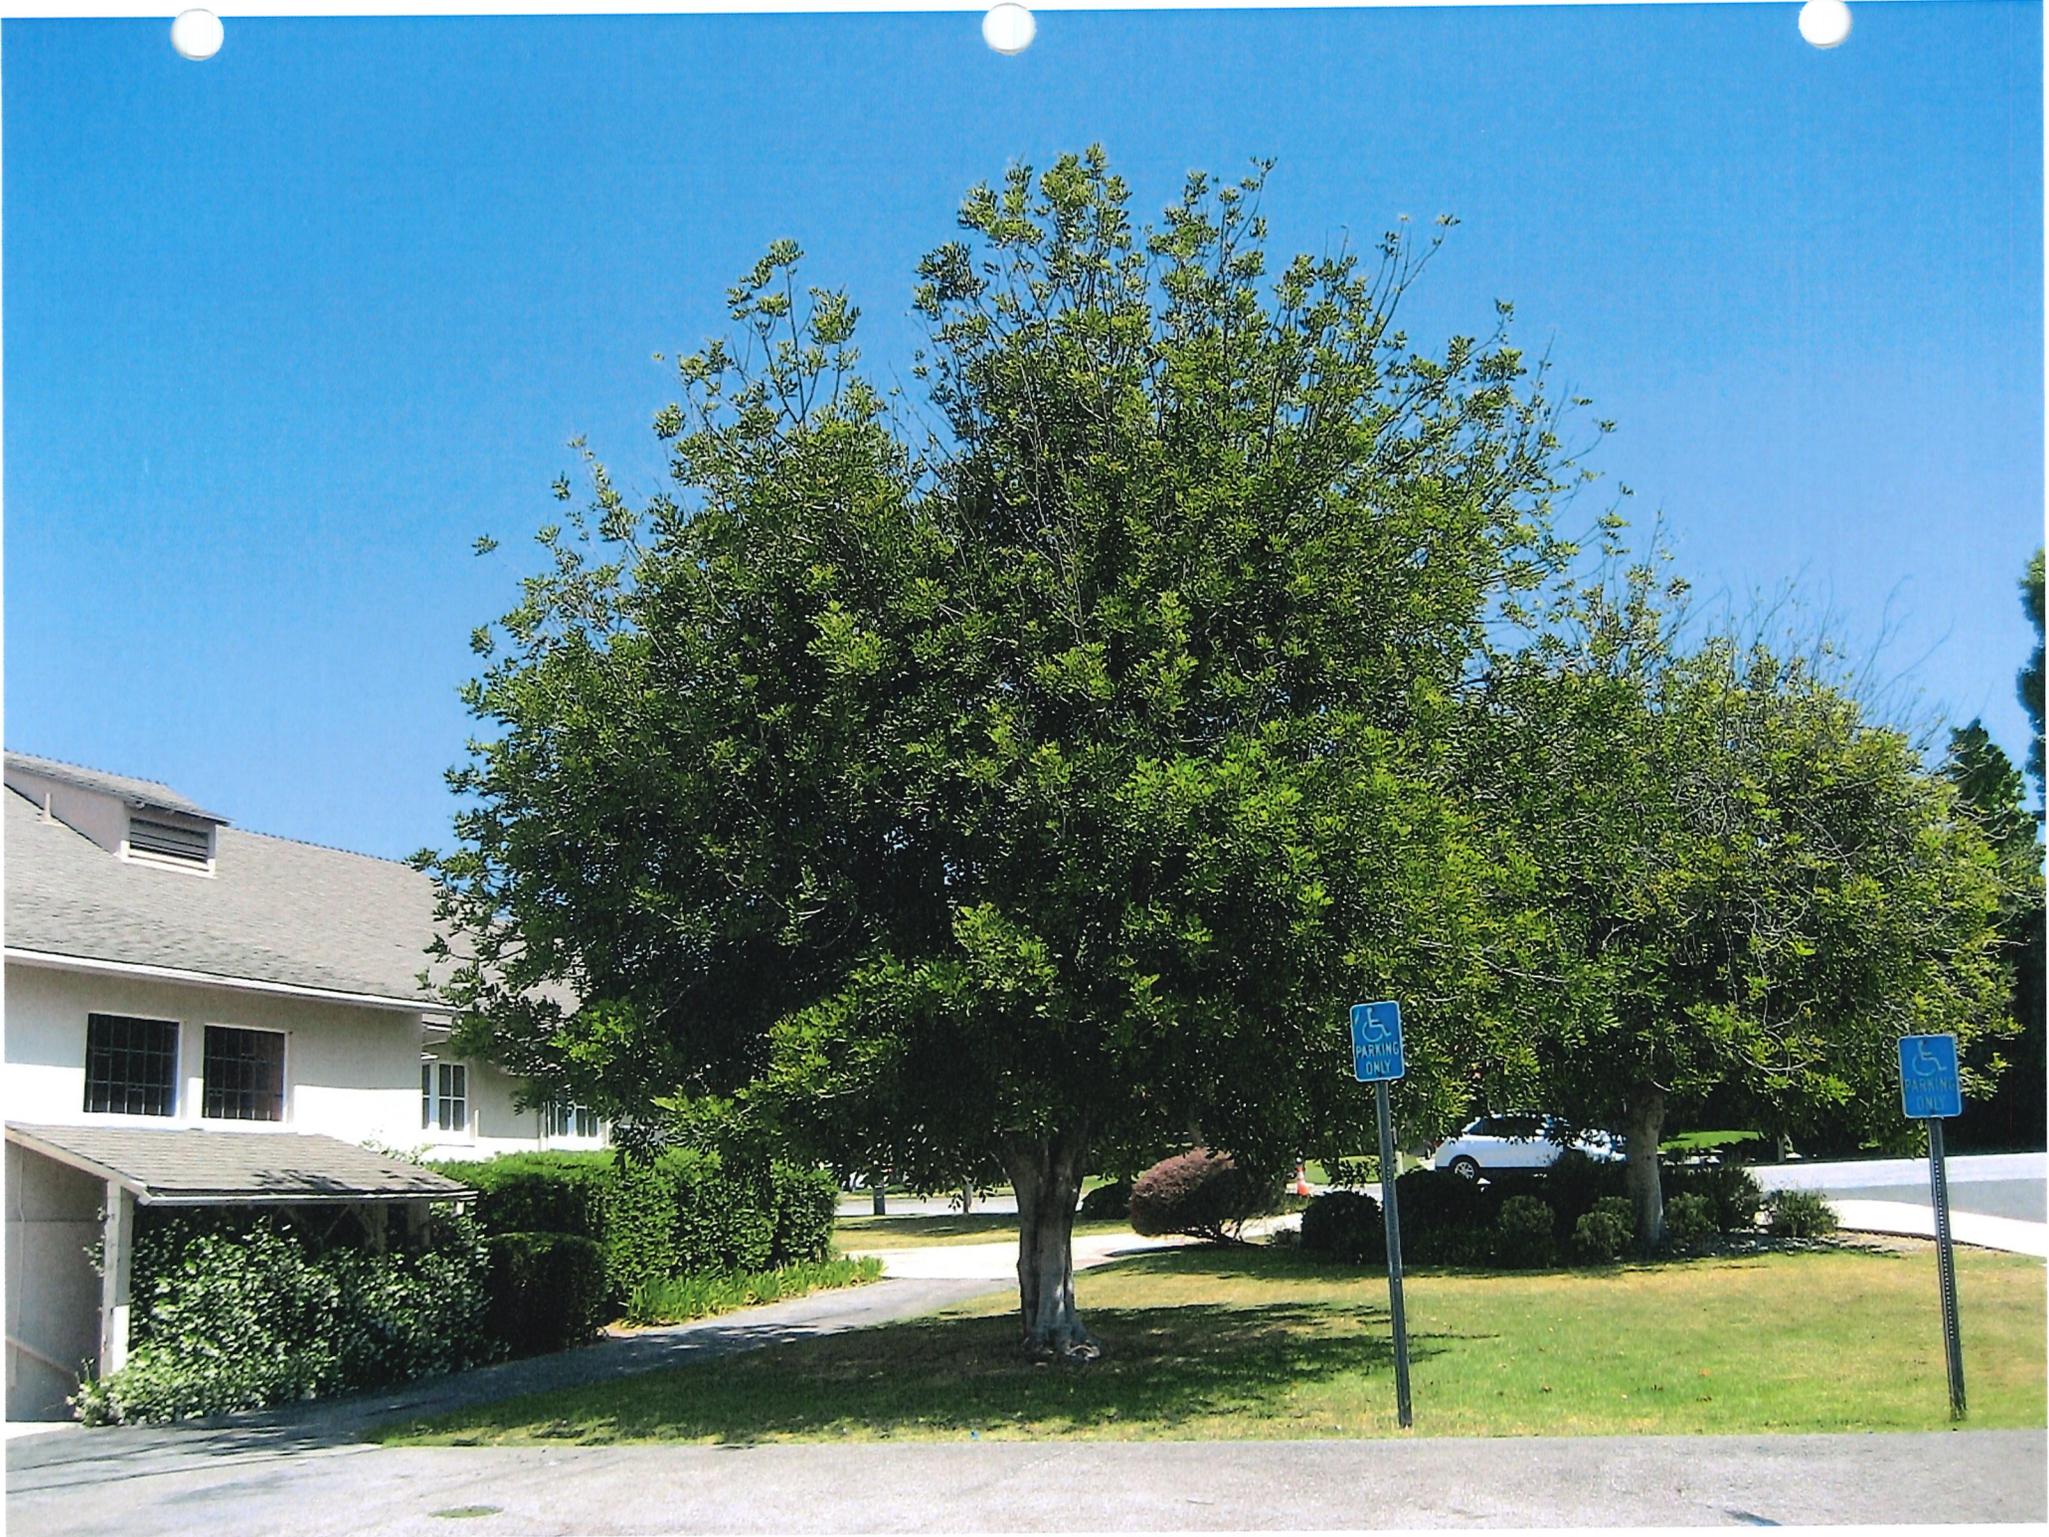
TRISE #8

Tree #8 is a Cupaniopsis anacardioides or Carrotwood. The tree measures 21 inches in diameter at D.B.H. The tree has a drip line, which measures roughly 16 feet from the tree's trunk. The spread of the tree is approximately 30 feet. The height of the tree is estimated to be roughly 28 feet tall. The tree is located east of the existing building and south of Tree #7. It is situated in an irrigated lawn area. The lower trunk area is intact. No mushrooms, cavities or decay was observed. This single-trunk tree forms co-dominant

stems at a point 5 feet above the ground. Included bark was observed at the union of these stems, creating weak structure. The tree is balanced with the minor asymmetry. The tree's crown has been pruned and raised. The foliage size is and color appear normal. There is minor dead wood in the tree's crown. The crown density is normal. The tree is in average health and condition. Rating: C

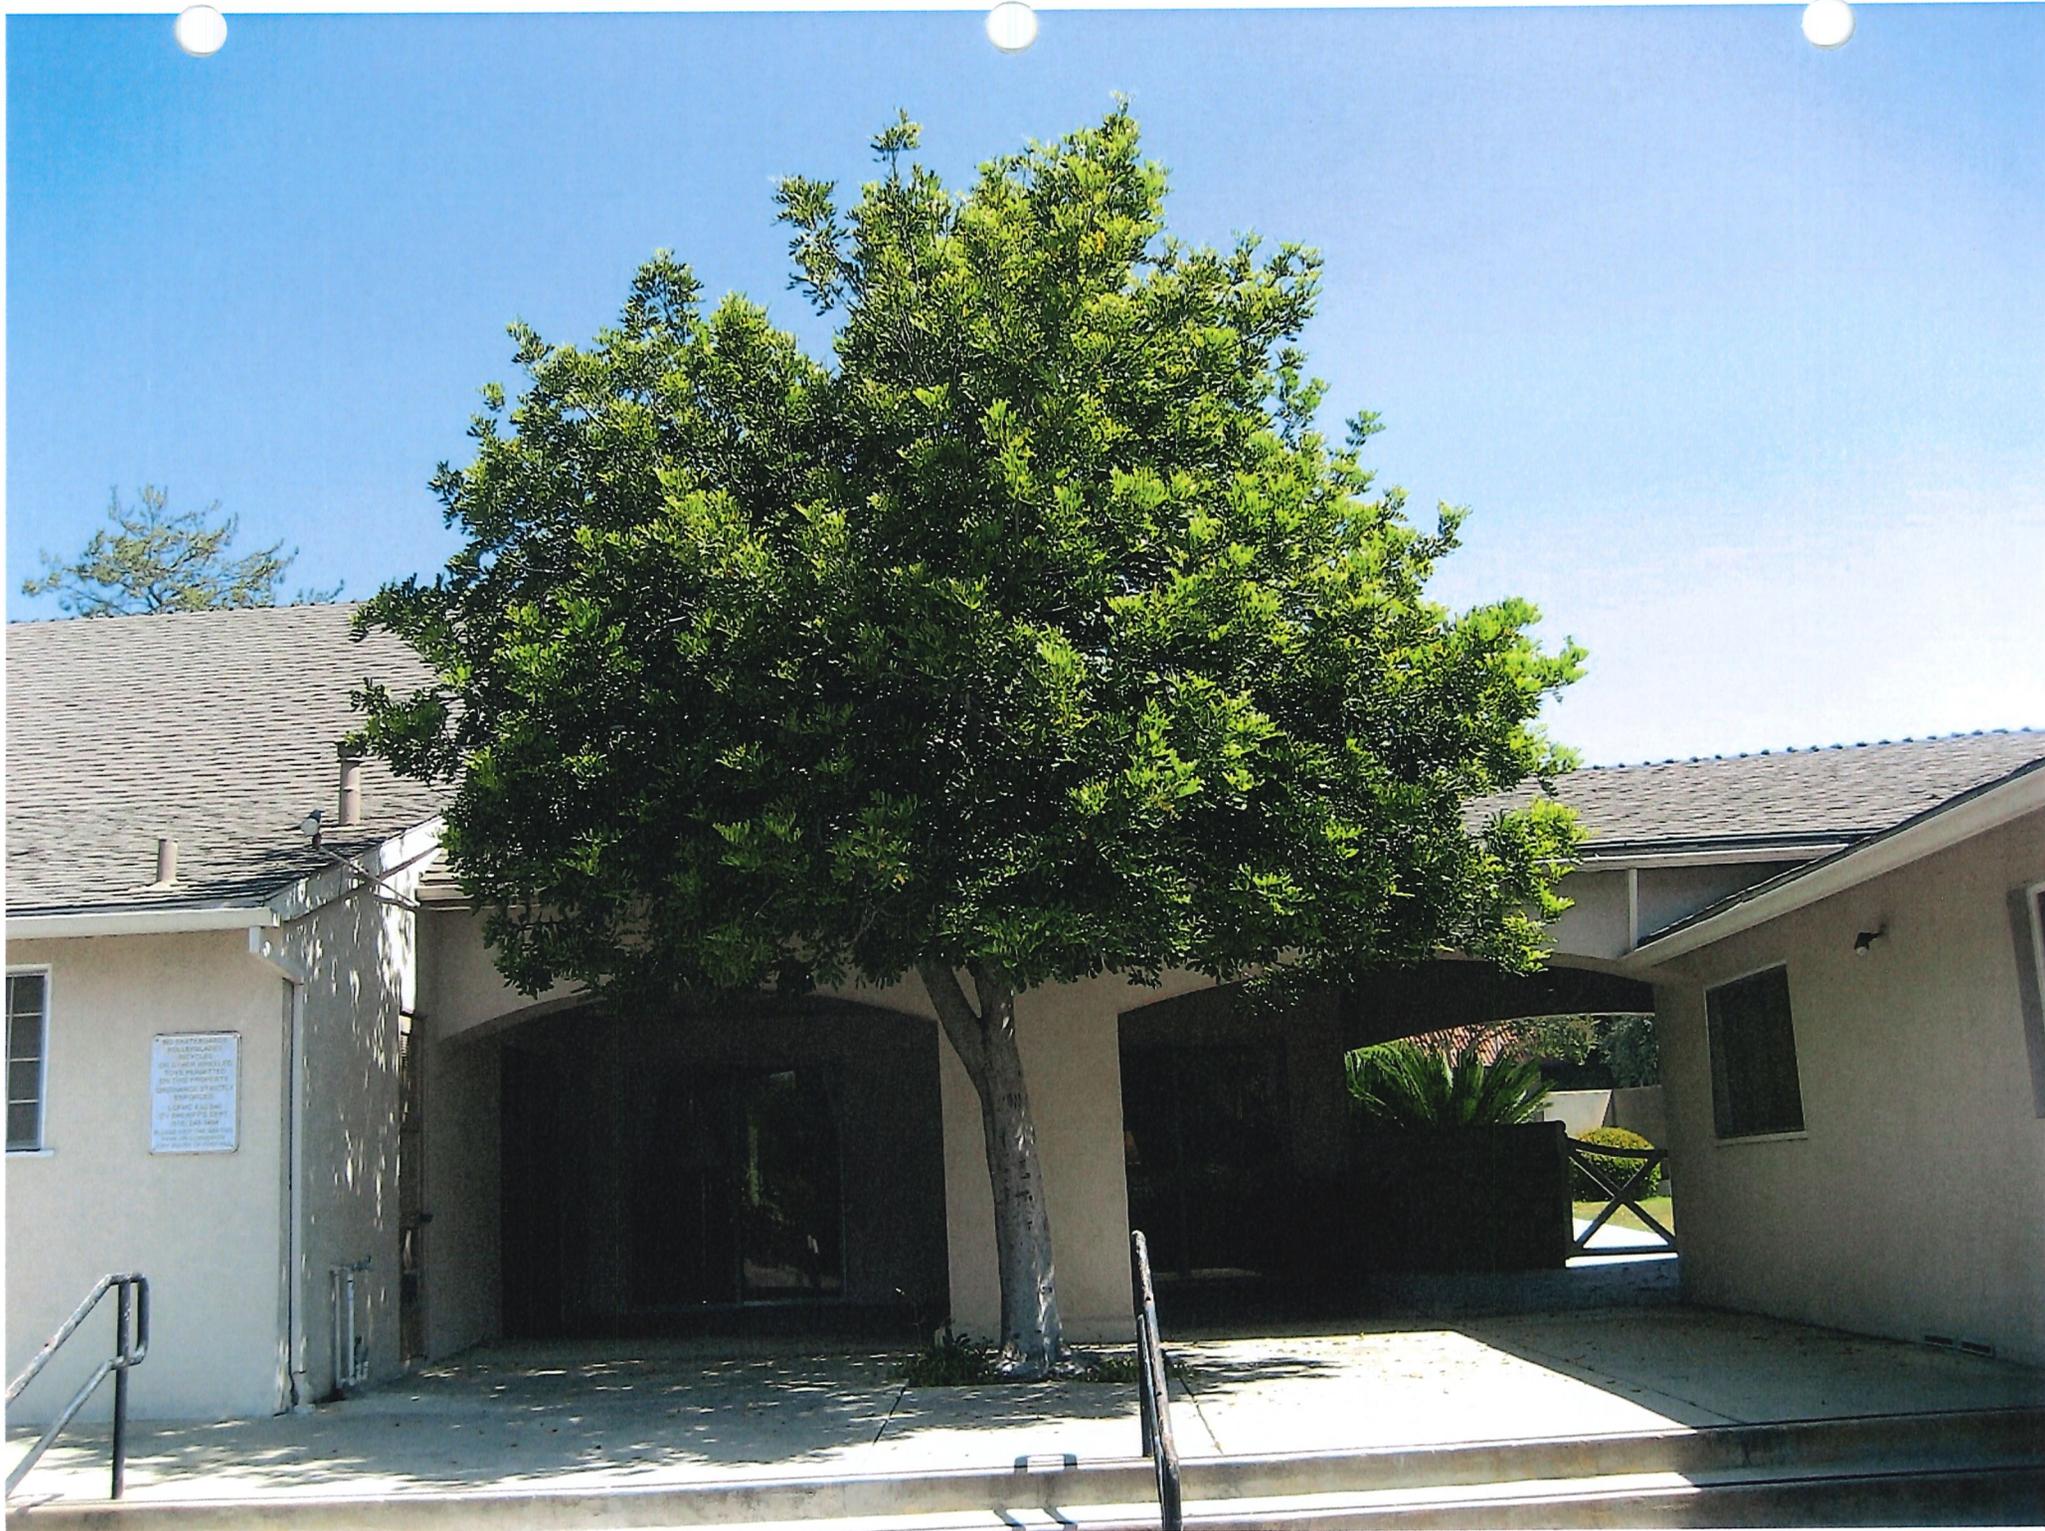
TREE #9

Tree #9 is a Cupaniopsis anacardioides or Carrotwood. The tree measures 9 inches in diameter at D.B.H. The tree has a drip line, which measures roughly 10 feet from the tree's trunk. The spread of the tree is approximately 20 feet. The height of the tree is estimated to be roughly 17 feet tall. The tree is located in the courtyard on the south side of the existing building. It is situated in an irrigated tree planter bed. Red Apple Ice Plant grows nearby. A concrete patio surrounds the tree planter. The lower trunk area is intact. No mushrooms, cavities or decay was observed. The tree is balanced with the minor asymmetry. The tree forms multiple stems at a point 8 feet above the ground. It has narrow crotches and weak structure. The tree's crown has been pruned and raised. The foliage size is and color appear normal. The crown density is normal. The tree is in good health and condition. Rating: B

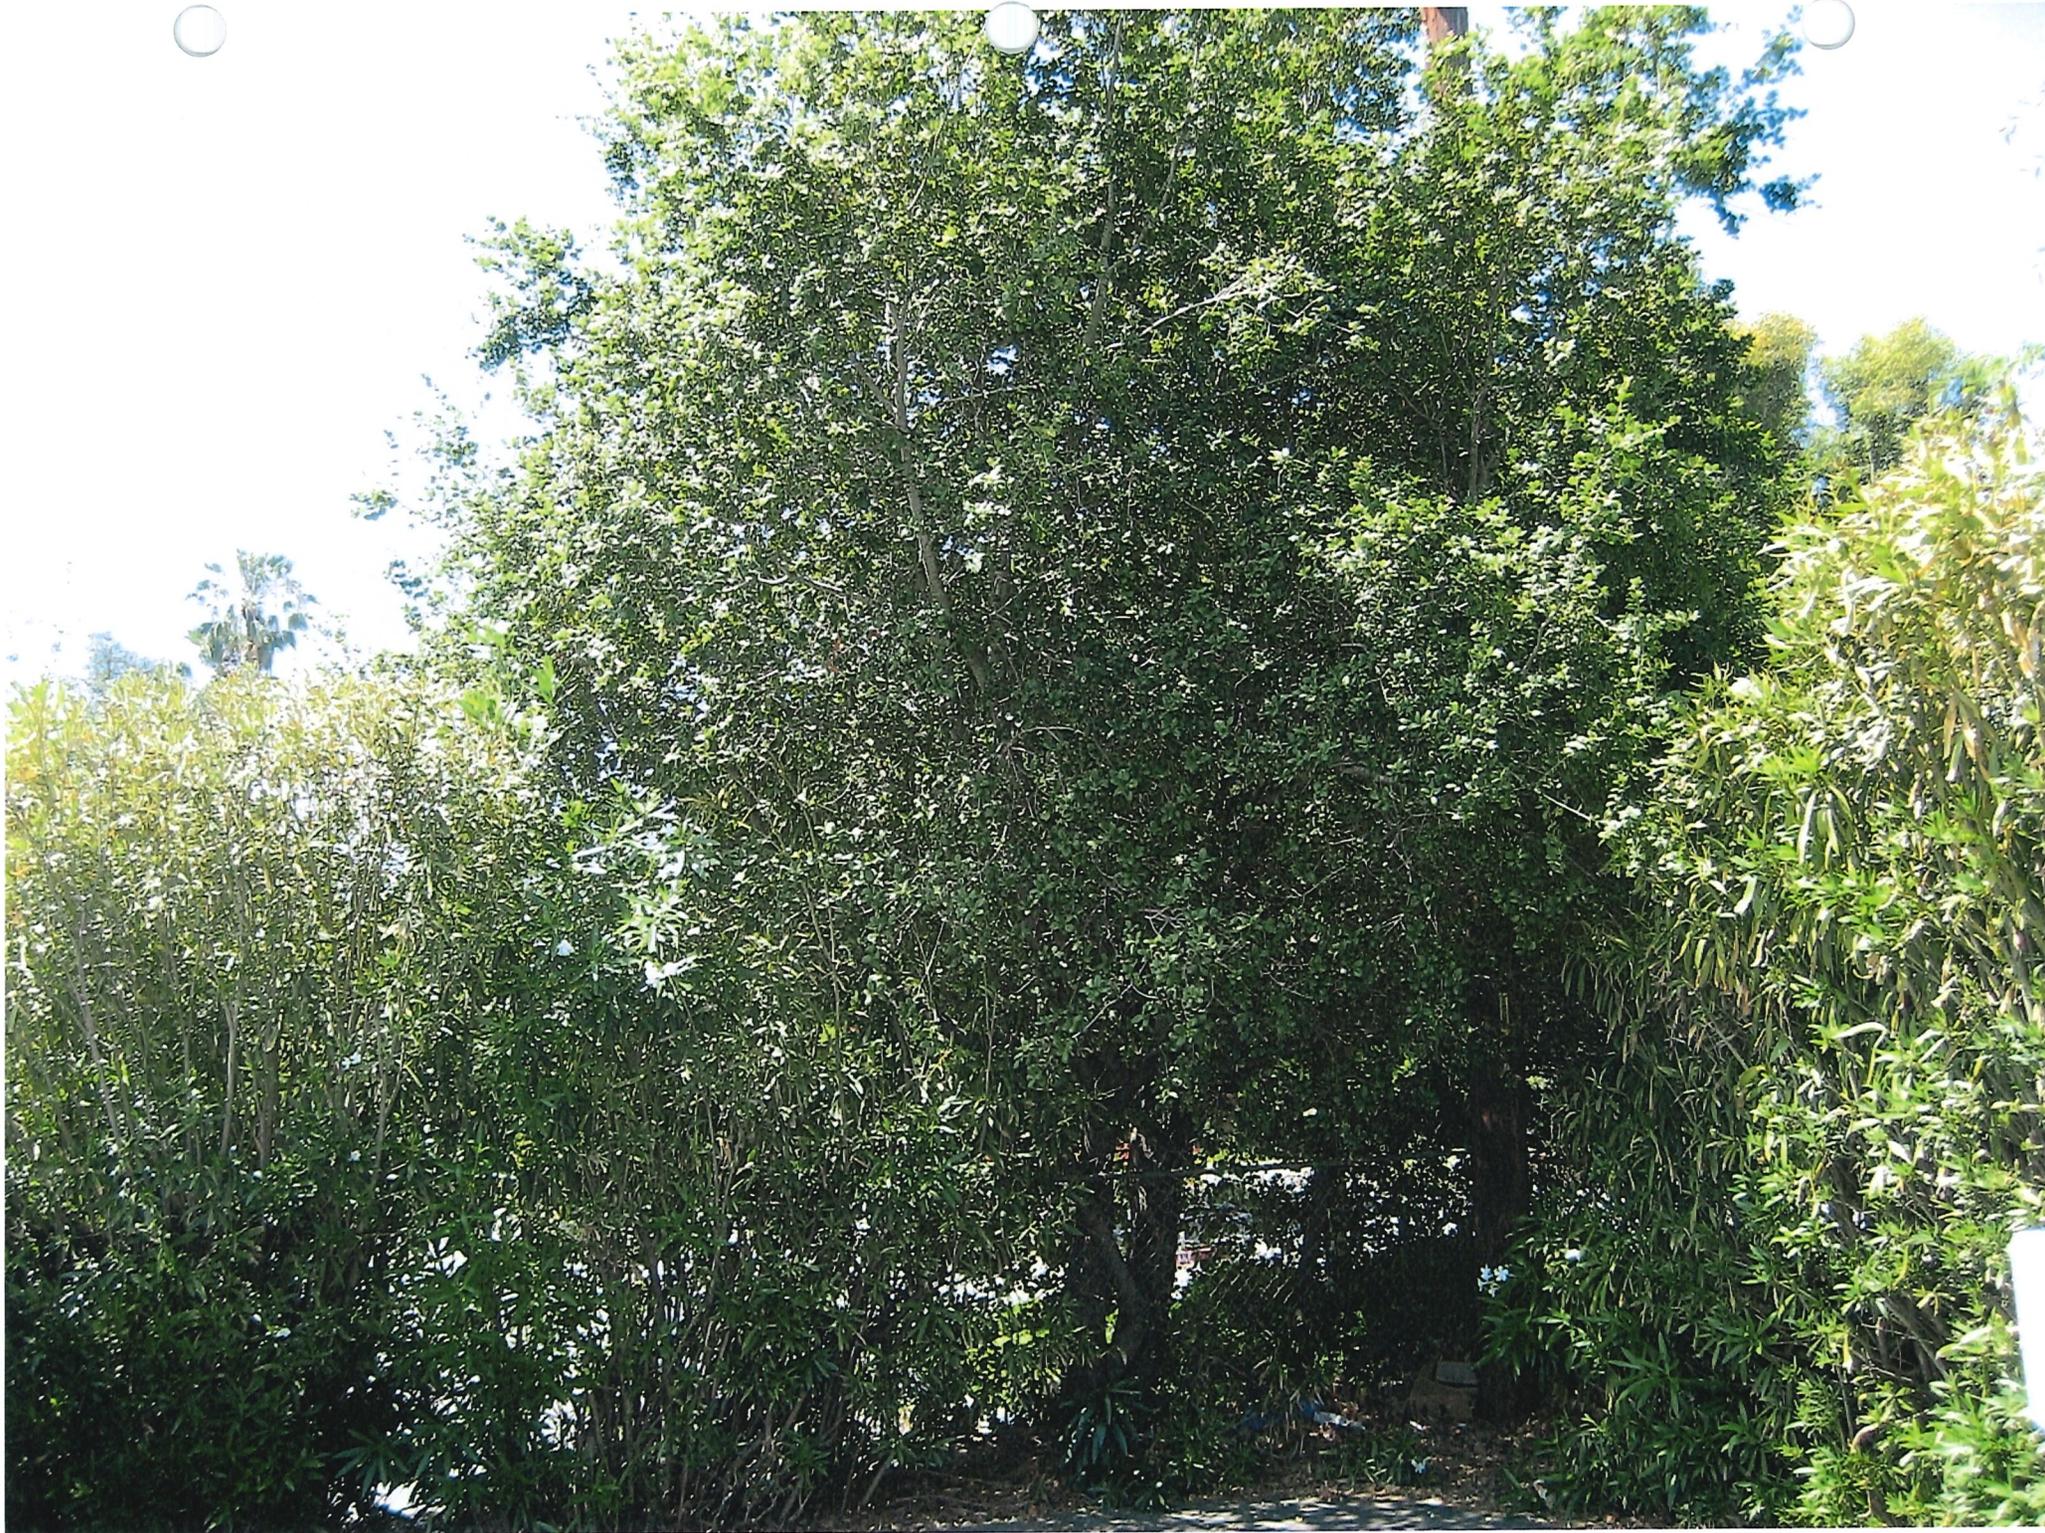
TREE #10

Tree #10 is a Quercus agrifolia or Coast Live Oak. The tree measures 3, 5 and 6 inches in diameter at D.B.H. The tree has a drip line, which measures roughly 10 feet from the tree's trunk. The spread of the tree is approximately 20 feet. The height of the tree is estimated to be roughly 25 feet tall. The tree is located near the southwest corner of the asphalt parking lot of the subject property. It is 5 feet east of Utility Pole #1197022E. Power lines run through the tree's crown. The tree is situated in a shrub planter bed surrounded by Oleander shrubs. The tree's trunk is embedded in the chain-link fence which runs along the southern boundary of the subject property. The tree's trunk straddles the south property line. The lower trunk area is intact. No mushrooms, cavities or decay was observed. It is a multi-trunk tree which has co-dominant stems and included bark creating weak structure. The crown is balanced with minor asymmetry. The tree has been pruned and raised. The foliage size and color appear normal. The crown density is normal. The tree is in slightly above average health and condition. Rating: C+

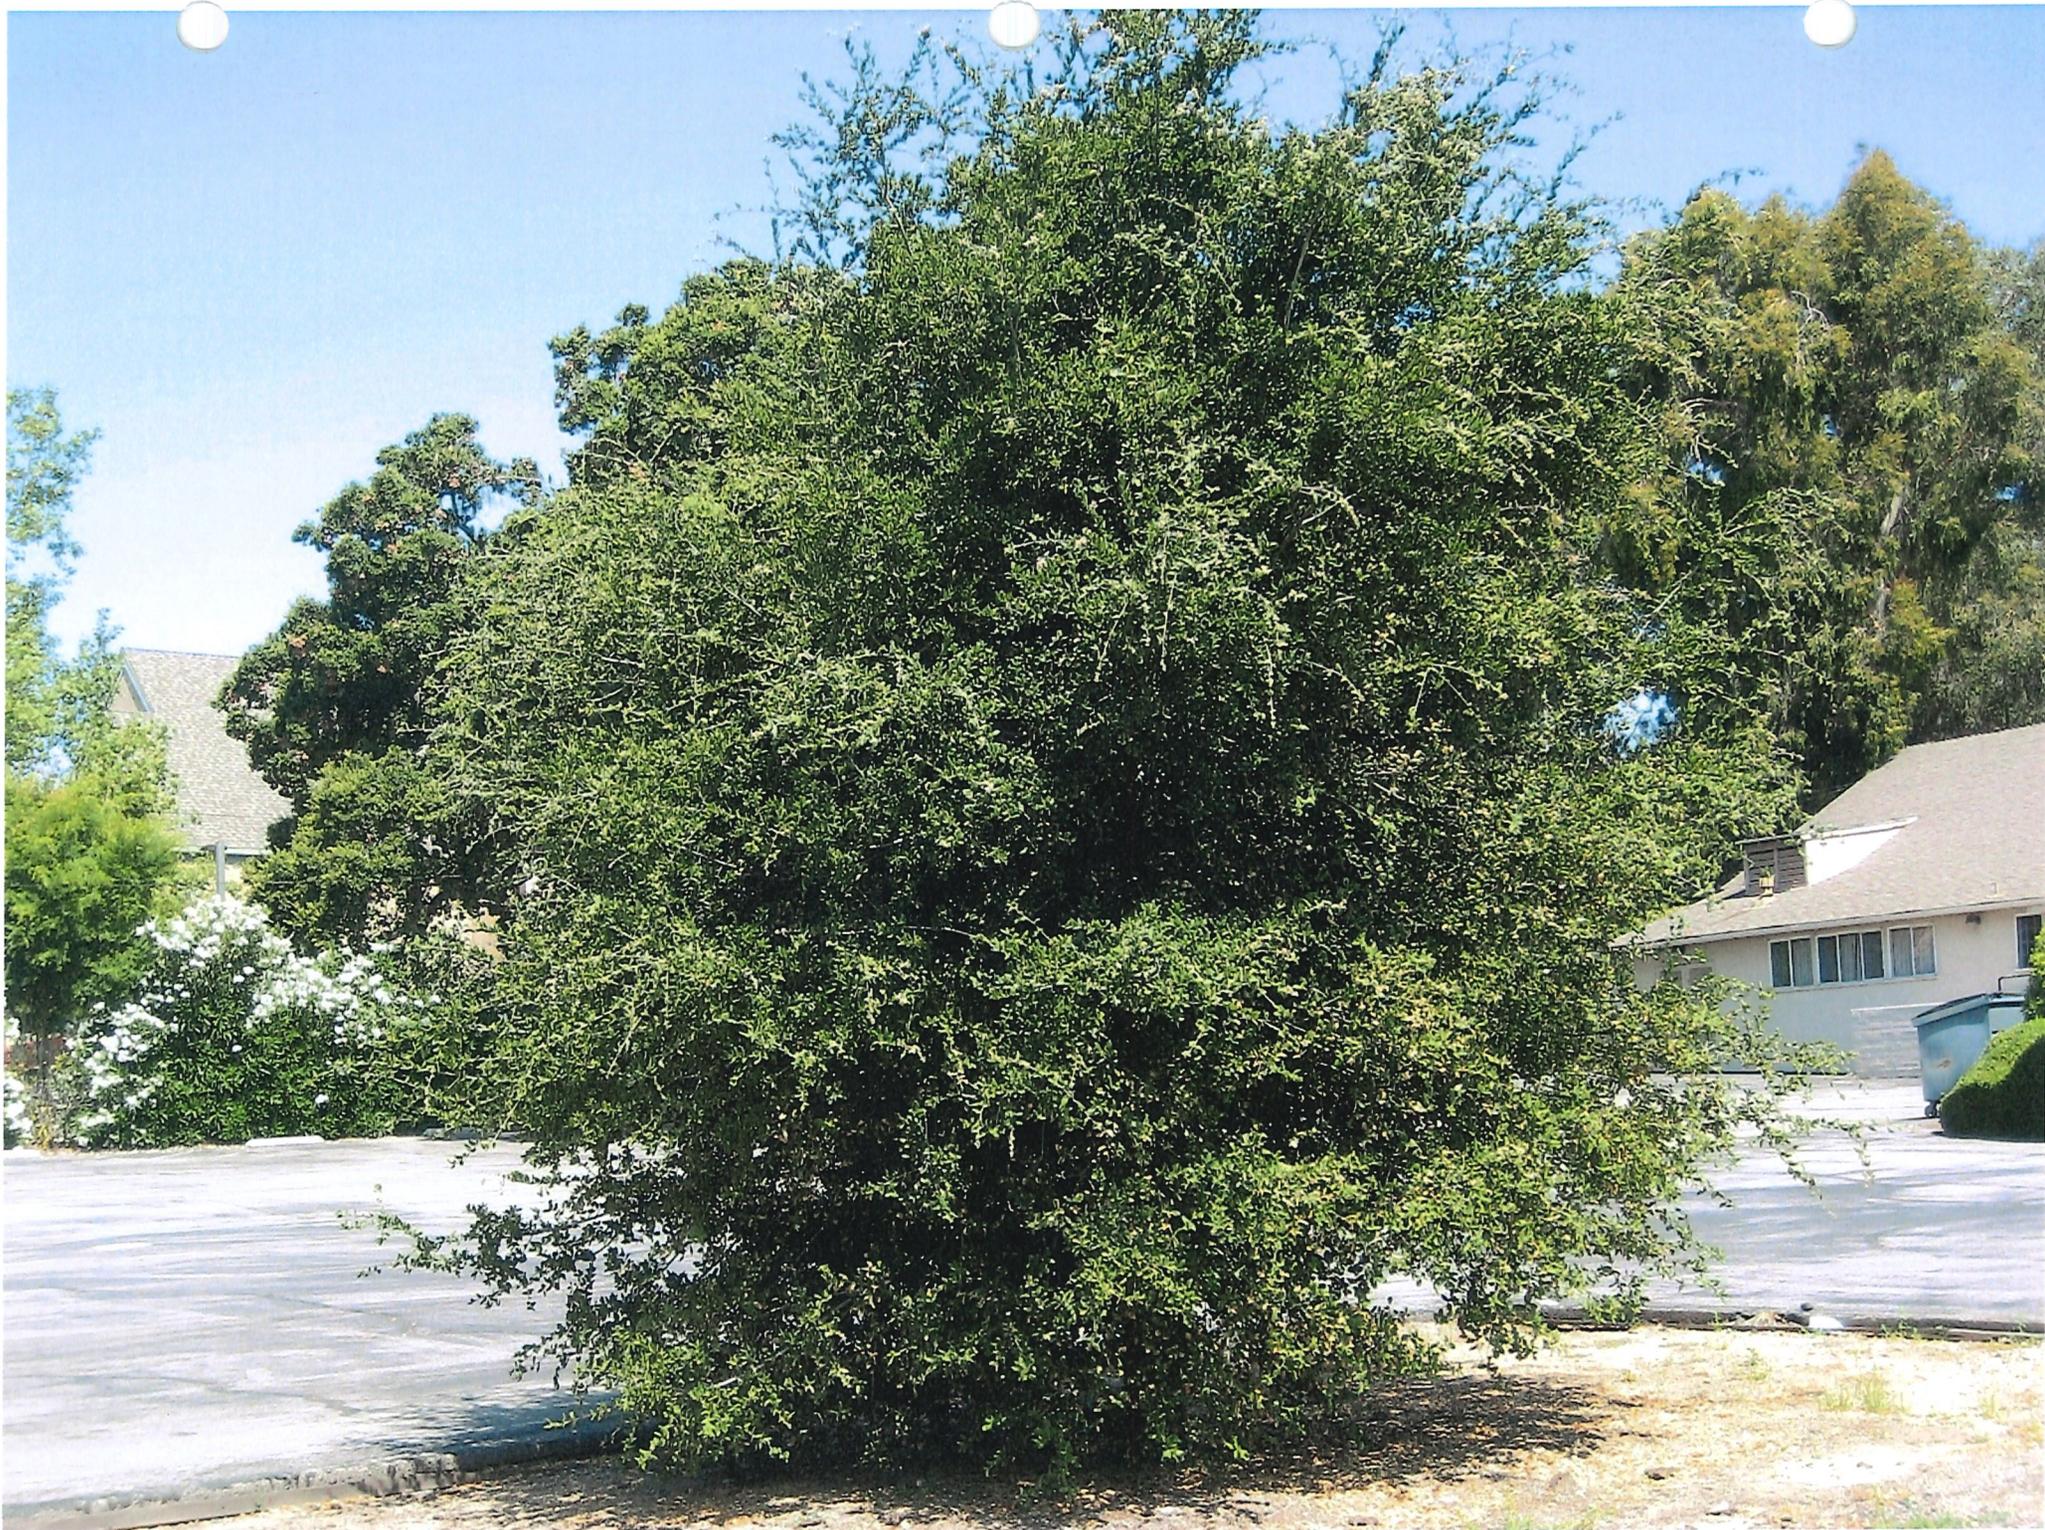
TREE #11

Tree #11 is a Quercus agrifolia or Coast Live Oak. The tree measures 7 inches in diameter at D.B.H. The tree has a drip line, which measures roughly 10 feet from the tree's trunk. The spread of the tree is approximately 20 feet. The height of the tree is estimated to be roughly 18 feet tall. The tree is located in the middle of the south asphalt parking lot area. It is 53 feet north of Utility Pole #4624479E. The tree is situated in a large, bare tree planter. The lower trunk area is intact. No mushrooms, cavities or decay was observed. No irrigation is visible. The tree's crown is low-growing. The foliage size and color appear normal. There is minor Anthracnose disease on the margins of the tree's leaves. The crown density is normal. The tree is in excellent condition. Rating: A-

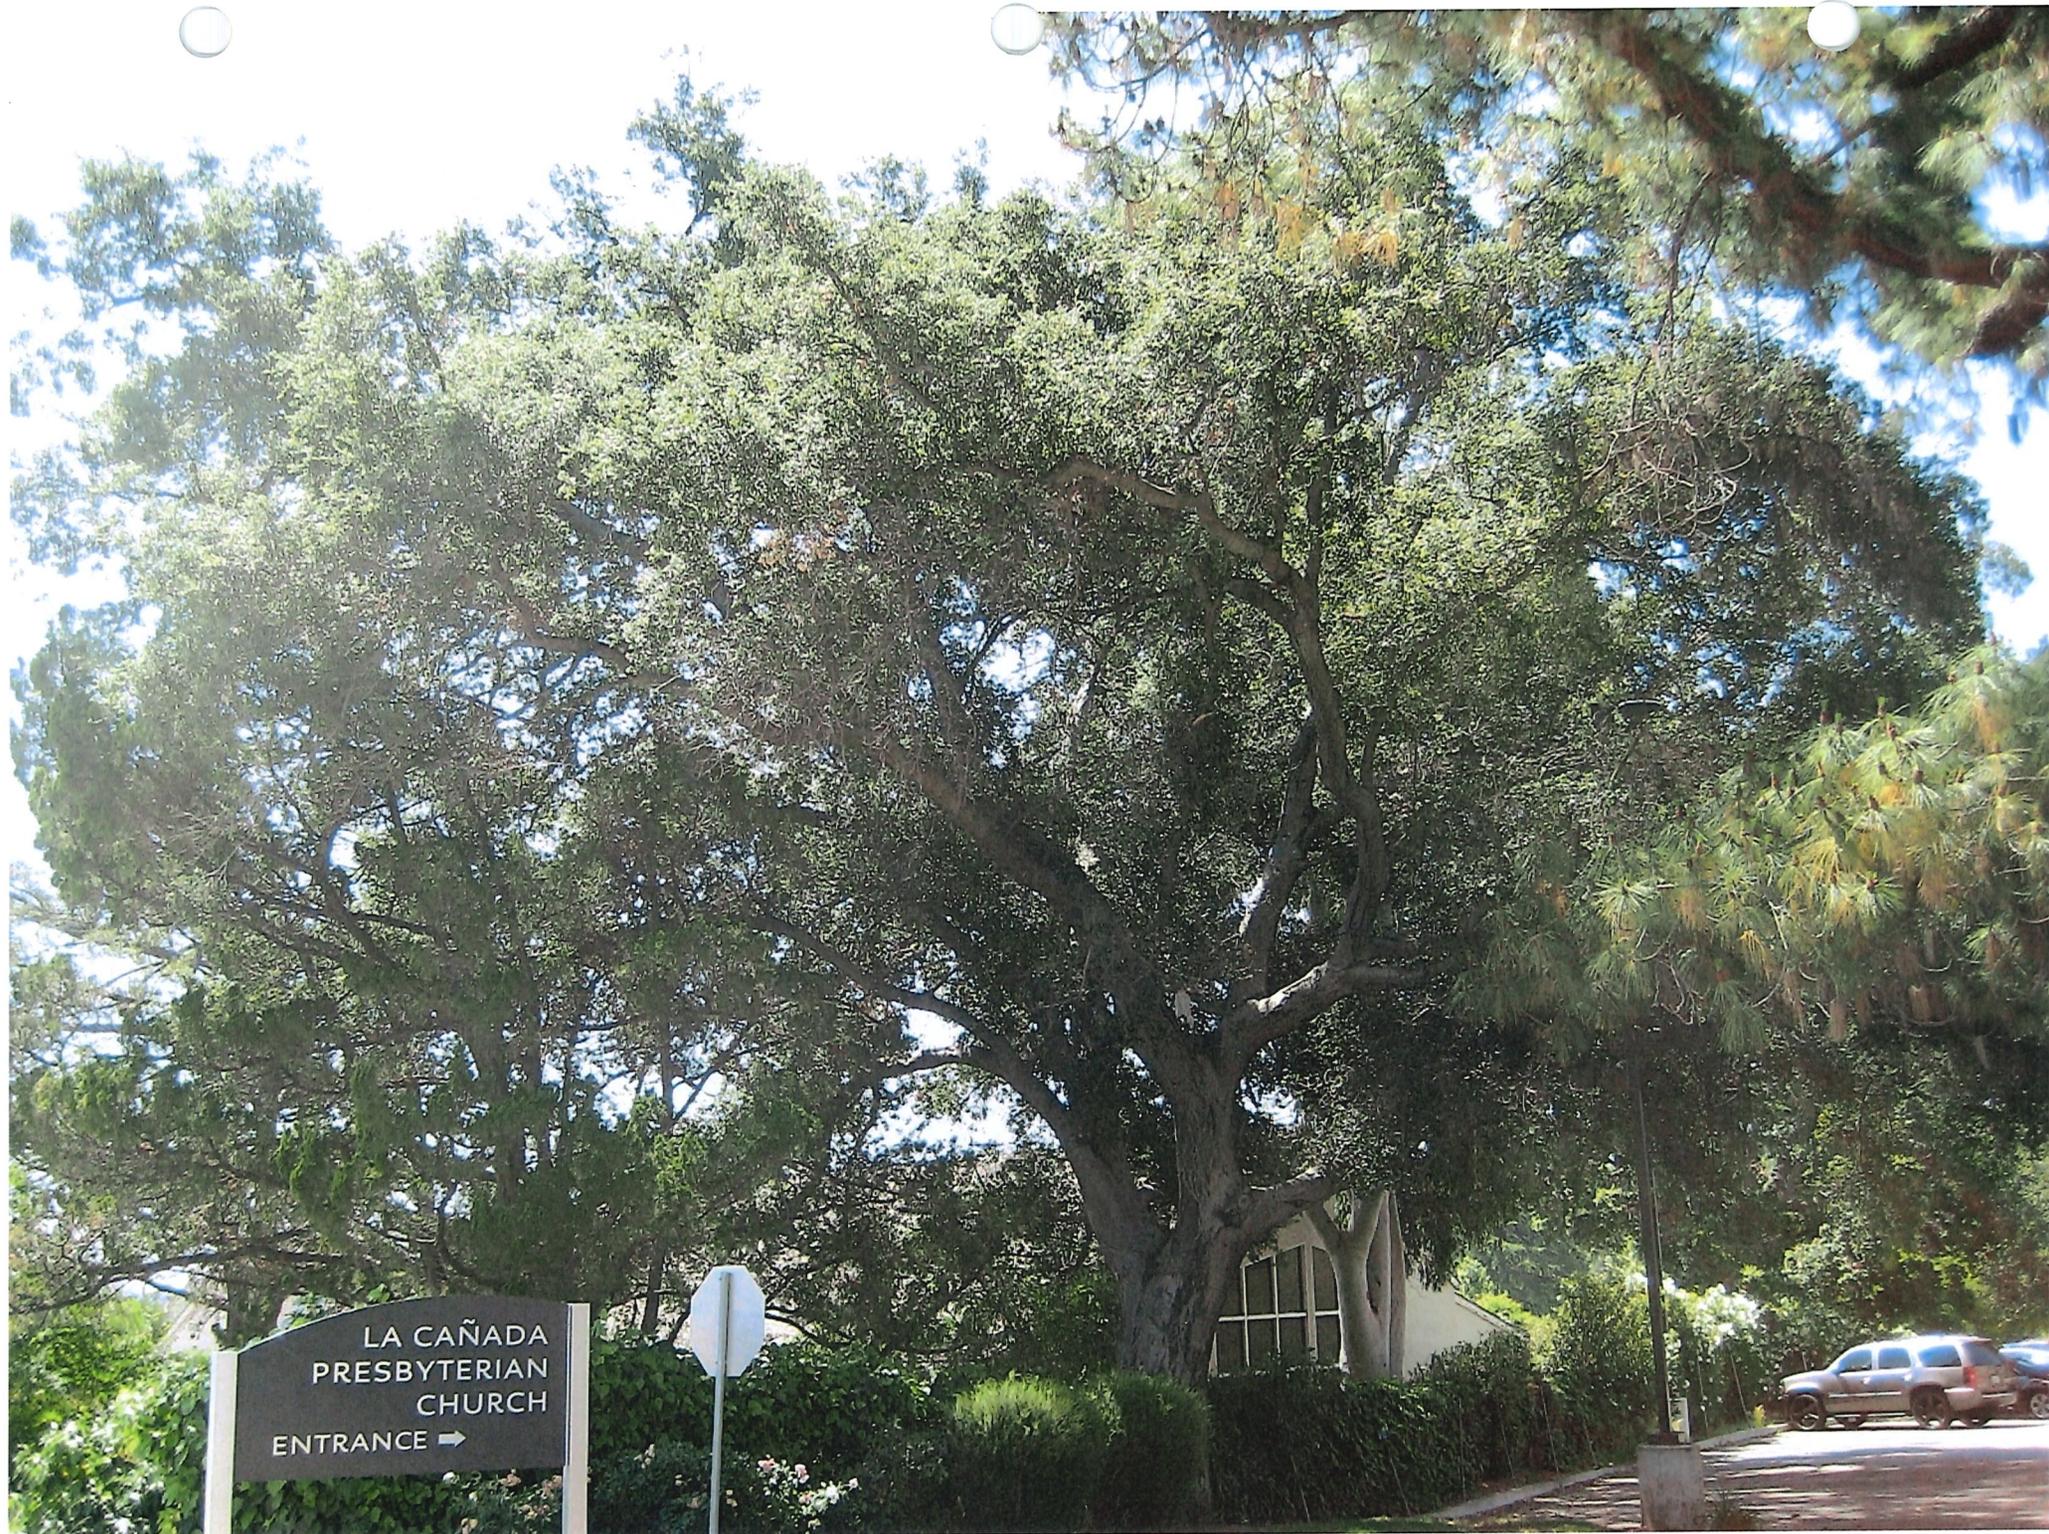
TREE #12

Tree #12 is a Quercus agrifolia or Coast Live Oak. The tree measures 30 inches in diameter at D.B.H. The tree has a drip line, which measures roughly 40 feet from the tree's trunk. The spread of the tree is approximately 80 feet. The height of the tree is estimated to be roughly 65 feet tall. The tree is located 16 feet southwest of Tree #4 and west of the chain-link fence which runs along the western boundary of the subject property. **It is located next to the chain-link fence inside the La Cañada Presbyterian Church property!** Algerian Ivy grows on the fence and under the Oak. The lower trunk area is intact. No mushrooms, cavities or decay was observed. The tree's crown has been pruned and raised. The crown is balanced with minor asymmetry. It is crowded by other nearby trees. The foliage size is and color appear normal. The crown density is fair. I would estimate that approximately 10% of the tree's crown is composed of dead wood. The tree is in slightly above average health and condition. Rating: C+
