Arborist Report

600 Foothill Blvd.
La Cañada Flintridge, California

June 22, 2020

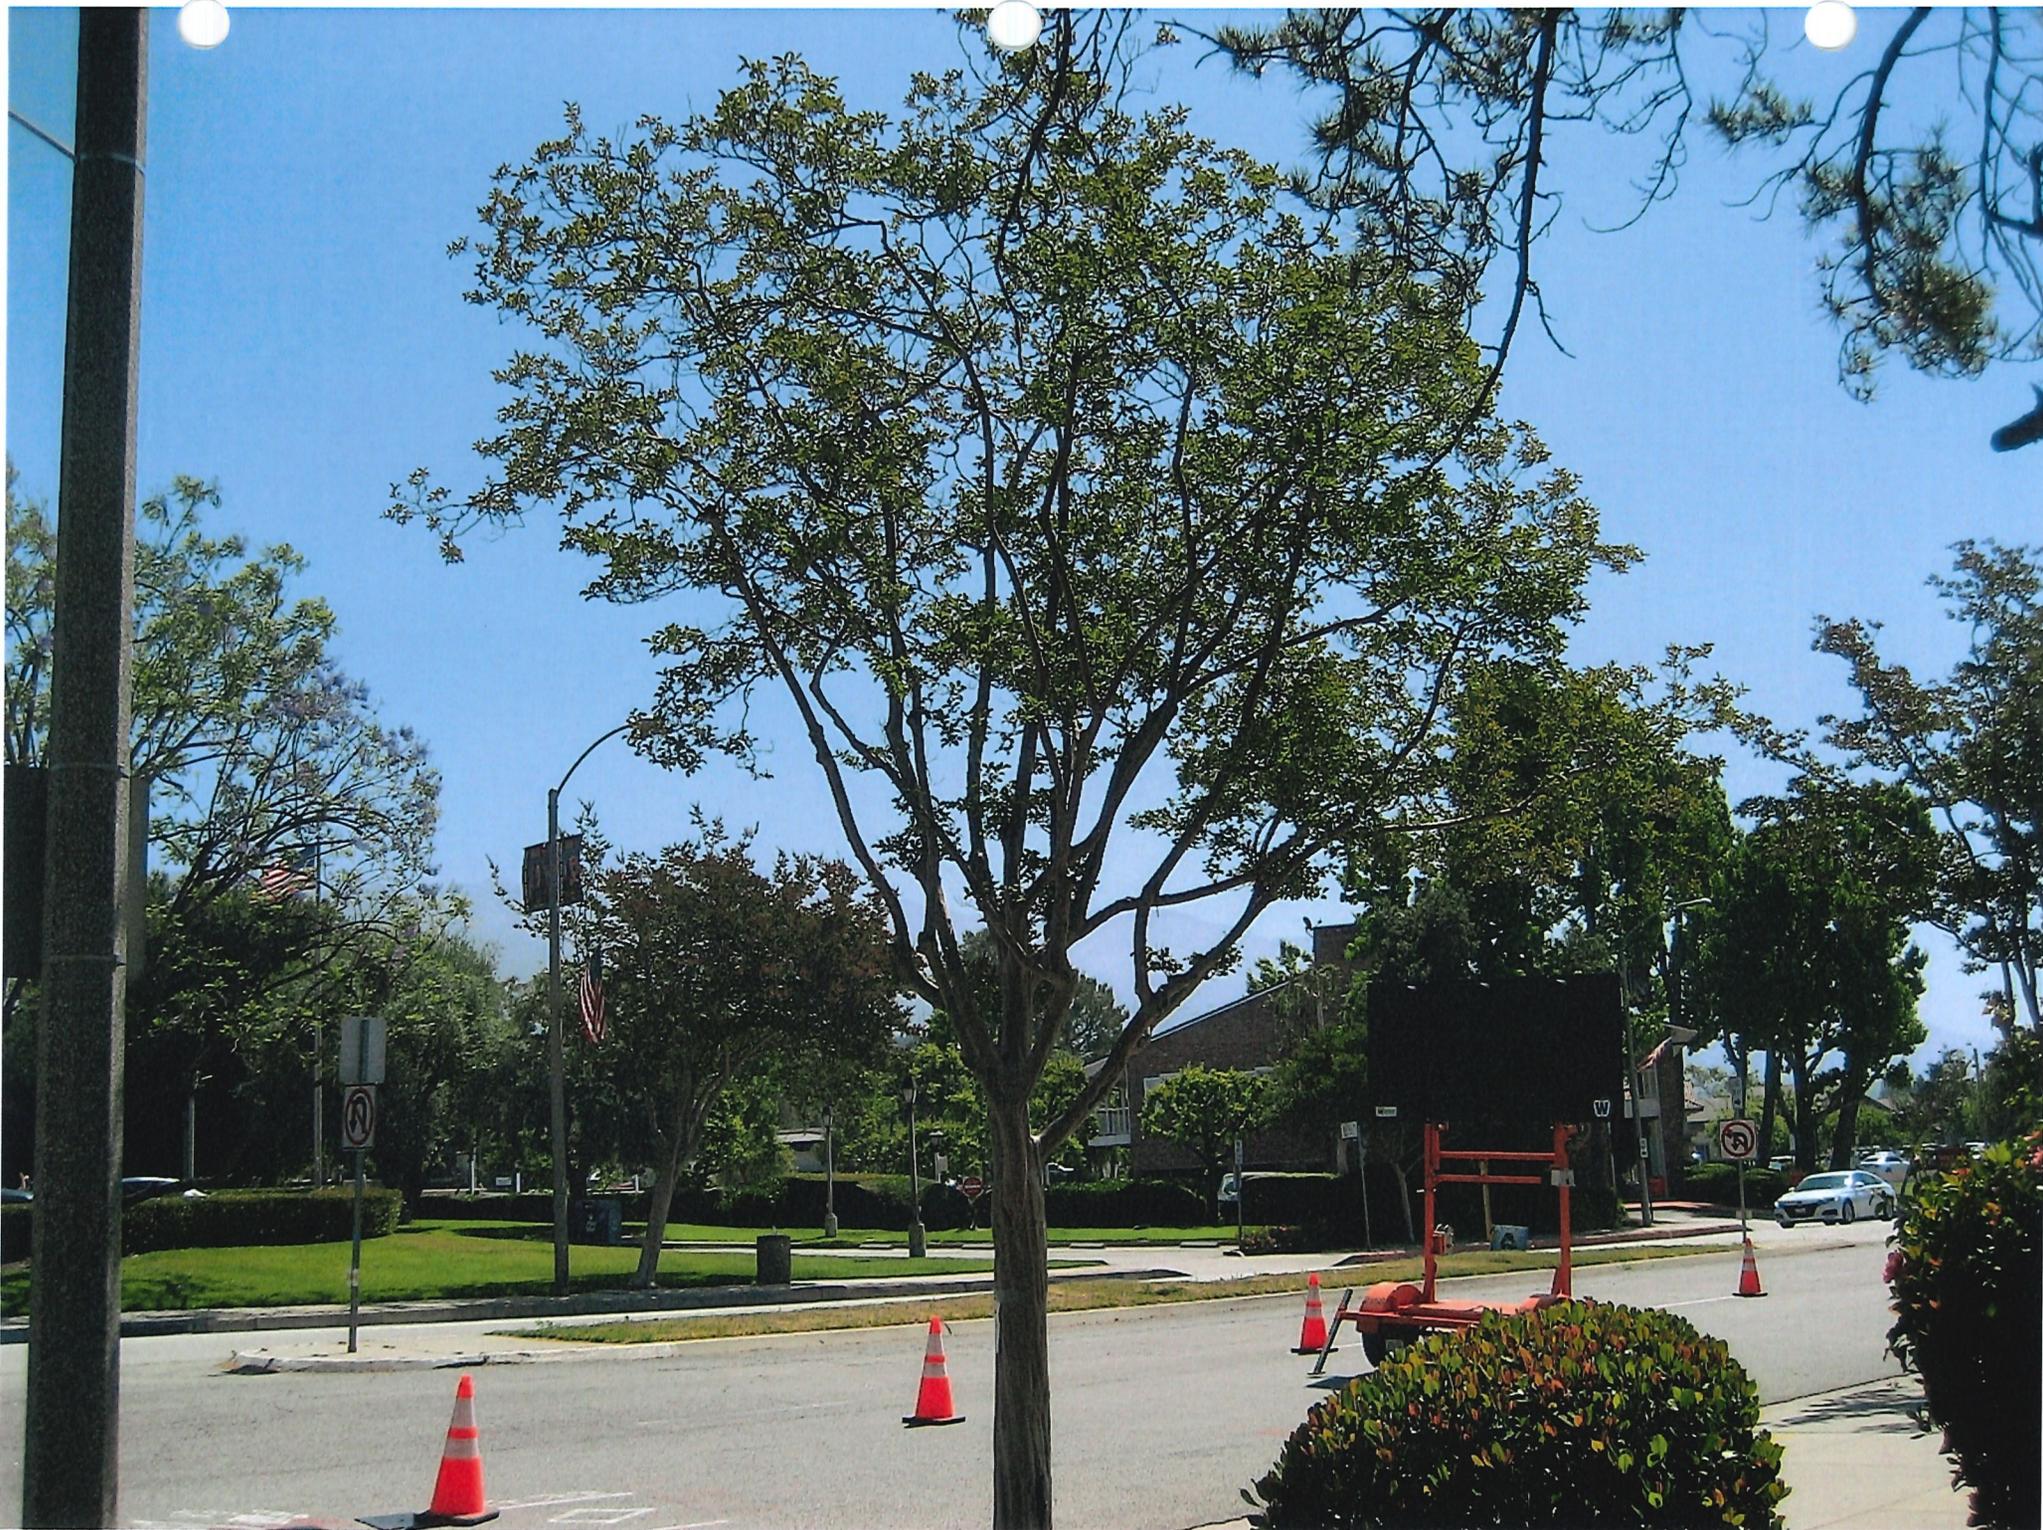
TREE #13

Tree #13 is a Lagerstroemia indica or Crape Myrtle. The tree measures 7 inches in diameter at D.B.H. The tree has a drip line, which measures roughly 8 feet from the tree's trunk. The spread of the tree is approximately 16 feet. The height of the tree is estimated to be roughly 17 feet tall. The tree is located in the front of the subject property. It is on the left or west side of the entrance walkway and 2 feet south of the curb along Foothill Blvd. The tree is situated inside a 3 foot by 3 foot tree planter surrounded by concrete sidewalk. No irrigation is visible. It is a City of La Cañada Flintridge Street Tree. There is no landscape in the planter. The lower trunk area is intact. No mushrooms, cavities or decay was observed. The tree's crown has been pruned and raised. The crown is balanced with minor asymmetry. The foliage size is and color appear normal. The crown density is fair. There is minor dead wood in the tree's crown. The tree is in average health and condition. Rating: C

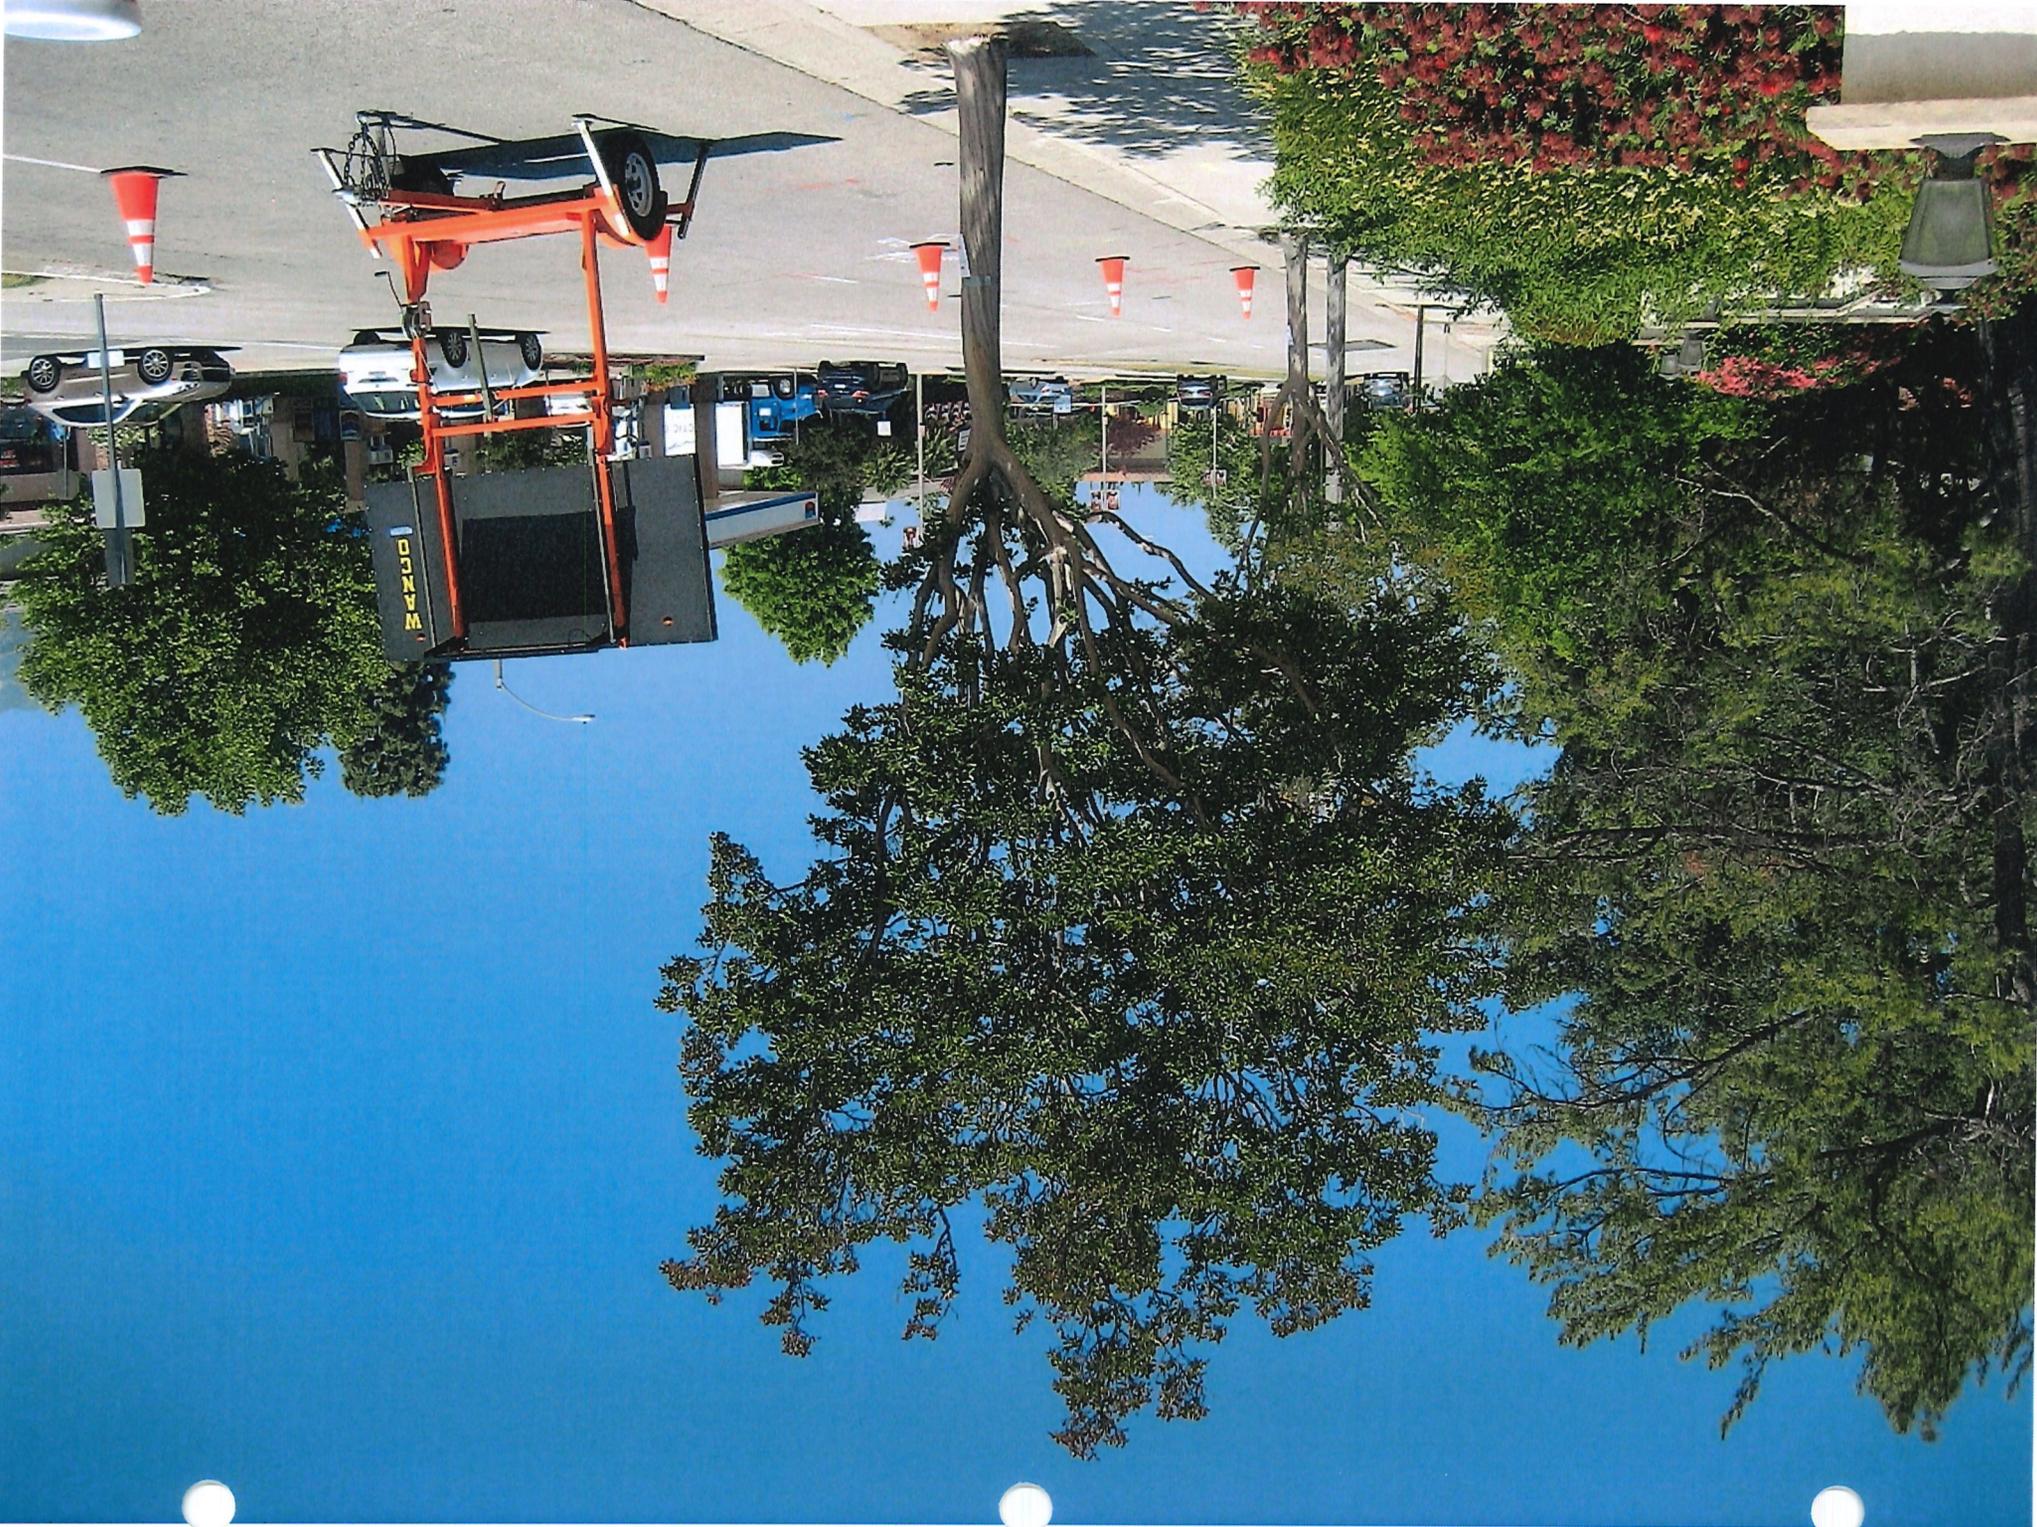
TREE # 114

Tree #14 is a Lagerstroemia indica or Crape Myrtle. The tree measures 7 inches in diameter at D.B.H. The tree has a drip line, which measures roughly 9 feet from the tree's trunk. The spread of the tree is approximately 18 feet. The height of the tree is estimated to be roughly 20 feet tall. The tree is located in the front of the subject property. It is 38 feet east of Tree #13 and 2 feet south of the curb along Foothill Blvd. The tree is situated inside a 3 foot by 3 foot tree planter surrounded by concrete sidewalk. No irrigation is visible. It is a City of La Cañada Flintridge Street Tree. There is no landscape in the planter. The lower trunk area is intact. No mushrooms, cavities or decay was observed. The tree's crown has been pruned and raised. The crown is balanced with minor asymmetry. The foliage size is and color appear normal. The crown density is fair. The tree is in slightly above average health and condition. Rating: C+

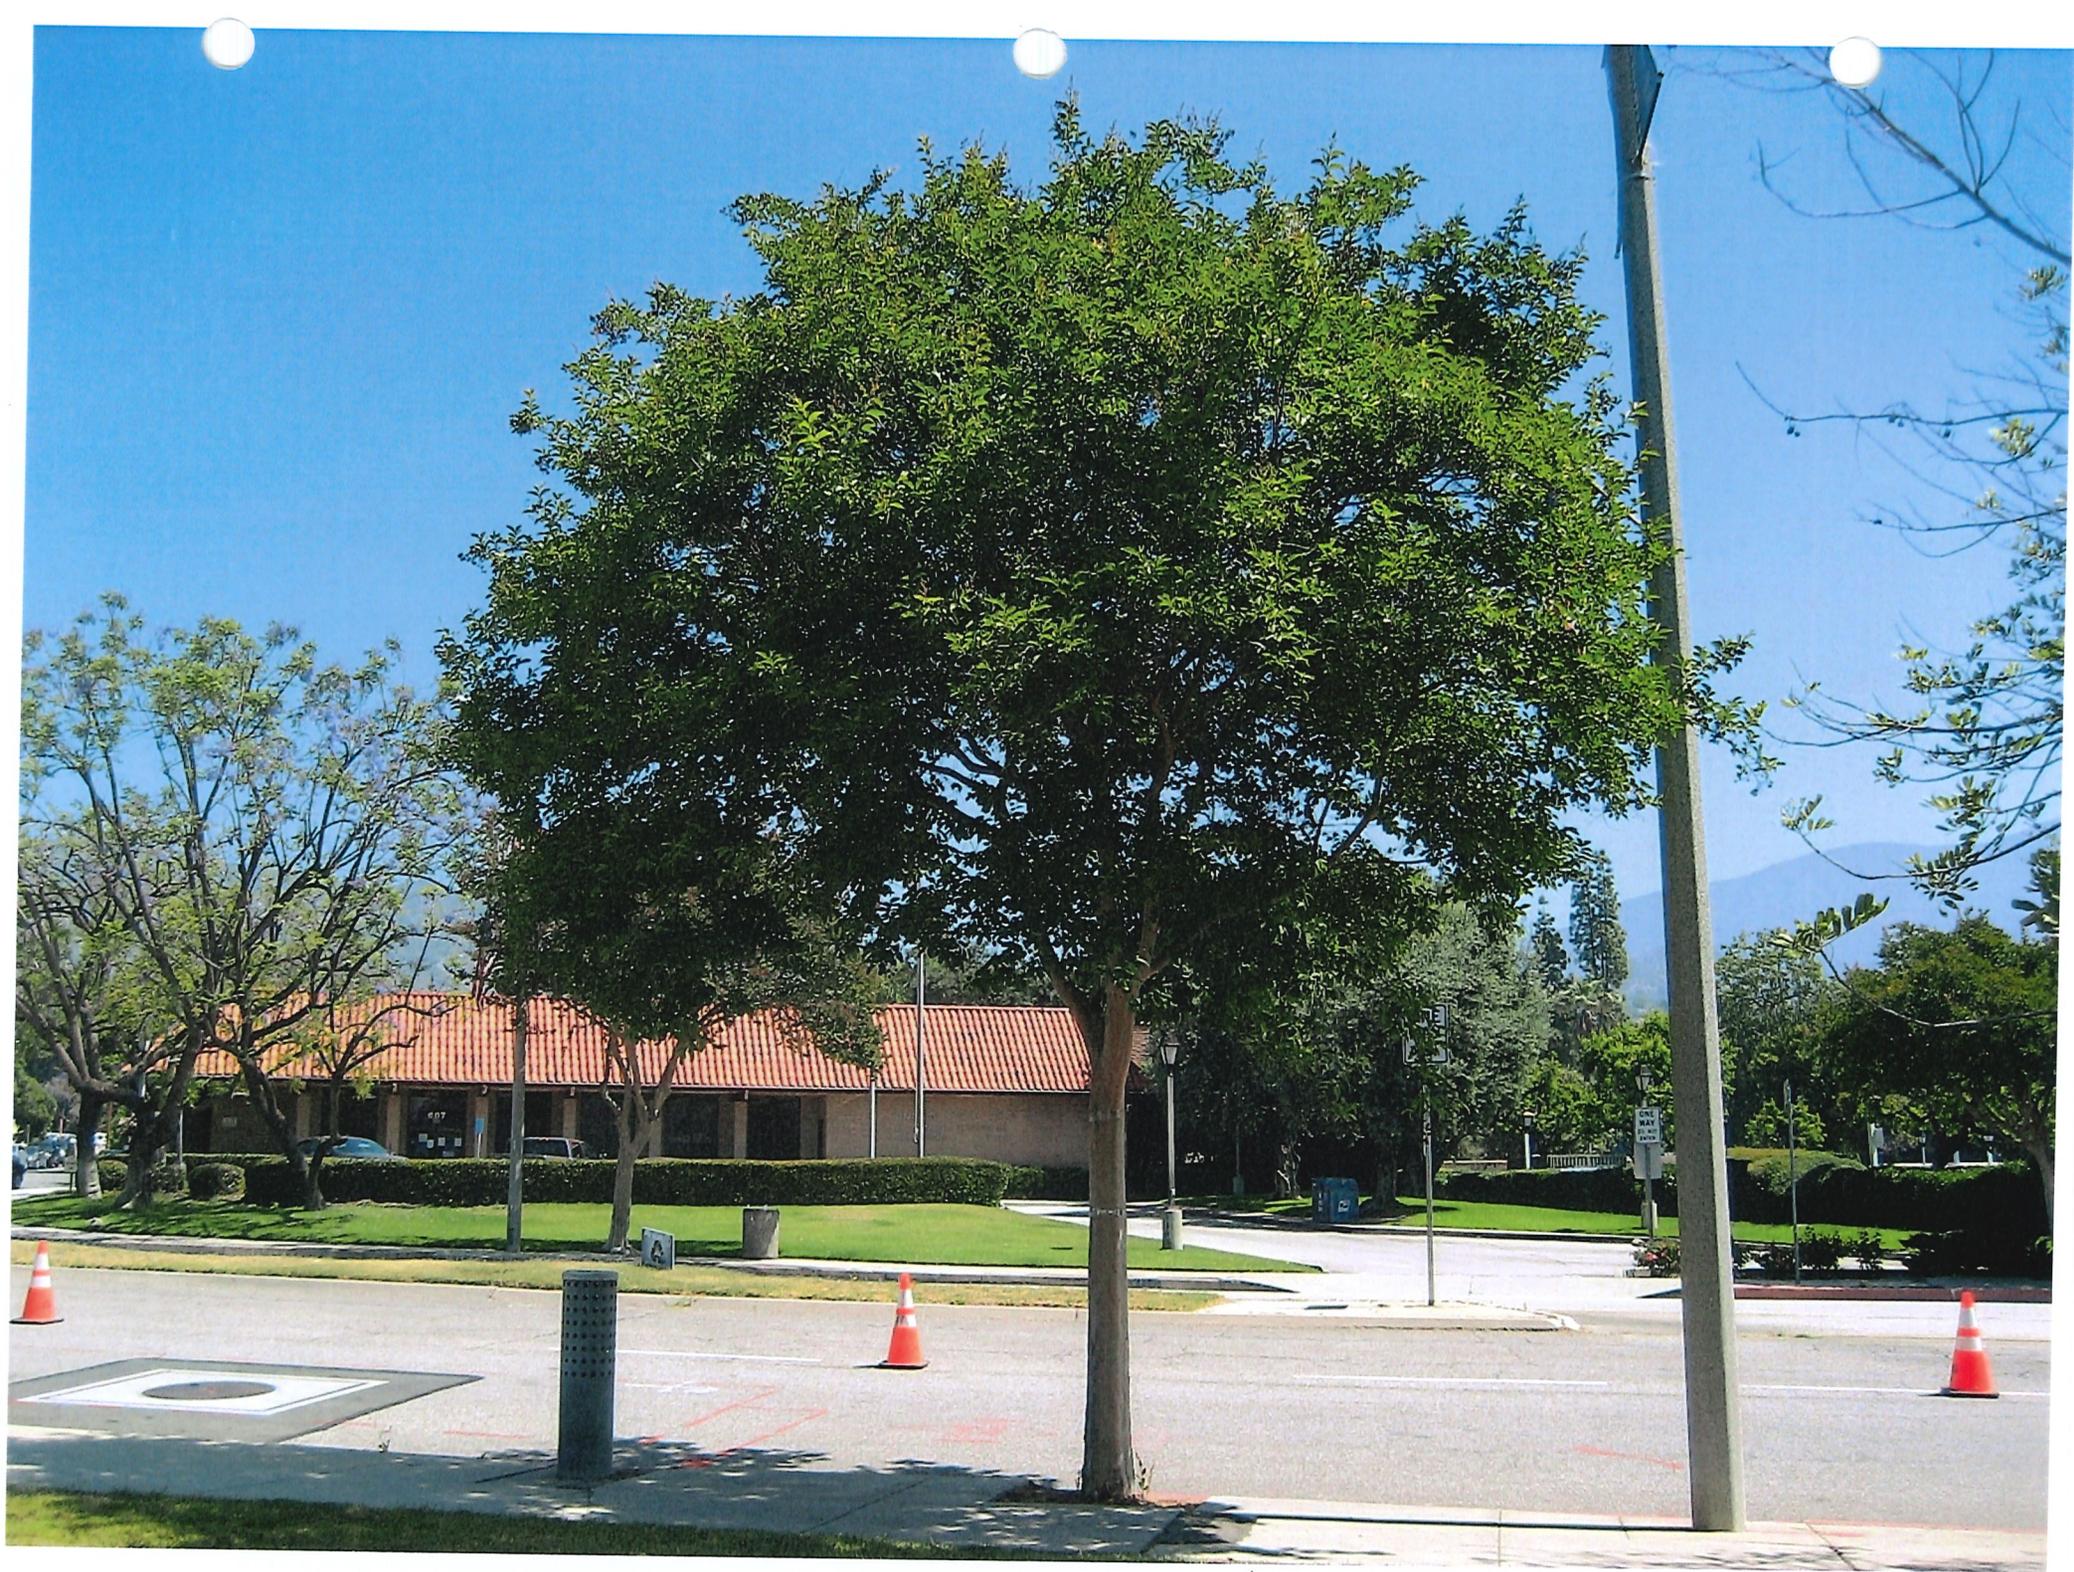
TREE #15

Tree #15 is a Lagerstroemia indica or Crape Myrtle. The tree measures 6 inches in diameter at D.B.H. The tree has a drip line, which measures roughly 10 feet from the tree's trunk. The spread of the tree is approximately 20 feet. The height of the tree is estimated to be roughly 19 feet tall. The tree is located in the front of the subject property. It is 57 feet east of Tree #14 and 2 feet south of the curb along Foothill Blvd. The tree is situated inside a 3 foot by 3 foot tree planter surrounded by concrete sidewalk. No irrigation is visible. It is a City of La Cañada Flintridge Street Tree. There is no landscape in the planter. The lower trunk area is intact. No mushrooms, cavities or decay was observed. The tree's crown has been pruned and raised. The crown is balanced with minor asymmetry. The foliage size is and color appear normal. The crown density is fair. The tree is in excellent condition. Rating: A-

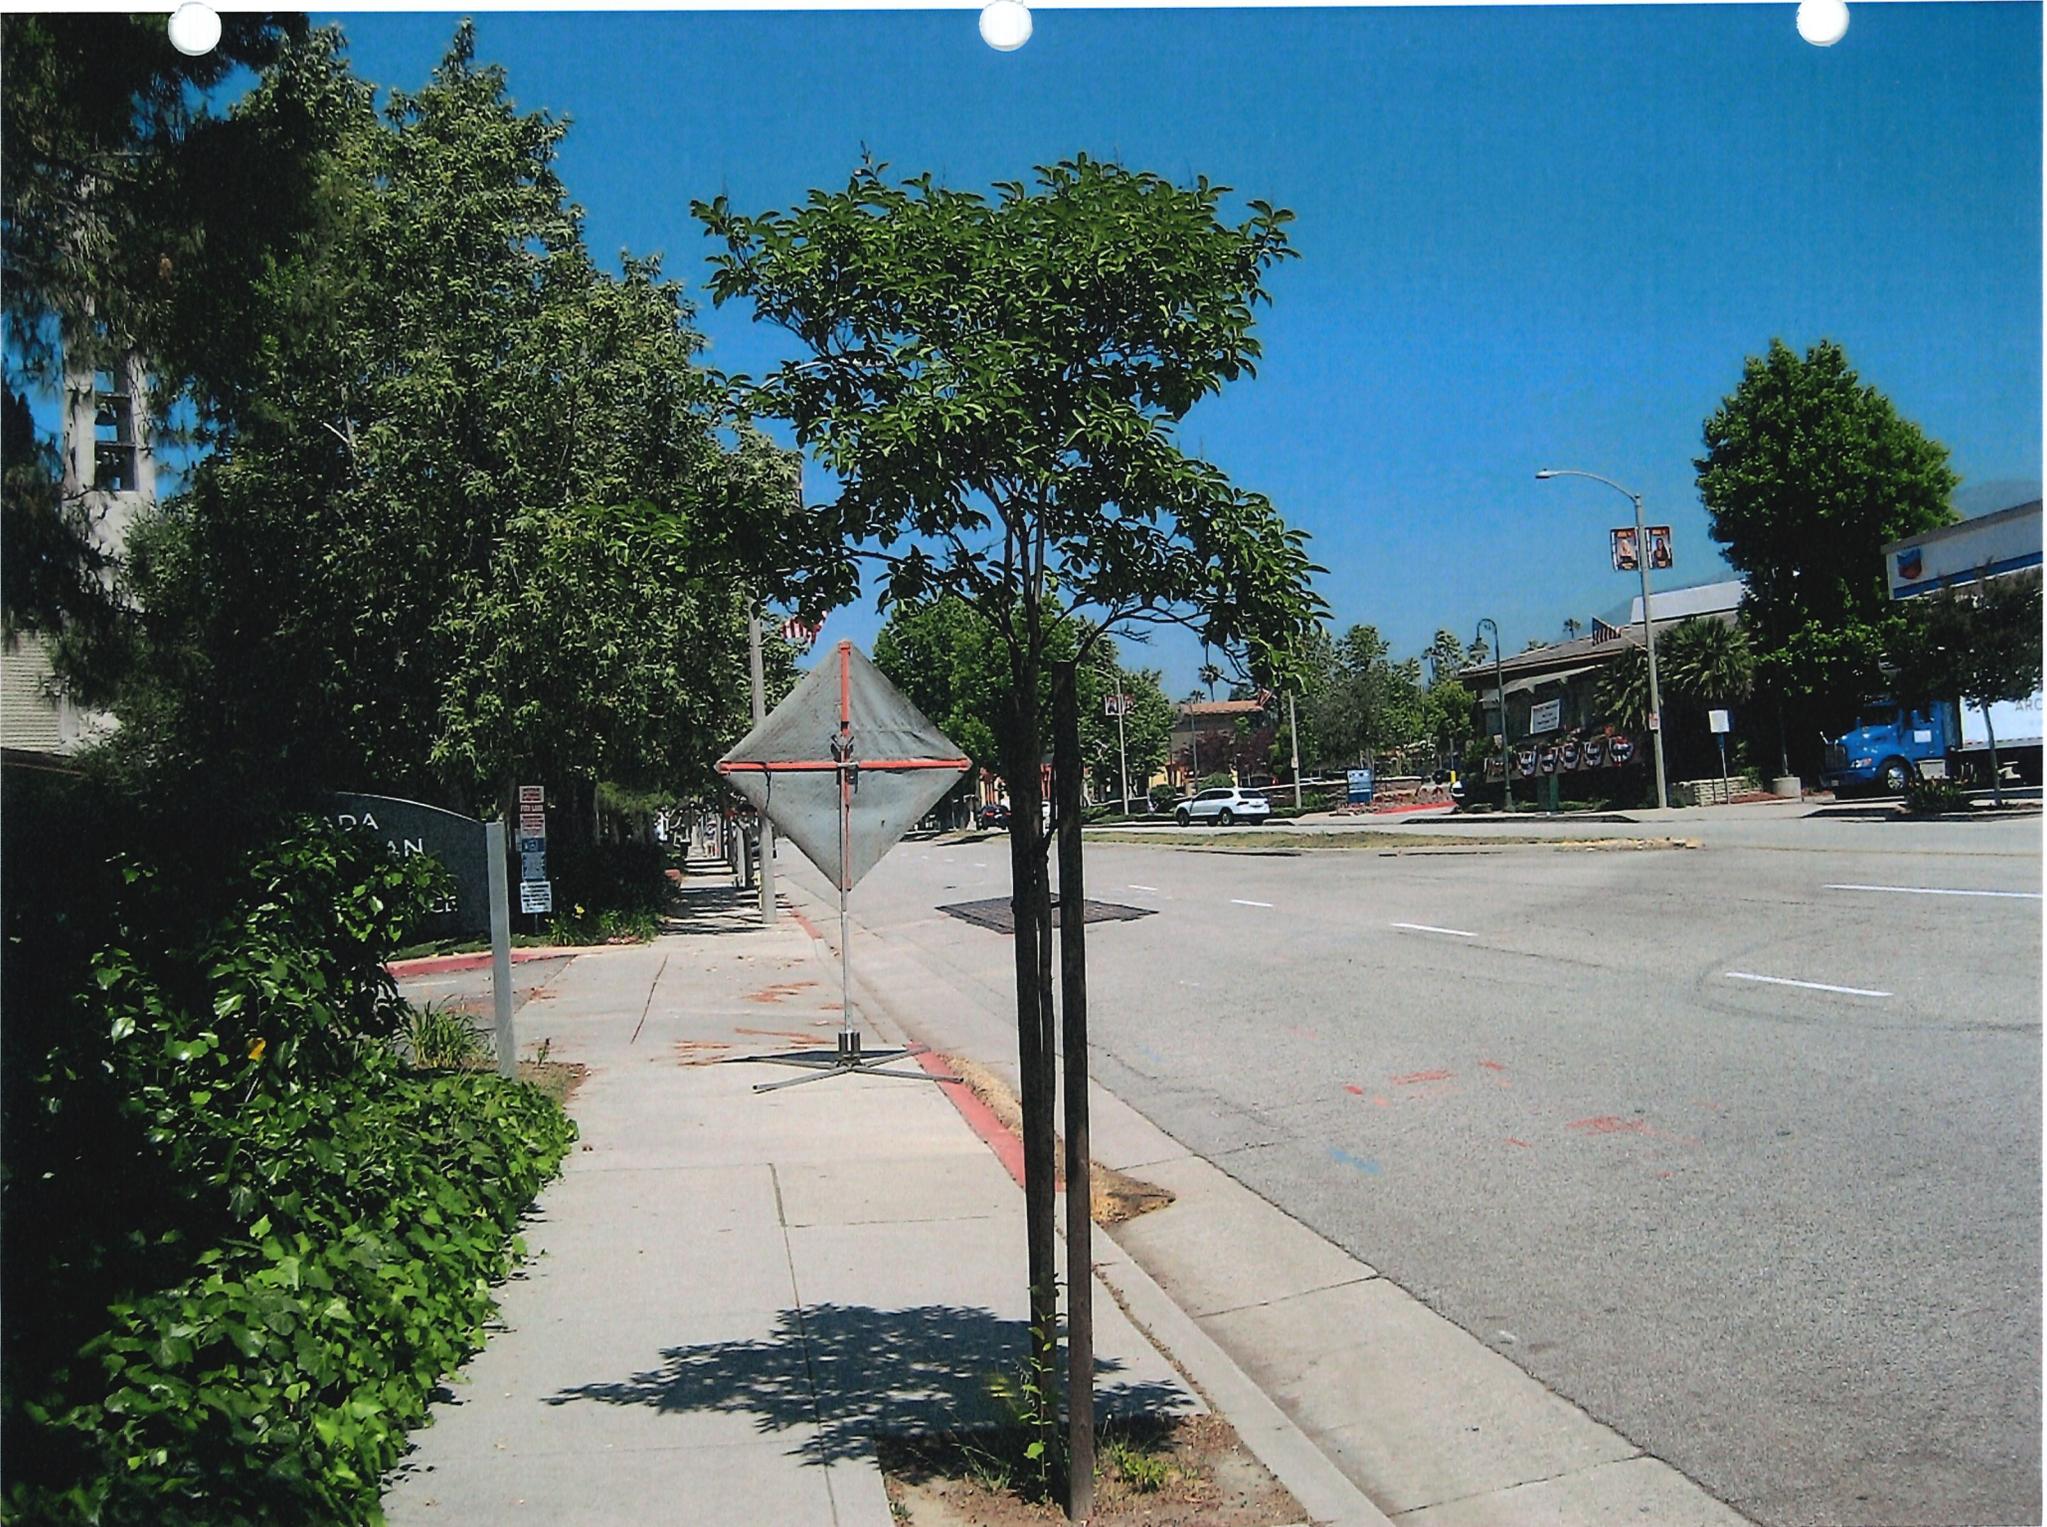
TRSE #16

Tree #16 is a Lagerstroemia indica or Crape Myrtle. The tree measures one inch in diameter at D.B.H. The tree has a drip line, which measures roughly 3 feet from the tree's trunk. The spread of the tree is approximately 5 feet. The height of the tree is estimated to be roughly 8 feet tall. The tree is located in the front of the subject property. It is west of Tree #13 near the western boundary of the subject property and 2 feet south of the curb along Foothill Blvd. The tree is situated inside a 3 foot by 3 foot tree planter surrounded by concrete sidewalk. No irrigation is visible. It is a City of La Cañada Flintridge Street Tree. There is no landscape in the planter. The lower trunk area is intact. No mushrooms, cavities or decay was observed. The tree's crown has been pruned and raised. The crown is balanced with minor asymmetry. The foliage size is and color appear normal. The crown density is fair. The tree is in good health and condition. Rating: B
