Tree Preservation Report

For: Yorba Villas Residential, Chino

APNs 1013-211-21 and 1013-211-22

Prepared by: **Greg Applegate, ASCA**
Arborgate Consulting, Inc.
1131 Lucinda Way
Tustin, CA 92780
714/ 731-6240
email – greg@arborgate.occoxmail.com

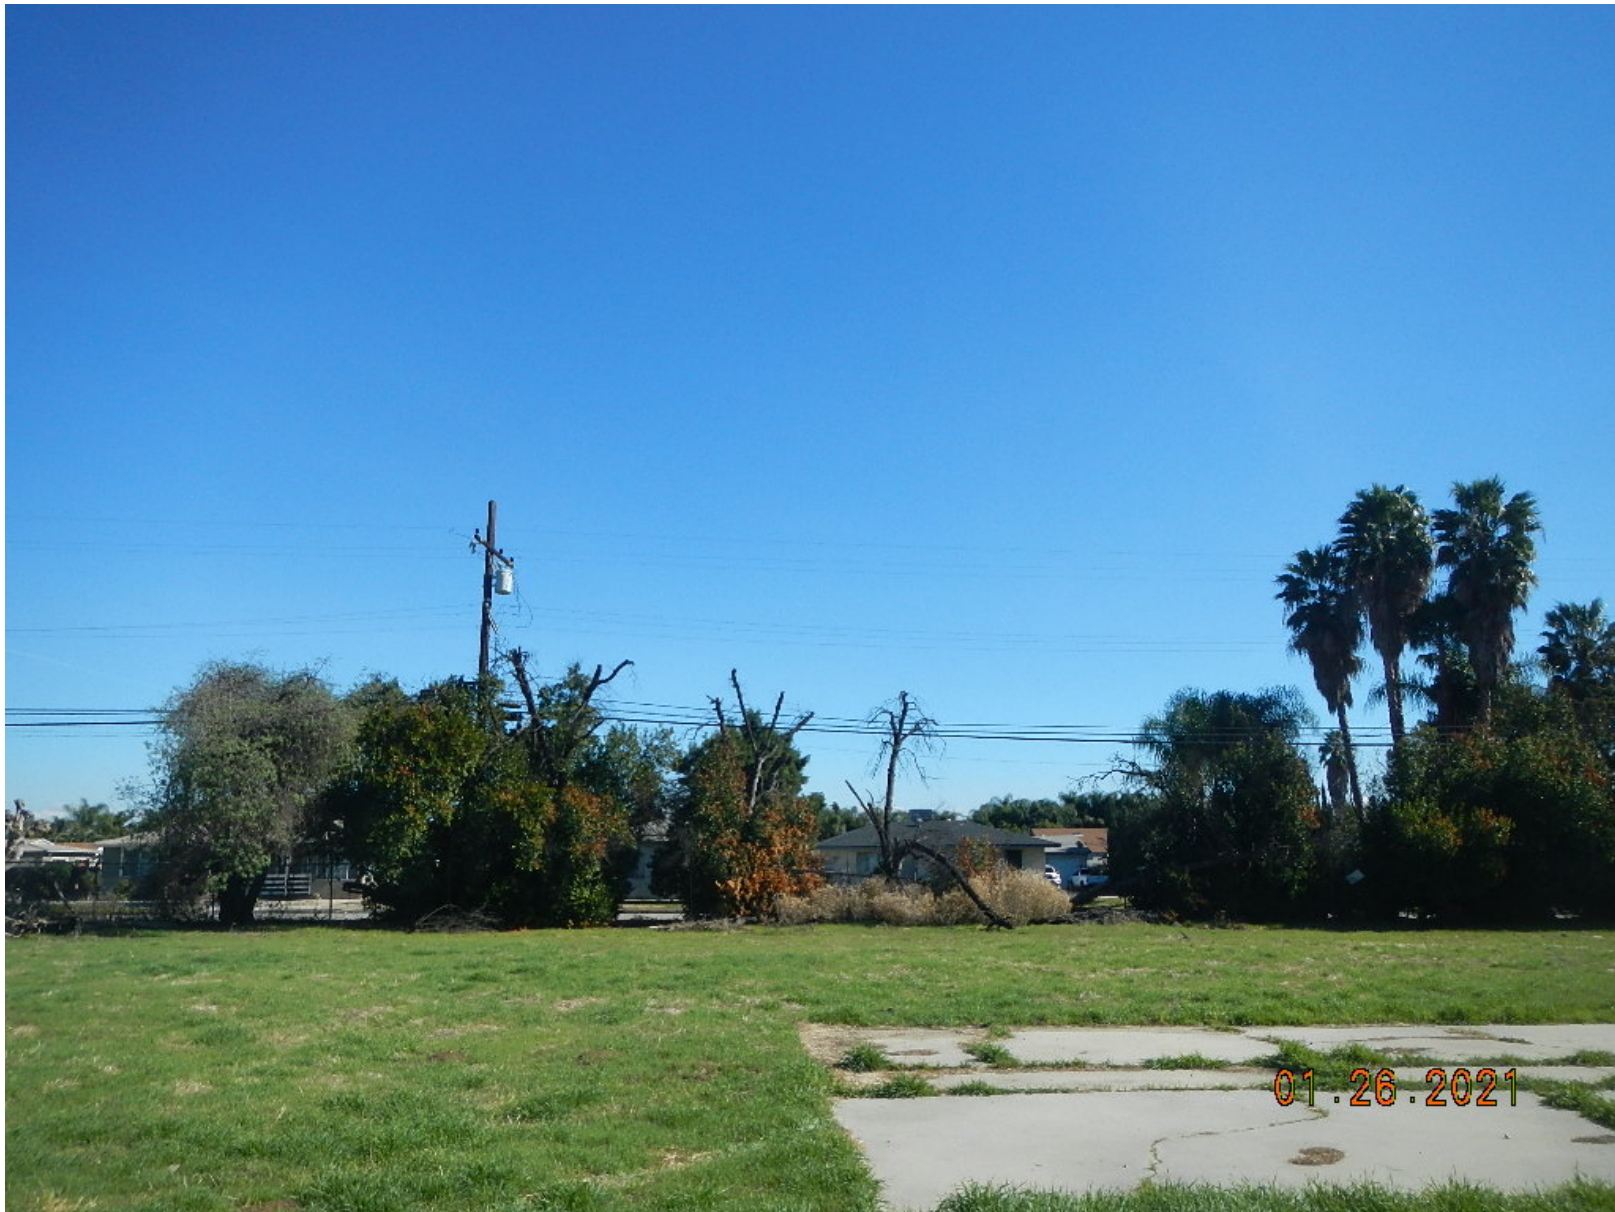
East edge of property – note Carolina cherries under the wires

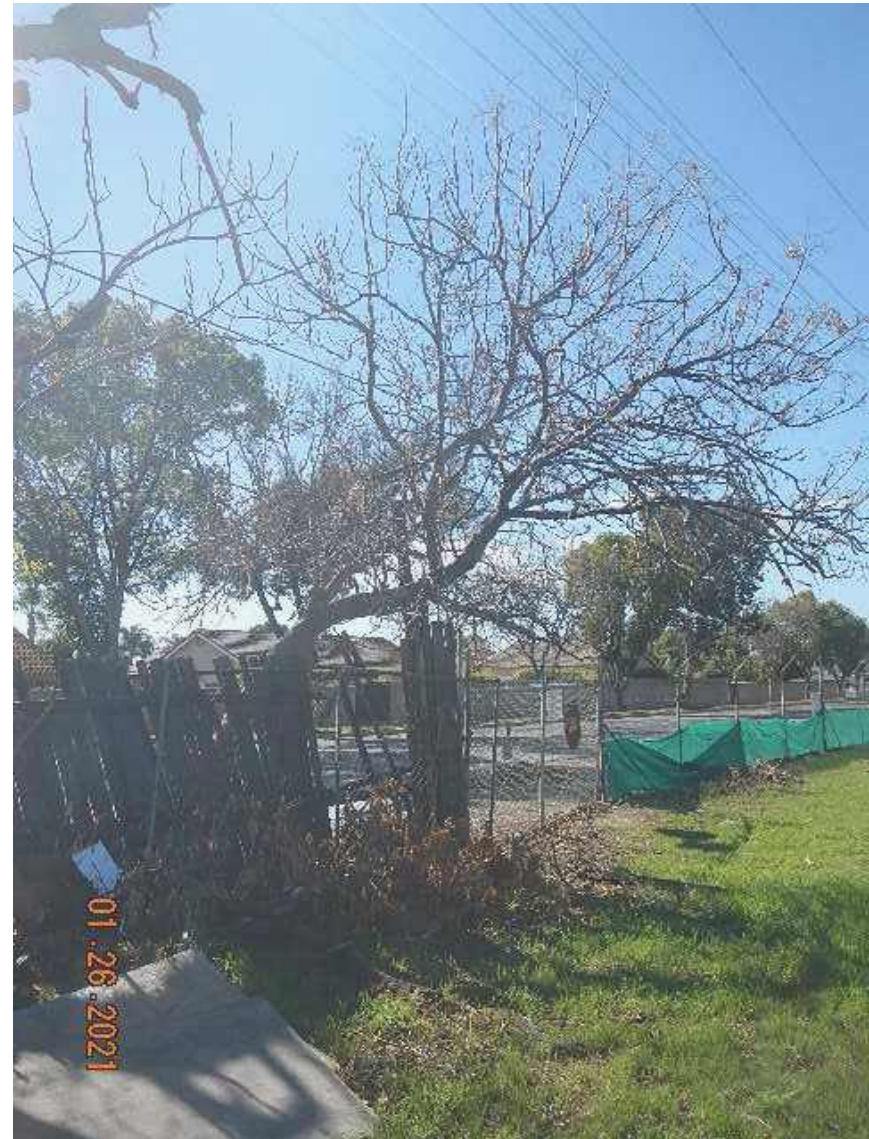
#31 Tree of heaven – note leaning trunk
