December 2, 2021

Project No. 2101-0252

Subject: Report of Findings – Asbestos and Lead-Based Paint Survey,
PRC 421 Decommissioning Project, Pier Access Road,
Goleta, Santa Barbara County, California

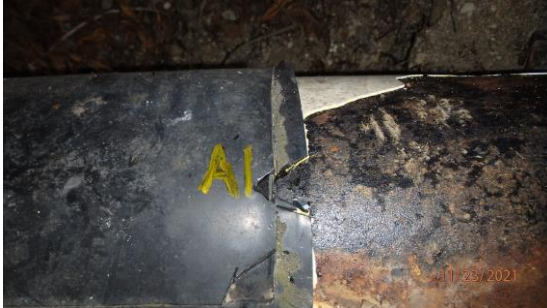
112321-ELLWOOD-A1
Black Pipe Wrap and Mastic
(No Asbestos Detected)

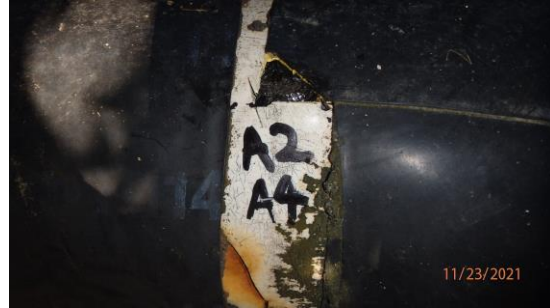
112321-ELLWOOD-A2
White Pipe Wrap and Mastic
(No Asbestos Detected)

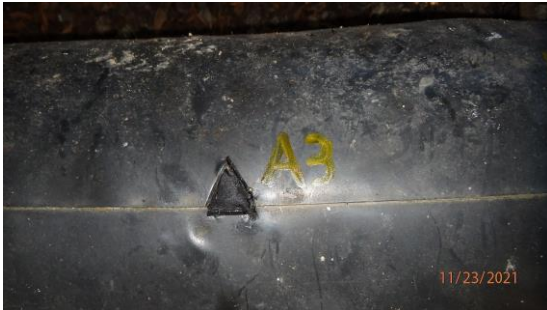
112321-ELLWOOD-A3
Black Pipe Wrap and Mastic
(No Asbestos Detected)

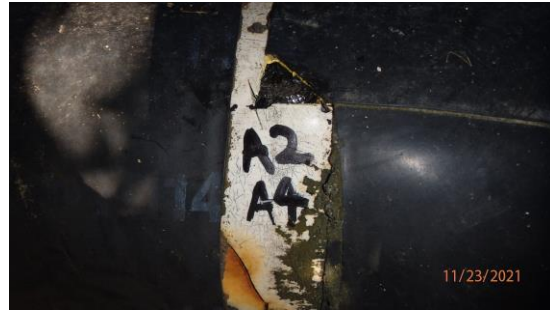
112321-ELLWOOD-A4
White Pipe Wrap and Mastic
(No Asbestos Detected)

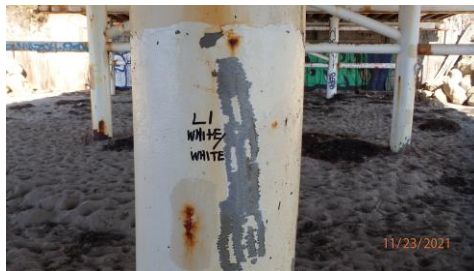
112321-ELLWOOD-L1
Pier 421-1
White Paint
(<60 PPM Total Lead)

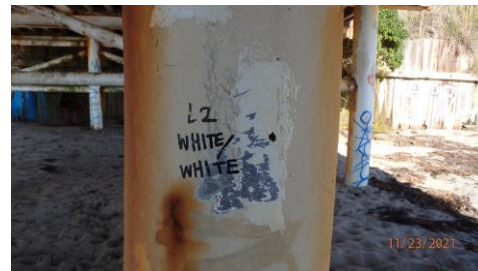
112321-ELLWOOD-L2
Pier 421-2
White Paint
(<60 PPM Total Lead)
