## Updated Arborist Report

**550 E. Brokaw Rd.,  
San Jose, CA**

December 15, 2021

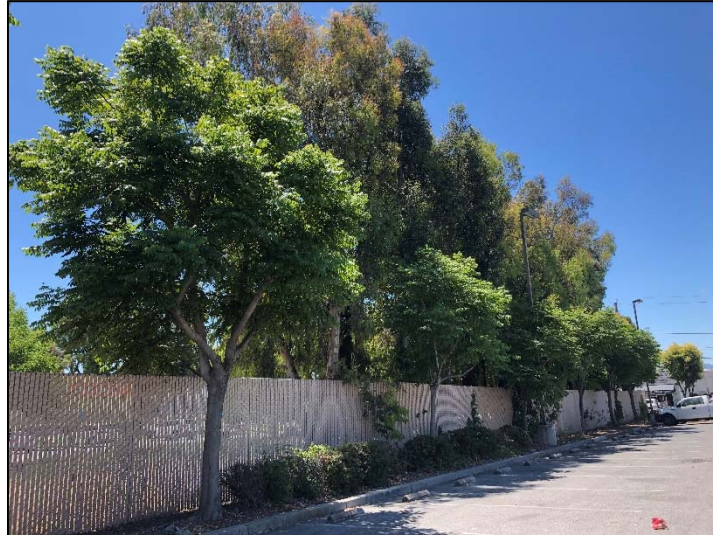
**Photo 1:** Chinese flame trees #28-33 were growing in a narrow parking lot planter along a chain-link fence on the southern perimeter.

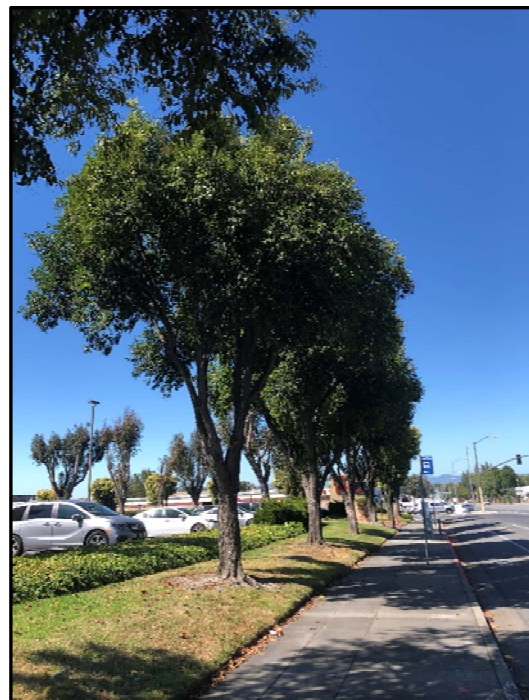
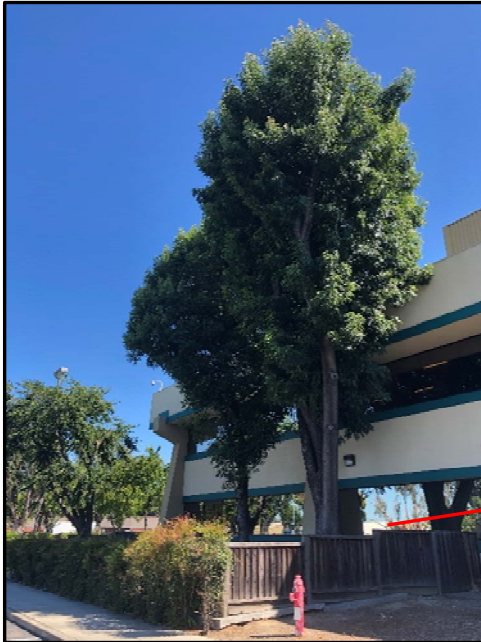
**Photos 3 (left) & 4 (below):** Evergreen ash #83 had a 34-inch trunk diameter. It was growing 5 feet west of the building with surface roots lifting the hardscape.
