Preliminary Arborist Report

131 Westmoor Avenue
Daly City, CA

January 18, 2021

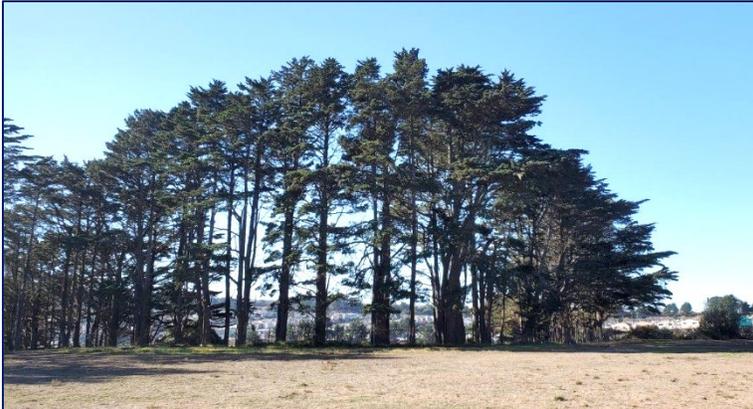
Most of the cypresses were mature with high, sparse crowns, planted closely together and competing for space with other nearby trees. Many had codominant stems and were leaning or one-sided, and had evidence of previous branch failures.

Photo 1. Monterey cypresses #55-44 (left to right) were at the edge, growing along the southern side of the site.

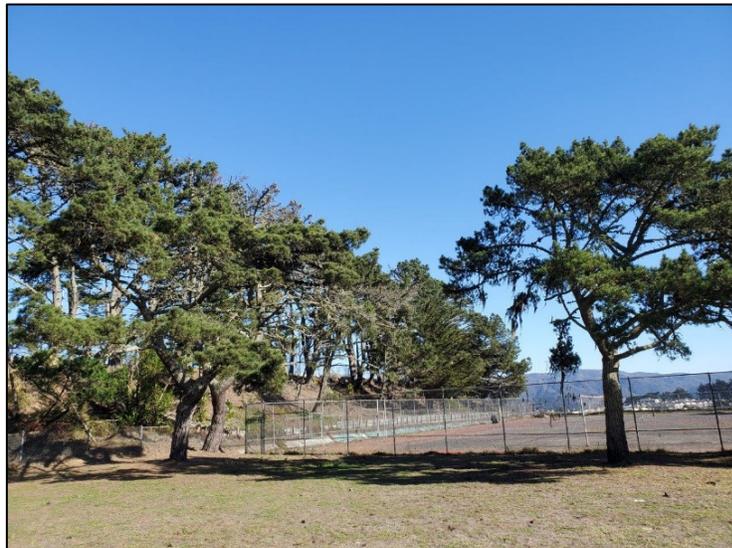
The second most frequently occurring species was Monterey pine, with 27 trees, approximately 43% of the population (Photo 2). Again, most of the pines were in poor condition (22 trees), with one tree in fair condition. None of the pines were in good condition; four of the trees were standing dead.

A few young pines were present (the smallest being 8 inches in diameter), the dominance of the Monterey pines were mature to over-mature in development, ranging up to 42-inch diameter, with an average diameter of 26 inches. Many trees showed evidence of bark beetle activity and pine pitch canker. Bark beetles such as red turpentine beetles typically attack stressed or dying trees and can further weaken them. Pitch canker causes dieback of individual branches, leading to a decline in overall tree health and, in some cases, premature death.

Photo 2. Monterey pines #62 and 61 (left to right in foreground); trees #2-12 and 63 were growing along the hillside (in the background) along the tennis court; most are in poor condition.

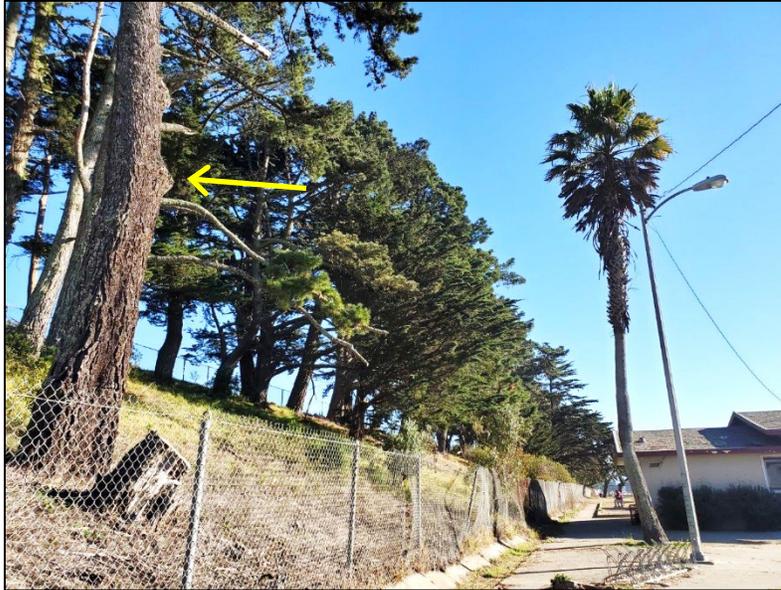
Photo 3. Mexican fan palm #28 was growing near the clubhouse building. Dead Monterey pine #27 visible at left (yellow arrow), viewed from west.

The final number of trees to be removed/retained is pending completion of the plans. Dead trees #5, 10, and 27 should be removed. It is possible that trees in the groups of #29-43 on the west side and #44-56 on the south side can be retained with by protecting their root zones and pruning branches as needed for clearance and safety.
