Arborist Report

**Arborist Report for the
Alexan Mixed-Use Development Project,
City of Arcadia, California**

SEPTEMBER 2021

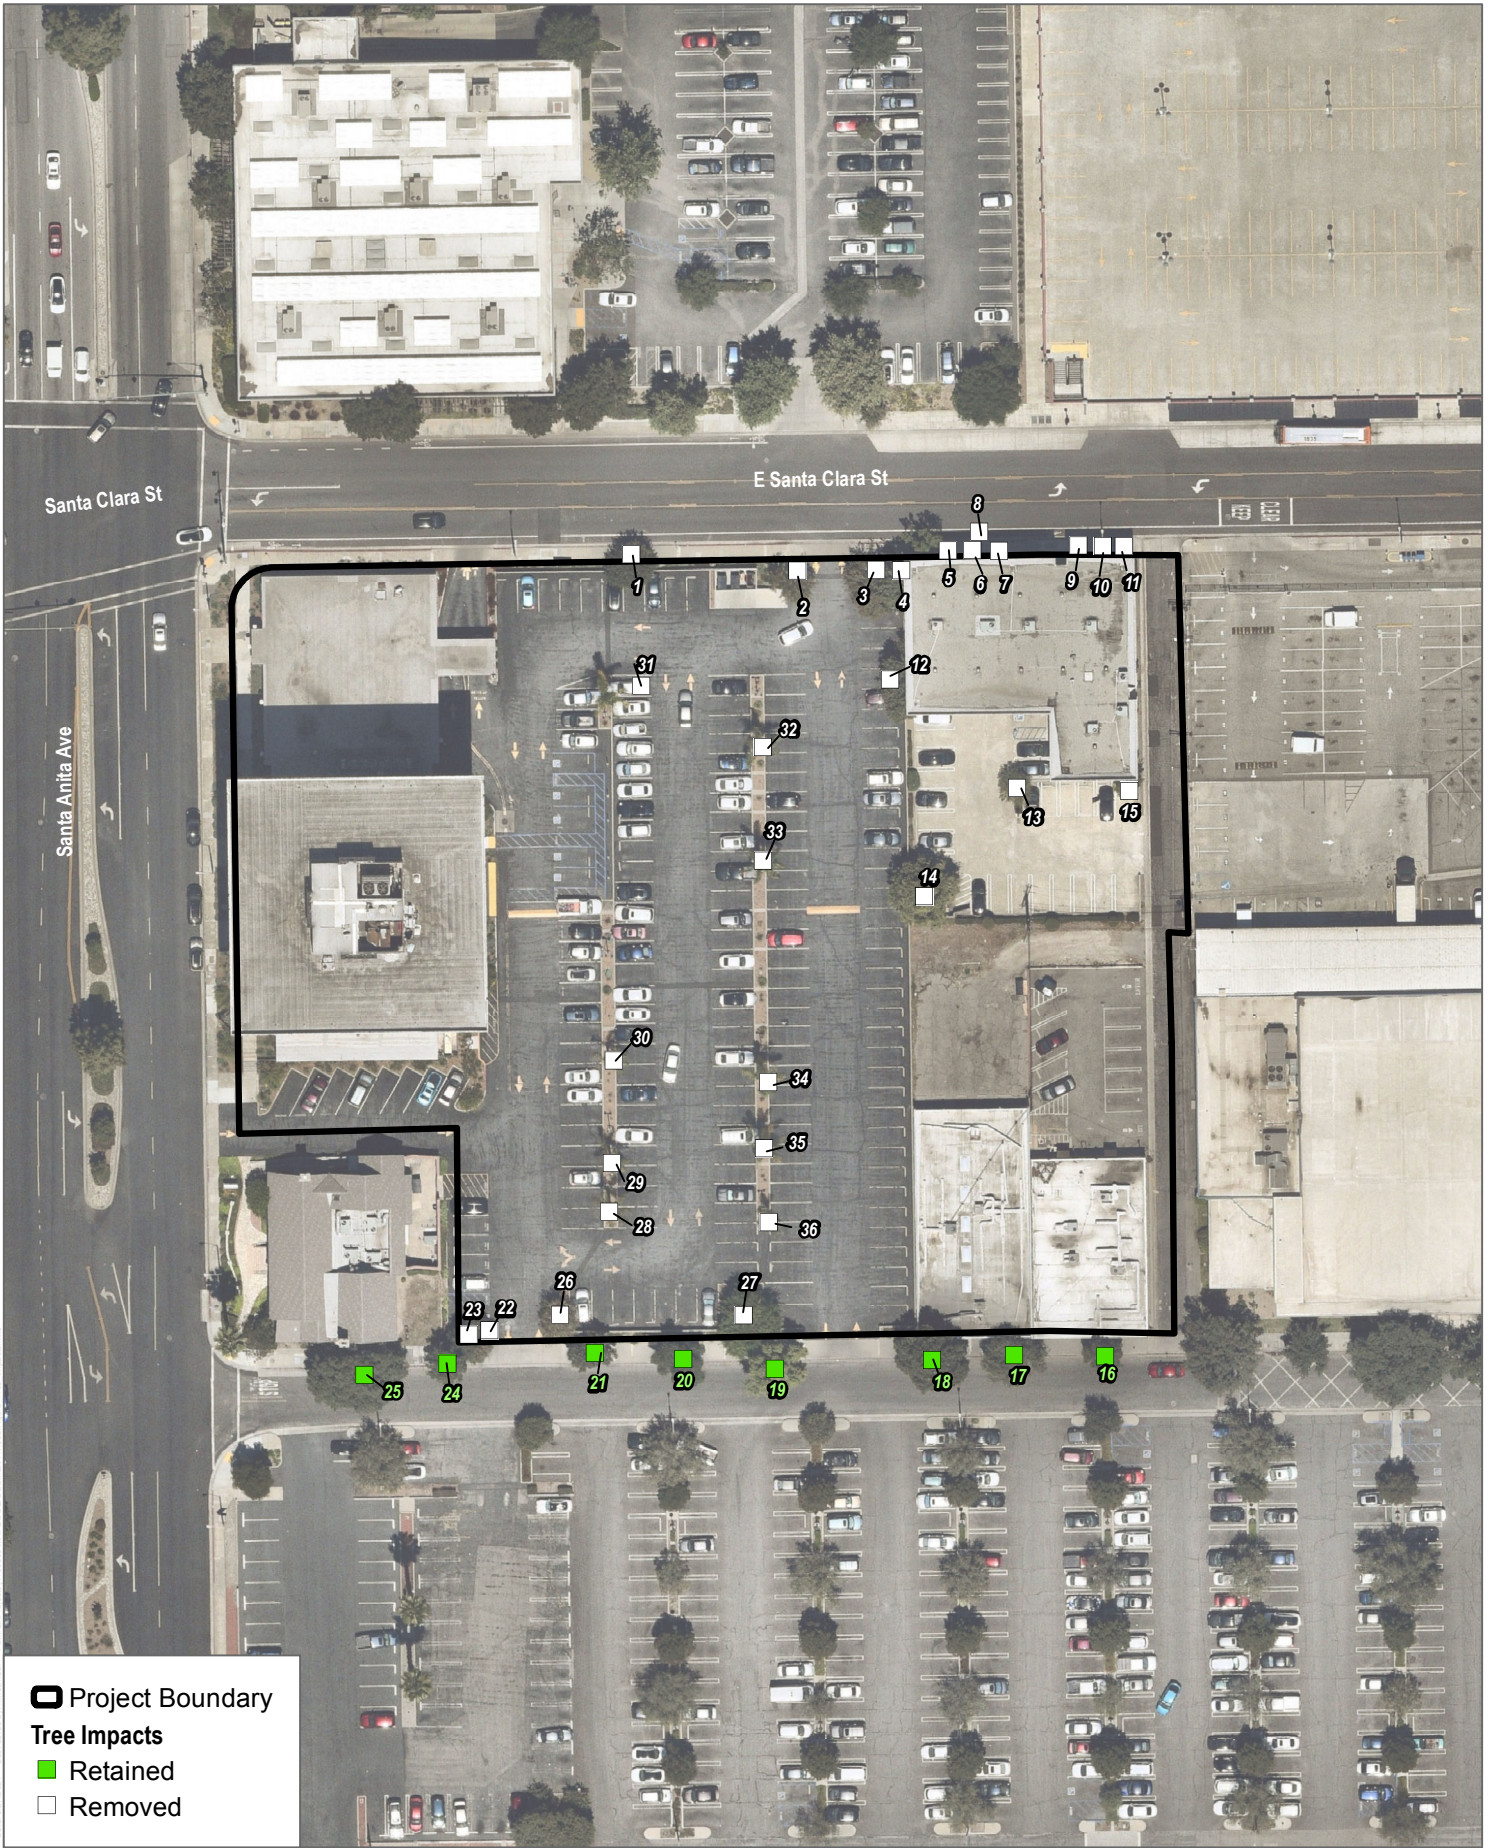
Tree Impact Exhibit

Tree removal is necessary to accommodate the construction of two above-ground parking areas, within Levels 1 and 2 of the building, and up to two subterranean parking levels. Tree removal is more desirable than alternative project designs as it would present unreasonable constraints that would make site development not feasible. Based on grading and development plans for the proposed Project, it is estimated that seven (19.4%) protected trees and 21 (58.3%) non-regulation trees will be removed.

Project disturbance is expected to encroach on the protected zone of 8 (22.2%) off-site protected street trees. The proposed Project site plan has the potential for direct impacts to all of the trees within survey area, whether through removal for all on-site trees or through encroachment through construction activities that could impact street trees.

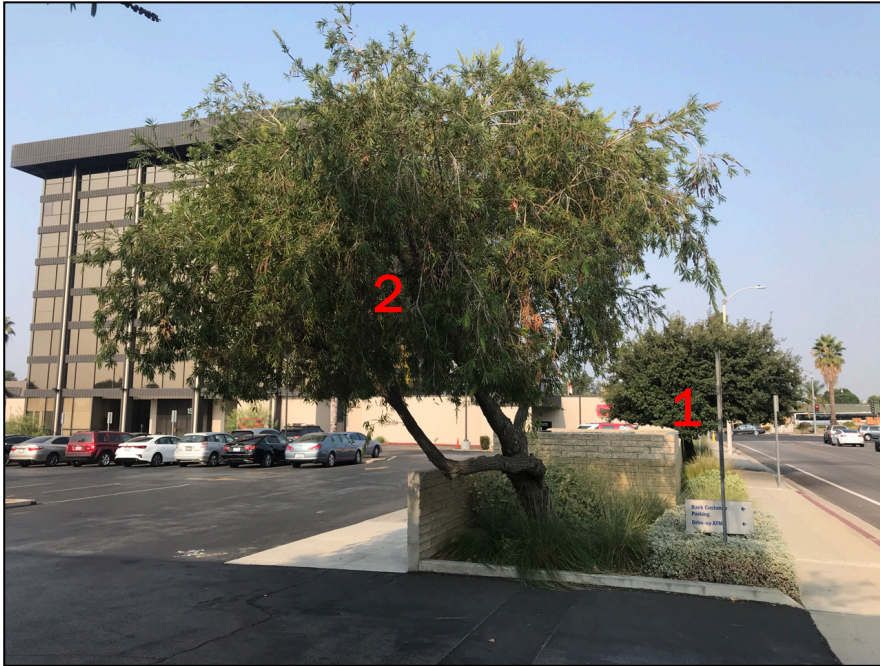
Photo #1. Representative photograph of tree nos. 1 and 2 on Santa Clara Ave.

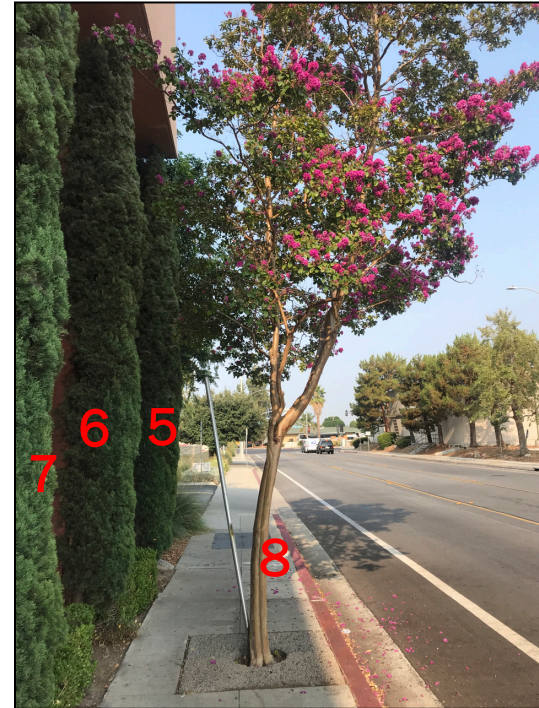
Photo #2. Representative photograph of tree nos. 5, 6, 7, and 8 on Santa Clara Ave.

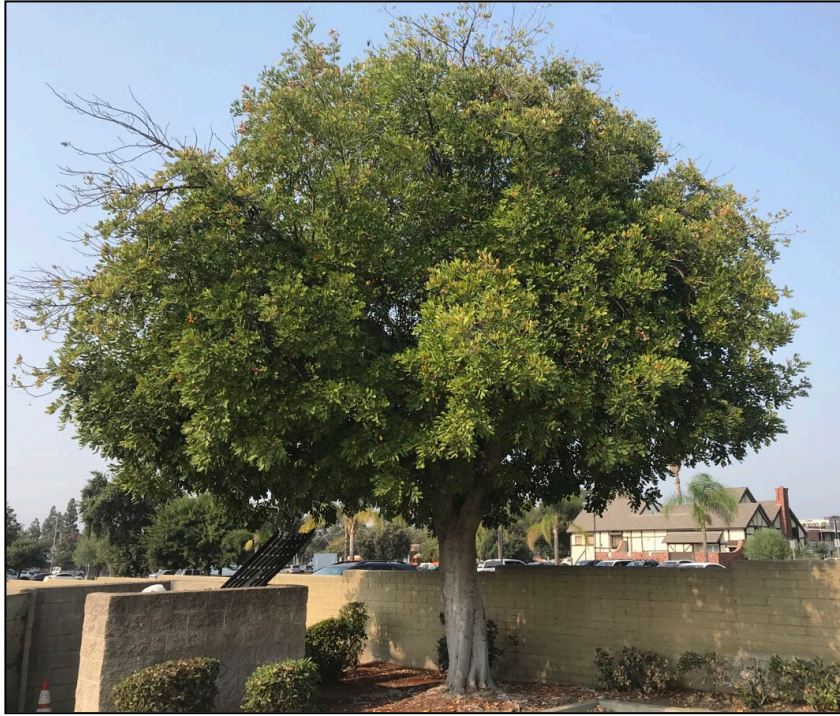
Photo #3. Representative photograph of tree no. 14 located in east end parking lot.

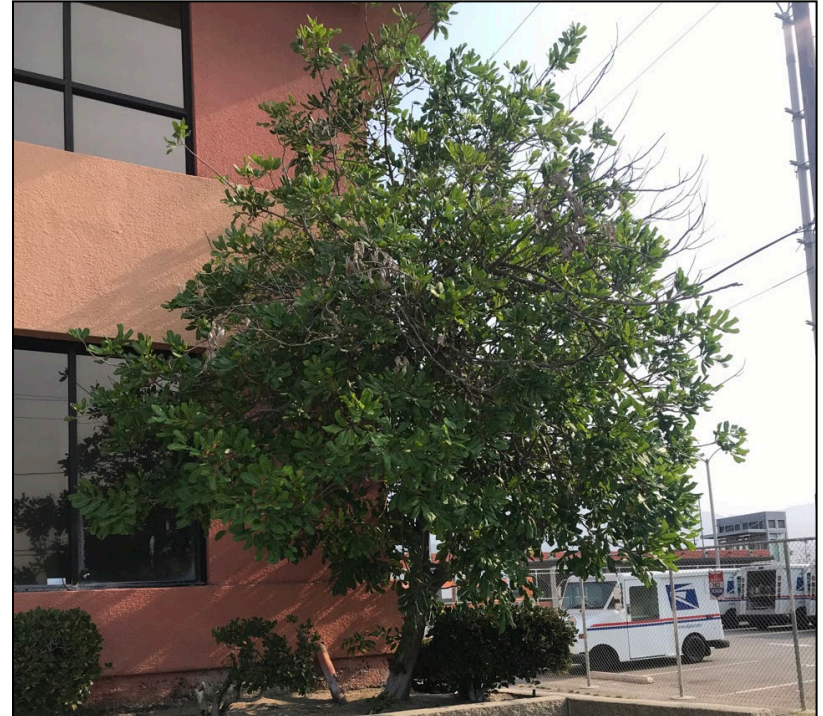
Photo #4. Representative photograph of tree no. 15 located in east end parking lot.

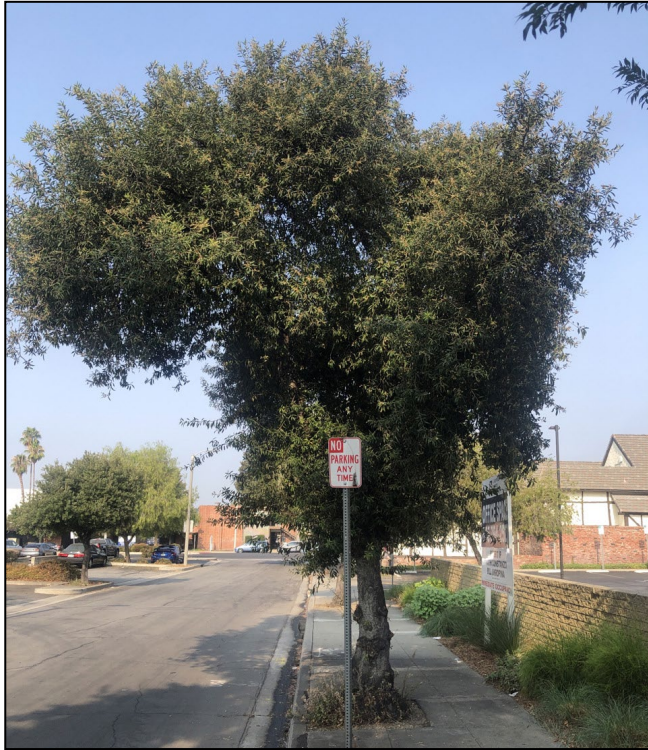
Photo #5. Representative photograph of tree no. 20 located on Wheeler Ave.

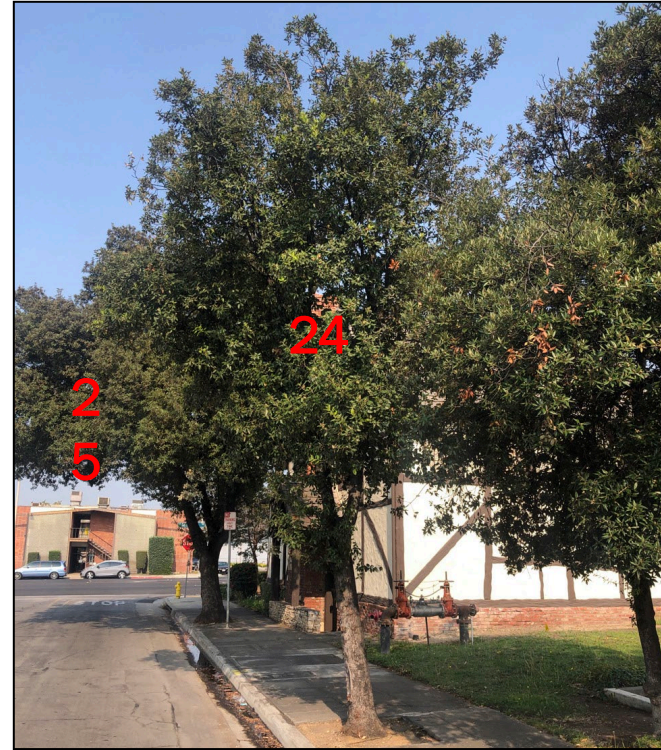
Photo #6. Representative photograph of tree nos. 24 and 25 located on Wheeler Ave.

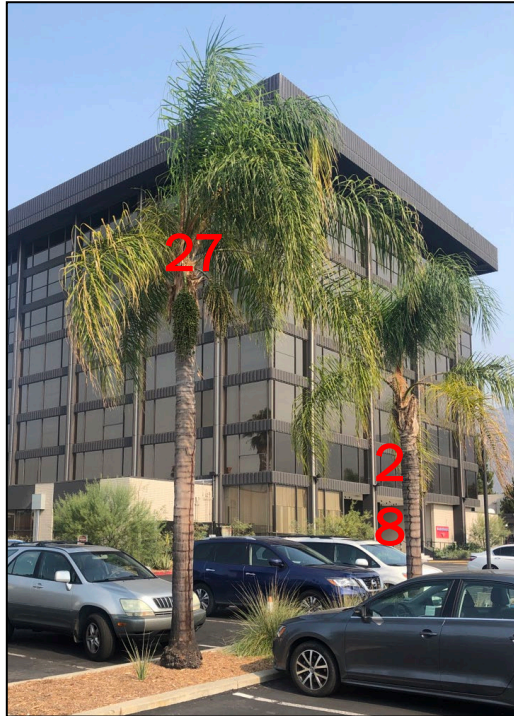
Photo #7. Representative photograph of tree nos. 27 and 28 located in bank parking lot.

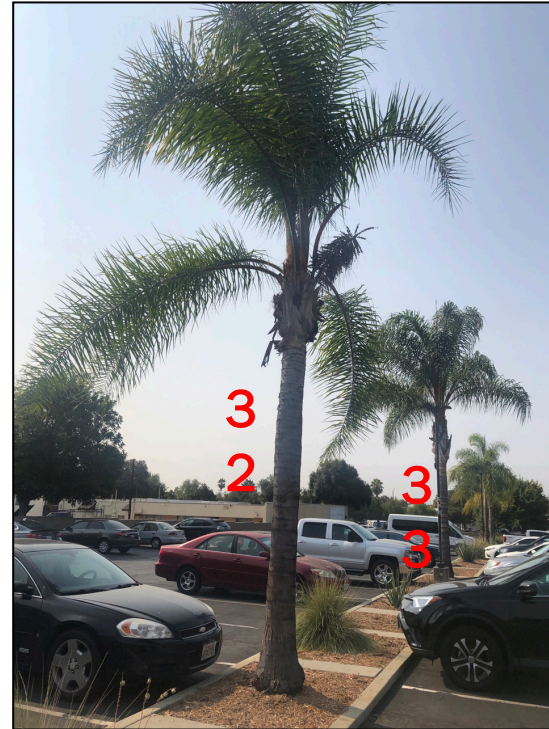
Photo #8. Representative photograph of tree nos. 32 and 33 located in bank parking lot.
