Appendix F-3

Asbestos Survey Report

April 22, 2021
698-24

**ASBESTOS SURVEY REPORT
33 WHEELER AVENUE, 25 WHEELER AVENUE
AND 30 EAST SANTA CLARA STREET
ARCADIA, CALIFORNIA**

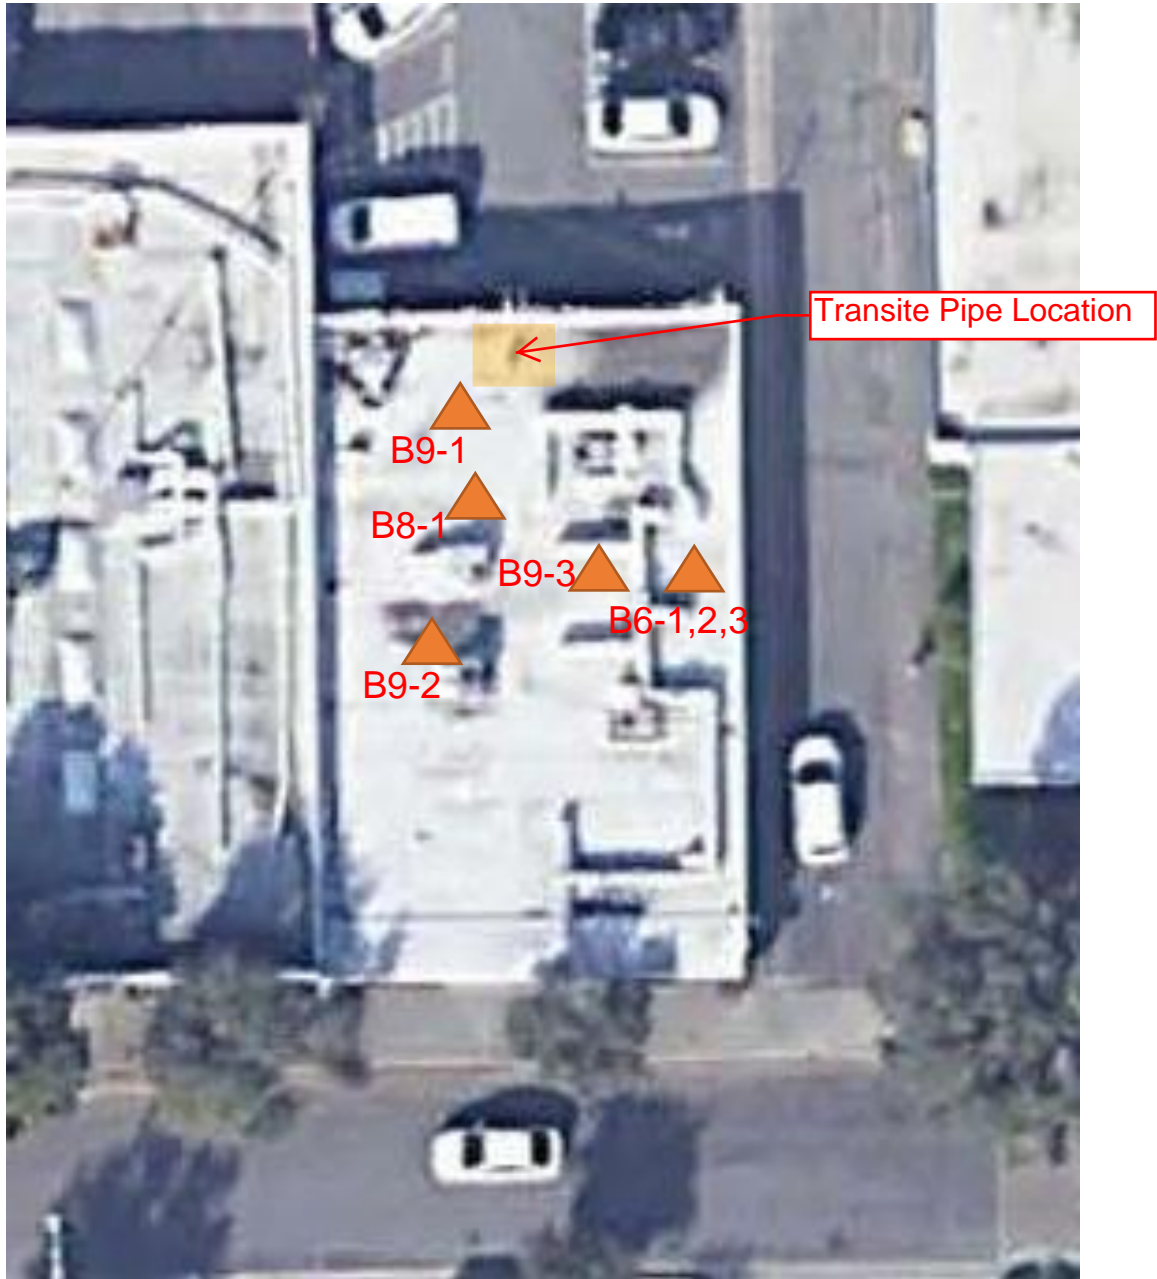
FIGURE 1
SITE SKETCH SHOWING
ACM LOCATIONS AT
33 WHEELER AVENUE
ARCADIA, CALIFORNIA

- Samples collected from floor tiles and floor tile mastic were reported to contain asbestos at concentrations greater than 1% in both the 9”x9” floor tile and the black mastic. These materials were judged to be non-friable and were generally observed to be present in an undamaged condition at the time of the survey.

- Samples collected from black carpet mastic in the were reported to contain asbestos in concentrations greater than 1%. These materials were judged to be non-friable and were generally observed to be present in an undamaged condition at the time of the survey.

- Samples collected from spray-applied acoustic ceiling texture were reported to contain asbestos in concentrations greater than 1%. These materials were judged to be friable and were generally observed to be present in an undamaged condition at the time of the survey.

- Samples collected from roof mastic were reported to contain asbestos in concentrations greater than 1%. These materials were judged to be non-friable and were generally observed to be present in an undamaged condition at the time of the survey.

- Two 4-inch diameter asbestos-cement pipes (Transite) was observed on the roof of the 33 Wheeler Avenue building. This material is assumed to contain asbestos. The material was judged to be non-friable and was observed to be present in an undamaged condition at the time the survey was conducted.

- Materials reported to contain asbestos (ACMs) should be removed by a qualified asbestos abatement contractor prior to conducting any work that may disturb this material including maintenance activities, building renovation, or demolition.

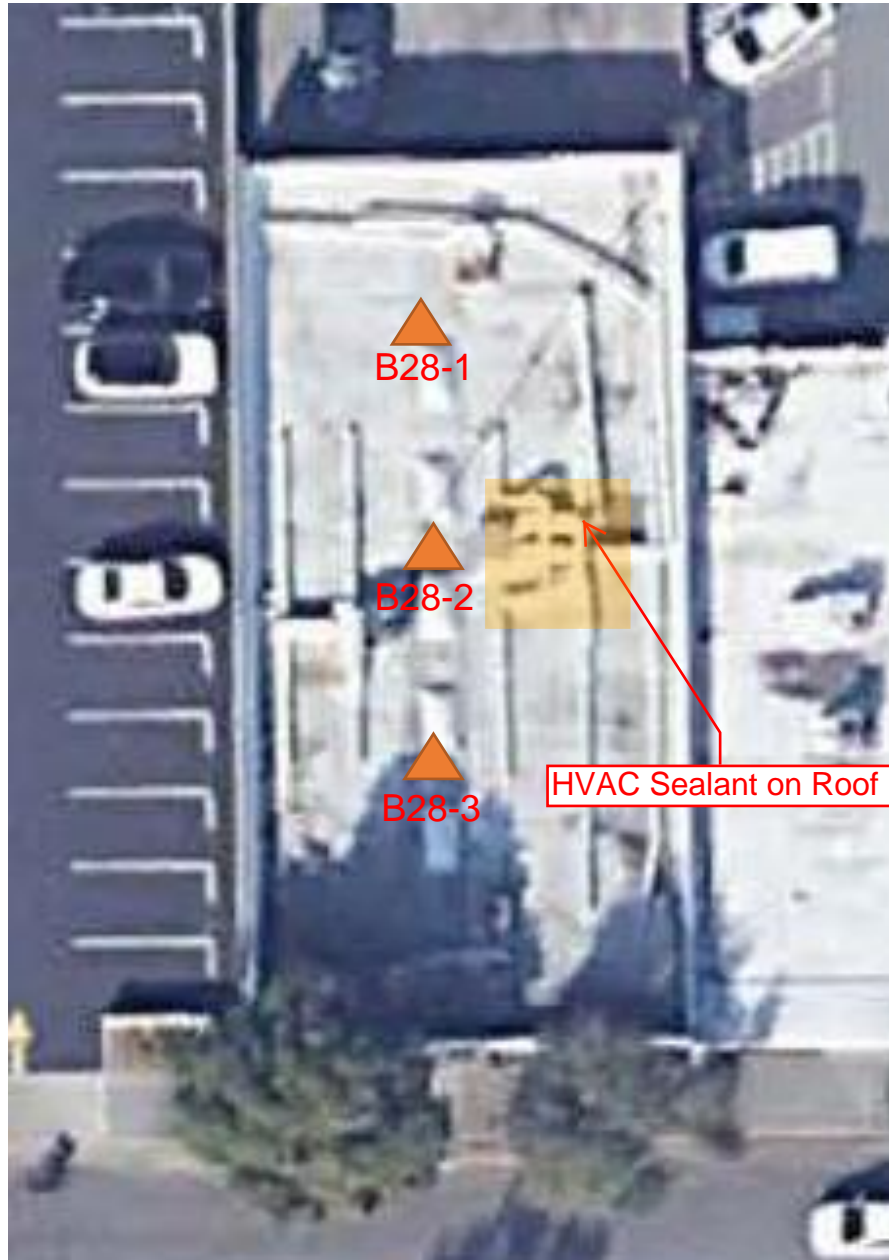
FIGURE 2
SITE SKETCH SHOWING
ACM LOCATIONS AT
25 WHEELER AVENUE
ARCADIA, CALIFORNIA

- Samples collected from HVAC Sealant on the roof HVAC system were reported to contain asbestos in concentrations greater than 1%. These materials were judged to be non-friable and were generally observed to be present in an undamaged condition at the time of the survey.
- Samples collected from spray-applied acoustic ceiling texture were reported to contain asbestos in concentrations greater than 1%. These materials were judged to be friable and were generally observed to be present in an undamaged condition at the time of the survey.

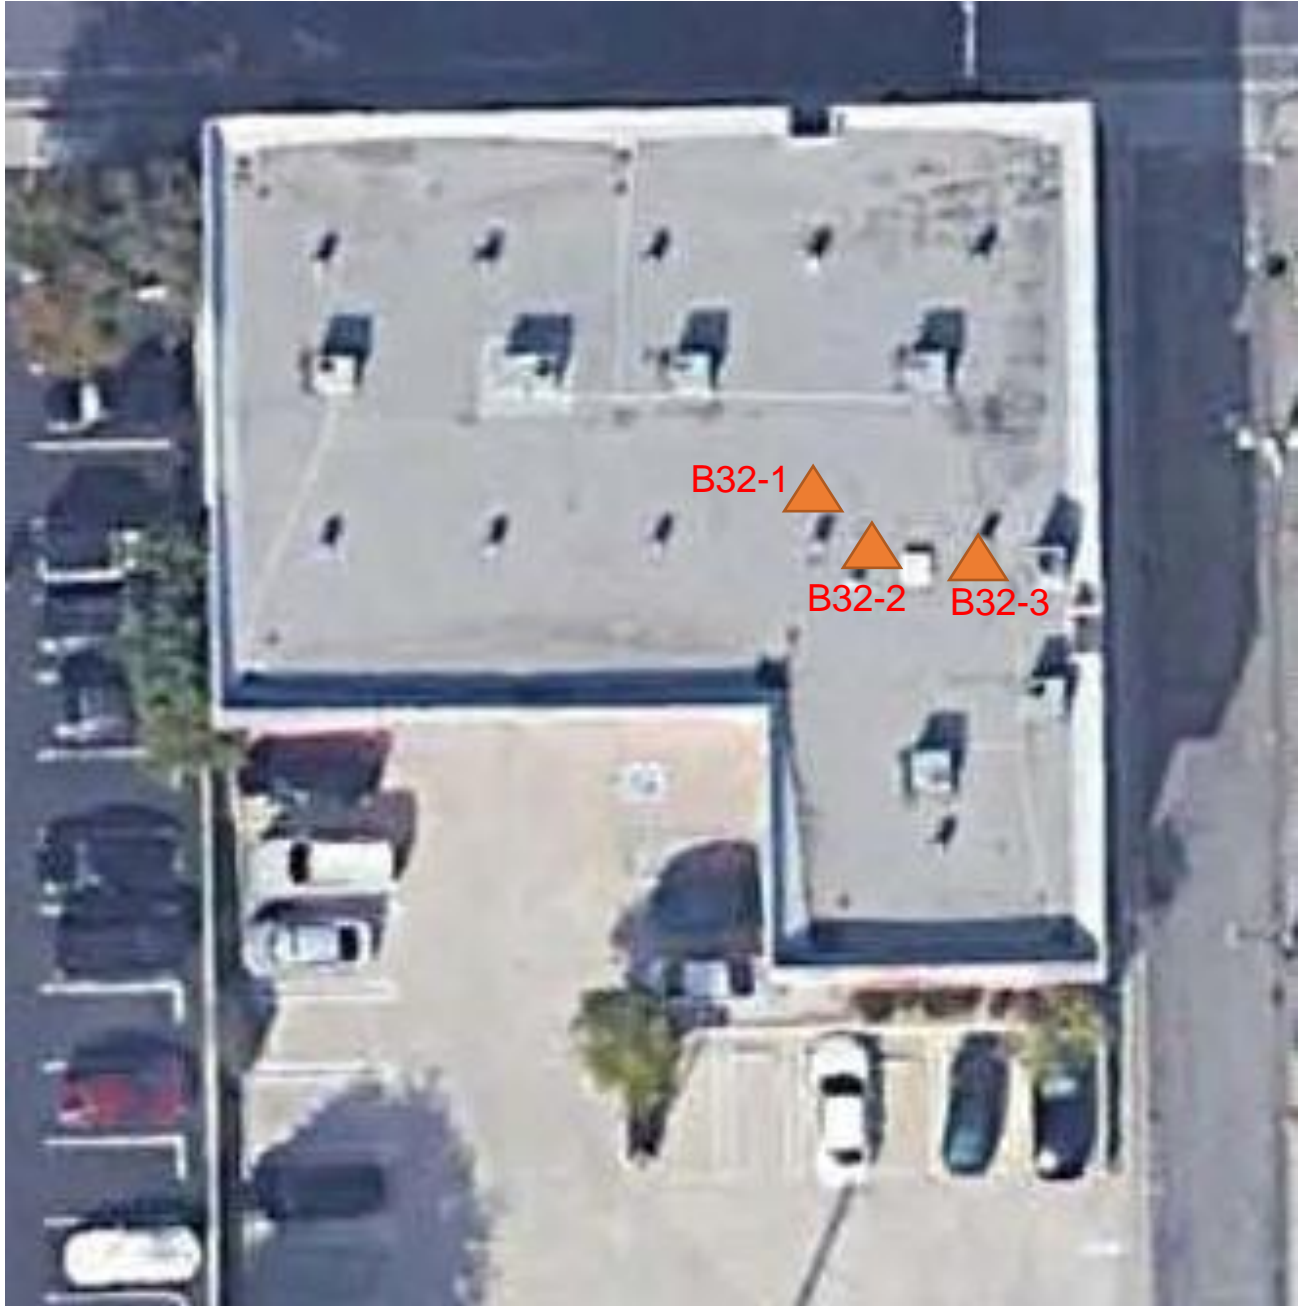
FIGURE 3
SITE SKETCH SHOWING
ACM LOCATIONS AT
30 SANTA CLARA STREET
ARCADIA, CALIFORNIA

- Samples collected from roof mastic were reported to contain asbestos in concentrations greater than 1%. These materials were judged to be non-friable and were generally observed to be present in an undamaged condition at the time of the survey.
