2016 Tree Report, 2020 Tree Survey and
Update Memorandum, and 2021 Tree
Survey Update Memorandum

TREE REPORT

1251 N. Spring Street

October 31, 2016

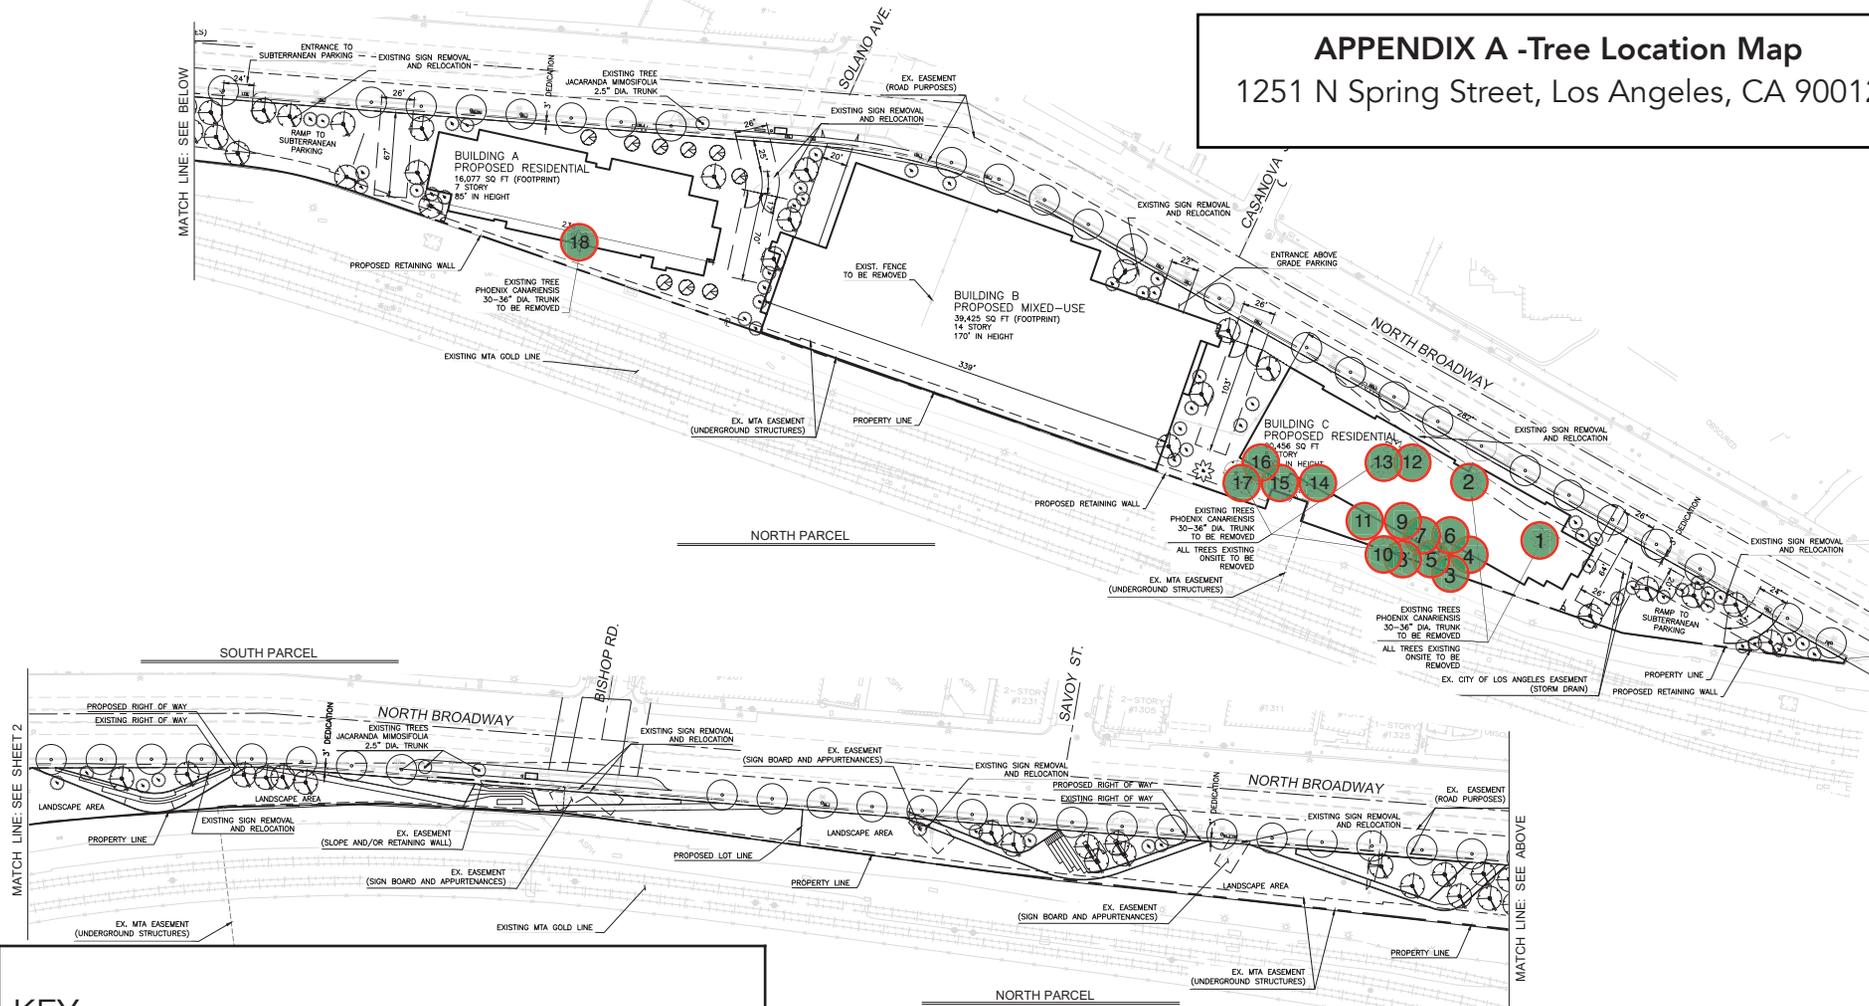
APPENDIX A - Tree Location Map

At this time, I observed twenty (20) **Non-Protected Significant Trees** on the property. All twenty (20) of these trees will be impacted by construction and are recommended for removal and mitigation to the satisfaction of the City of Los Angeles Department of City Planning.

The proposed construction for this project will require extensive grading and soil work to the site. Due to the narrow nature of the site, all the trees on site will be impacted by the proposed construction. These trees are recommended for removal and mitigation to the satisfaction of the City of Los Angeles.

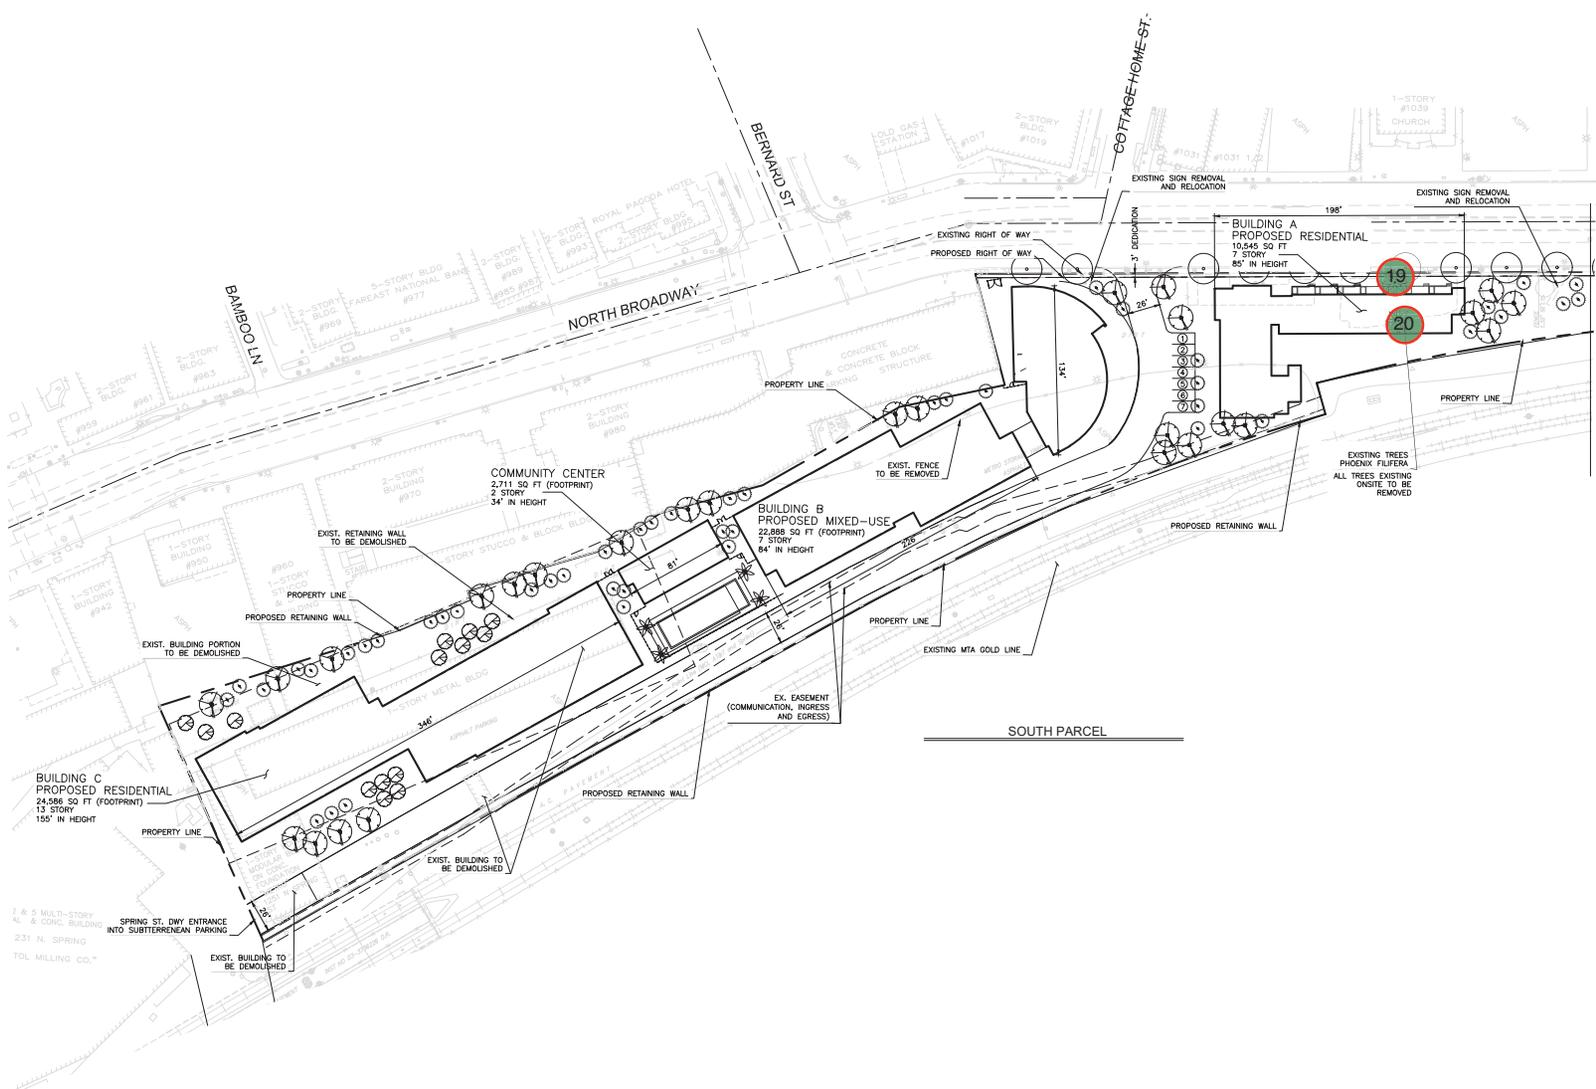
EXISTING TREES
PHOENIX FILIFERA
ALL TREES EXISTING
ONSITE TO BE
REMOVED

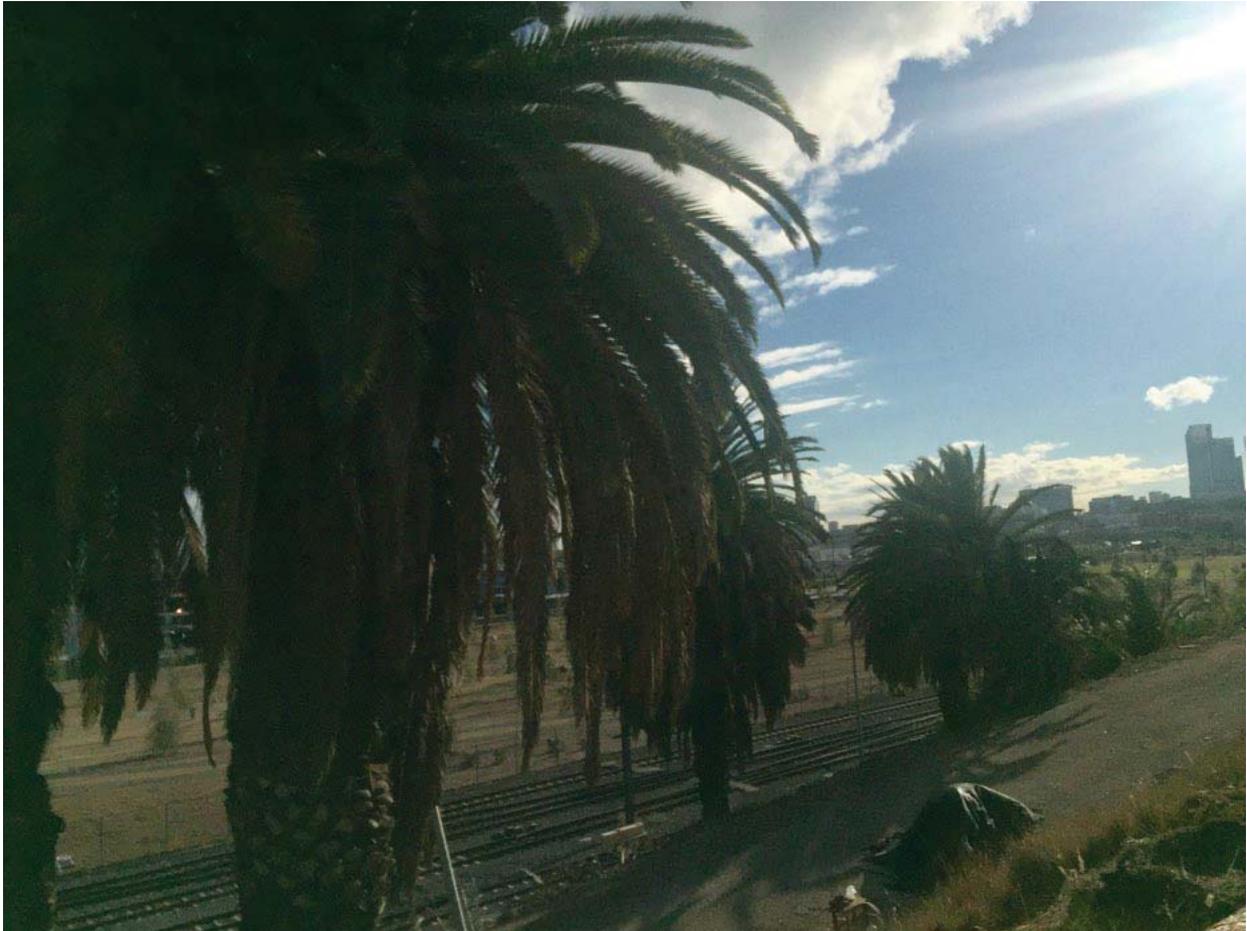
PHOTO 1. shows the subject property and the Canary Island palms on the property.

All (20) twenty trees are recommended for removal due to the proposed footprint of the new project combined with the required grading and soil work.

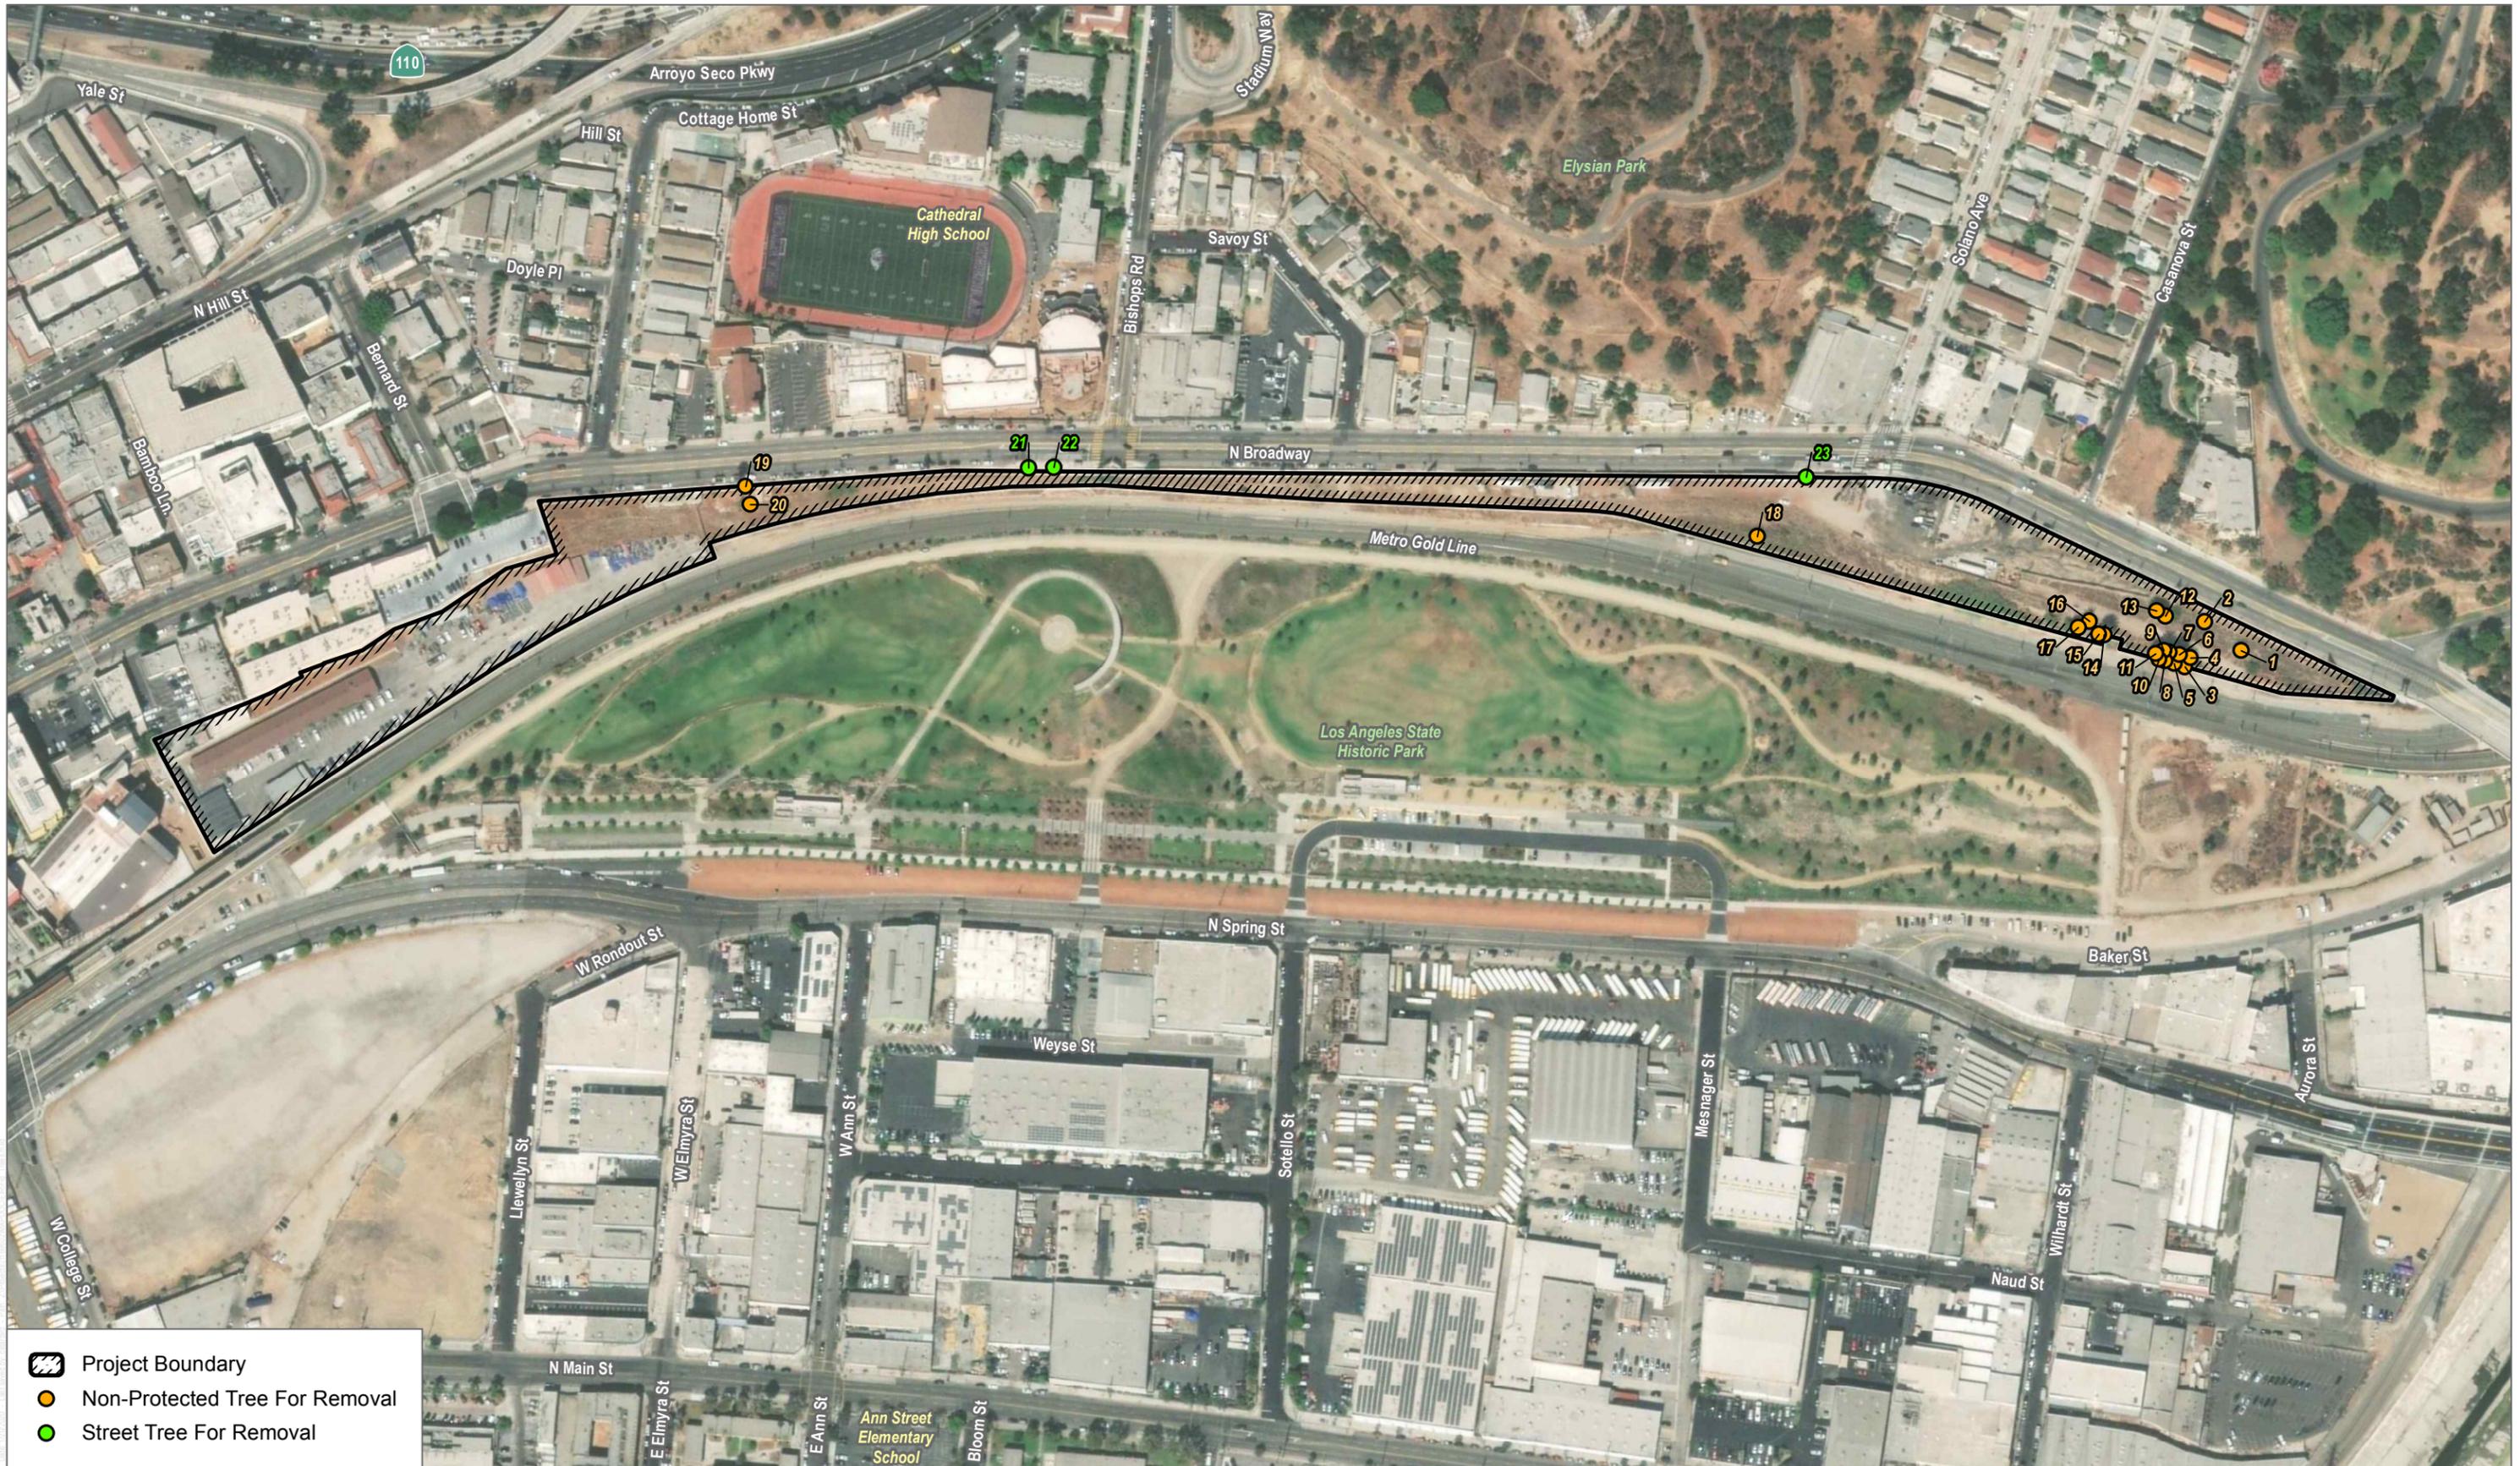
Att.: *Appendix A Tree Locations*
Appendix B Tree Information Matrix

The evaluation of the 20 trees at 1251 N. Spring Street reflect that the inventoried trees conditions are consistent with those of the initial assessment detailed in the arborist report dated October 31, 2016. The tree species, locations, and status as a Los Angeles City Protected Tree were found to be in agreement with the original report. The current diameter at breast height (DBH) and height of the inventoried trees is consistent with expected growth patterns of the inventoried trees over a three year period. The updated DBH and height conditions are provided in Attachment B, Tree Information Matrix.

In addition, three jacaranda (*jacaranda mimosafolia*) trees were inventoried, that were not reported in the original inventory. The two trees located by the bus stop on N. Broadway by Bishops Rd. have had their main stems broken, and are generating new growth as 'stump sprouts'. Their current condition does not make them viable as street trees as they will continue to grow with a structure that is not suitable for the public right of way. The third tree located by the bus stop on N. Broadway by Solano Rd. is approximately 9' tall and 5' wide, with a 2" diameter at standard height. The tree has fair health and poor structure.

In conclusion, this report concurs with the 2016 assessment that no mitigation or replacement is required for the 20 trees located on the property at 1251 N. Spring St. based on the standards of the City of Los Angeles Protected Tree Ordinance #177404. The three trees existing in the public right of way are subject to a replacement ratio determined by the City of Los Angeles Urban Forestry Division as stated in the City of Los Angeles Department of Public Works 'Permit for Tree Removal'.
