IconEcho Resi & Office Tower
147 E. Santa Clara St.

Arborist Report

April 16, 2021

Arborist Report
IconEcho Resi & Office Tower
147 E. Santa Clara St.
San Jose CA

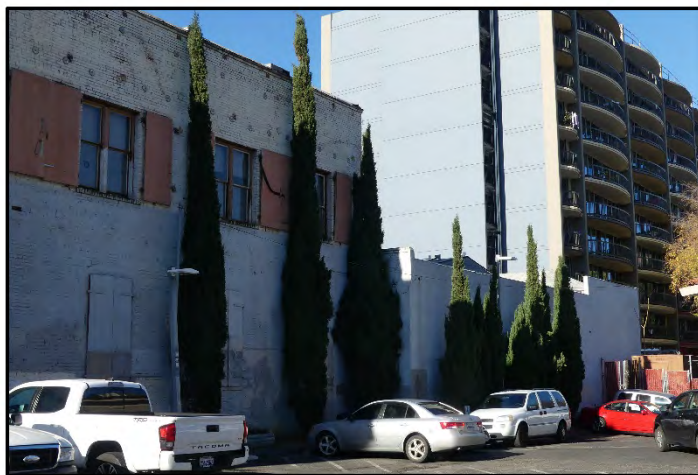
Italian cypresses #260 – 269 were located on the west side of the site in the gasoline station (Photo 1). Trees were installed in a narrow planting at or near the property line. Cypresses #260 – 262 were taller than the others with typical form and structure. Canopies of these three trees were one-sided to the east. Their condition was good.

Photo 1. Looking west at Italian cypresses #260 – 269 (left to right).

Trees #263 – 269 had been topped near ground level and allowed to resprout. Canopy density was normal. Condition of trees #263 – 269 was fair due to the topping.

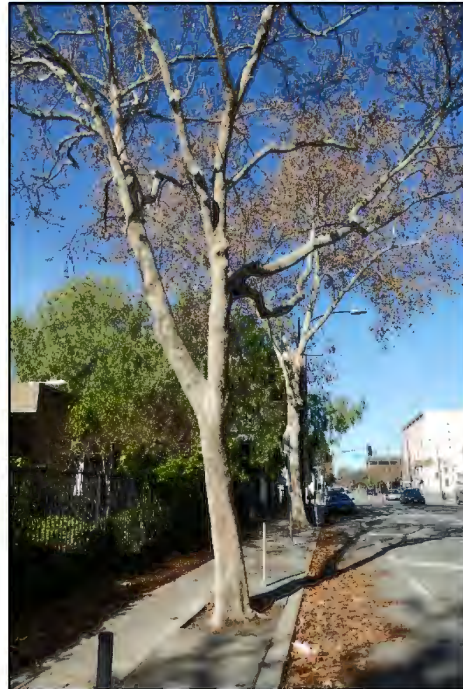
Nine London planes were street trees along 4th and E. Santa Clara Streets (Photo 2). Trees were semi-mature and mature in development with trunk diameters between 10 and 22 in. All were located in cutouts in the sidewalk. Tree condition was variable, ranging from fair (#253, 254, 255, 258, 259) to good (#251, 282) to excellent (#250, 257). Factors influencing tree condition included vigor and structure. Trees in fair condition lacked vigor and had poor structure including codominant and multiple attachments.

Photo 2. Looking north along 4th Street at London planes #251 (foreground) and #250.

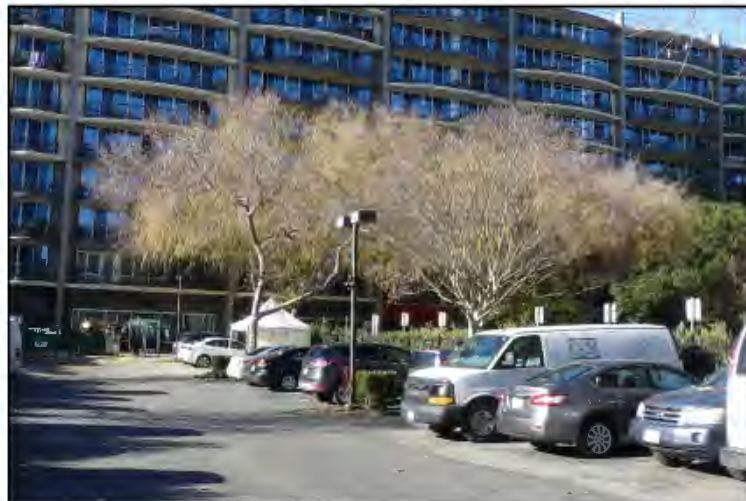
Five Chinese elms were located in the parking lot area (Photo 3). Trees were generally mature in development with trunk diameters between 13 and 21 in. Elms #274 and 276 were in fair condition while #277, 278 and 279 were good. All trees had somewhat irregular crowns and had lost the center leader.

Photo 3. Chinese elm #274 (left) and crape myrtle #275 (right) were among trees located in the parking area.

Crape myrtles #270, 272, 273 and 275 were also located in the parking area, interspersed with the Chinese elms (Photo 3). Trees were mature in development with trunk diameters of 6 to 8 in. All crape myrtles were in excellent condition.

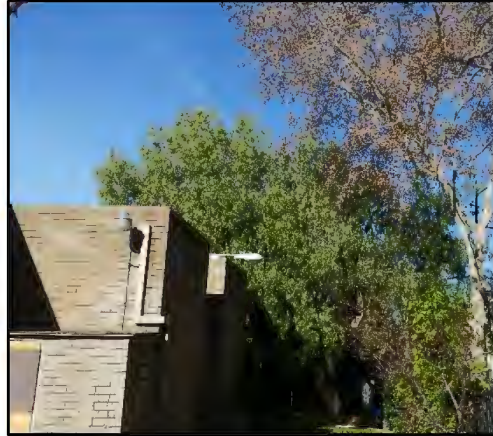
- Almonds #288 and 289 were small trees in fair condition. Neither tree was Ordinance site.
- Australian willow #284 was a multi-stem tree in poor condition (Photo 4). The stems arose at one point on the trunk and leaned away from one another. The tree had been topped one or more times resulting in poorly attached resprouts.

Photo 4. Looking north at Australian willow #284.

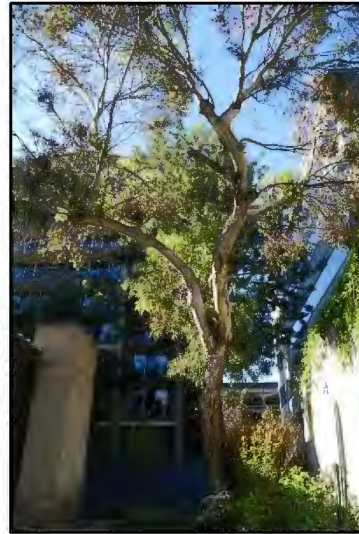
- White ironbark #285 was a large mature tree with a trunk diameter of 22 in. (Photo 5). Tree condition was poor due largely to a history of reduction pruning.

Photo 5. Looking west at white ironbark #285.

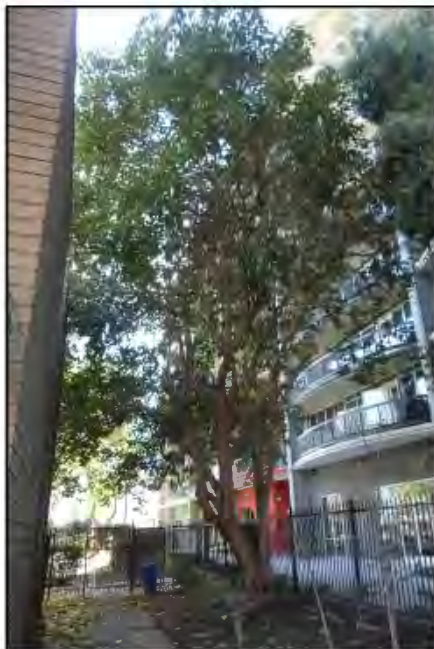
- Glossy privet #290 was a mature tree with numerous stems that arose near ground level (Photo 6). Tree condition was fair.

Photo 6. Looking south at glossy privet #290.

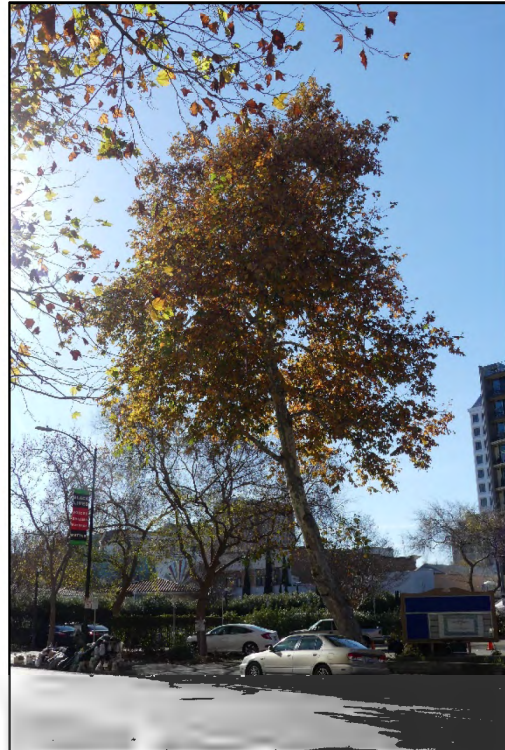
- Mulberries #280, 281 and 283 were mature trees with trunk diameters of 9, 11 and 11 in. respectively. All were in fair condition having been topped annually and allowed to resprouted. No decay was observed in the topping points.
- Plum #271 was a very small tree in fair condition.
- Silk oaks #286 and 287 were small seedings of 2 and 3 in. Both were in excellent condition.
- Sweetgum #291 was 10 in. and in good condition.
- Western sycamores #252 and 256 were street trees along 4th Street (Photo 7). Trunks diameters were 25 and 18 in. respectively. Tree #252 was in excellent condition while #256 was fair.

Photo 7. Looking west across 4th Street at western sycamore #252.
