Revised Preliminary Arborist Report

**Middlefield Park
Mountain View, CA**

PREPARED FOR
Google, Inc.
1600 Amphitheatre Parkway
Mountain View, CA 94043

April 23, 2021
Revised January 26, 2022

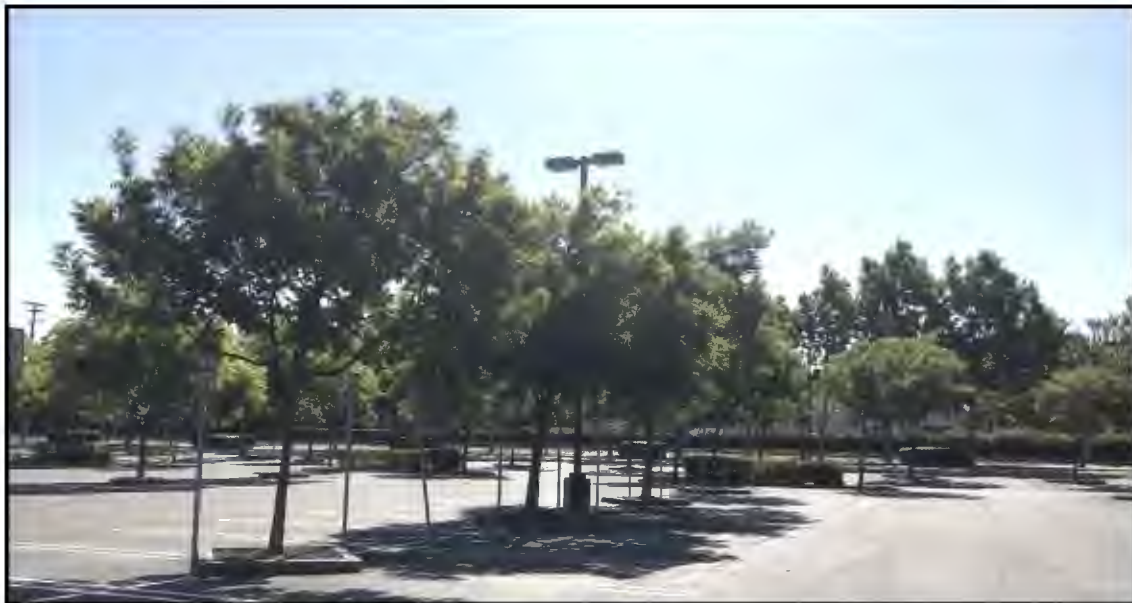
Photo 1: Chinese pistache was the most common species assessed. The pistache trees were primarily growing in parking lot planters.

trees had multiple or codominant branching originating from a single point and were primarily growing in small parking lot planters (Photo 1).

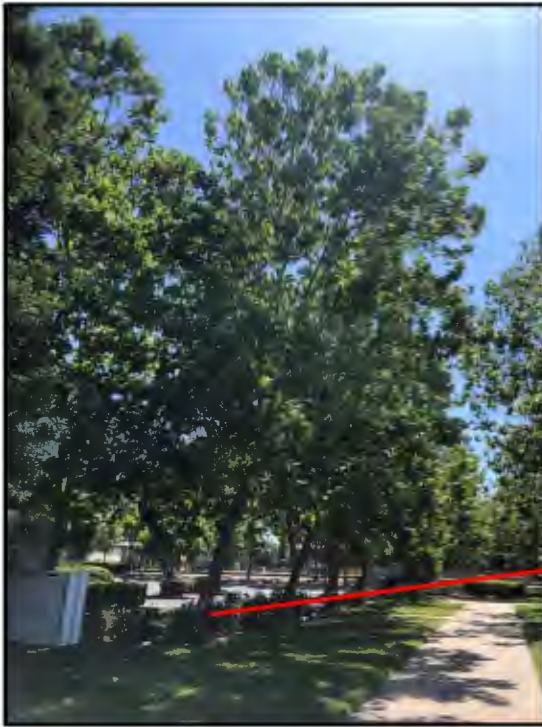
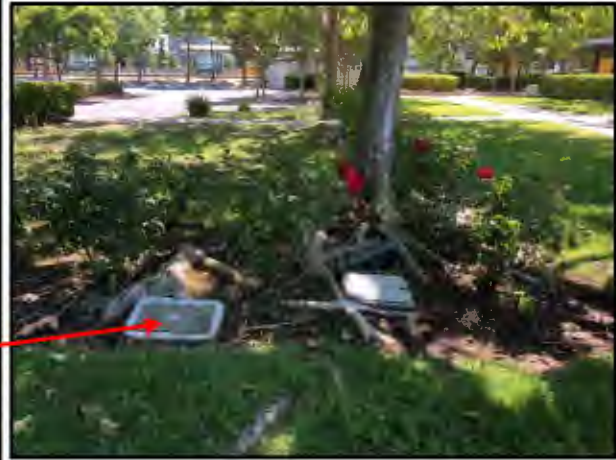
One hundred twenty-two (122) London plane trees were evaluated (12% of population). London planes were generally in fair (74 trees) and good (38 trees) condition, with eight trees in poor condition. Trees were primarily semi-mature in development (average trunk diameter 10 inches) with trunk diameters ranging from 2 to 17 inches. Over half of the trees had surface roots which were often significant in size. The large roots created conflicts with electric and irrigation valve boxes (Photos 2 & 3, next page).

Photos 2 & 3: London plane trees were often leaning and had surface roots. London plane #564 had a 15 inch trunk diameter, was leaning to the west and had large surface roots near utility boxes.

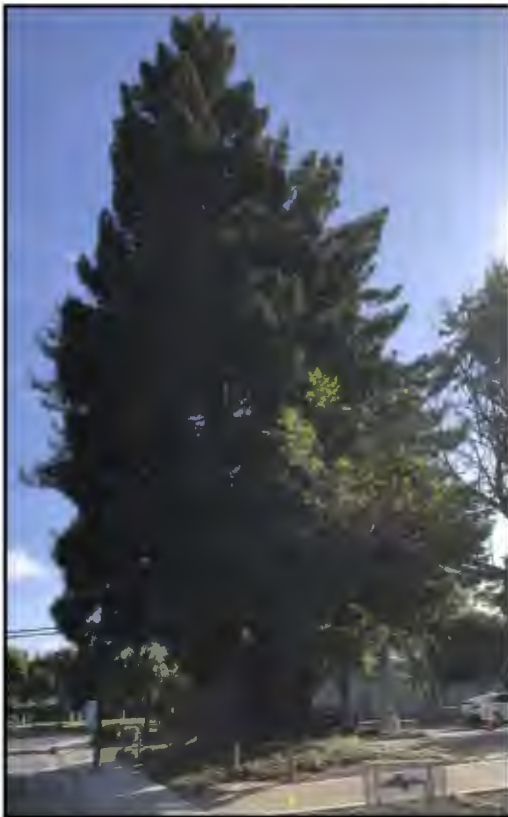
Among 104 coast redwoods 51 trees were in good condition, 31 were fair, and 22 were poor. Trees ranged from young (5 inches trunk diameter) to large trees (80 inches trunk diameter) with an average trunk diameter of 30 inches. Coast redwoods were often in small groves and had dense canopies with good color. The coast redwoods were the largest trees assessed. Three of the largest redwoods include #307, 34 and 220 with corresponding trunk diameters of 60, 70 and 80 inches.

Photo 4 (left): Coast redwoods were often growing in groves. Redwoods #218, 219 and 220 had trunk diameters of 45, 26 and 80 inches.

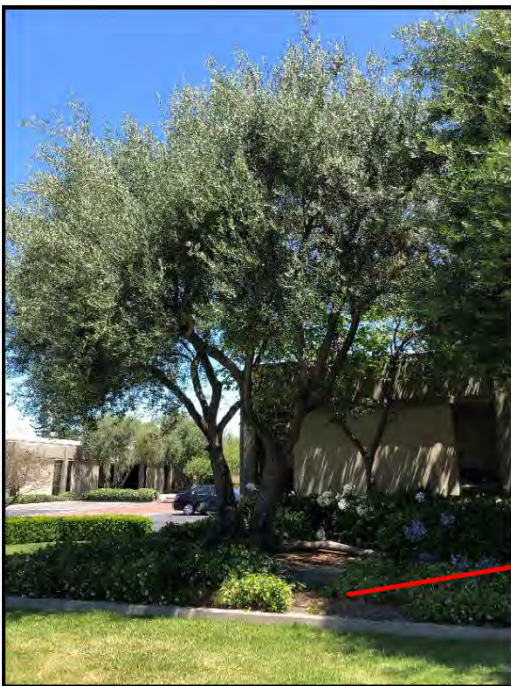
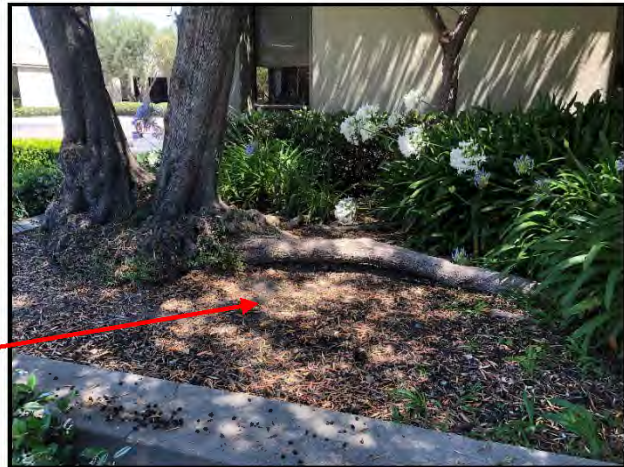
Twenty of 26 olives were in fair condition. Two olives were in good condition and four were poor. Olives were semi-mature, multiple trunk trees with an average trunk diameter on 7 inches. Twelve olives were off-site trees and many of those were growing in a hedge. Five olives were growing in a raised planter (Photos 5 & 6).

Photos 5 & 6: Olive #329 had codominant trunks (18 and 14 inches) originating from the base. It was growing in a raised planter and had large surface roots extending north and west.

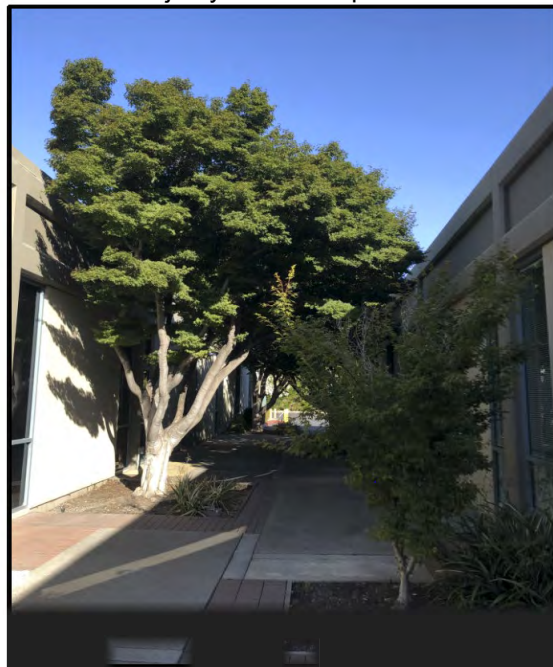
Fifteen (15) Japanese maples were young to mature in development (average trunk diameter 12 inches) with trunk diameters ranging from 4 to 18 inches. The maples were in fair (9 trees) to good (4 trees) condition with two trees in poor condition. The majority were multiple trunked and growing in hedges between buildings.

Photo 7: Japanese maple #14 had a 17 inch trunk diameter measured below the multiple attachments. The canopy was one-sided to the west, away from the building.

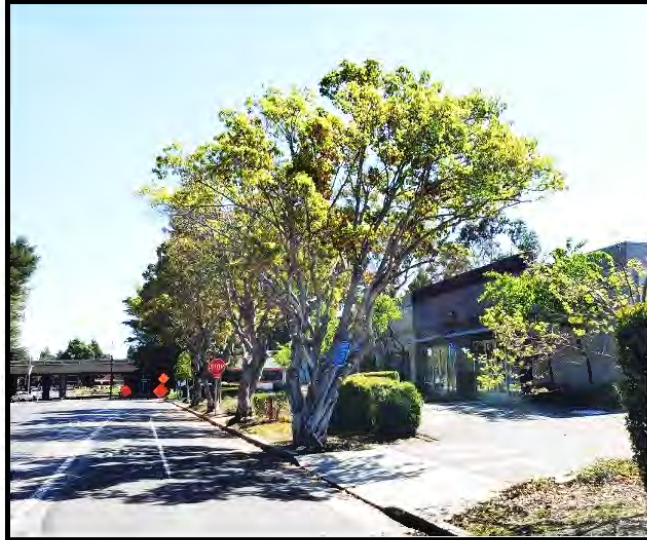
Photo 8: Evergreen maples #1030 – 1027 (left to right) were street trees growing along Maude Avenue.
