Tree Survey and Arborist Report

for the Ventana Specific Plan

In the City of Fontana, County of San Bernardino, California

Report Date: July 4, 2021

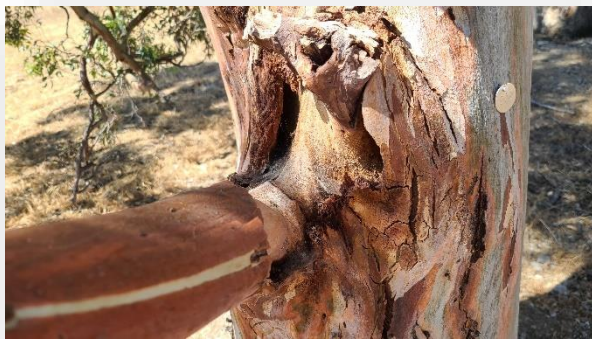
Plate 2. This a view of a cavity with internal decay above a branch collar (#902).

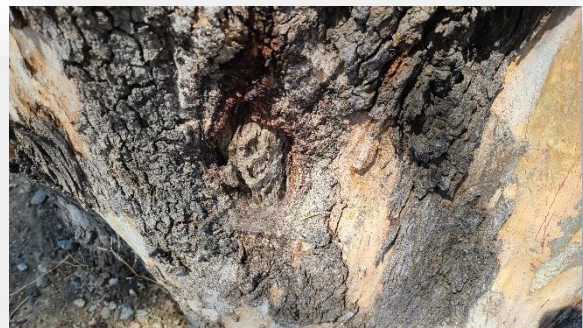
Plate 3. This is a view of internal deadwood with evidence of termites and borings (#903).

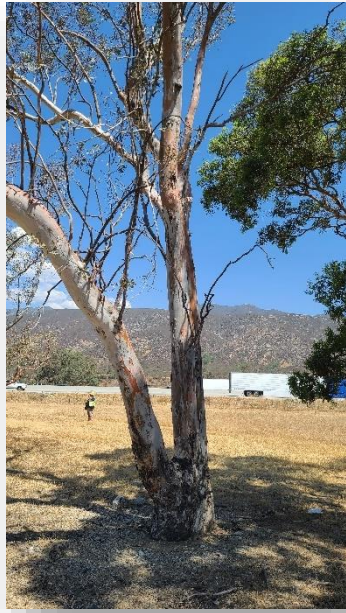
Plate 4. This is a view of a tree with a co-dominant stem (#903).

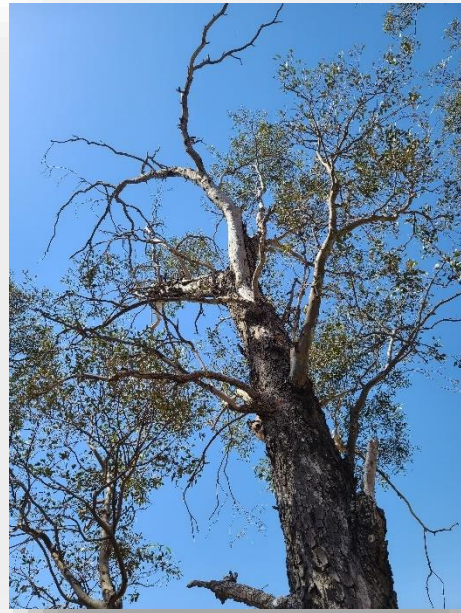
Plate 5. This is a view of upper canopy deadwood of a tree in decline (#906).

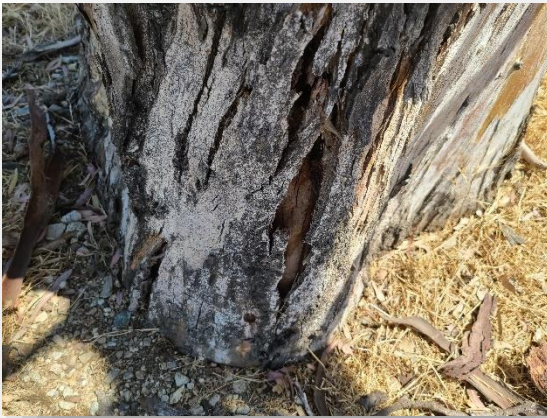
Plate 6. This is a view of exposed deadwood beneath infected tissue (#907).

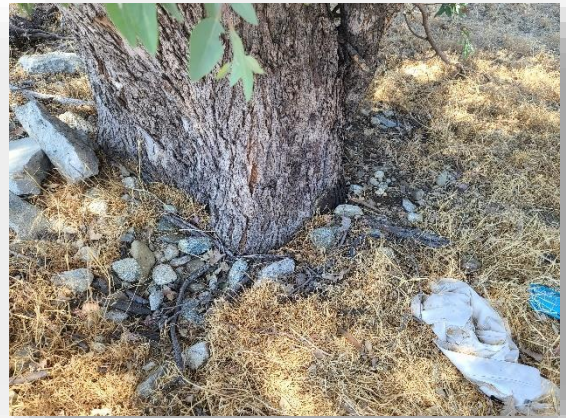
Plate 7. This is a view of stained soil at the base of a tree likely due to disposed motor oil (#912).

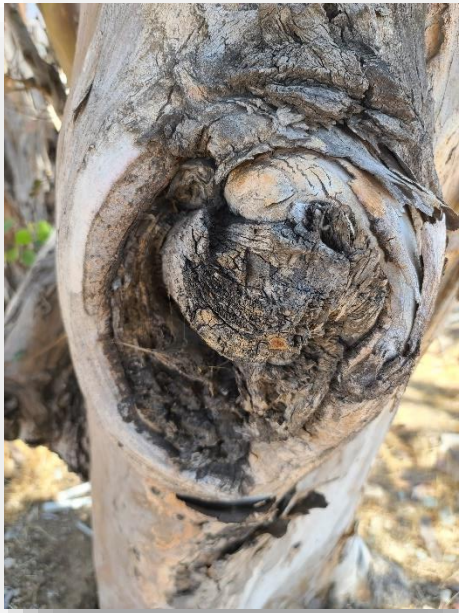
Plate 8. This is a view of decayed wood within an unclosed branch cut (#917).

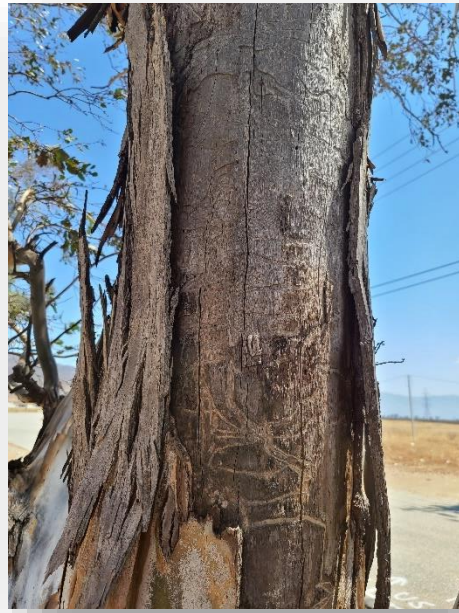
Plate 9. This is a view of a gallery produced by a borer (#916).

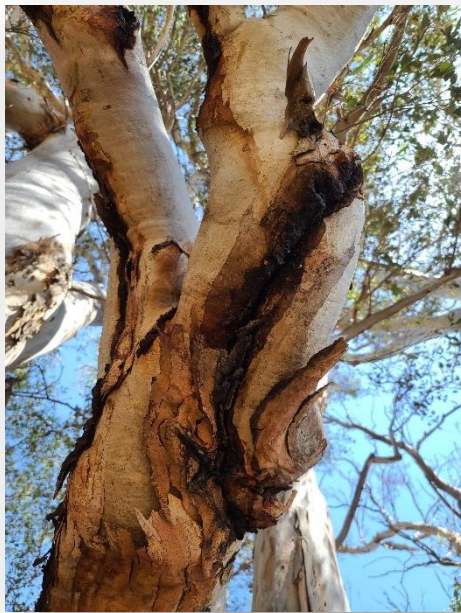
Plate 10. This is a view of stained wood possibly due to infected tissue (#919).

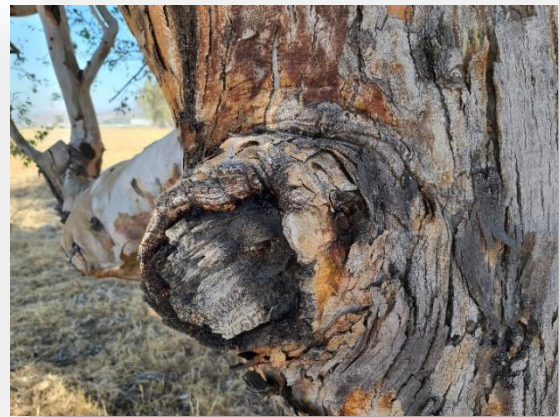
Plate 11. This is a view of internal deadwood within an unclosed wound (#919).

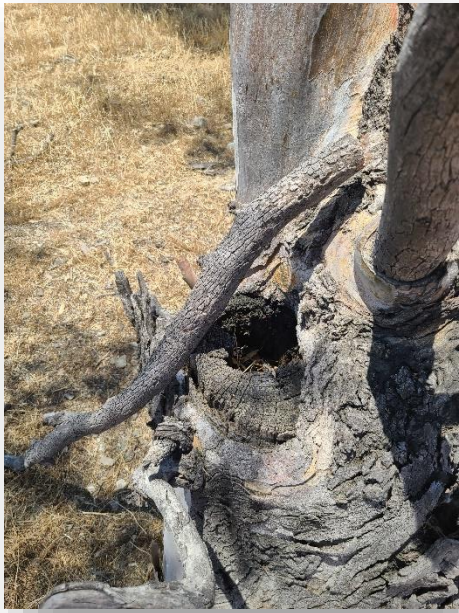
Plate 12. This is a view of a topped tree trunk with matured sprouters (#932).

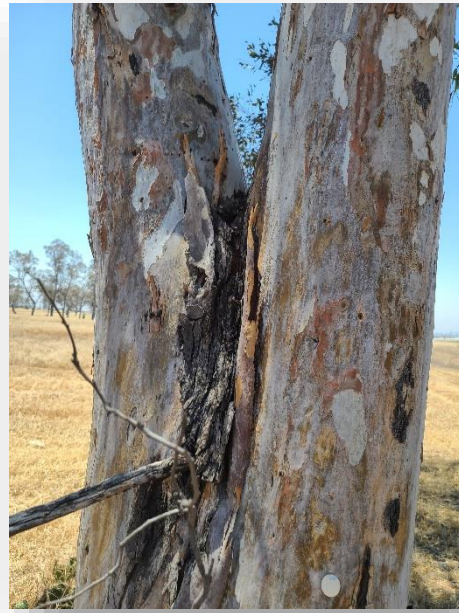
Plate 13. This is a view of included bark within the crotch between two codominant stems (#934).

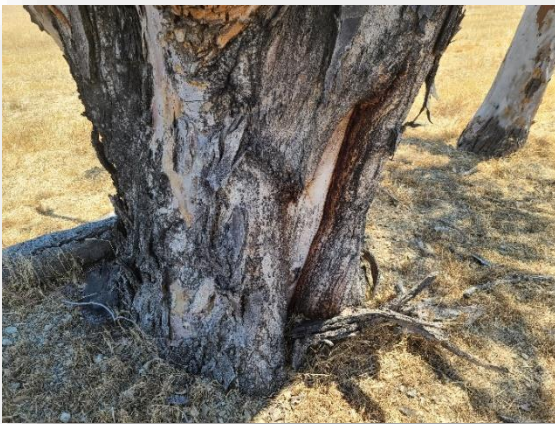
Plate 14. This is a view of a decay at a stem flare (#924).

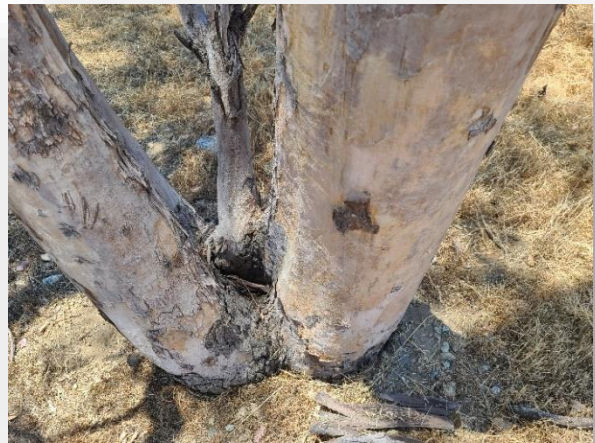
Plate 15. This is a view of sprouters that matured into codominant stems closing a topped stump (#949).

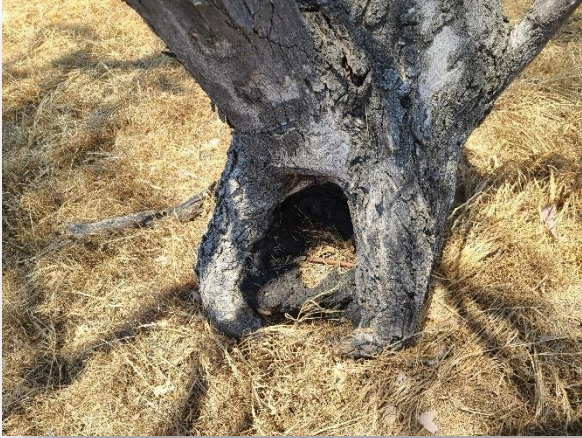
Plate 16. This is a view of a stump that has sprouted leaving an unclosed area with weak branch attachment (#952).
