Phase II Environmental Site Assessment

PHASE II ENVIRONMENTAL SITE ASSESSMENT MERIDIAN – WEST CAMPUS UPPER PLATEAU

Project No. 13226.003

January 17, 2022

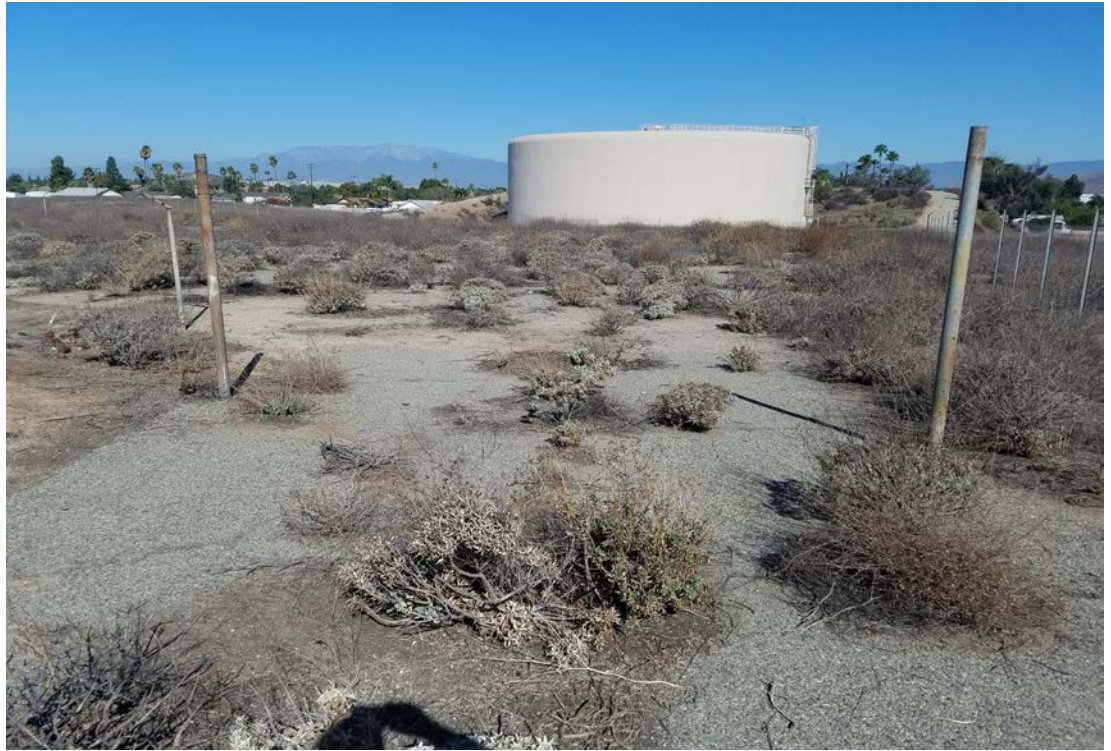
**Photo No. 4****View of Direction of Photo:**

U-Shaped Feature - From at least 1962 to 1989, an unknown U-shaped feature (likely concrete pad) and associated access road existed near the northern edge of the Site. Its use is unknown. Limited shallow soil sampling (0-5 feet bgs) focused around the southern, western and northern edges is recommended.

View of U-shaped asphalted area at ground surface

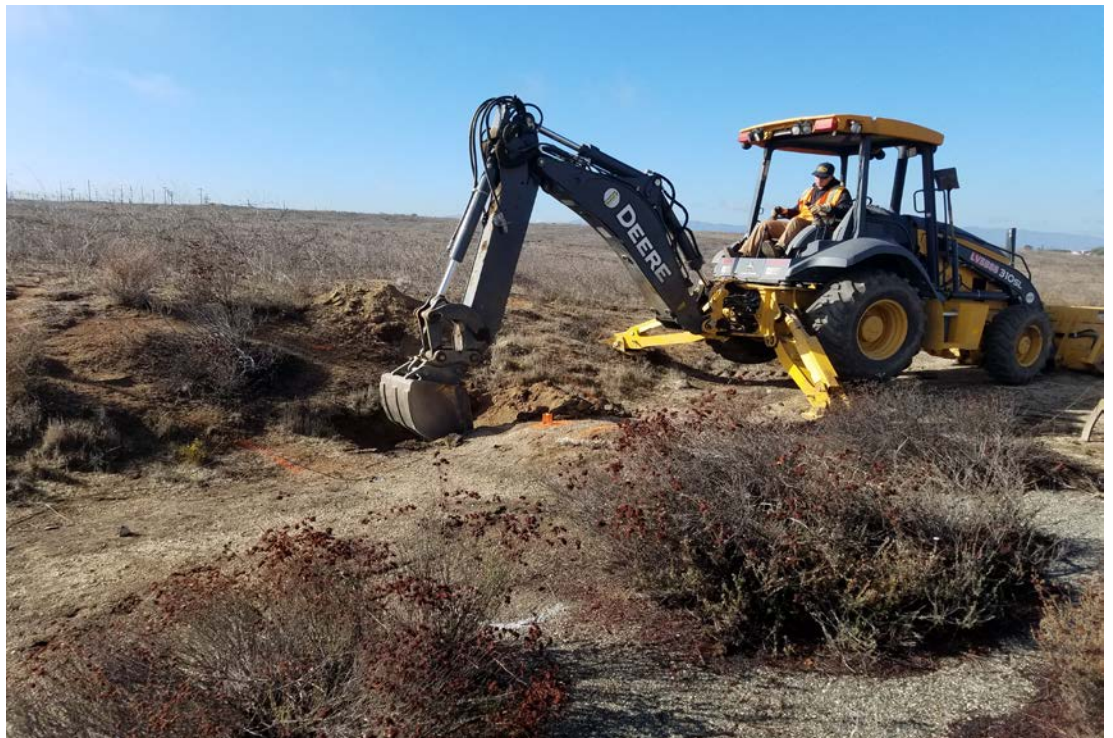
Client Name:
Meridian – West Campus Upper Plateau**Site Location:**
Riverside, California**Project No.**
13226.003**Photo No. 7****View of Direction of Photo:**

Soil sample collection in unknown U-shaped asphalt area

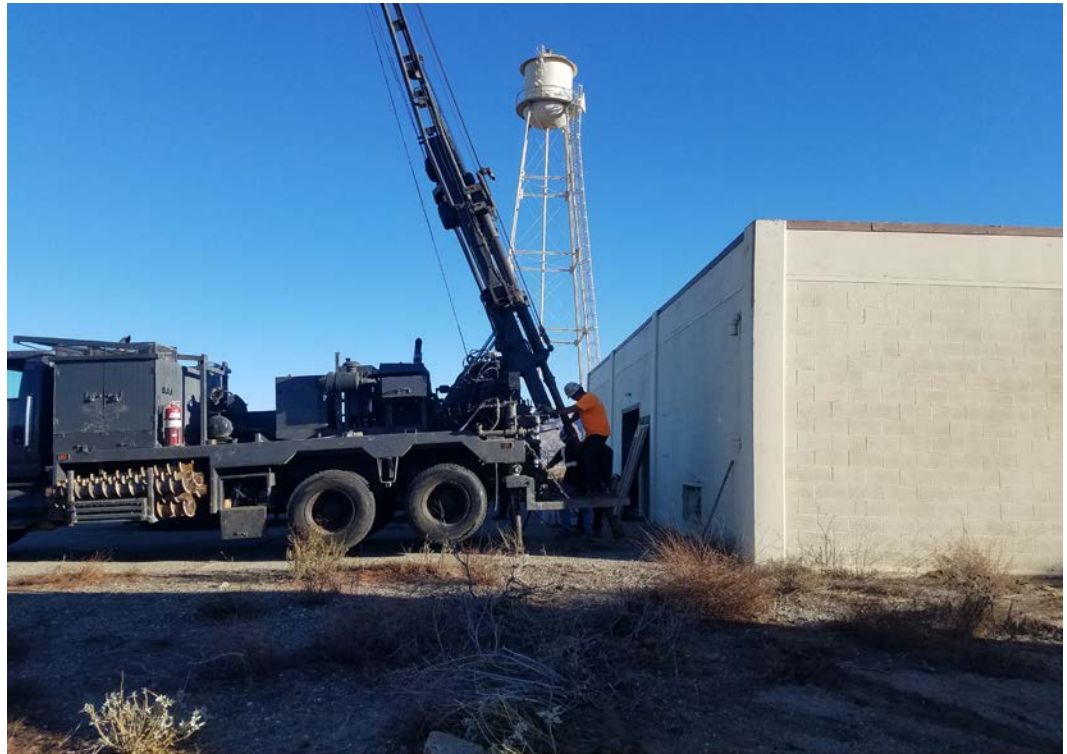
**Photo No. 10****View of Direction of Photo:**

Drilling of slant soil boring SB3 beneath Building 2 southern most wall.

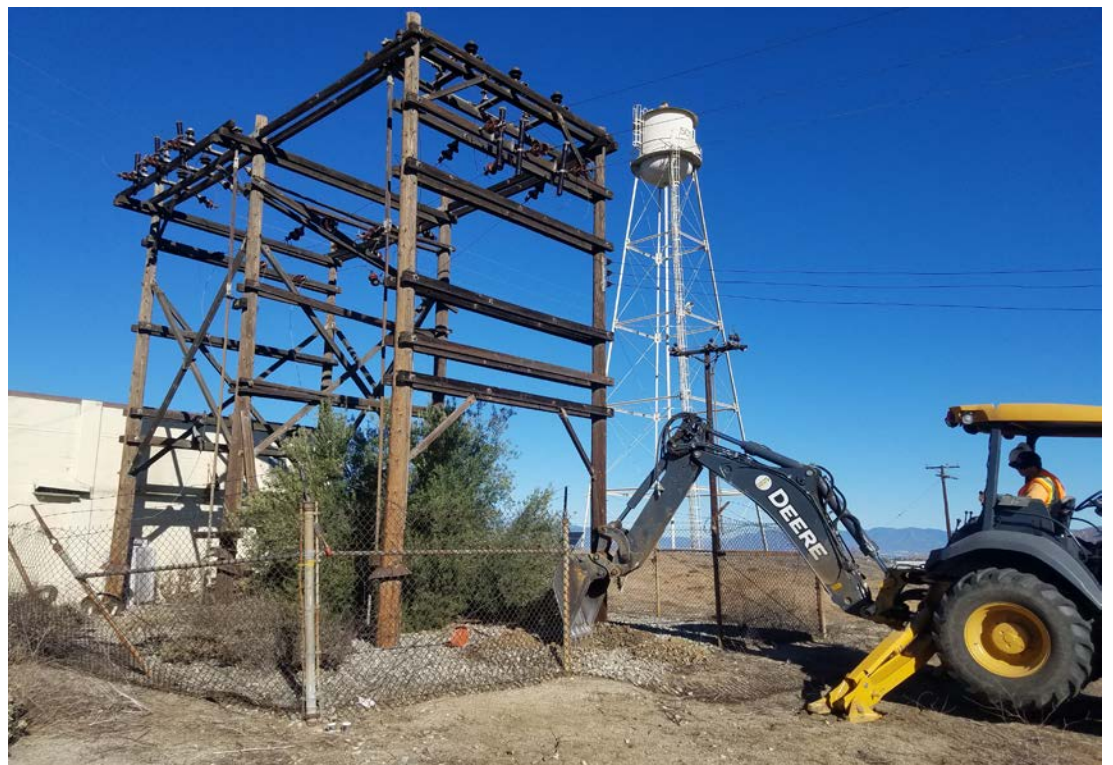
Client Name:
Meridian – West Campus Upper Plateau**Site Location:**
Riverside, California**Project No.**
13226.003**Photo No. 13****View of Direction of Photo:**

Empty former transformer housing on ground at background right.

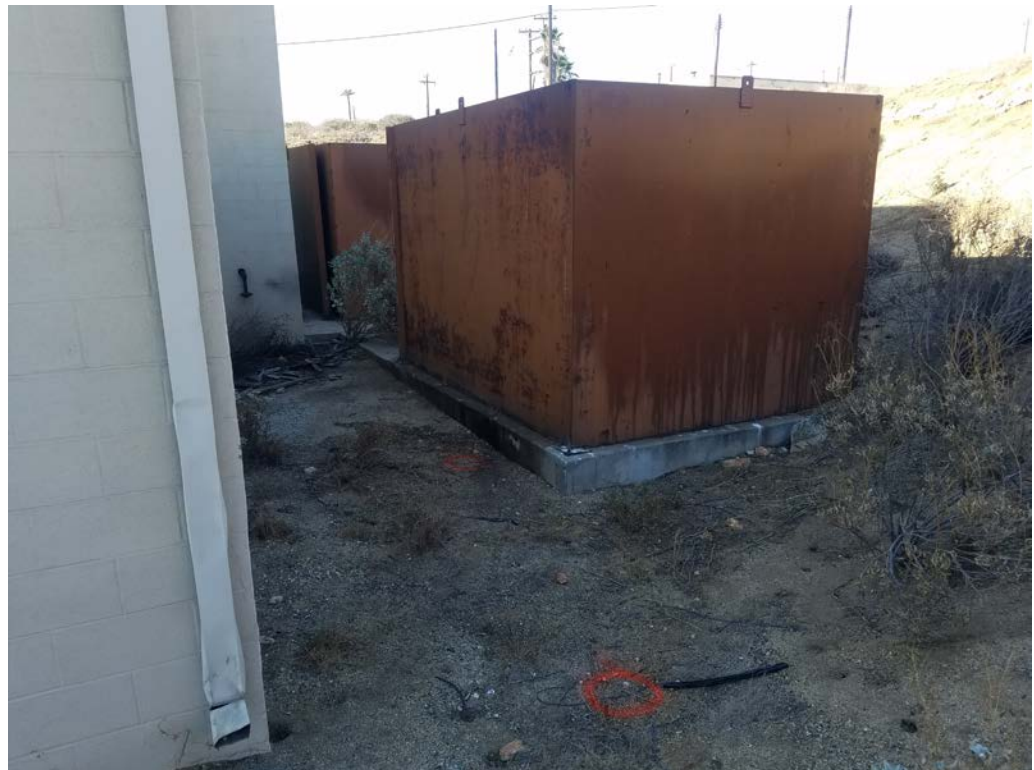
Client Name:
Meridian – West Campus Upper Plateau**Site Location:**
Riverside, California**Project No.**
13226.003**Photo No. 15****View of Direction of Photo:**

Pad mounted electrical transformers on west side of Building 5. Each transformer surrounded by steel shrouds.

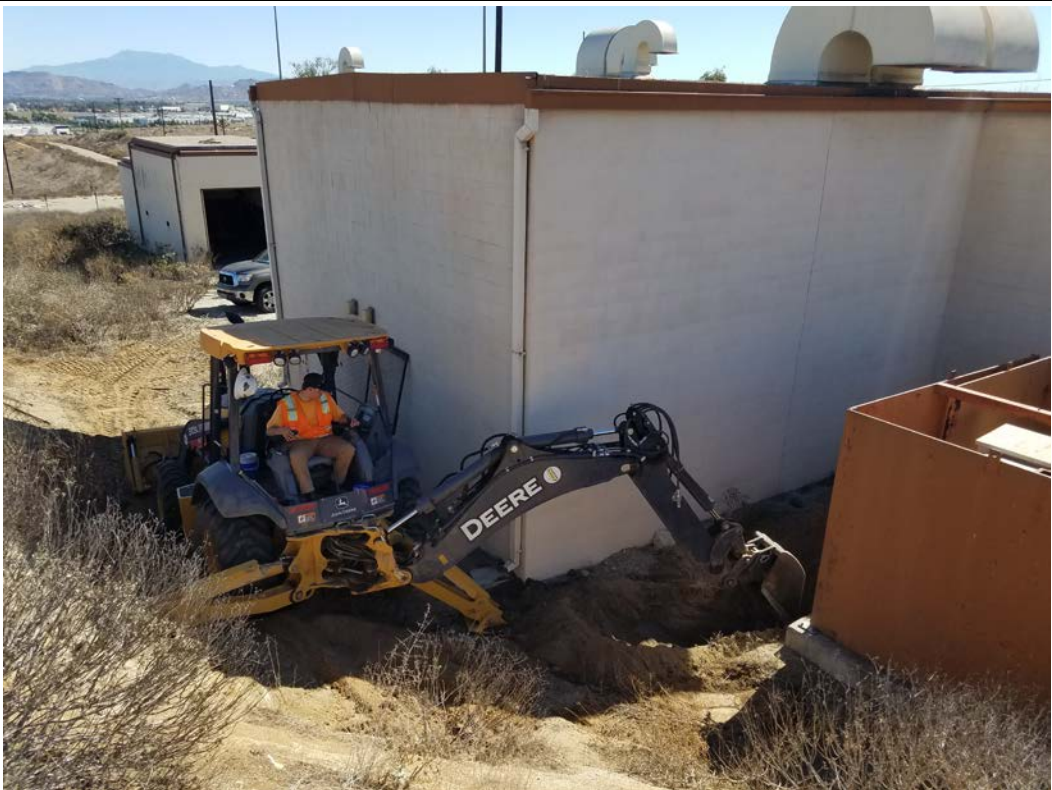
Client Name:
Meridian – West Campus Upper Plateau**Site Location:**
Riverside, California**Project No.**
13226.003**Photo No. 17****View of Direction of Photo:**

Completion and backfilling of trench PD2-1 near exterior west wall of electrical equipment enclosure.

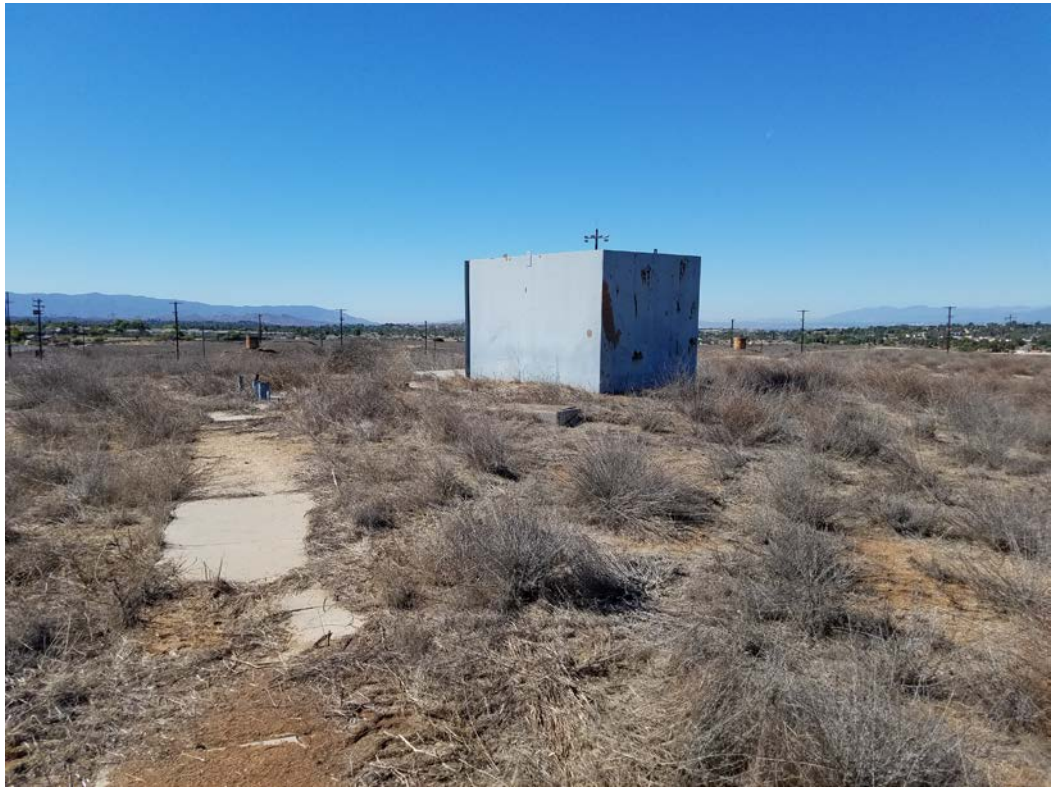
**Photo No. 22****View of Direction of Photo:**

Remnants of small electrical transformer inside of steel shrouding.
