**Appendix C-1**  
**Recommendations Memo, Chattel Historic Preservation Consultants**

## MEMORANDUM

**RE** San Marino Center (San Marino Women's Club)  
1800 Huntington Drive, San Marino, California  
Recommendations Memorandum

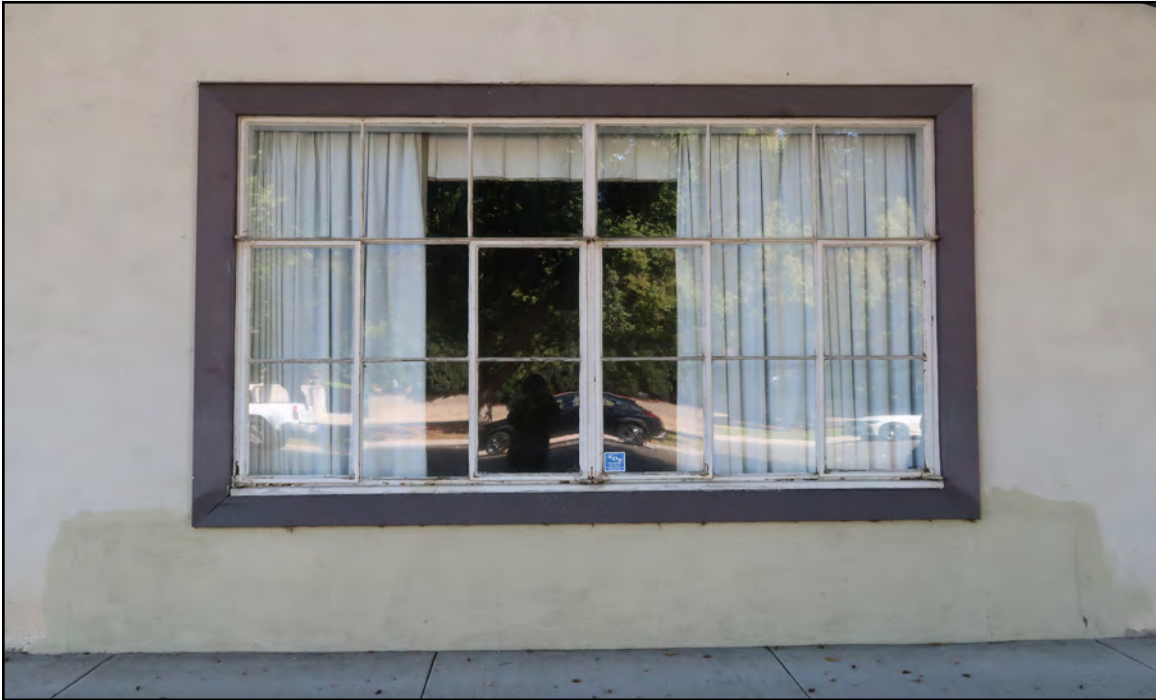
**Image 5:** San Marino Center, north elevation, note steel sash windows with wooden bevel frame, view south (Chattel, 2021)

- Rehabilitate and repair steel sash windows, as necessary.
- Retain and rehabilitate original paving, as necessary.
- Restore original planter at north elevation, match vegetation with library.

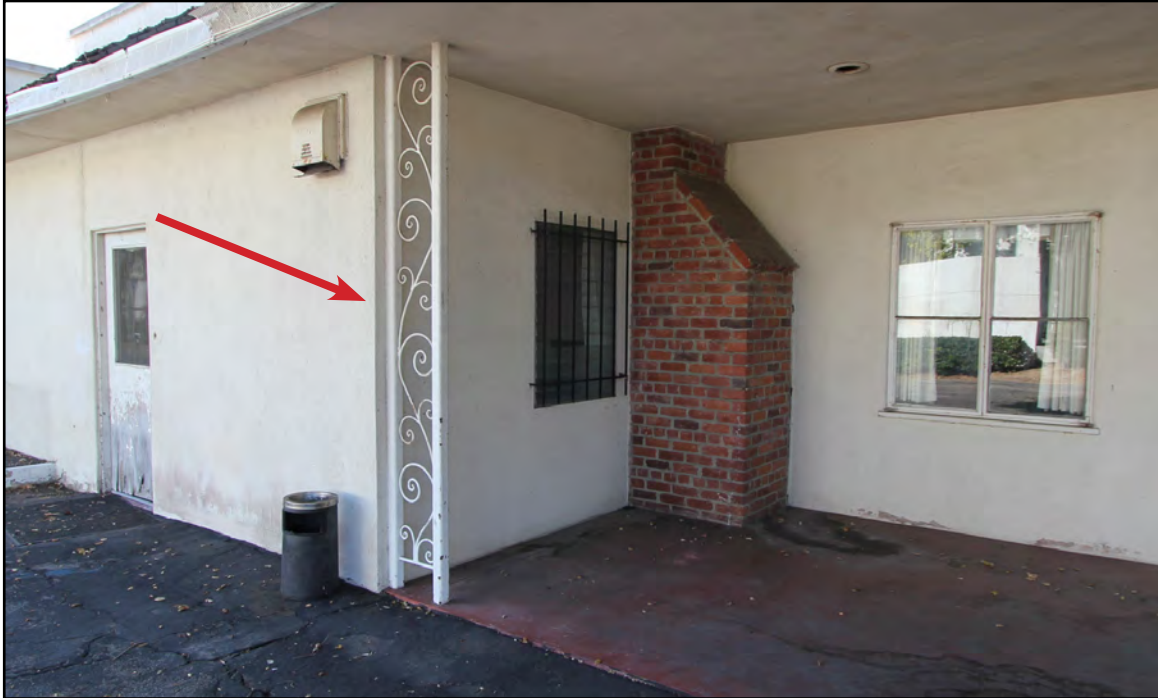
**Image 7:** San Marino Center, east elevation (far left) and north elevation (center), note brick chimney bisected by east storage addition and ornamental ironwork (Chattel, 2021)

- Remove two porch additions (east storage addition and west office addition). Ensure that brick chimney is not damaged in removal of east storage addition. Chemically remove overpaint on brick.

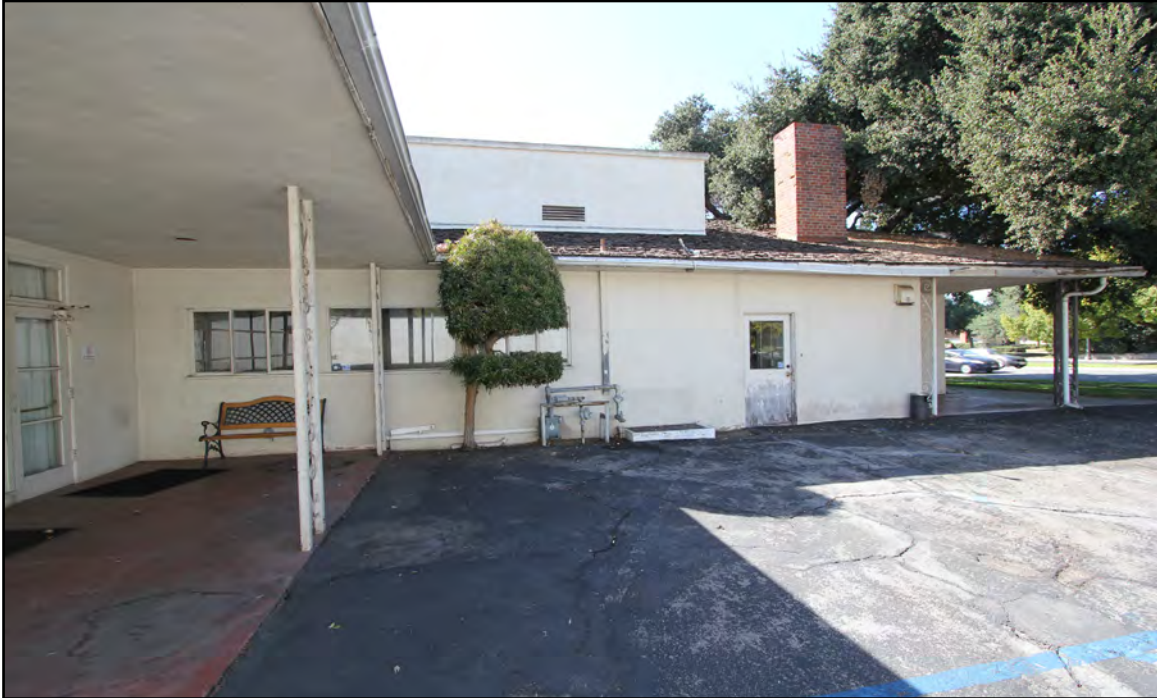
**Image 8:** San Marino Center, north elevation (left) and east elevation (right), note recessed porch with original paving painted red, view west (Chattel, 2021)

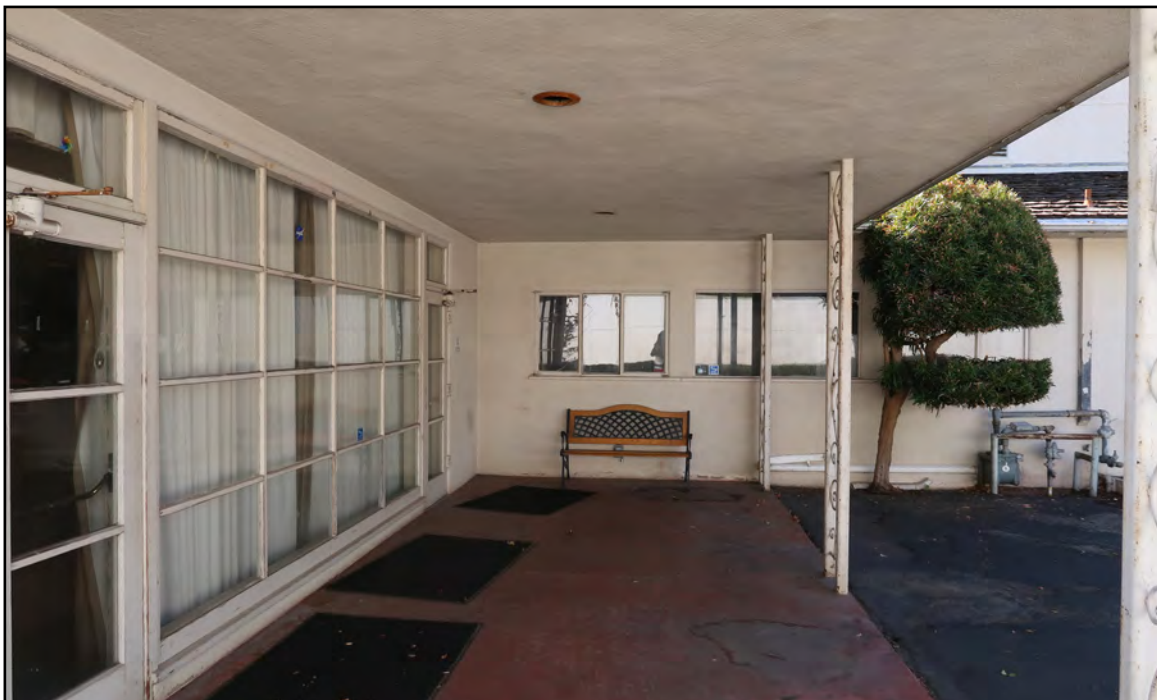
This entry faces north and consists of a large 4x4 wooden casement window framed by two narrow wooden doors with three windows and transoms. These doors are barely wider than the 28-inch variance permitted through the California Historic Building Code (CHBC).

**Image 9:** Detail of recessed porch on east elevation, note steel sash windows and original wooden doors, view west (Chattel, 2021)

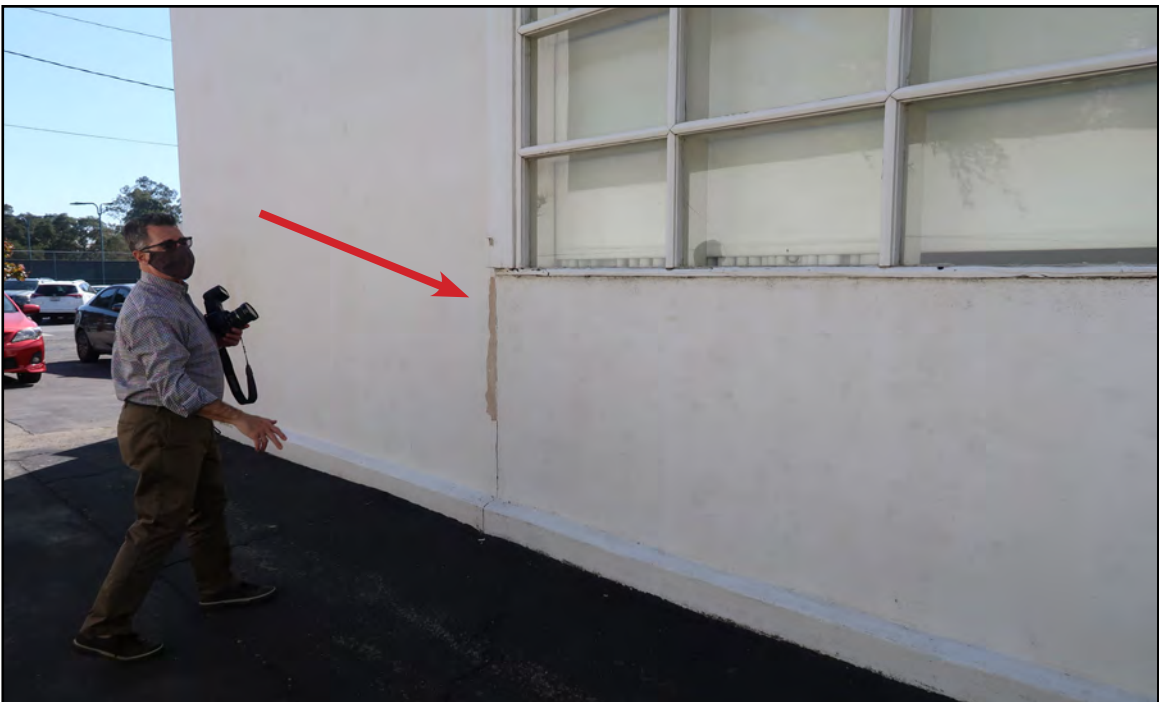
Along the east elevation's south end, is a large three by six panel steel casement windows. This window is half of its original height, evident by markings on the stucco that extend from the window to the ground level. Chattel was informed that the bottom half of the window was filled in at an unknown date (likely soon after construction) due to drainage and flooding issues with having the window be at ground level. The roofline above this window is a false gable parapet over a flat roof. The rest of the east elevation's envelope is painted stucco and minimally detailed. This elevation is less visible from the public right of way as it directly faces the library.

**Image 11:** Detail of steel sash window on east elevation, note the tear in stucco where window originally extended to ground level and infilled at a unknown date, view southwest (Chattel, 2021)

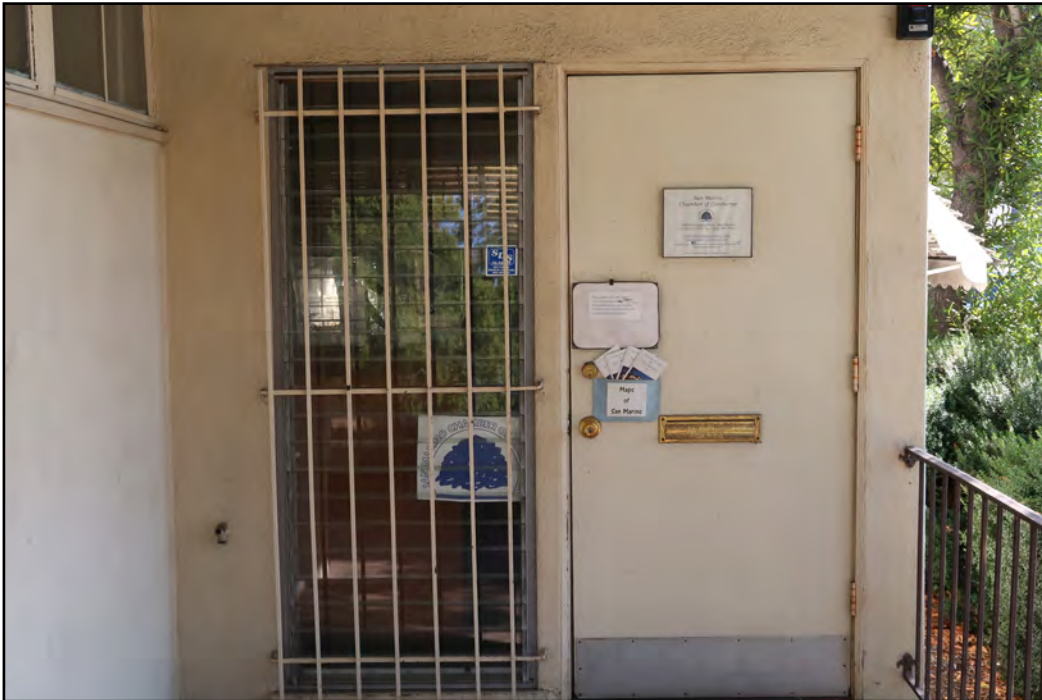
**Image 22:** Detail of door and window of west office addition, north elevation, view south (Chattel, 2021)

- Remove porch addition (west office addition). Restore missing square steel porch columns with ornamental ironwork.
