**CHATEL HISTORIC PRESERVATION ARCHITECT TECHNICAL MEMO,
NOVEMBER 15, 2021**

MEMORANDUM

RE San Marino Center (San Marino Women's Club)
1800 Huntington Drive, San Marino, California
Recommendations Memorandum

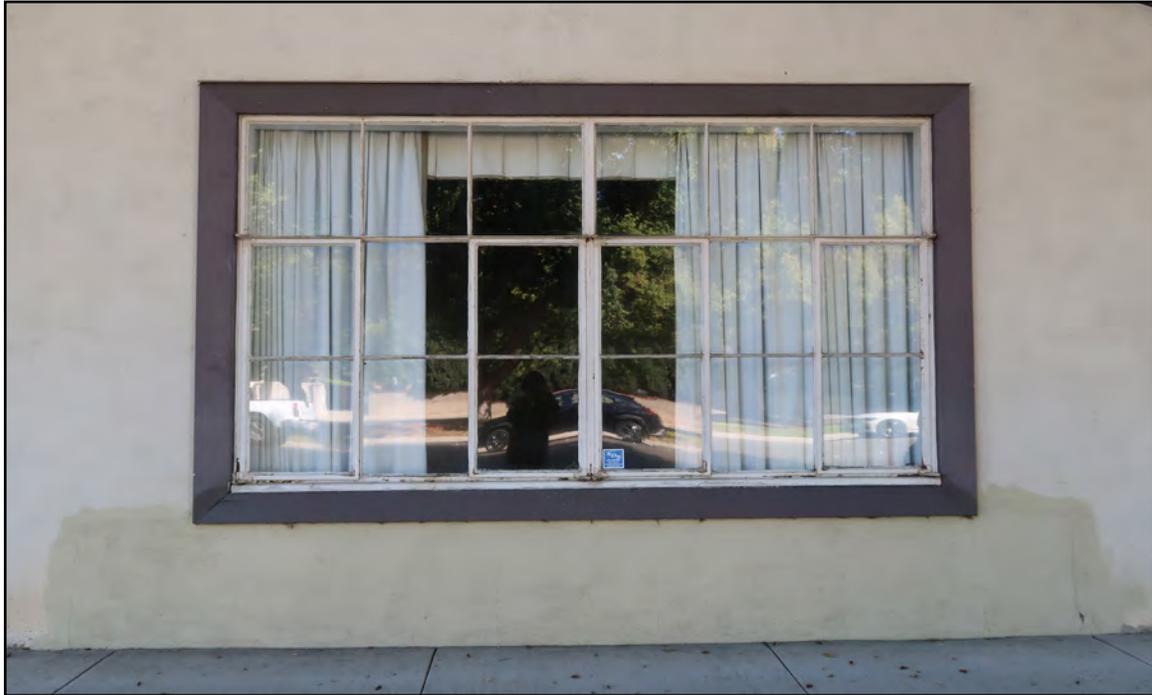
Image 5: San Marino Center, north elevation, note steel sash windows with wooden bevel frame, view south (Chattel, 2021)

- Rehabilitate and repair steel sash windows, as necessary.
- Retain and rehabilitate original paving, as necessary.
- Restore original planter at north elevation, match vegetation with library.

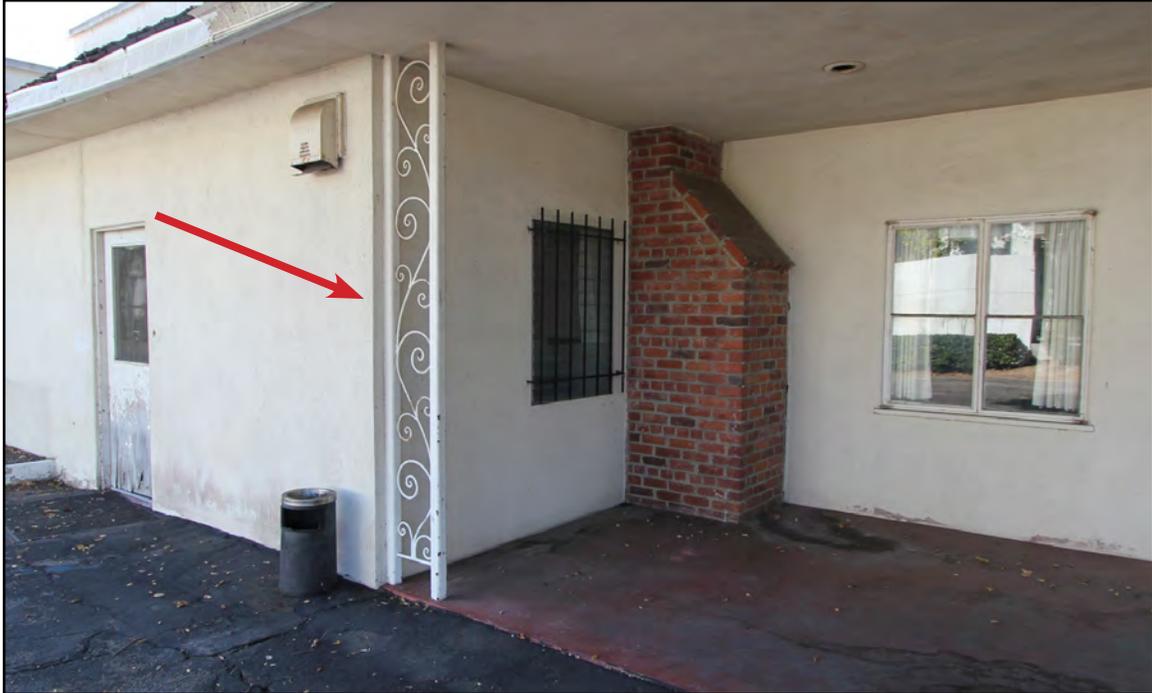
Image 7: San Marino Center, east elevation (far left) and north elevation (center), note brick chimney bisected by east storage addition and ornamental ironwork (Chattel, 2021)

- Remove two porch additions (east storage addition and west office addition). Ensure that brick chimney is not damaged in removal of east storage addition. Chemically remove overpaint on brick.

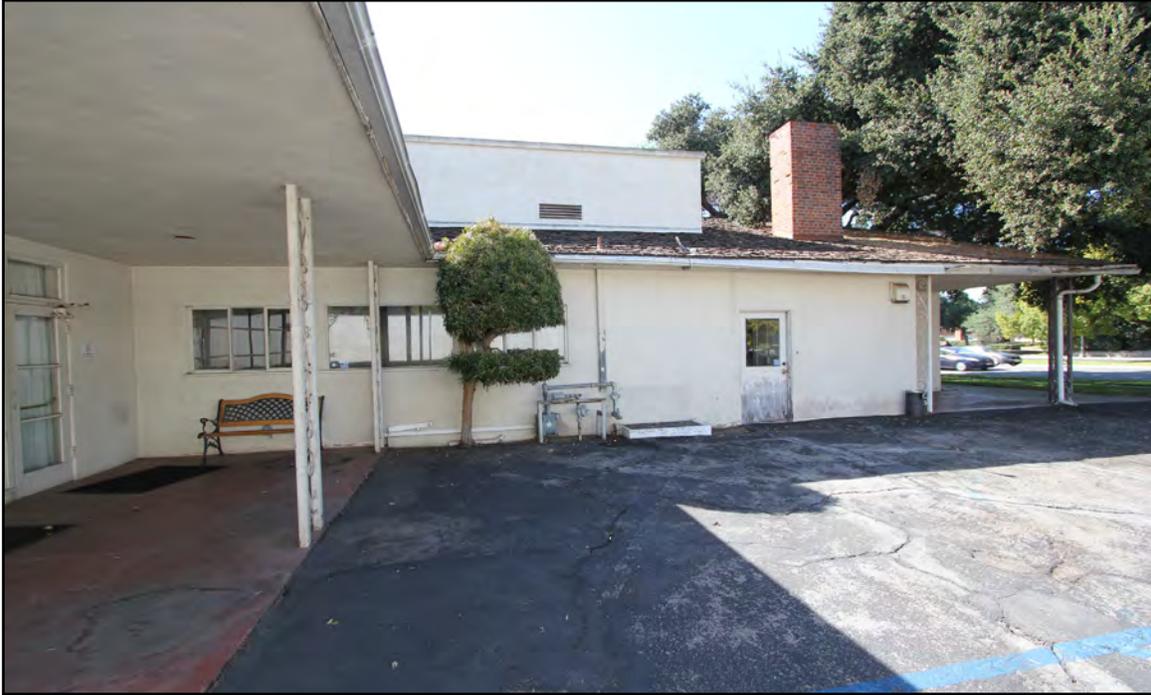
Image 8: San Marino Center, north elevation (left) and east elevation (right), note recessed porch with original paving painted red, view west (Chattel, 2021)

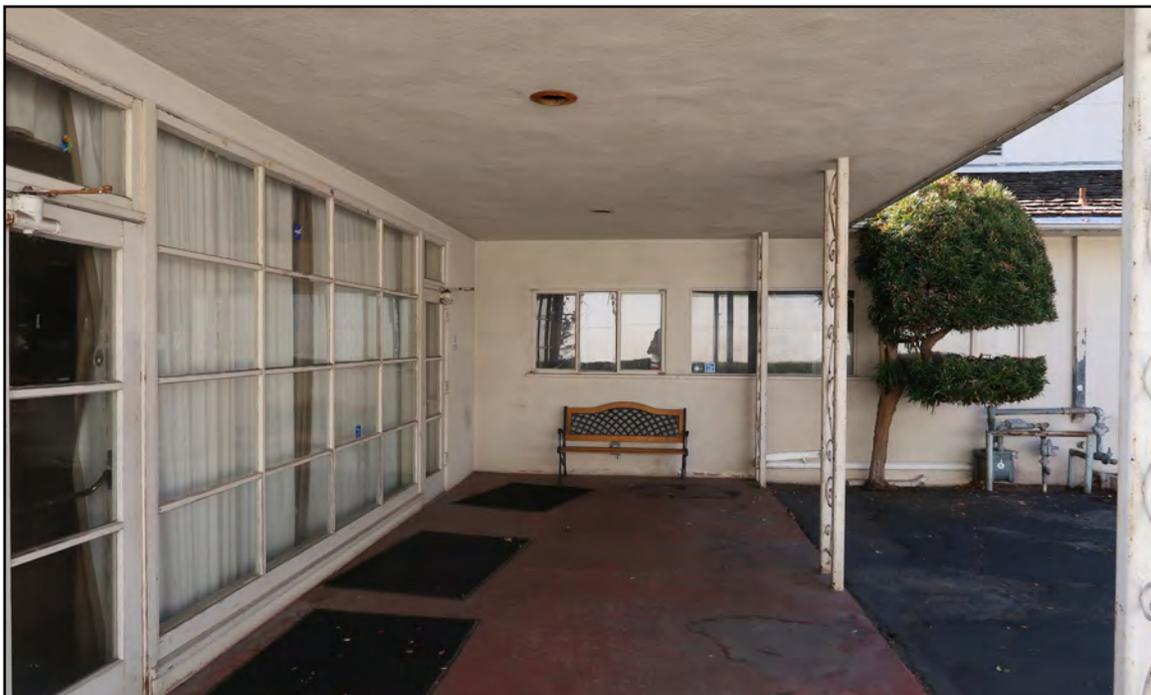
This entry faces north and consists of a large 4x4 wooden casement window framed by two narrow wooden doors with three windows and transoms. These doors are barely wider than the 28-inch variance permitted through the California Historic Building Code (CHBC).

Image 9: Detail of recessed porch on east elevation, note steel sash windows and original wooden doors, view west (Chattel, 2021)

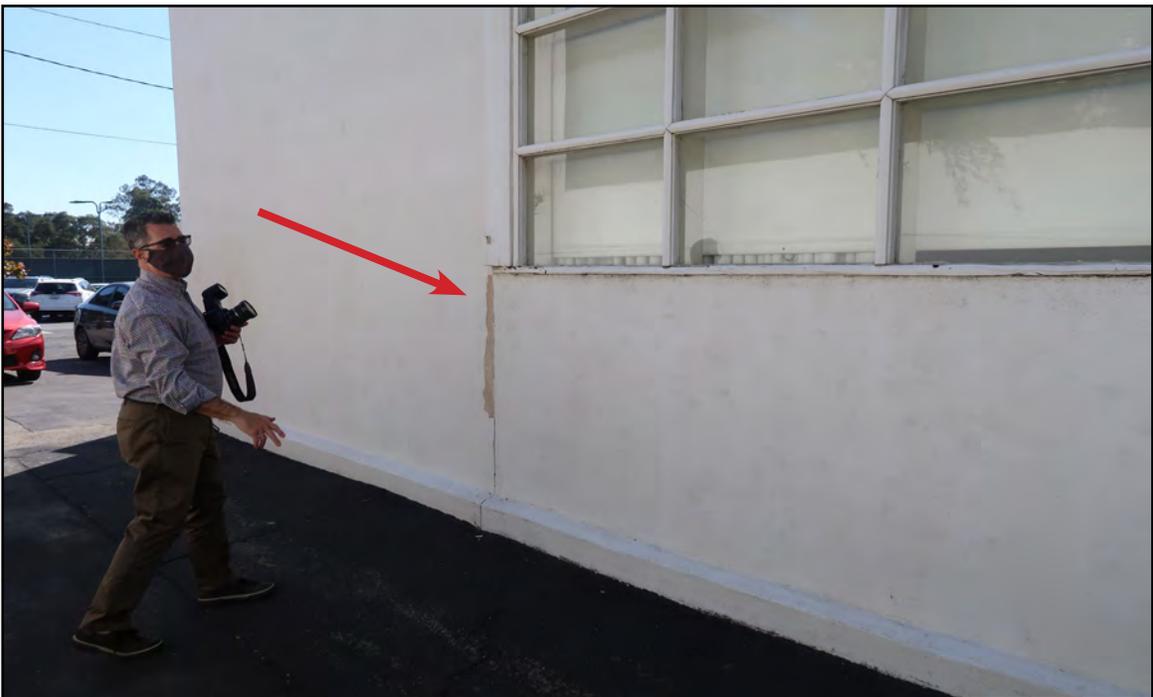
Along the east elevation's south end, is a large three by six panel steel casement windows. This window is half of its original height, evident by markings on the stucco that extend from the window to the ground level. Chattel was informed that the bottom half of the window was filled in at an unknown date (likely soon after construction) due to drainage and flooding issues with having the window be at ground level. The roofline above this window is a false gable parapet over a flat roof. The rest of the east elevation's envelope is painted stucco and minimally detailed. This elevation is less visible from the public right of way as it directly faces the library.

Image 11: Detail of steel sash window on east elevation, note the tear in stucco where window originally extended to ground level and infilled at a unknown date, view southwest (Chattel, 2021)

- Retain and rehabilitate character-defining features to greatest extent feasible.
- Patch, repair and repaint stucco, as necessary. Stucco can be painted to be compatible with the adjacent library.
- Rehabilitate and repair steel sash and wood grid windows, as necessary.
- Remove porch addition (east storage addition). Ensure that brick chimney is not damaged in removal of east storage addition. Chemically remove overpaint on brick. Restore steel sash doors that were removed to provide access into addition.

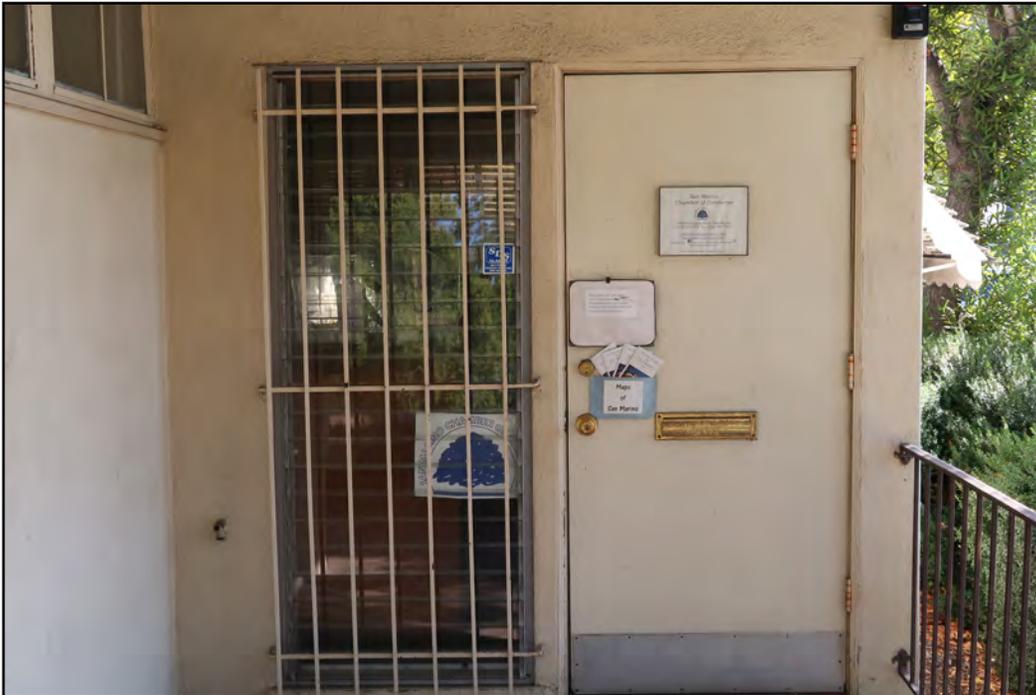
Image 22: Detail of door and window of west office addition, north elevation, view south (Chattel, 2021)

- Remove porch addition (west office addition). Restore missing square steel porch columns with ornamental ironwork.
