Tree Report

August 6, 2021

Subject: Tree Evaluation Report for the 1111 South Hill Street Project Site, City of Los Angeles, California

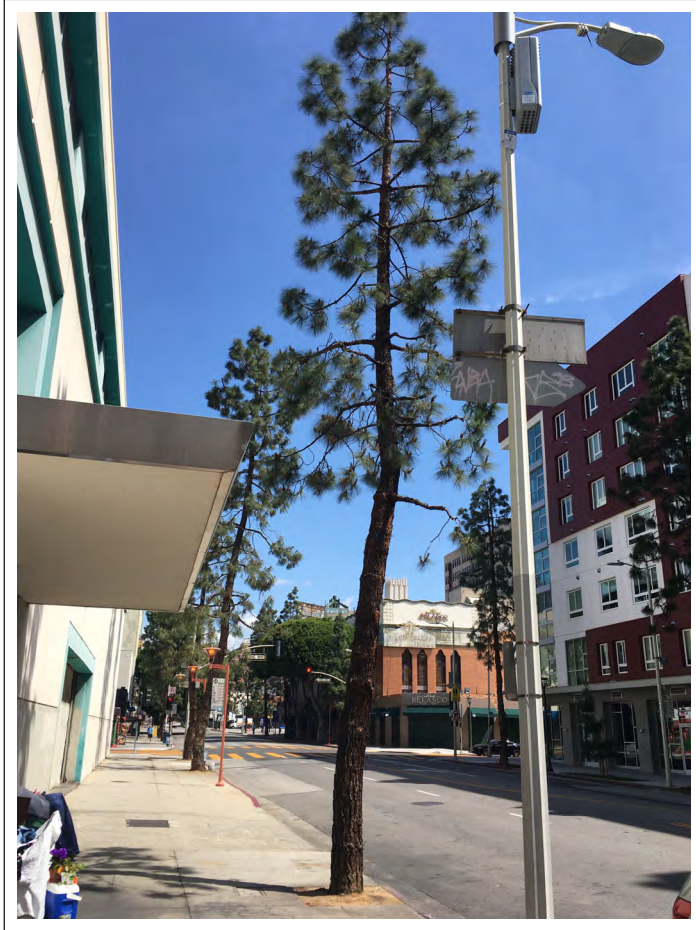
March 28, 2020. Overview of Tree 1. Canary Island pine (*Pinus canariensis*).

Project development will require the removal of tree number 1, a Canary Island Pine. The other existing street trees will remain in place and be incorporated into the building’s ground floor design. To compensate for the removal of the Canary Island Pine, 2 replacement trees will be planted along South Hill Street.

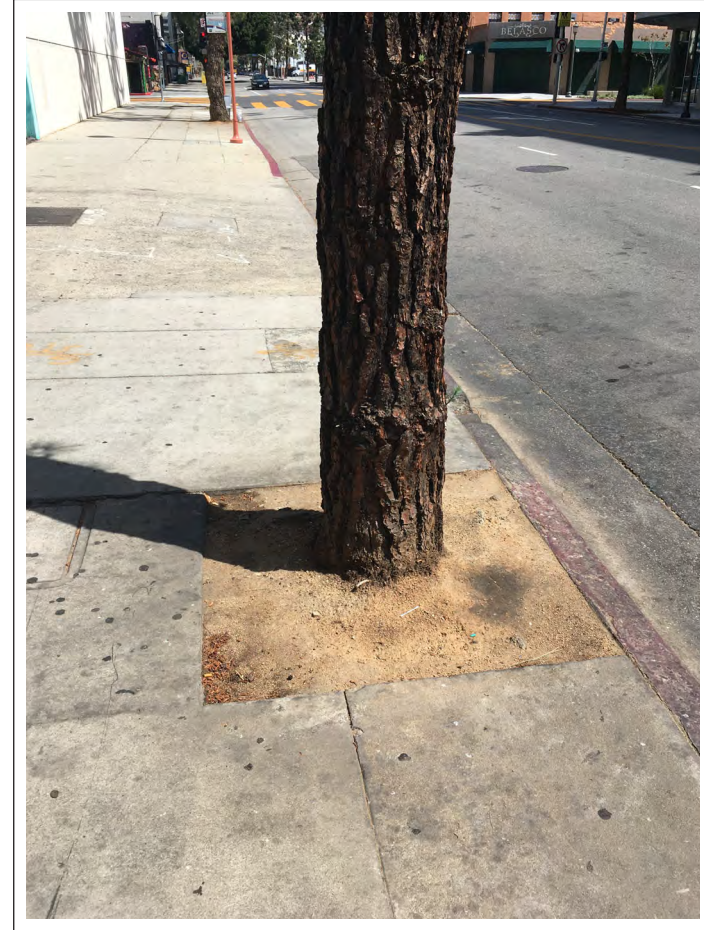
March 28, 2020. View of base of Tree 1. Tree is not causing any damage to sidewalk or curb.

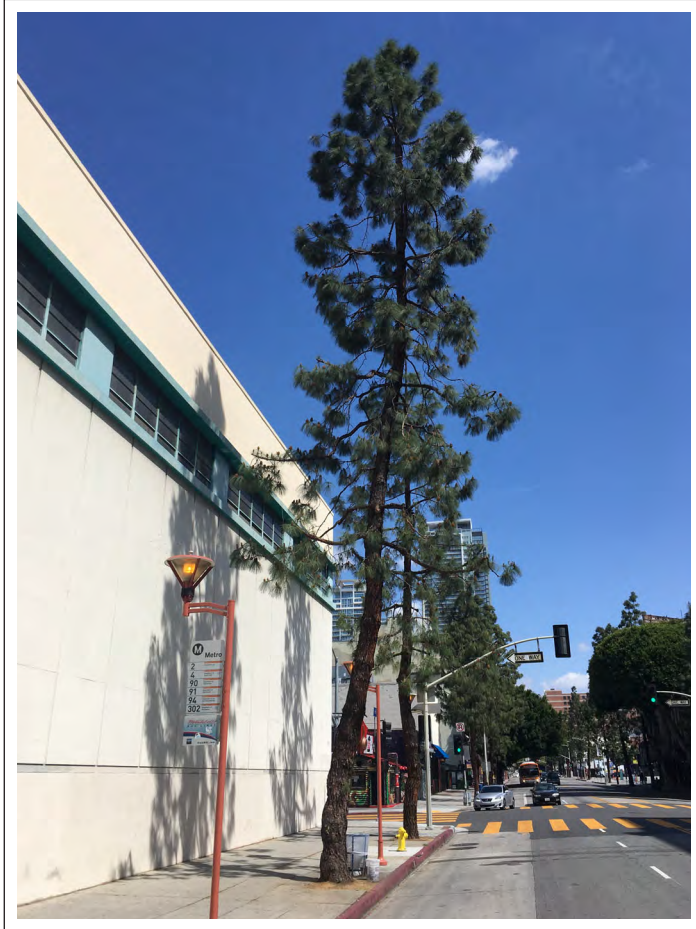
March 28, 2020. Overview of Tree 2. Canary Island pine (*Pinus canariensis*).

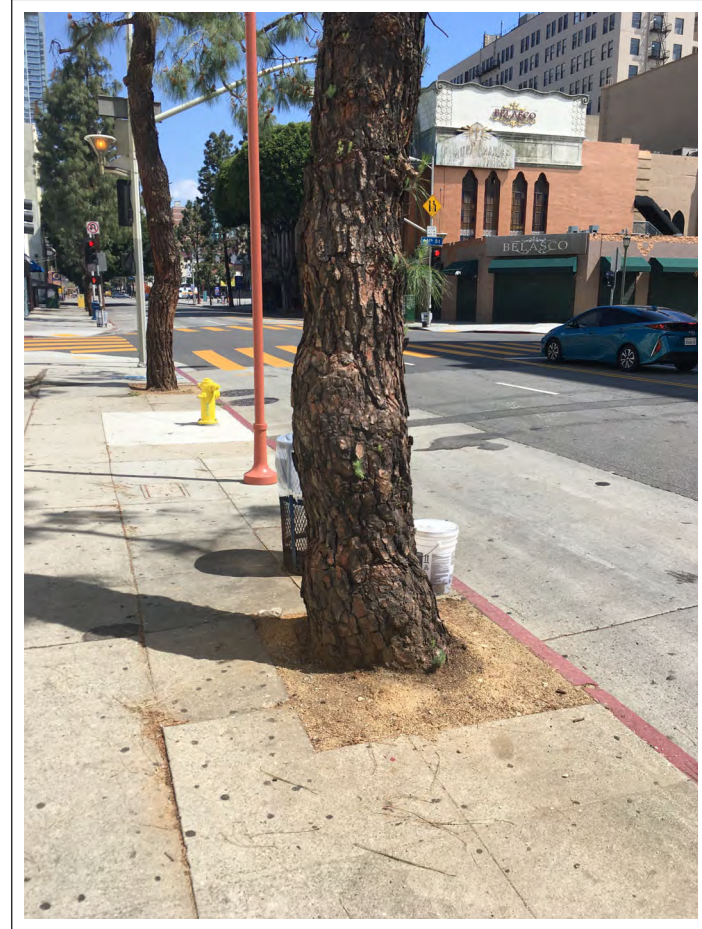
March 28, 2020. View of base of Tree 2. Tree is not causing any damage to sidewalk or curb.

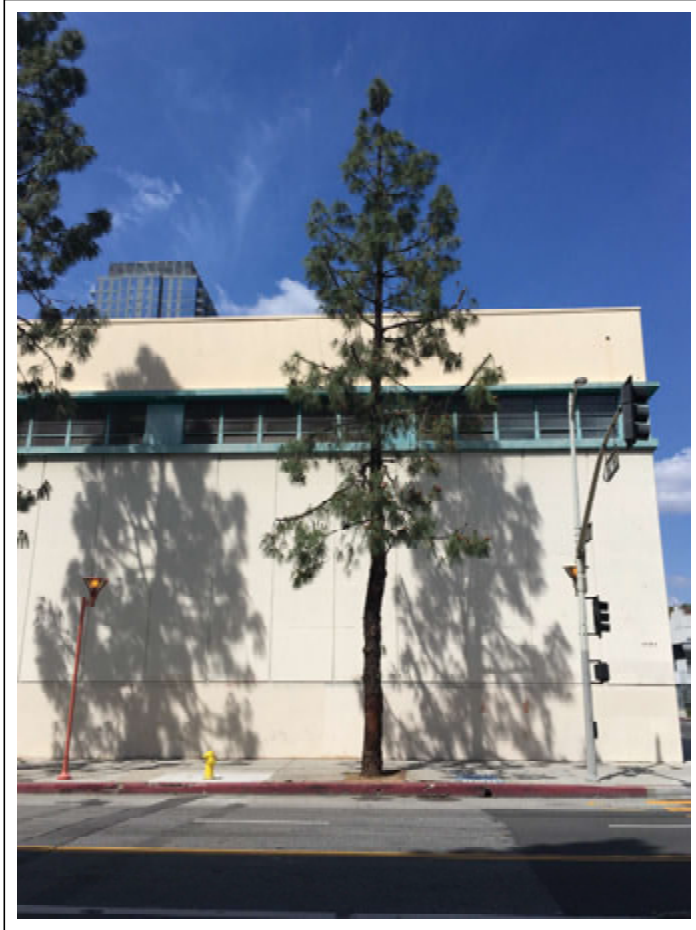
March 28, 2020. Overview of Tree 3. Canary Island pine (*Pinus canariensis*).

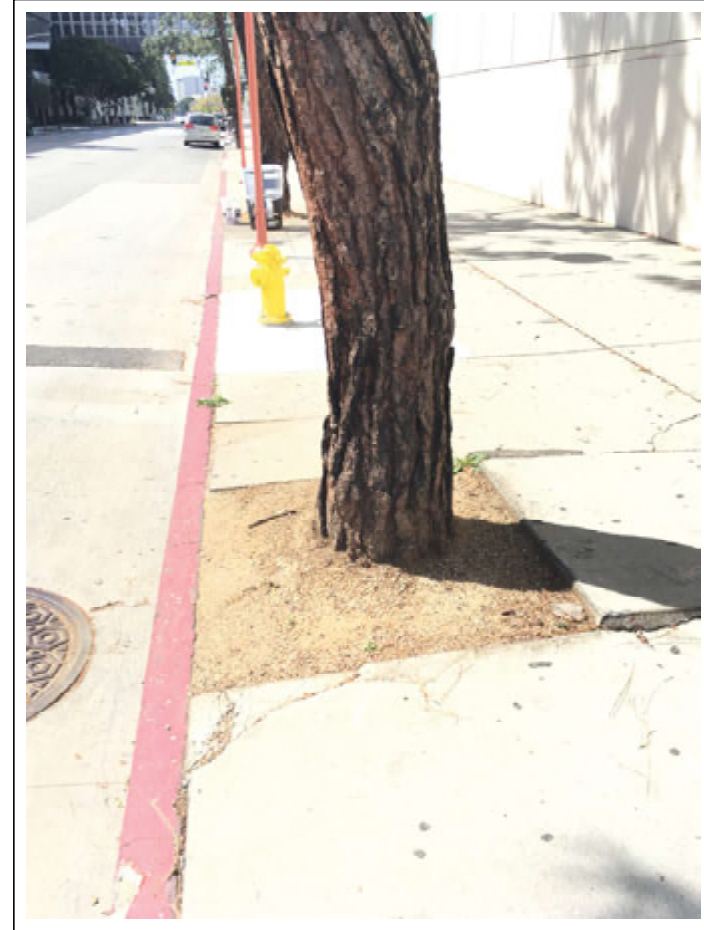
March 28, 2020. View of base of Tree 3. Tree roots have caused approximately two inches of vertical displacement to adjacent sidewalk.

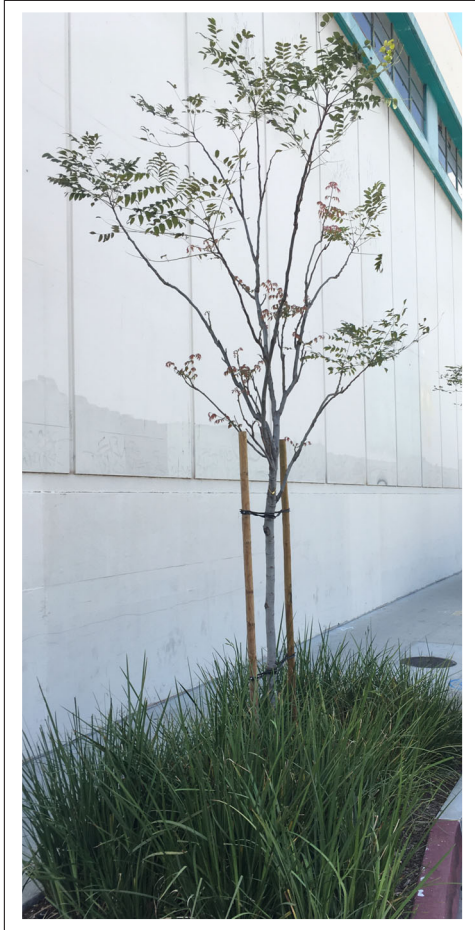
Overview of Tree 4. Chinese flame tree (*Koelrueteria bipinnata*).

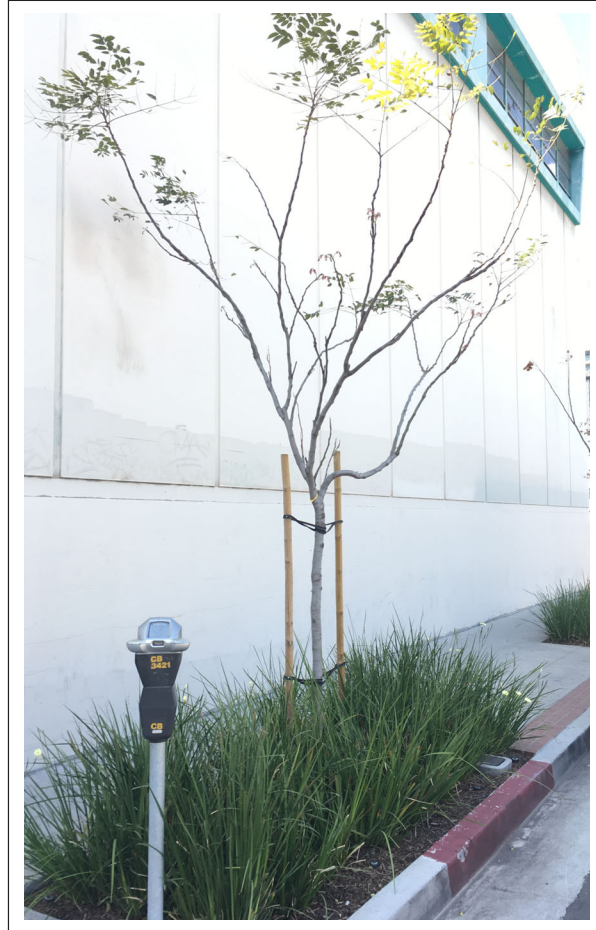
Overview of Tree 5. Chinese flame tree (*Koelrueteria bipinnata*).

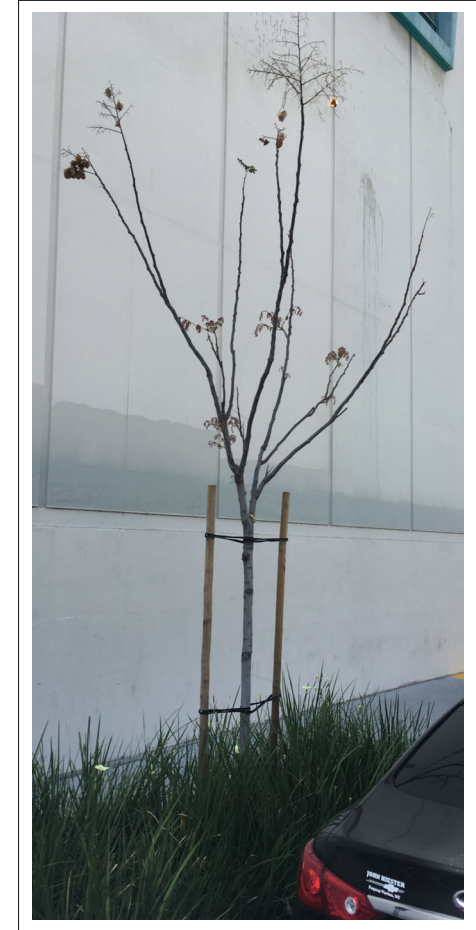
Overview of Tree 6. Chinese flame tree (*Koelrueteria bipinnata*).

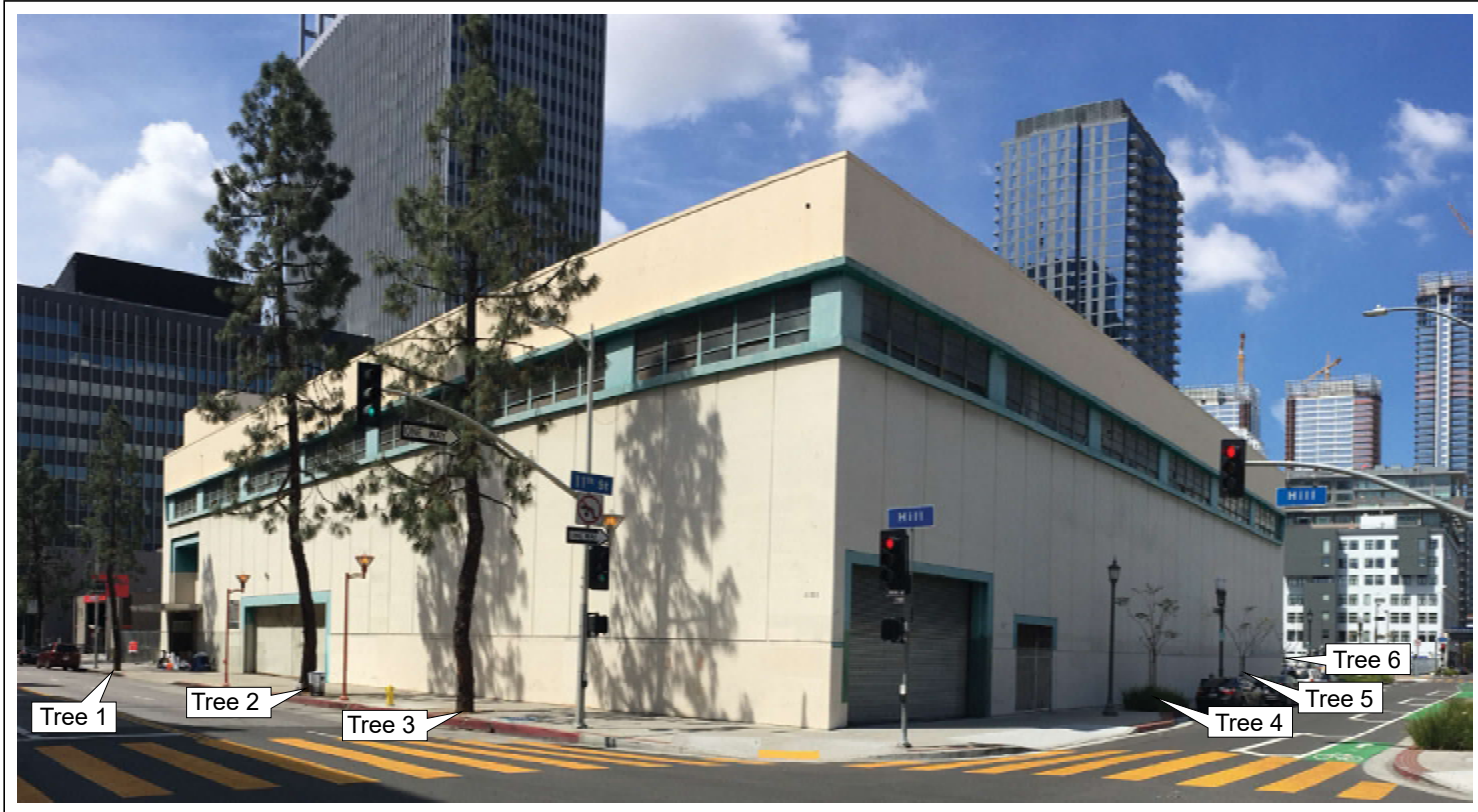
March 28, 2020. Overview of project site conditions, facing southwest.
