September 19, 2019

Job No. 7845.02

Subject: Slope Stability Study
Proposed Minor Subdivision
1276 Jensen Lane
Windsor, California

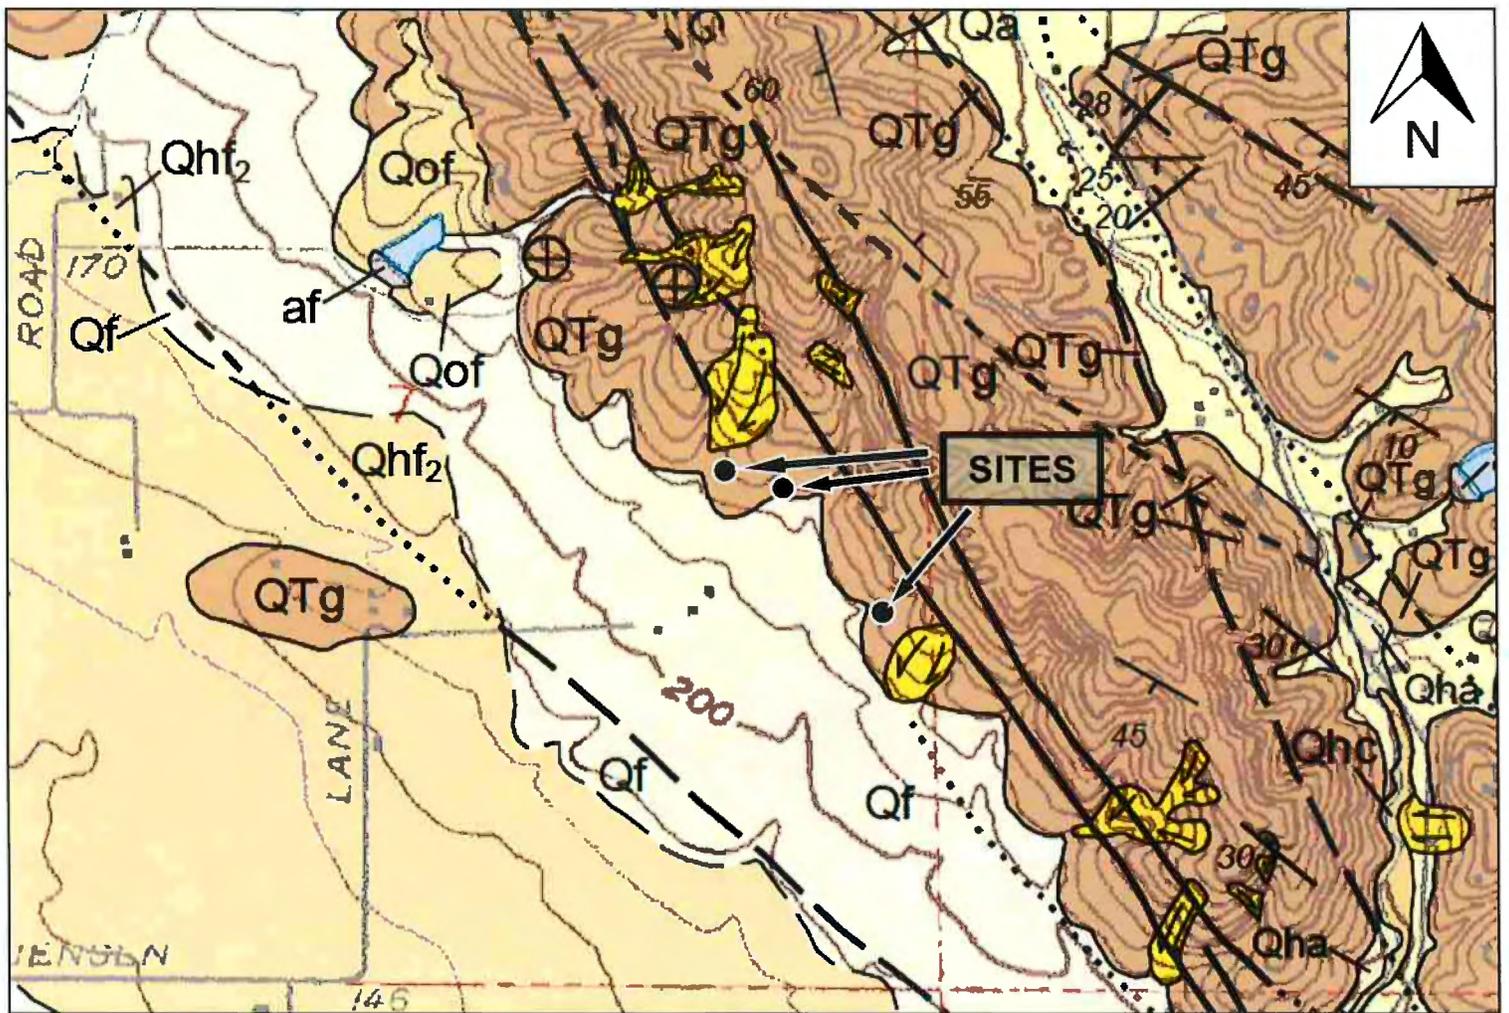
PLATE
2B

Lot 3 is located on moderately sloping terrain which is bordered by a deeply incised seasonal drainage course to the north. Review of LiDAR images and our surficial reconnaissance has revealed the presence of a relatively large landslide deposit south and southeast of the potential building envelope on Lot 3, see Plate 2D. During our site reconnaissance we observed hummocky terrain within the forest and vineyard block south and southeast of the potential building envelope on Lot 3. The location of this landslide appears to generally coincide with a mapped landslide on a geologic map of the Healdsburg 7.5 Minute Quadrangle, see Plate 2B.

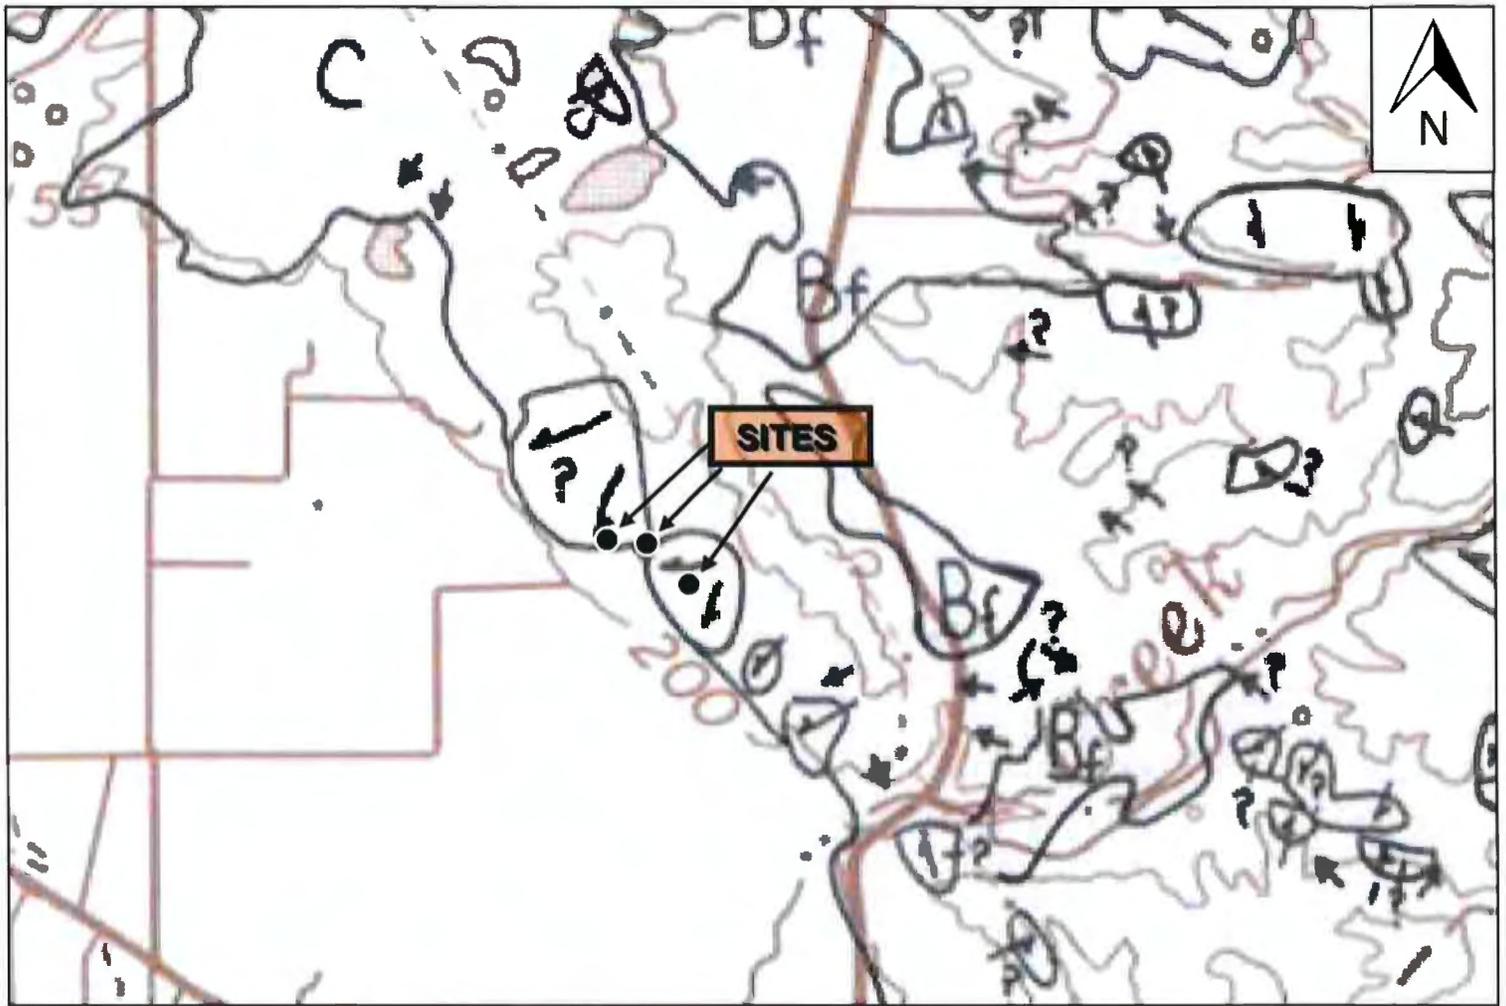
PLATE
2C

The regional geologic map presented on Plate 2C also indicates that the previously discussed large landslides, but as much bigger features. The regional slope stability also indicates that the large

landslide north of Lot 1 is a questionable feature, which suggests a degree of uncertainty.

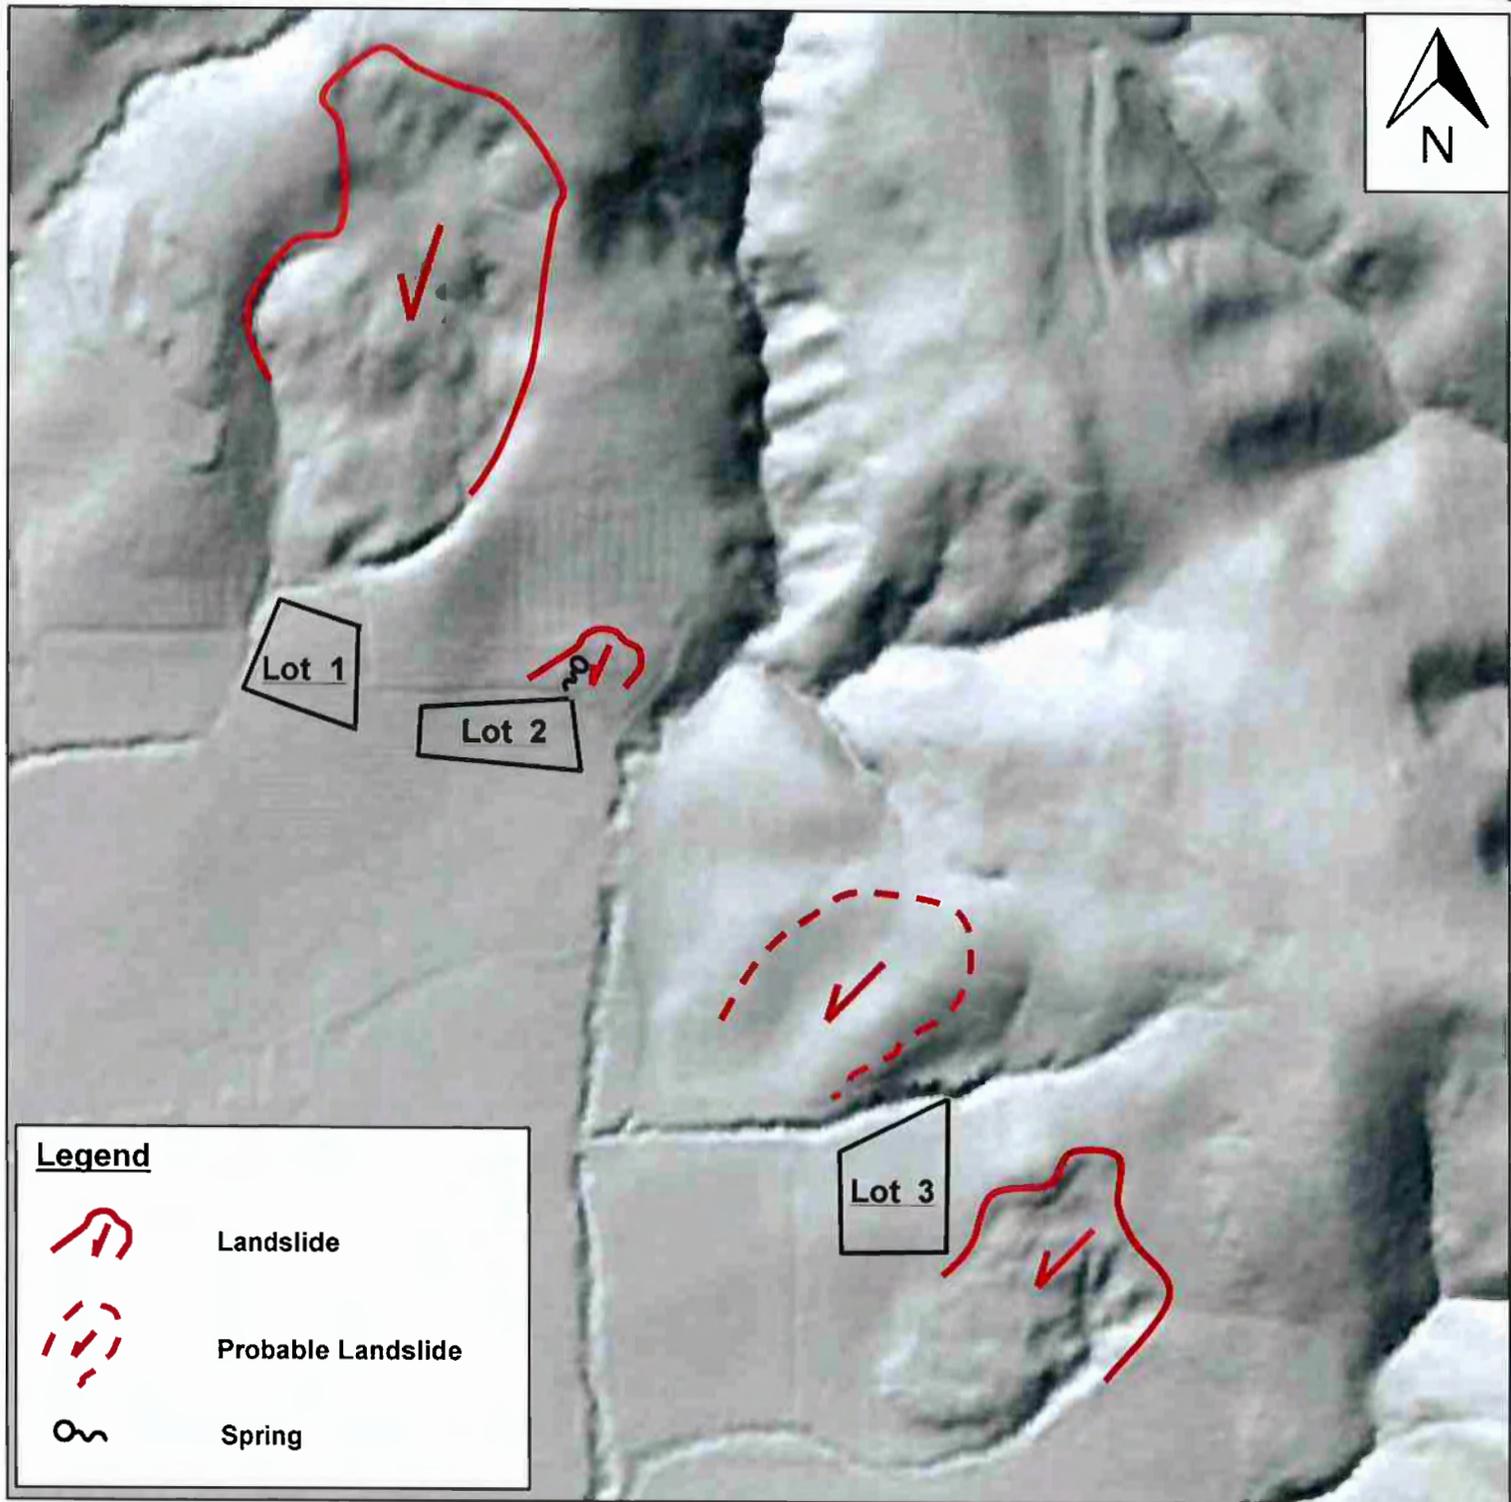
**PLATE
 2D**

As previously discussed, review of a LiDAR image indicates the presence of a relatively large landslide feature north of Lot 1. The landslide feature appears to be confined to the sloping terrain north of Lot 1 and is located a significant distance away from the potential building envelope on Lot 1. Therefore, this landslide does not appear to be serious geologic concern for the development on Lot 1.

During our site reconnaissance we documented significant spring activity and a small active landslide in the vineyard block immediately north of the potential building envelope on Lot 2. The landslide is easily recognizable due to the contorted vine rows and significant surface seepage. However, due to relatively small size of the landslide, shallow downslope gradients, and distance away from the potential building envelope on Lot 2, this landslide did not appear to be a significant geologic hazard to the potential building envelope on Lot 2.

Lot 3 is located on moderately sloping terrain which is bordered by a deeply incised seasonal drainage course to the north. Review of a LiDAR image and our surficial reconnaissance has revealed the presence of a relatively large landslide deposit south and southeast of the potential building envelope on Lot 3. During our site reconnaissance we observed hummocky terrain and partially closed topographic depressions within the forest and vineyard block south and southeast of the potential building envelope on Lot 3. The hummocky terrain and unusual topographic features are interpreted as accumulated landslide debris which was derived from a relatively large landslide on the steep slope west facing slope upslope and southeast of the potential building envelope on Lot 3. The subdued nature of the hummocks, and lack of an obvious landslide scarp suggest that this feature was likely an ancient landslide event. This particular landslide appears to be a relatively old feature which was likely triggered during a climatic wet period of the Pleistocene epoch which coincided with a significant seismic event. Based on our site reconnaissance there are no obvious indications that the particular landslide in the vicinity of the project site is actively moving. Furthermore, the potential building envelope on Lot 3 is set-back a significant distance away from this landslide features.

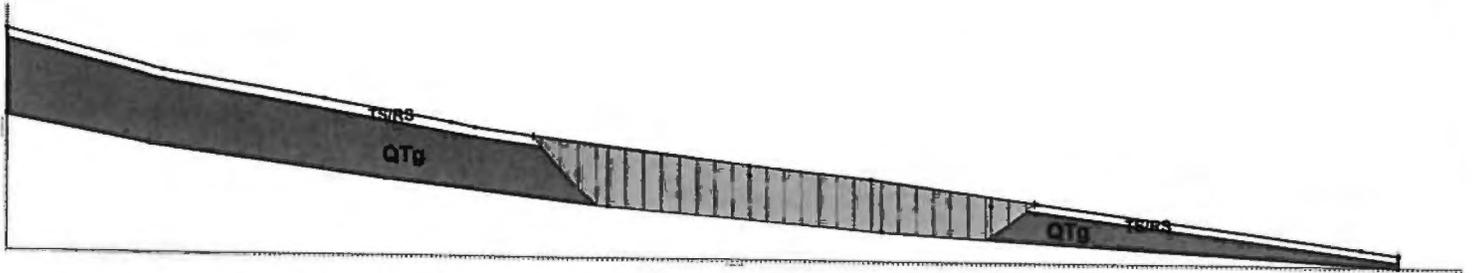
Based on the results of our analyses, the slope at Lot 3 has substantially adequate safety factors against landsliding during static and seismic conditions. The results of the slope stability analysis are presented on Plates 7 and 8.
