**PRELIMINARY SOILS INVESTIGATION
BLEDSOE CREEK STORM DRAIN (LINE 'A')
AND SLOPE REPAIR
HIGHLAND, CALIFORNIA**

**PROJECT NO. 40155BB.13
MARCH 17, 2020**

Subject: Preliminary Soils Investigation, Bledsoe Creek Storm Drain (Line 'A') and Slope Repair, Highland, California.

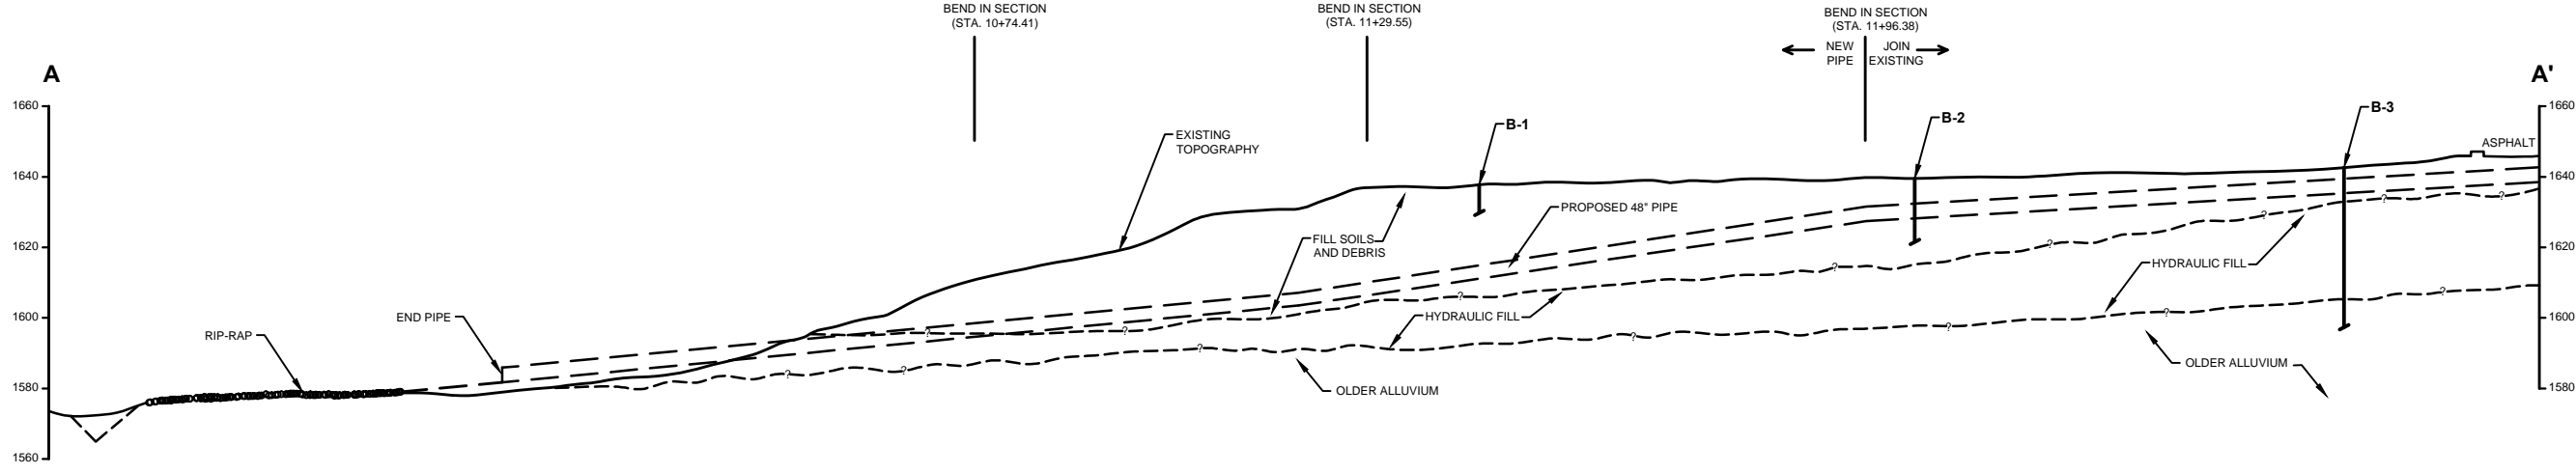
CROSS SECTION A-A'

Natural soils in the form of alluvial deposits were encountered only within our exploratory boring B-3 and at considerable depth. These are present beneath the fill soils in other areas of the site as well. The alluvial soils were generally sandy and medium dense to dense. Groundwater was encountered within our exploratory boring B-3 at a depth of 26 feet below the ground surface.

Cross-section A-A', Enclosure A-3 within Appendix A, depicts our approximation of the subsurface conditions within and along the area of the storm drain. A detailed description of the subsurface conditions as encountered within our exploratory borings is presented on the Boring Logs within Appendix B.
