Arborist Report

Kielty Arborist Services

April 13, 2020

Site: 3000 Bowers Avenue, Santa Clara CA

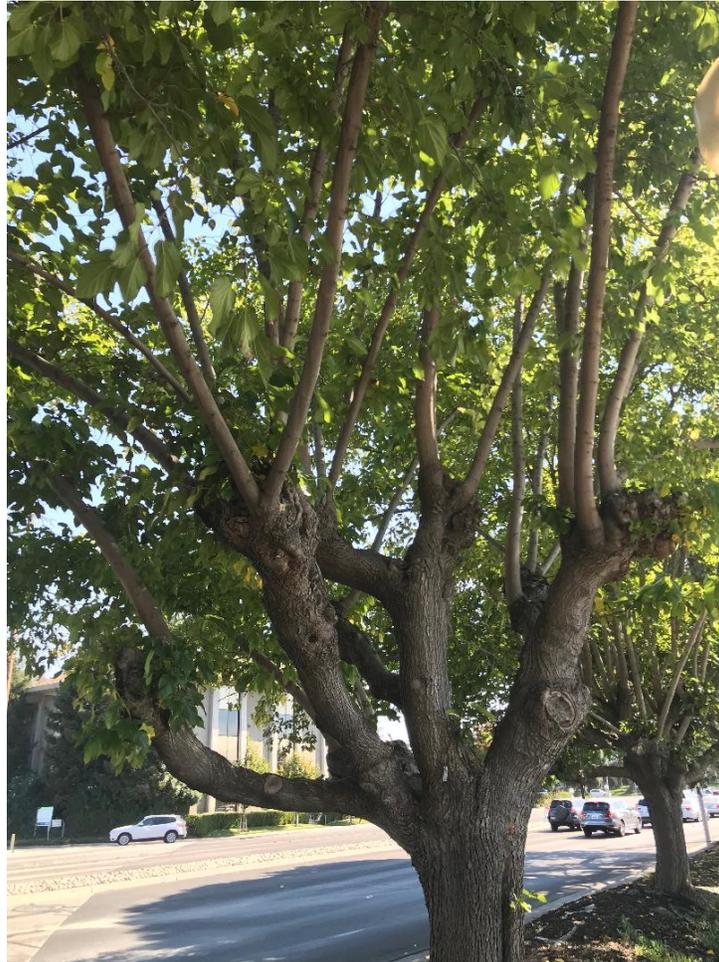
The landscape at 3000 Bowers has been poorly maintained in the past as no apparent recent maintenance to the trees was observed. All of the mulberry trees have been repeatedly topped in the past. Many large Italian stone pine trees were observed near the street.

Showing topped mulberry tree

Trees surveyed with a condition rating lower than 50 are considered to be poor trees and should be removed regardless of the proposed construction. All of the surveyed mulberry trees were given poor condition ratings due to being topped repeatedly. Topping trees is not an acceptable pruning practice due to future hazards created. Topping trees leads to decay at the point of origin as the cut is too large for the tree to develop enough wound wood to stop the spread of decay. Future growth following topping cuts consist of weakly attached sprout like growth. These new limbs do not develop proper branch to trunk attachments, and as a result future limb failure is at a high risk. Mulberry trees #2 and #3 are the only mulberry trees on site to be retained at this time. These trees should be pruned annually to reduce risk of limb failure. Crown reduction pruning should be applied to these trees to reduce limb failure risk.

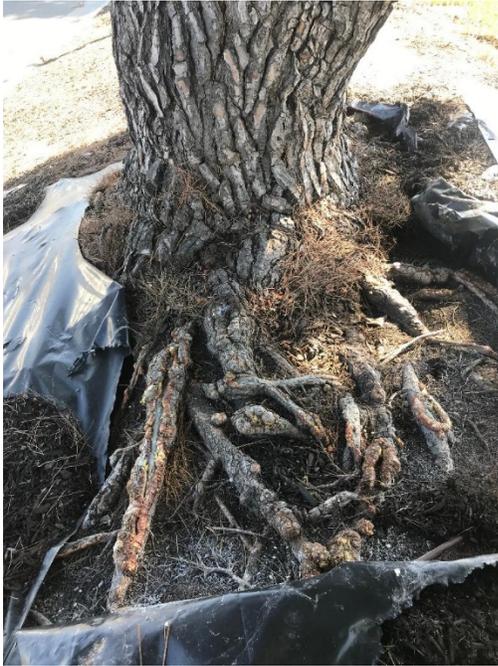
Showing lawn mower damage

All of the surveyed Italian stone pine trees are mature trees. Past lawn mower damage was observed at the root crowns of all the pine trees with surface roots being damaged. It appears that the landscape has been covered by mulch and a weed barrier. The pine trees all have dense canopies. Naturally most of the Italian stone pine trees are codominant with poor attachments (included bark) observed. The natural architecture of this species is poor and makes the tree prone to limb and trunk failure. Not only do they develop poor codominant unions, but the species also has a wide spreading canopy that creates more stress on the poorly formed unions and heightens risk of limb failure. This species needs a large area for root growth, and generally are not a well-suited species for street trees. The species has a branch strength rating of weak to medium weak (<https://selectree.calpoly.edu/tree-detail/pinus-pinea>). Most branch failures (60%) occur at the point of attachment due to included bark. Root failures are the most common types of failures reported with this species according to the California tree failure report program.

All of the pine trees to be retained are recommended to be pruned to reduce heavy end weight on the lateral limbs and to reduce stress to the poorly formed codominant unions. Cabling of large codominant leaders is also recommended to reduce limb failure risk.

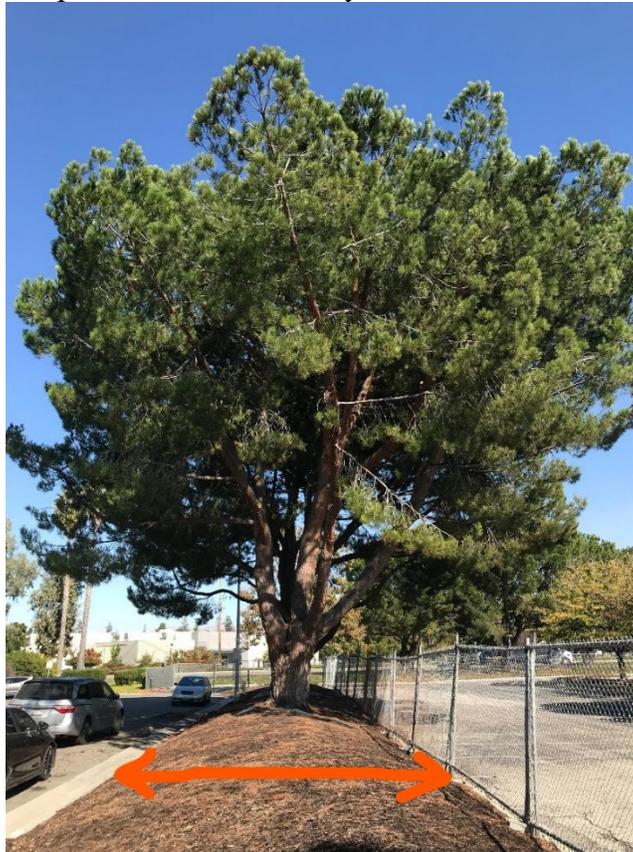
Proposed hardscapes (pathways) within the above distances should be constructed on top of existing natural grade while using biaxial geogrid as an underlayment. By using this “zero cut method” the trees structural stability can be maintained. The geogrid will help to reduce compaction levels within the tree protection zones. Any underground utility lines within the above distances can be excavated by hand in combination with an air knife. Lines will need to be placed below or besides roots to avoid cutting roots where necessary. Exposed roots during this process will need to be kept moist by wrapping the roots with burlap and spraying down the burlap multiple times a day. If the above distances from the trees to excavation or construction recommendations cannot be done, then the trees should be removed and replaced. Tree protection fencing will need to be installed and maintained at the above distances throughout the construction process. During hardscape construction or utility line work within these distances, tree protection fencing will need to be temporarily reduced. The Project Arborist will need to be on site during the proposed work within the above distances. During this time the work will be documented with mitigation measures recommended as needed. Impacts to these trees are expected to be minor if the above recommendations are followed. The existing landscaped areas for the large Italian stone pine trees are recommended to be retained as is. All of the pine trees have large elevated root crowns. Any grading near these could impact health and stability.

Arrow showing landscape area below stone pine trees. This area should remain unaltered if possible.

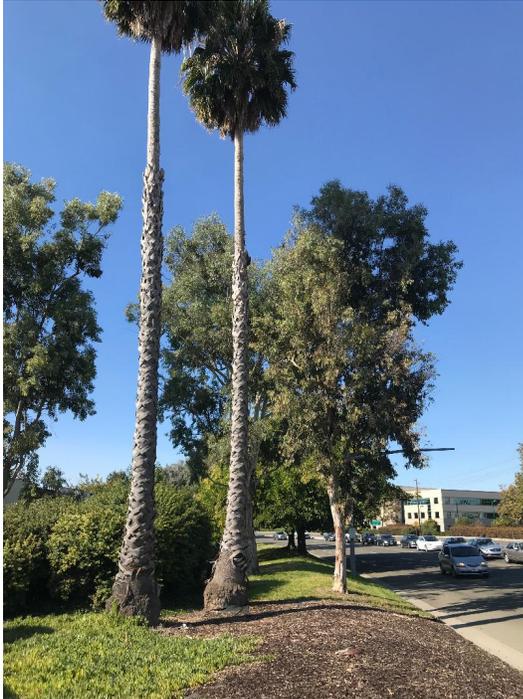
Mexican fan palm trees #12 and #13, as well as Silver dollar eucalyptus trees #14 and #15 are near the proposed grass paver area and landscape work. These trees have a moderate tolerance to construction impacts and are young trees. These trees were therefore given a tree protection zone multiplication factor of 6. Below is the recommended offset from construction impacts for the palm trees and eucalyptus trees.

Showing palm trees and eucalyptus trees

#12- 14.5 feet #13- 14.5 feet #14- 9 feet
#15- 7 feet

The proposed hardscape work within the above distances should take place on top of grade while using biaxial geogrid as an underlayment. If this can happen then impacts would be nonexistent as no cut would be needed.
