Type of Services	Phase I Environmental Site Assessment
Location	APNs 220-32-057 & 220-32-058 3017-3157 El Camino Real Santa Clara, California
Client	Bayview Development Group, Inc.
Client Address	60 South Market Street, Suite 450 San Jose, California 95113
Project Number	958-4-1
Date	June 19, 2018

Prepared by **Sarah E. Kalika, P.G.**
Senior Project Geologist

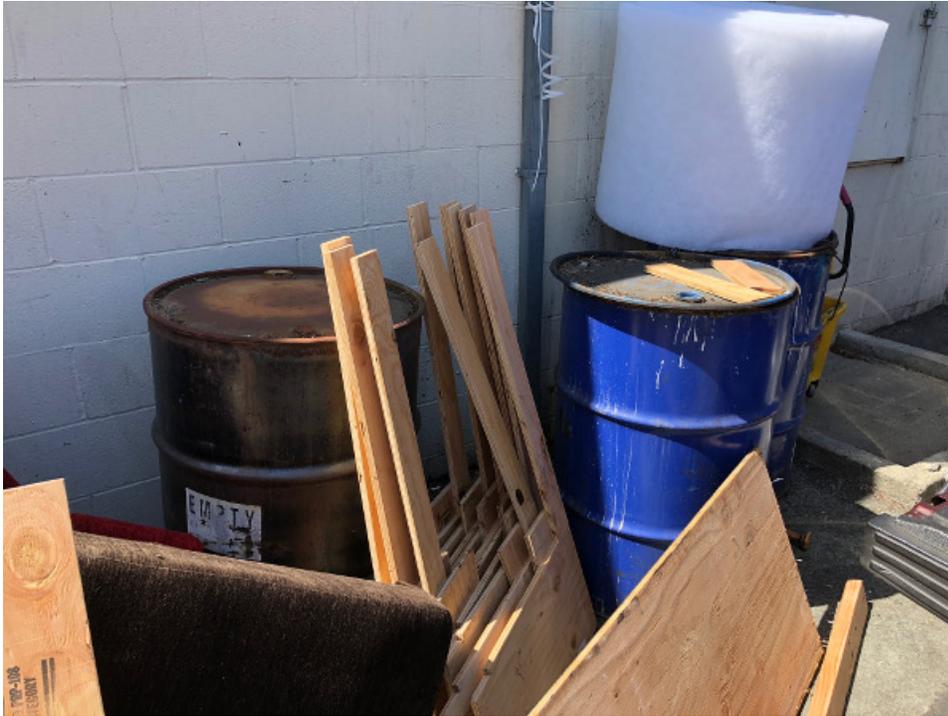
Photograph 21. Three (labeled empty) 55-gallon drums and renovation-related construction materials along north side of bar / restaurant.

No additional spills or leaks were noted around the hazardous materials observed. We recommend requiring the property owner and tenants to remove all hazardous materials for proper disposal prior to purchasing the Site.

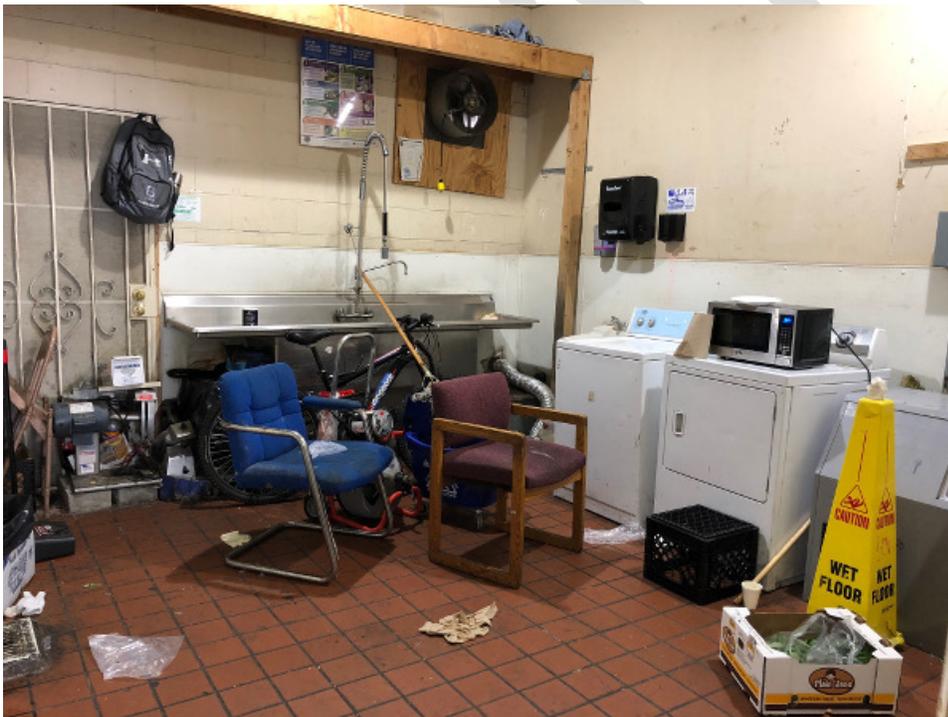
Photograph 42. Washer & dryer, ice machine and sink within rear of additional market tenant space. Washer and dryer reportedly drains to an exterior containment.

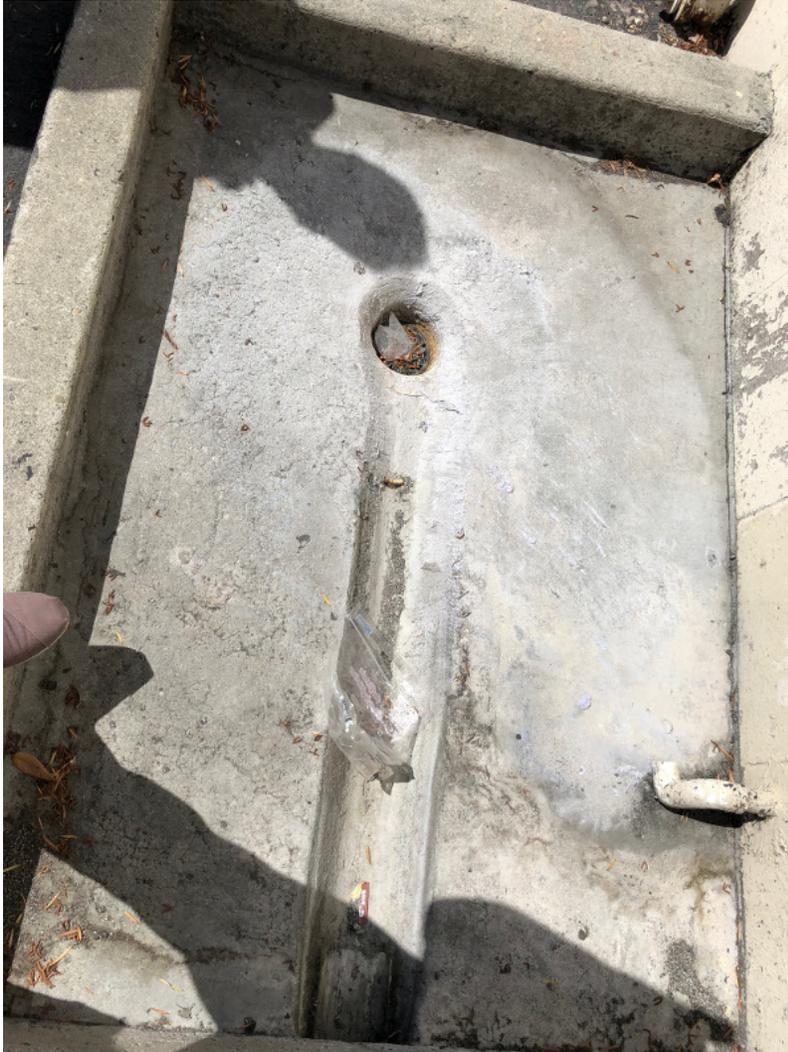
A concrete-curbed exterior drain, fed by a pipe connected to the rear of one of the food market tenant spaces, was observed along the eastern side of the shopping center structure. This drain is reportedly used to drain a washing machine within the tenant unit.

Photograph 43. Exterior containment and drain, reportedly serving the washer and dryer shown in photo 41.

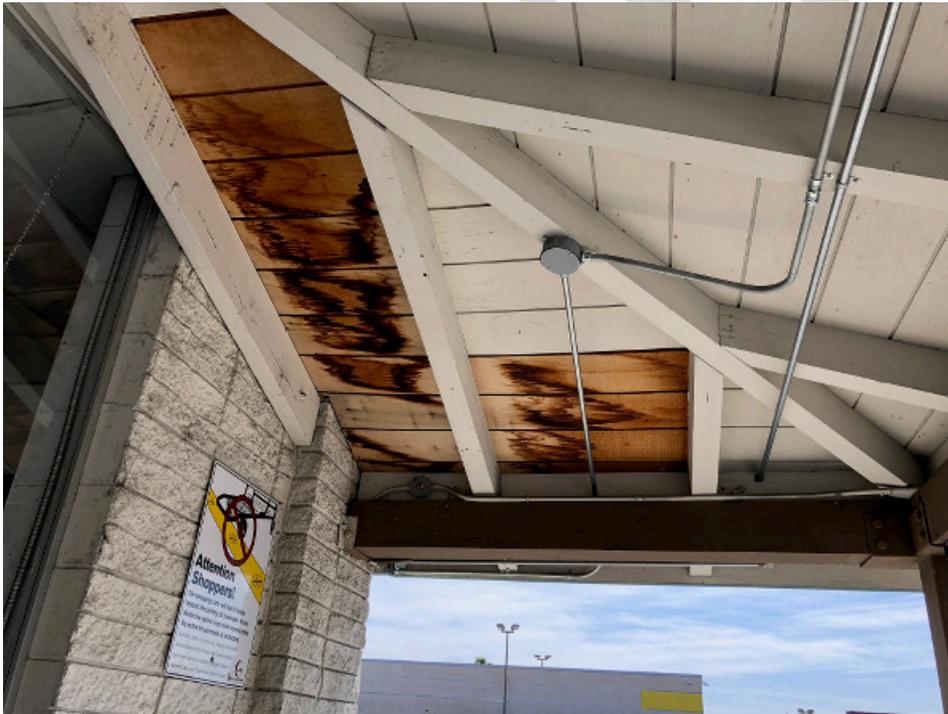
Photograph 49. Apparent damage to roof at southeast corner of shopping center structure.

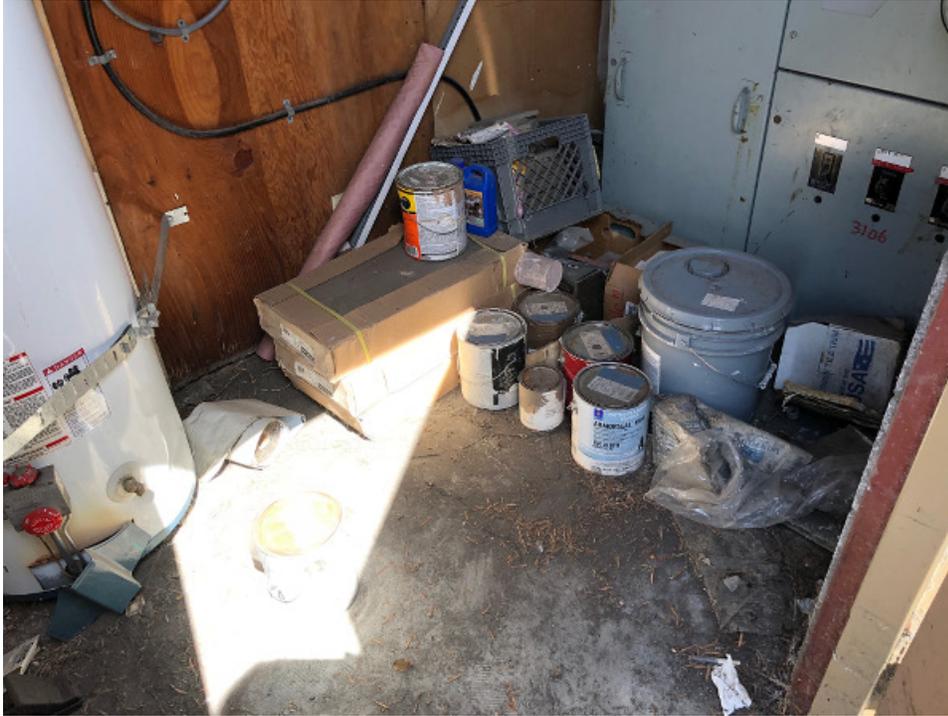
Photograph 52. Additional view of paint and property maintenance supplies.

Minor quantities of household and commercial-grade cleaners, paints, and cooking oils were observed within the various tenant spaces and maintenance storage areas.

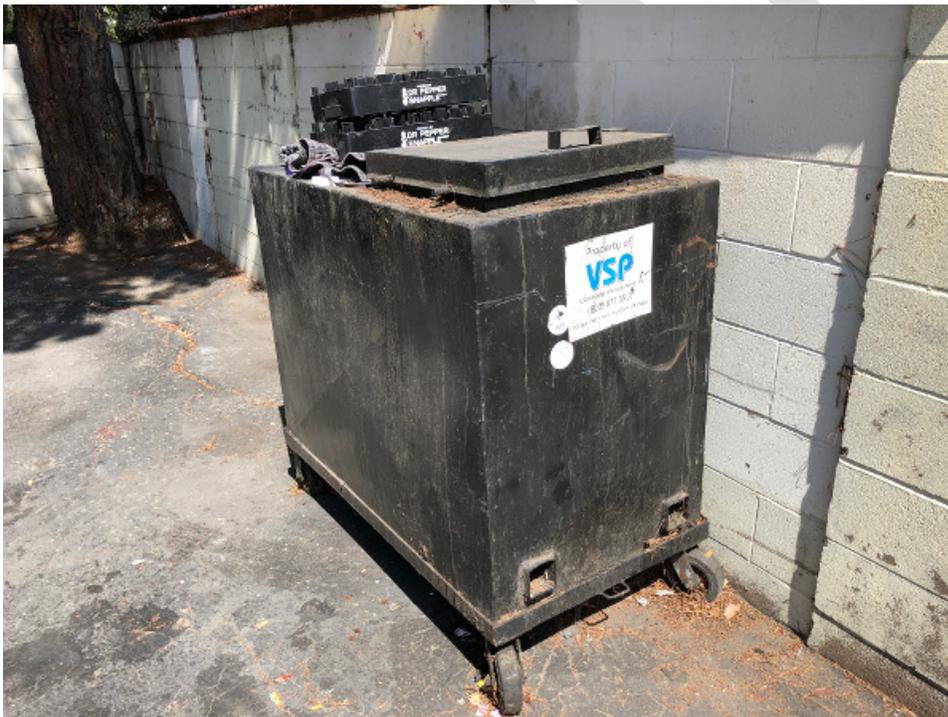
At least three subsurface cooking oil sumps were observed along the northern side of the shopping center structures. Several additional above-ground cooking oil disposal containers were observed near on-Site restaurants.

Photograph 53. Cooking oil disposal container, located along northern boundary of Site.

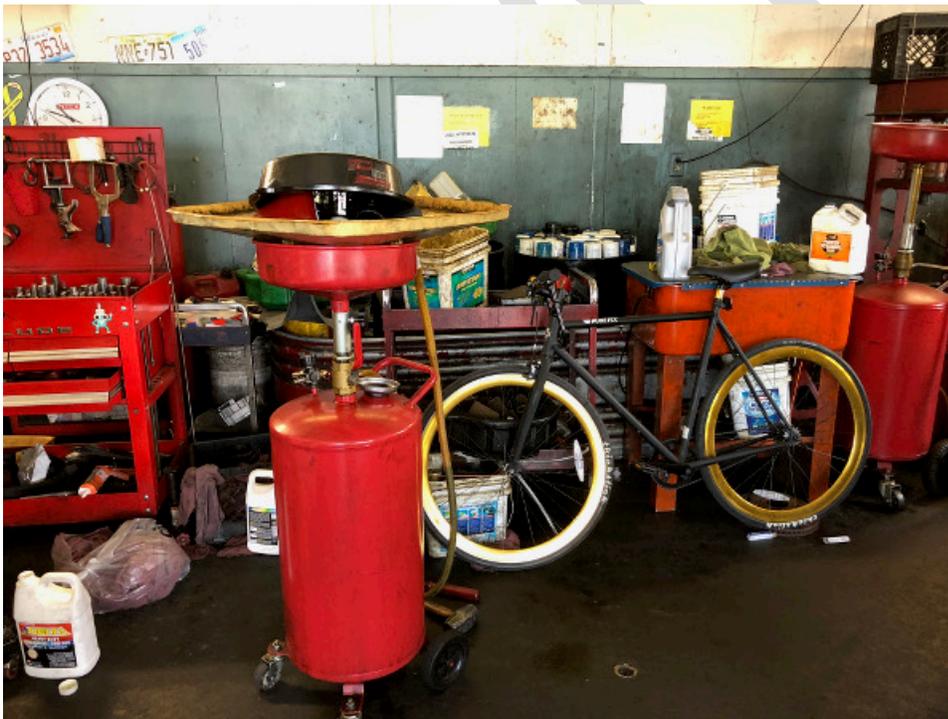
Photograph 65. Waste oil container with tools and service-center related fluids and debris along wall.

Hazardous materials, including waste oil, oil filters, tires, automotive fluids, Freon gas, lubricants, and 55-gallon drums were observed during our Site visit within the former Mobil service station space, now operated by US Auto, who performs automobile service. Surface staining typical of automobile repair businesses was observed on concrete and asphalt within the service center space and surrounding asphalt pavement and storage areas. No exposed soil was observed in these areas.

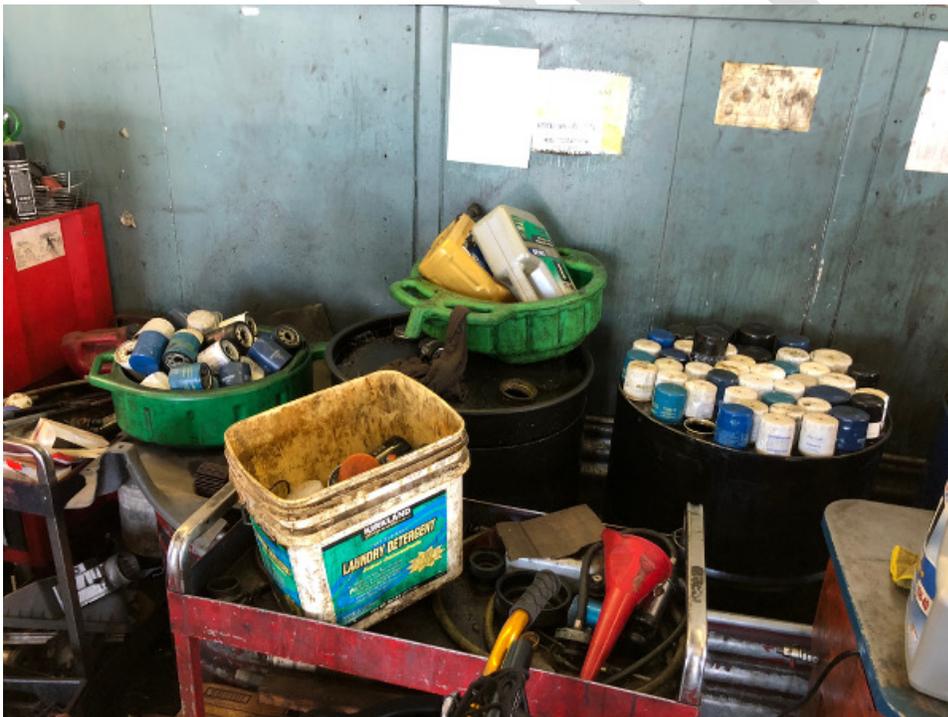
Photograph 67. Used oil filters and 55-gallon drums along northern wall.

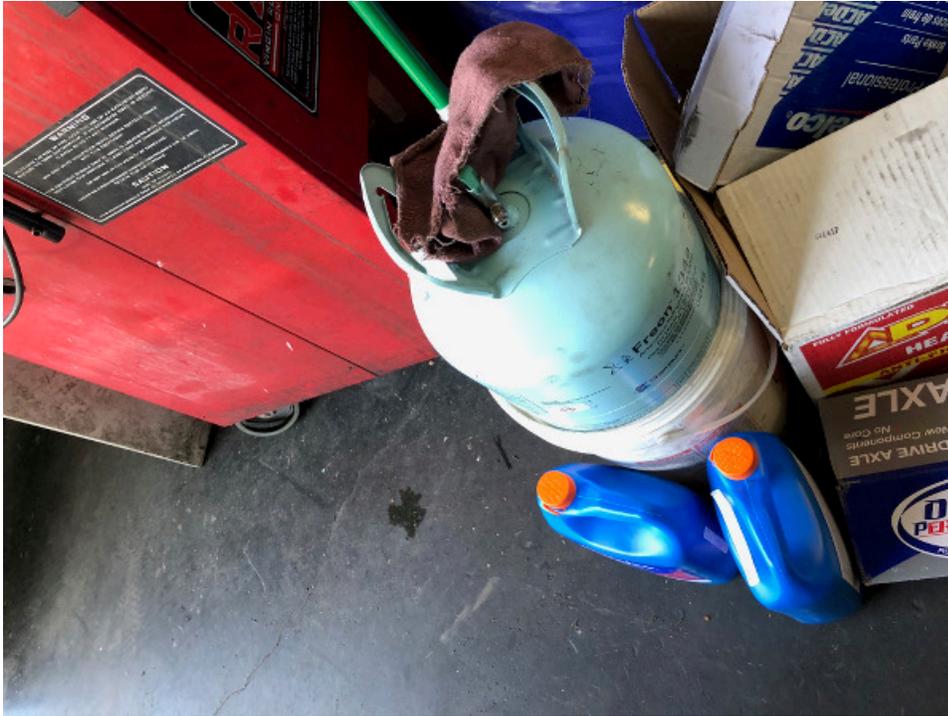
Photograph 70. Canister of Freon, containers of transmission oil.

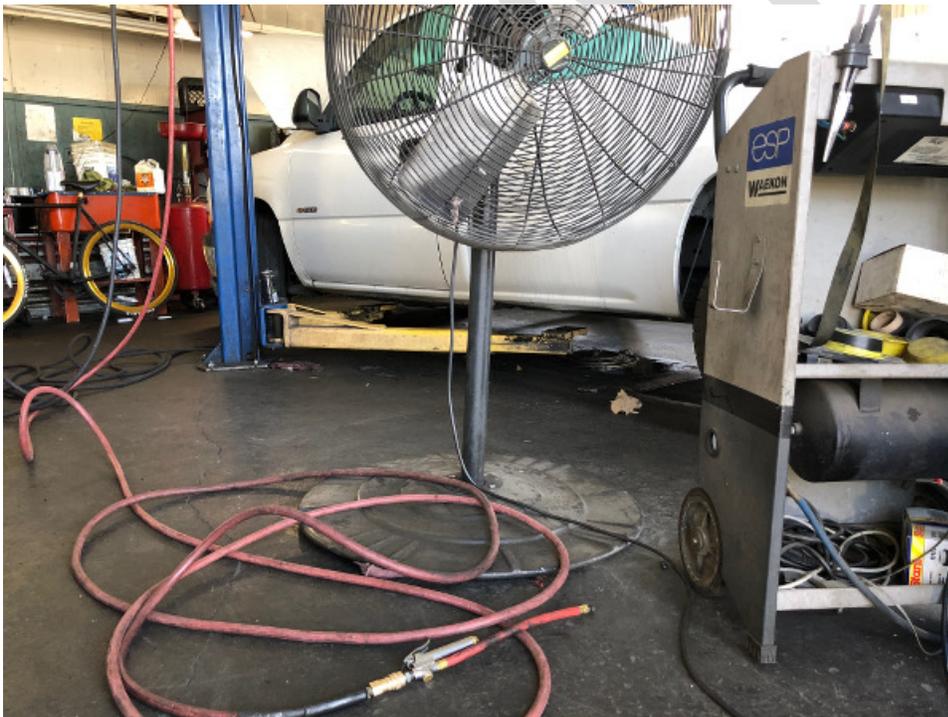
The automobile service station was observed to have one above-ground vehicle lift and one in-ground hydraulic lift, though mechanisms for each lift were obscured by the presence of vehicles. 55-gallon drums of waste oil, oil filters, and vehicle fluids were observed within the auto service area and within a fenced storage area adjacent to the east. Vehicle-related wastes, including automobile batteries and tires were additionally observed.

Photograph 71. Vehicle lift system, apparent hydraulic lift.

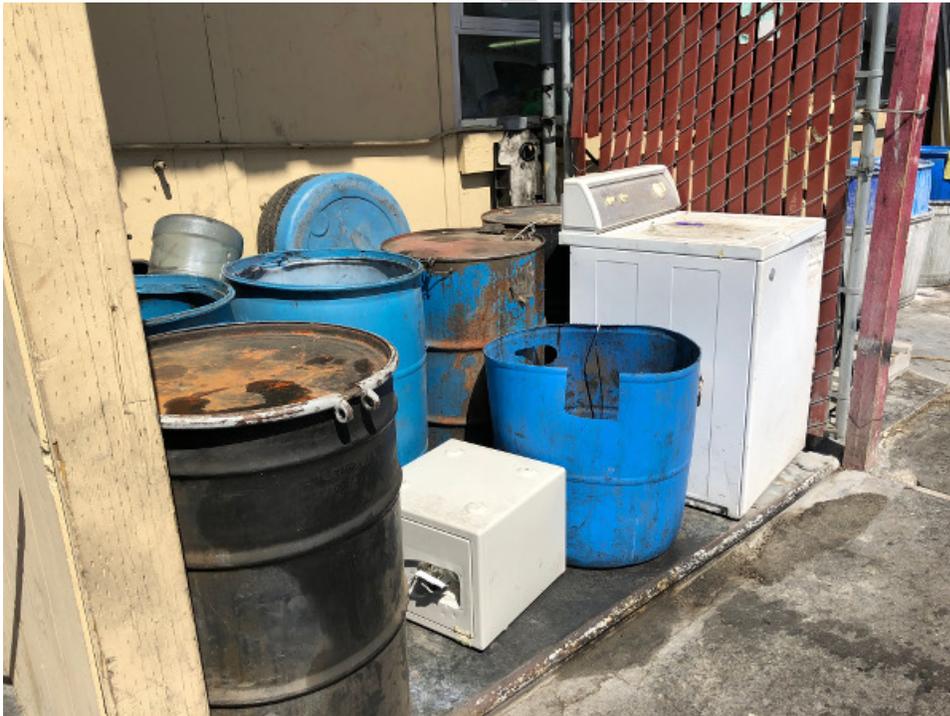
Photograph 73. Drum storage, debris storage area along eastern exterior of automobile service structure.

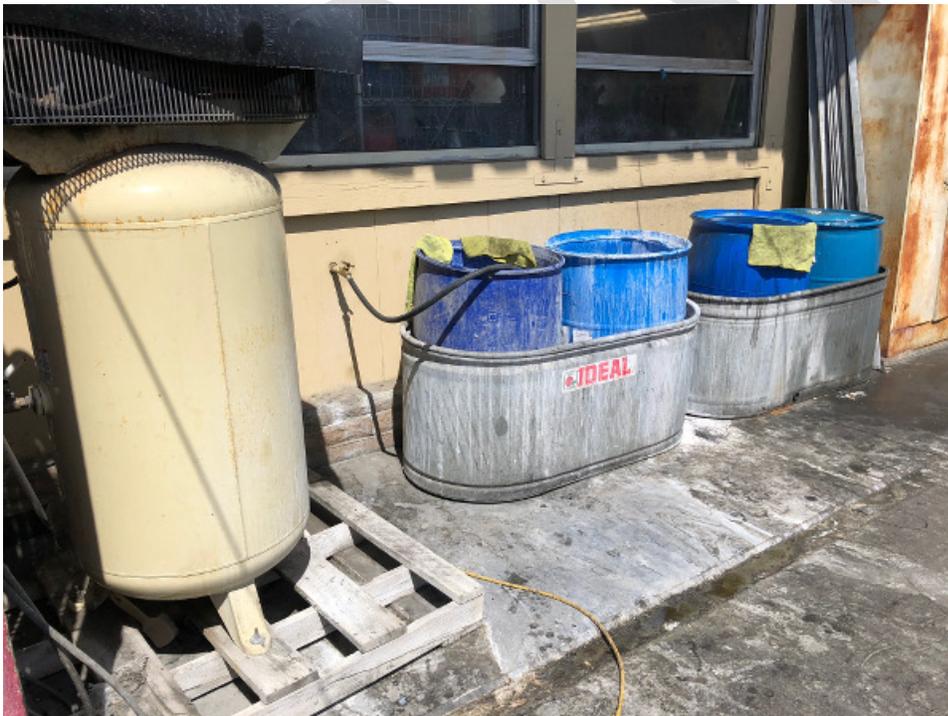
Photograph 75. Additional view of storage area, drums containing liquids, compressor.

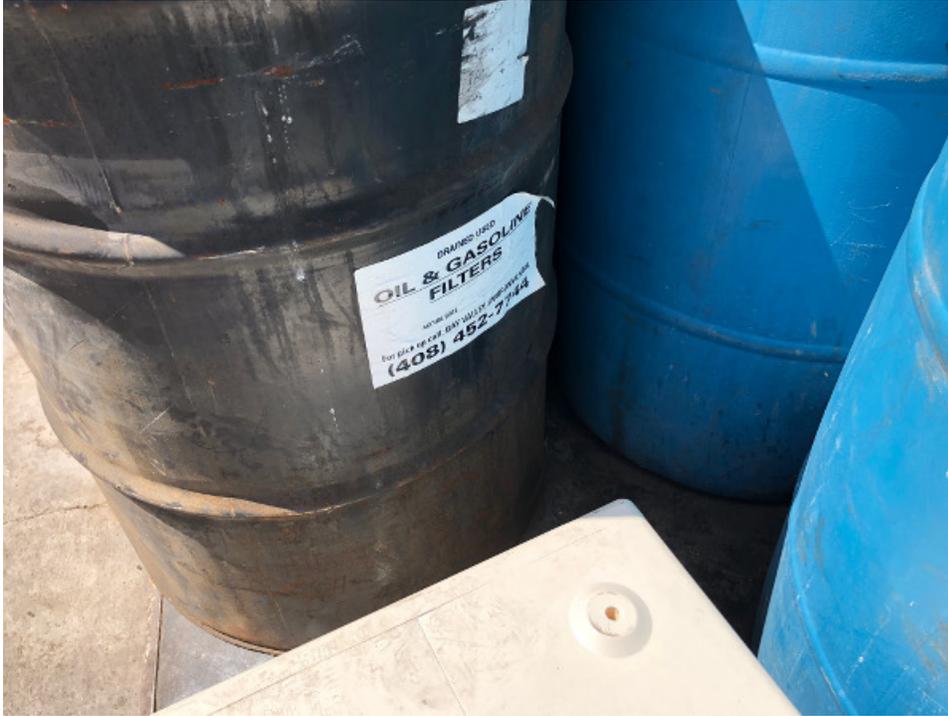
Photograph 77. 55-gallon drum labeled oil & gasoline filters within storage area.

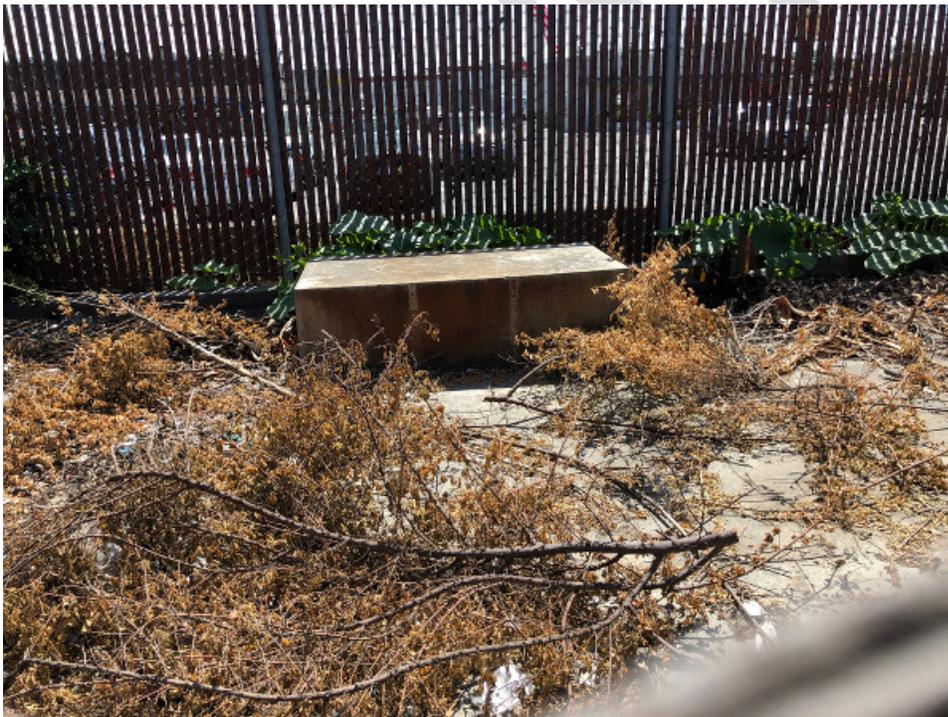
Photograph 78. Reported former location of ground water treatment system on-Site, located southeast of automobile service structure within fenced area.

Due to the presence of remaining petroleum hydrocarbons within soil, ground water, and soil vapor, DEH noted within the closure letter that residual contamination in both soil and ground water that remains on-Site could pose an unacceptable risk to development activities including site grading, excavation, or the installation of water wells. The Santa Clara County Department of Environmental Health and the City of Santa Clara Planning Department request notification if any changes in land use or proposed excavation or site grading is planned and additionally request that residual contamination be assessed to ensure that no significant impact to human health, safety, or the environment occurs (County of Santa Clara, 2016). We recommend collecting and analyzing soil vapor samples to evaluate whether the concentrations of gasoline range hydrocarbons detected in soil and ground water present a significant vapor intrusion risk.
