September 14, 2020

Project # OMP-08

Subject: Arborist Report for the 1953 Concourse Drive Project, City of San Jose, California

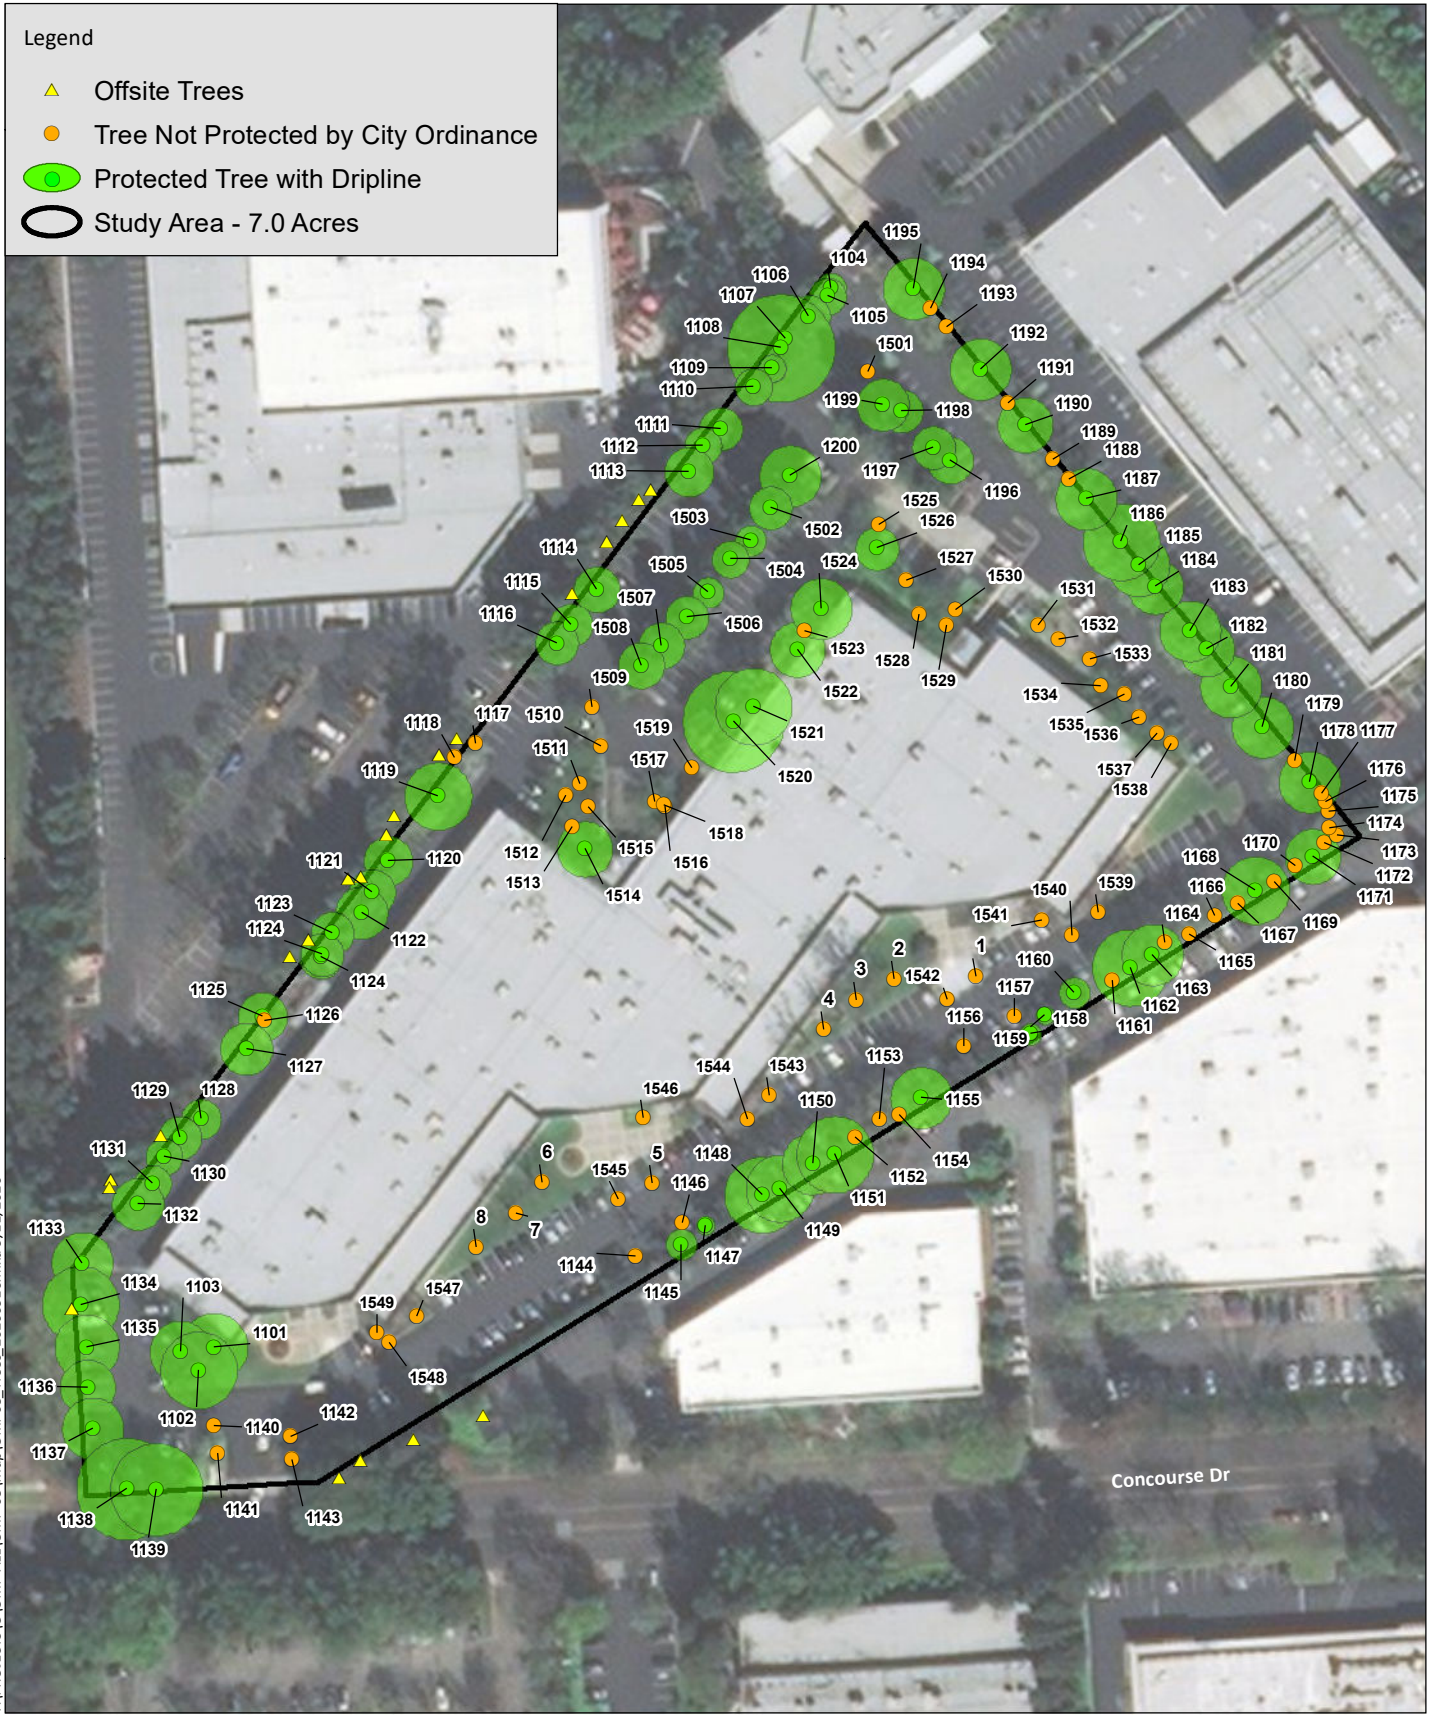
80 of the inventoried trees within the Study Area are regulated by the Ordinance. The total DBH of these trees is 1,402 inches. 78 trees not regulated by the Ordinance were inventoried within the Study Area. The total DBH of these trees is 581 inches. Detailed tree data can be found in Attachment C. Geospatial data of inventoried trees can be found in Figure 2 of Attachment A.

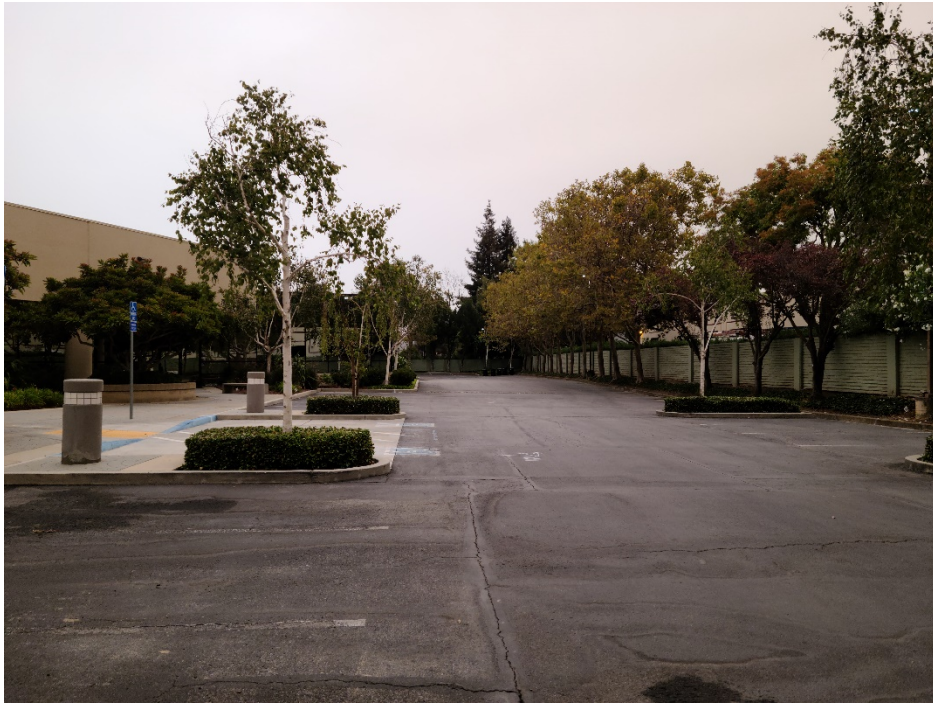
Photo 1: Looking northeast across Study Area.

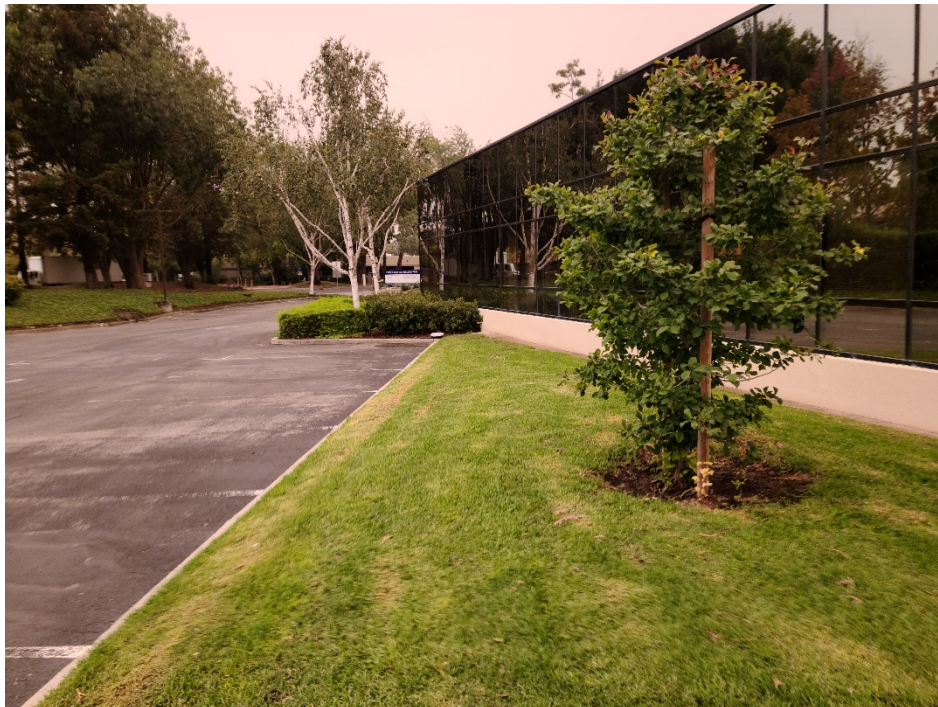
Photo 2: Looking Southwest across Study Area

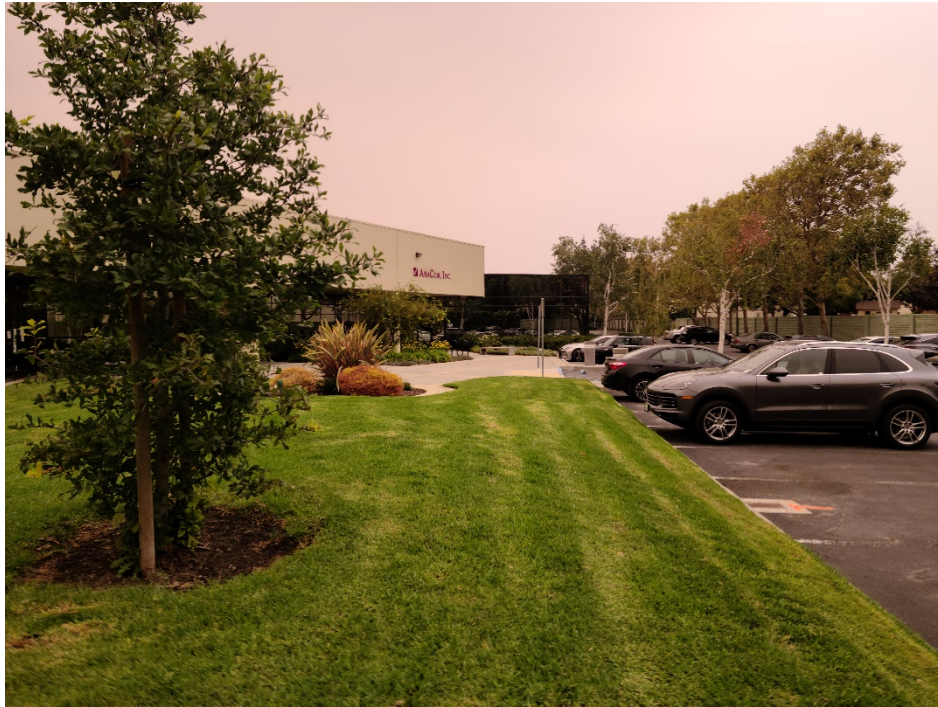
Photo 3: Looking southeast across Study Area.

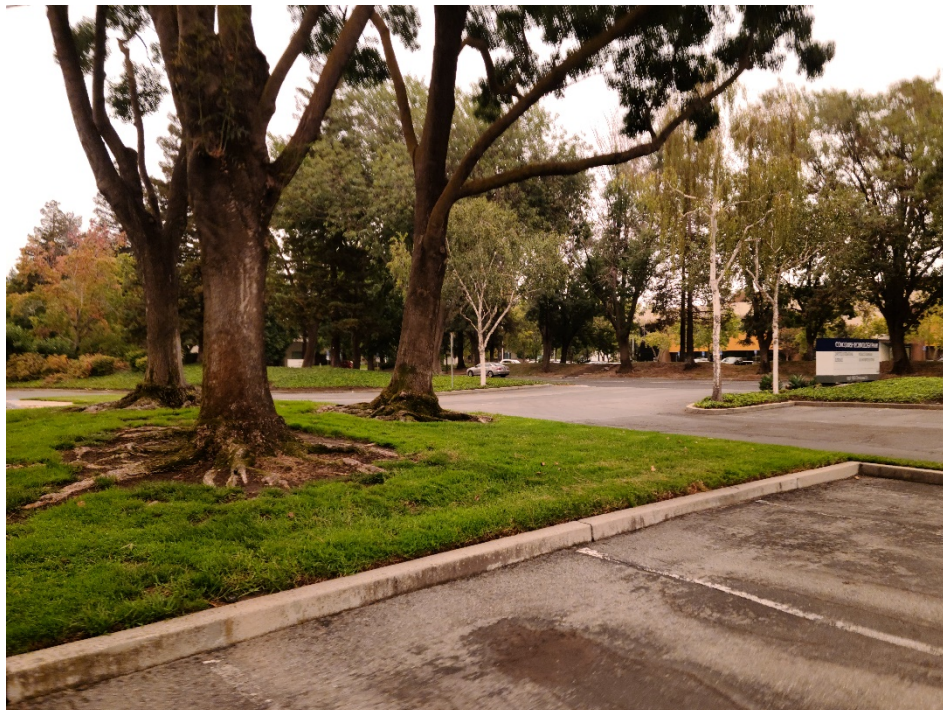
Photo 4: Looking south at southern border of Study Area.

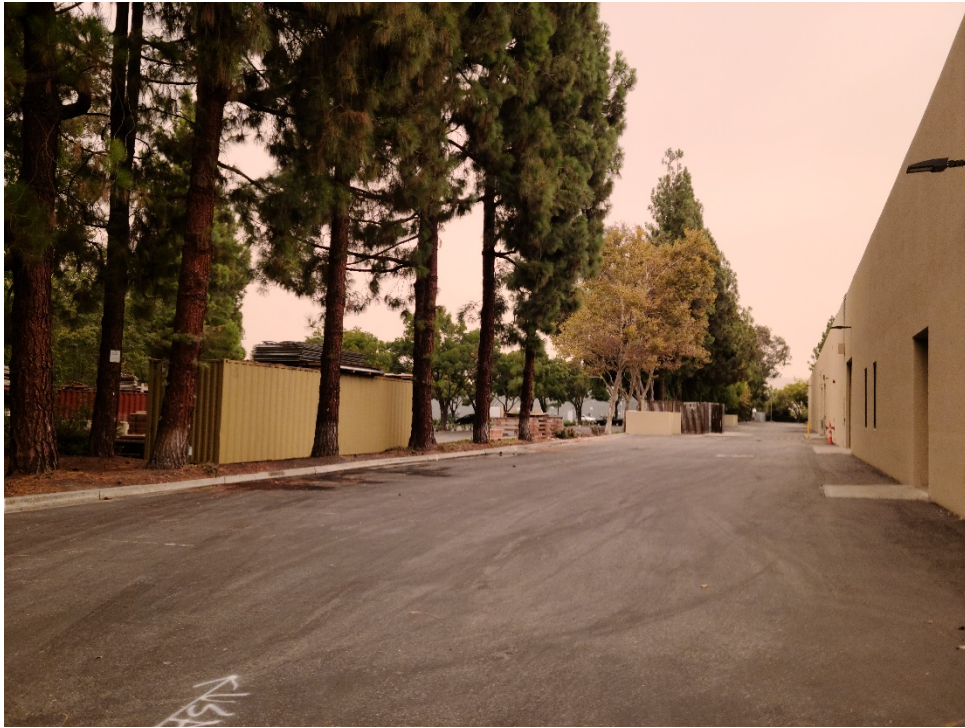
Photo 5: Looking northeast across northern border of Study Area (southern portion).

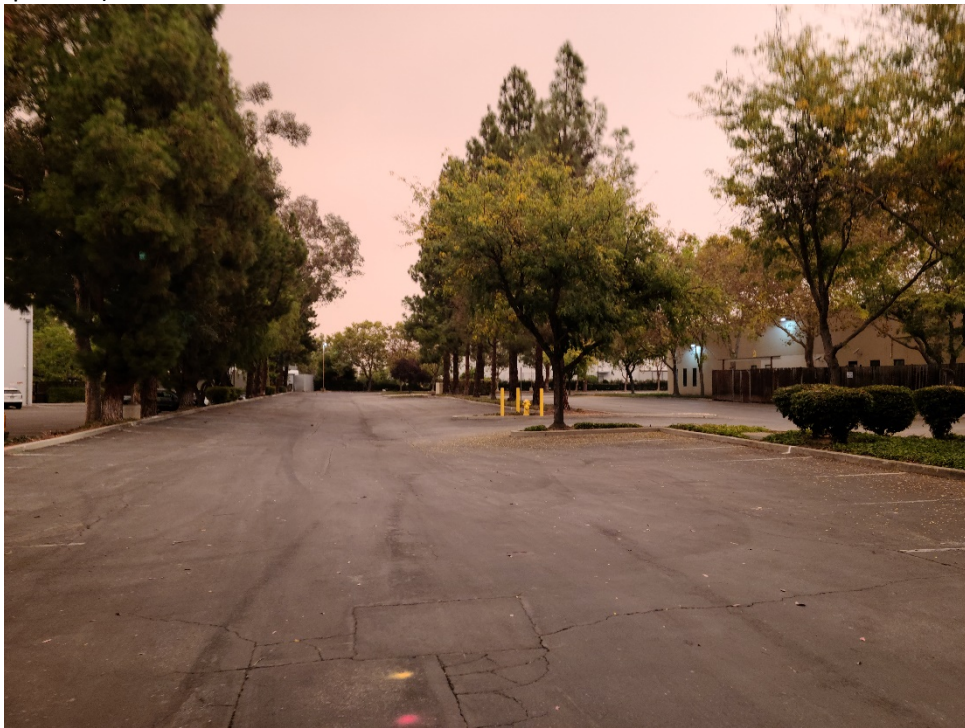
Photo 6: Looking northeast along northern border of Study Area (northern portion).
