Arborist Report and Tree Mitigation Memorandum

Updated Arborist Report

**681 East Trimble Road and adjacent vacant lot
San Jose, CA 95131**

October 29, 2021

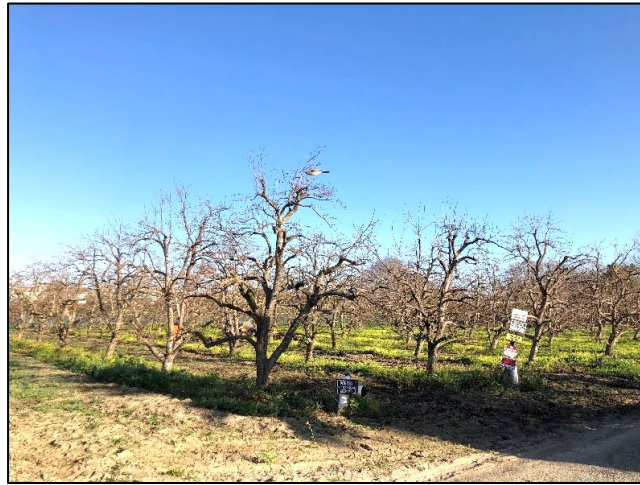
Persimmon was the most commonly occurring species on-site. One hundred and seven (107) persimmons were growing in an orchard on the southern half of the property (Photo 1). Tree conditions ranged from poor (32 trees) to fair (75 trees). The trees had been pruned for fruit production, resulting in vase shaped crowns, re-sprouting from heading cuts, and multiple stems or codominant stems arising from the same points along each tree's trunk. Many of the trees also had mechanically damaged trunks and lower branches, likely from farm equipment.

Photo 1 – One hundred and seven (107) persimmon orchards trees were growing onsite.

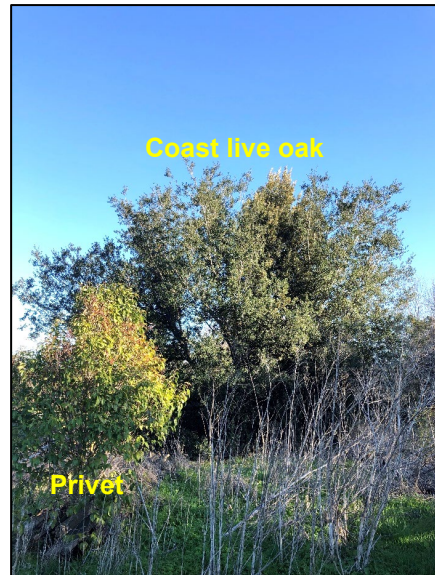
Forty (40) glossy privets were also assessed. Tree conditions ranged from poor (13 trees) to good (two trees), with 25 trees in fair condition. The privets were unmaintained and appeared to be volunteers. Many had shrubby, overgrown forms and multiple stems that arose from the ground (Photo 2).

Photo 2 – Background: The larger coast live oaks had vigorous, spreading crowns.
 Foreground: Many privets had shrubby, overgrown forms.

Thirty-nine (39) coast live oaks were growing onsite. Coast live oak #51 was growing off-site with an overhanging crown. Overall, tree conditions ranged from poor (four trees) to good (22 trees) with 14 trees in fair condition. The coast live oaks were amongst the largest trees onsite. For example, coast live oak #337 had trunk diameters of 20, 18, 17, 16, and 6 inches. The larger, established coast live oaks had vigorous, spreading crowns that often suppressed the trees growing in the understory (Photo 2). Many small coast live oaks appeared to be volunteers.

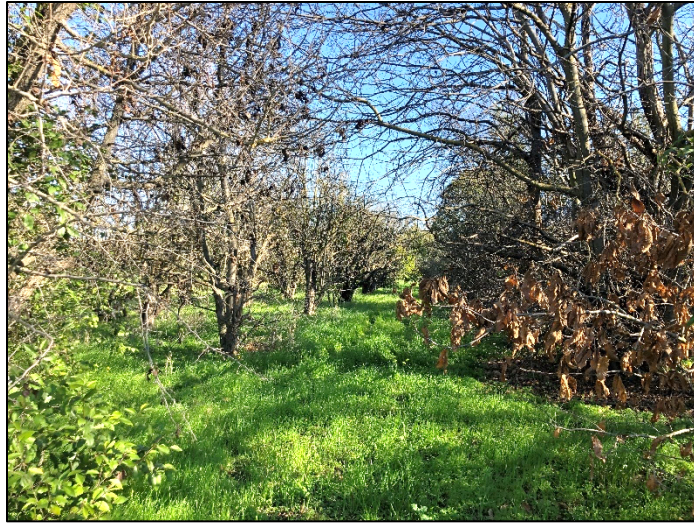
Photo 3 – Nineteen (19) almond orchard trees were also included in the assessment.

Nineteen (19) almond orchard trees were also included in the assessment (Photo 3). Tree conditions ranged from poor (12 trees) to fair (7 trees). Most of the trees exhibited signs of trunk and/or crown decay.

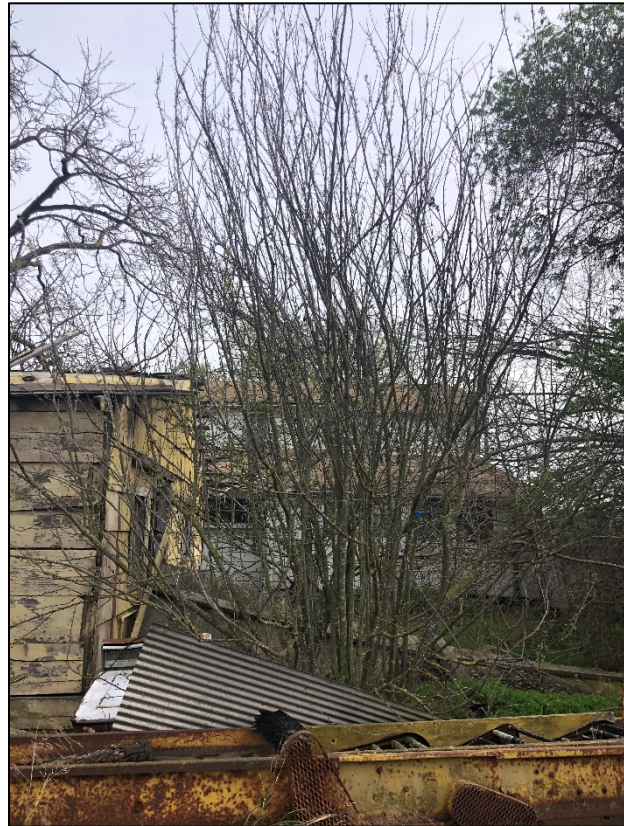
Twenty-three (23) trees of heaven were growing throughout the site. Tree conditions ranged from poor (one tree) to good (one tree) with 21 trees in fair condition. Most appeared to be volunteers with shrubby, vigorous, and unmaintained growth (Photo 4).

Photo 4 – Most of the trees of heaven appeared to be volunteers with shrubby, vigorous, and unmaintained growth.

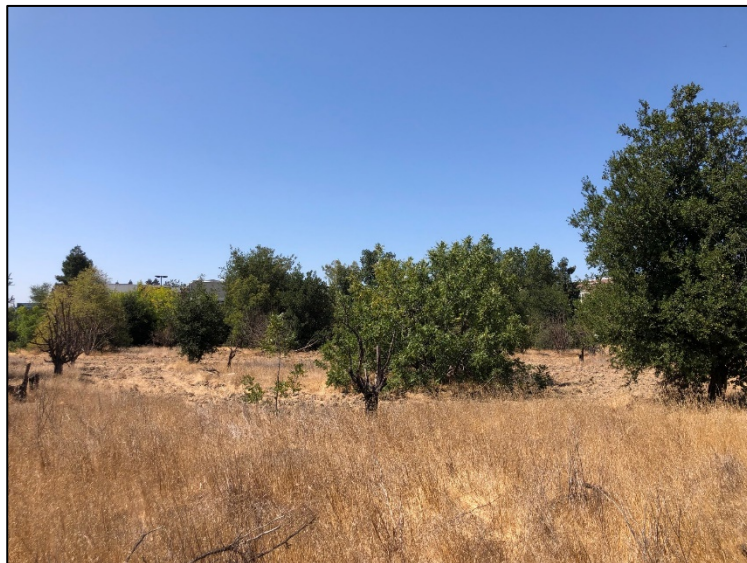
Many of the trees growing at the vacant lot were either volunteers (Photo 5), old dying orchard trees, or growing off-site as screening for the property at 2670 Seely Avenue, San Jose (Photo 6).

Photo 5 – Many of the trees at the vacant lot were growing as volunteers- they were not intentionally planted nor were they being maintained.

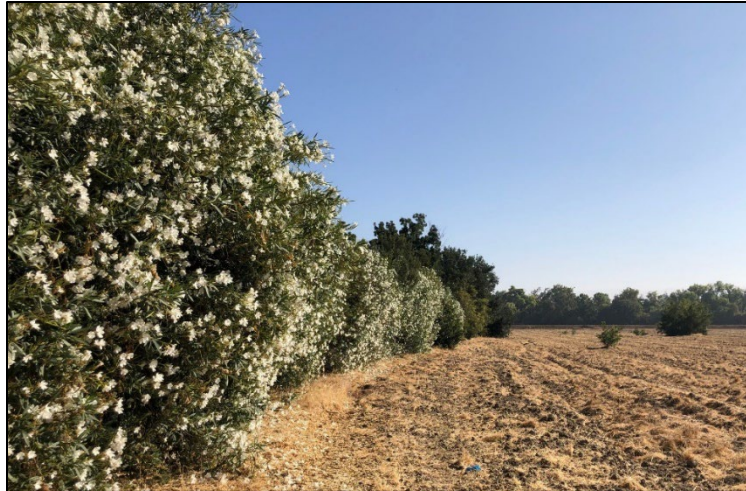
Photo 6 – Many trees near the vacant lot were growing along the western perimeter of the property. Most were off-site. These shrubby trees provided screening between the lot and the adjacent property.

The greatest opportunity for preservation lies with the 125 off-site trees located at 2670 Seely Avenue, San Jose. I recommend exploring the potential to preserve these trees and limit the proximity and intensity of development planned near them. These trees have crowns and likely also roots extending into the work area.

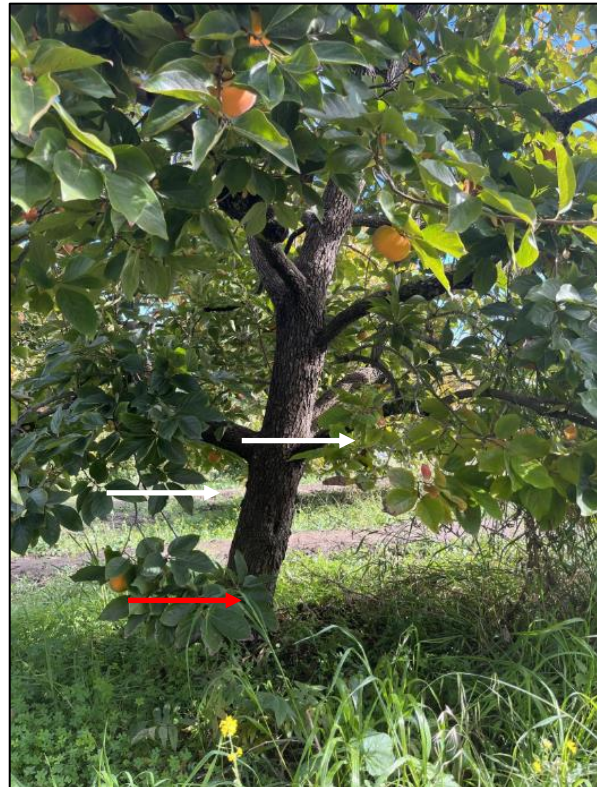
A tree with a diameter of 12-inches has a circumference of 38-inches and a trunk cross-sectional area of 113 square inches. Persimmon #121, for example, had three trunks measuring 8, 2, and 2 inches, totaling 12 inches in diameter, with a summed circumference of 38 inches, which requires replacement at a 3:1 ratio. The 8-inch stem is clearly the main trunk while the two 2-inch "trunks" are low branches that attach below the measuring point of 54 inches (Photo 1). The summed cross-sectional area of the three "trunks", however, is only 57 square inches, which is equivalent to a single-stem tree with a circumference of 27-inches (8.5 inches diameter). This is approximately 50% of the cross-sectional area of a single-stem tree with a circumference of 38-inches, well below the size threshold requiring mitigation.

Photo 1. Persimmon #121. The 8 inches stem (red arrow) is clearly the main trunk while the two 2-inch stems (white arrows) are low branches.
