## **Tree Inventory Report**

**North Bayshore  
Mountain View, CA**

**PREPARED FOR  
Google, Inc.  
1600 Amphitheatre Parkway  
Mountain View, CA 94043**

**January 17, 2022**

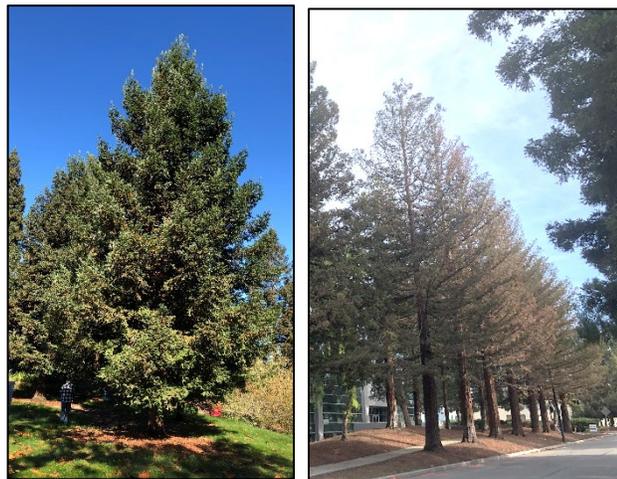
Coast redwood was 21% of the population with 828 trees. The coast redwoods were mostly in good condition (57% of population) with 30% in fair and 13% in poor condition. There was a wide range in trunk diameter from 4 to 58 inches with an average trunk diameter of 26 inches. The largest trees on the site were redwoods; tree #2489 was 55 inches in diameter, and tree #4 was 58 inches. Redwoods in good condition had dense canopies, good color and new growth in the top of the crown. Redwoods in poor condition had thin canopies, brown foliage and visible trunk exposed (Photos 1 & 2).

**Photos 1 & 2:** The coast redwood in good condition on the left had a dense, dark green crown. The coast redwoods on the right irrigated with recycled water were in poor condition and dying.

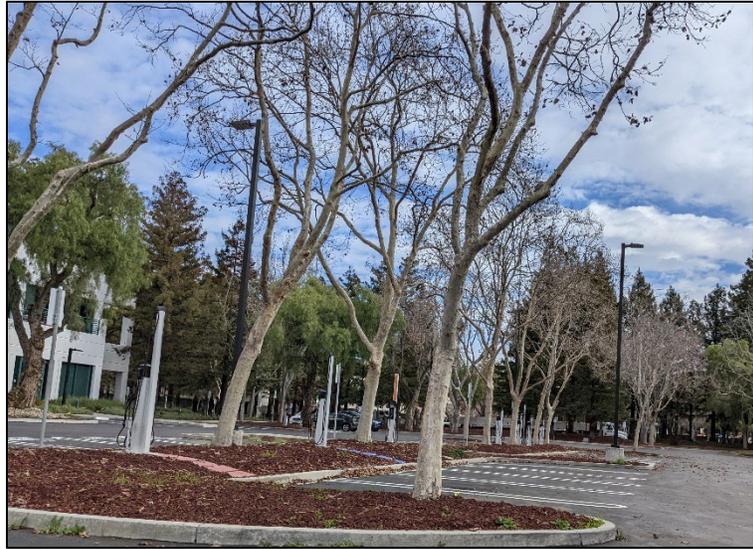
London plane comprised 15% of the tree population with 600 trees. The London planes were in good condition (60% of population) with 37% in fair and 3% in poor condition. Most planes were semi-mature (11 inch average trunk diameter) with trunk diameters ranging from 1 to 31 inches. London planes are generally tolerant of difficult growing conditions and were one of the more successful species in parking lots (Photo 3).

**Photo 3:** London plane was the dominant tree growing in parking lots on the site and were in good to fair condition.

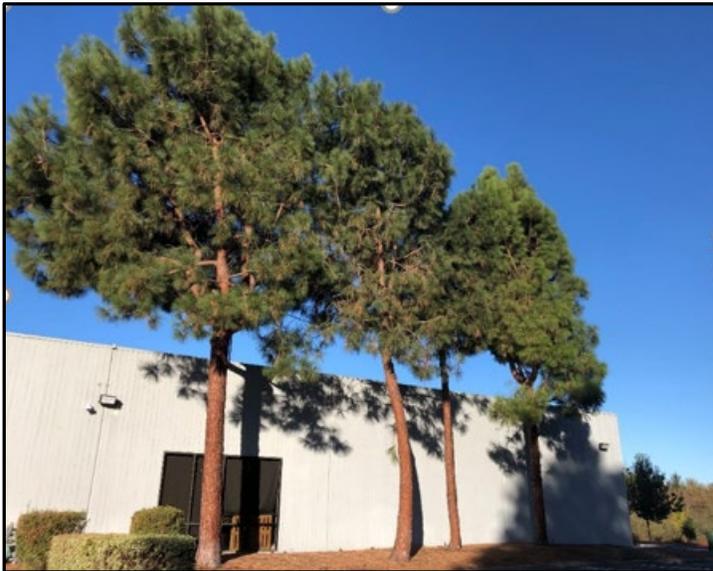
Canary Island pines comprised 5% of the population (193 trees). The pines were in good (100 trees) to fair (82 trees) condition with 11 trees in poor condition. Development ranged from young (5 inch trunk diameter) to mature (44 inch) with an average trunk diameter of 21 inches. Many of the Canary Island pines had low live crown ratios because lower branches had been removed (Photo 4).

**Photo 4:** Many of the Canary Island pines (#24-27 shown above) had lower branches removed, creating a low live crown ratio.
